**Newbank Garden Centre  
Preliminary Risk Assessment**

Job Number  
**LKC261155**

| <b>Site Address</b> | Newbank Garden Centre, Bury Road, Radcliffe, Bury, Greater Manchester, M26 2WW |
| <b>Report Title</b> | Phase 1 Preliminary Risk Assessment |

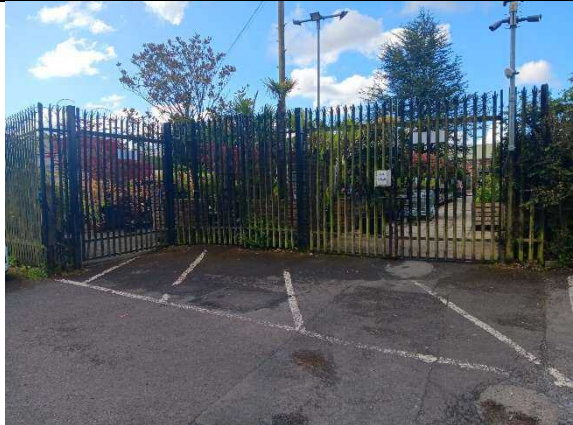
| <p><b>Photograph 1:</b> View of locked access gates on NW of site area, taken facing S.</p> | <p><b>Photograph 2:</b> View of site area from S facing N.</p> |

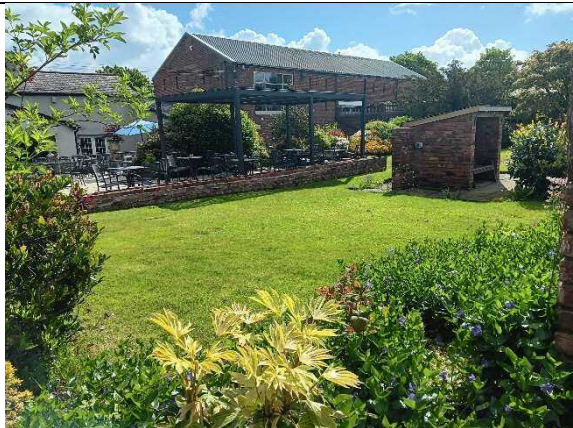
| <p><b>Photograph 3:</b> View of grassed display area in centre of the site, taken facing E. Brick service cabinet present.</p> | <p><b>Photograph 4:</b> View of external café seating from E facing NW.</p> |

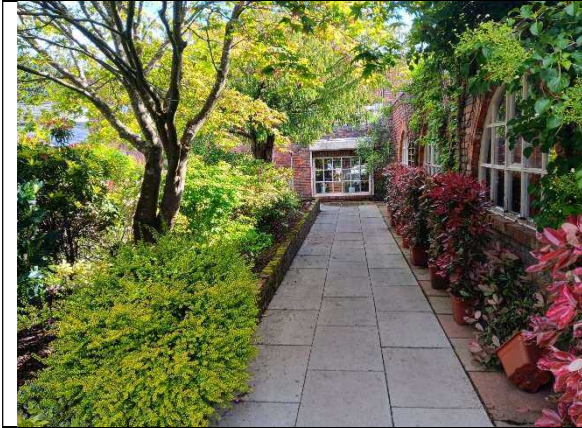
**Photograph 5:** View along SE boundary facing NE showing raised beds and vegetation planted beneath paving.

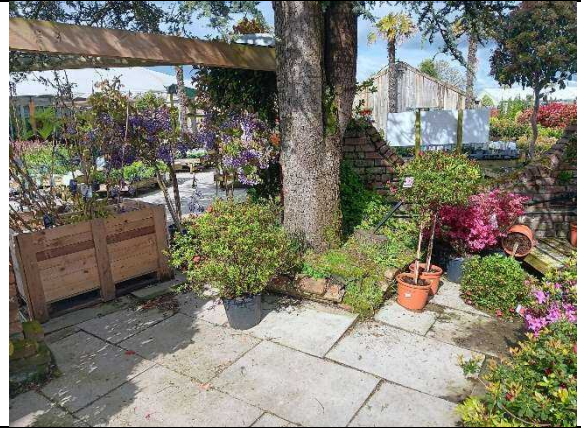
**Photograph 6:** Example of mature tree planted within paving in the west of site.

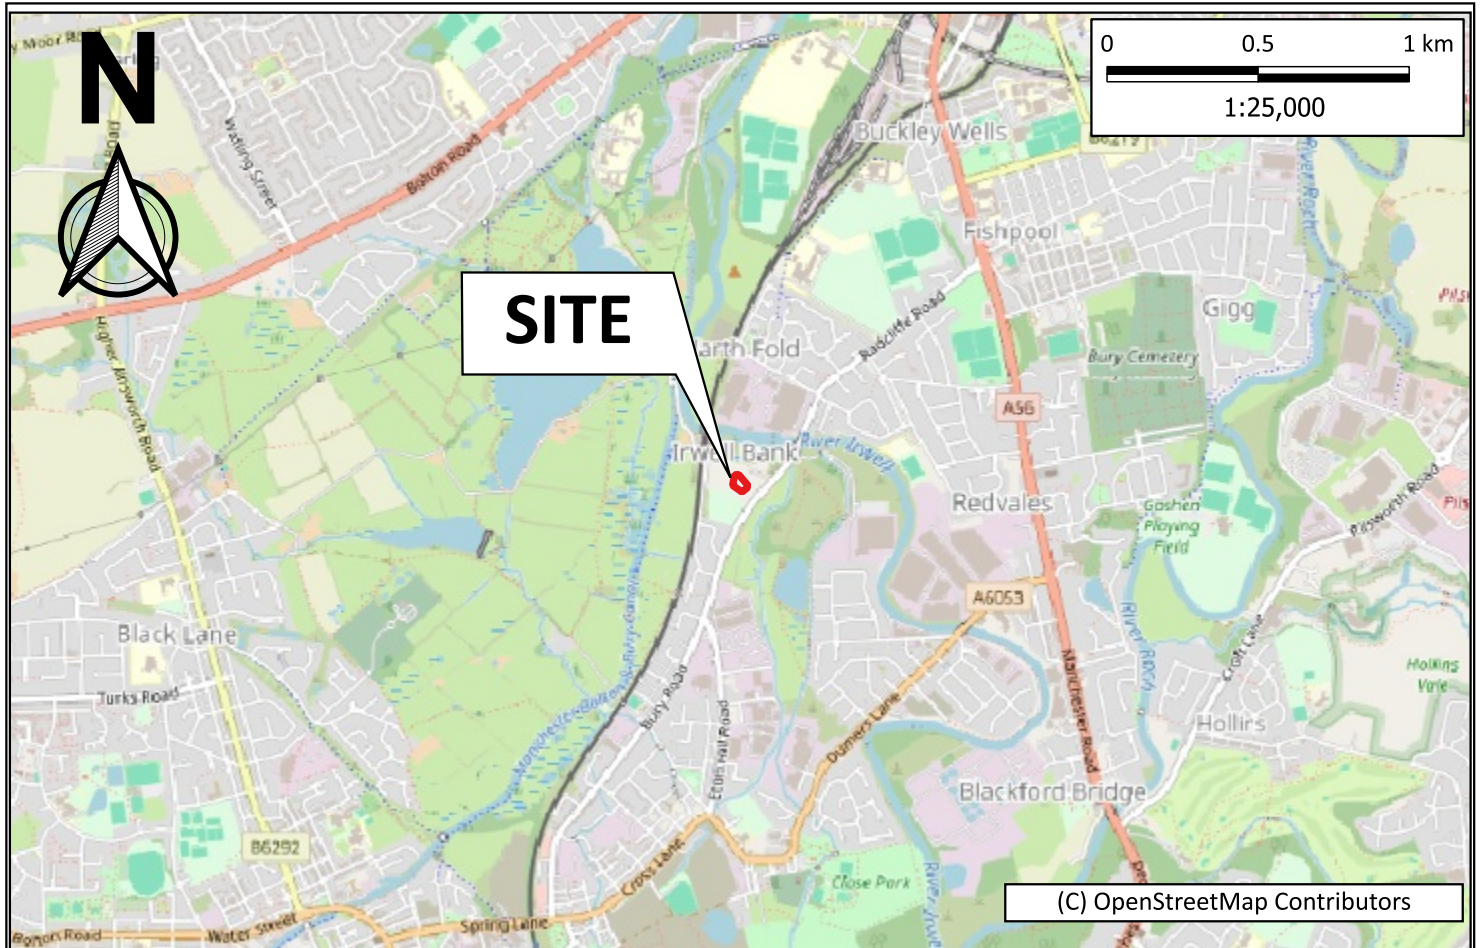
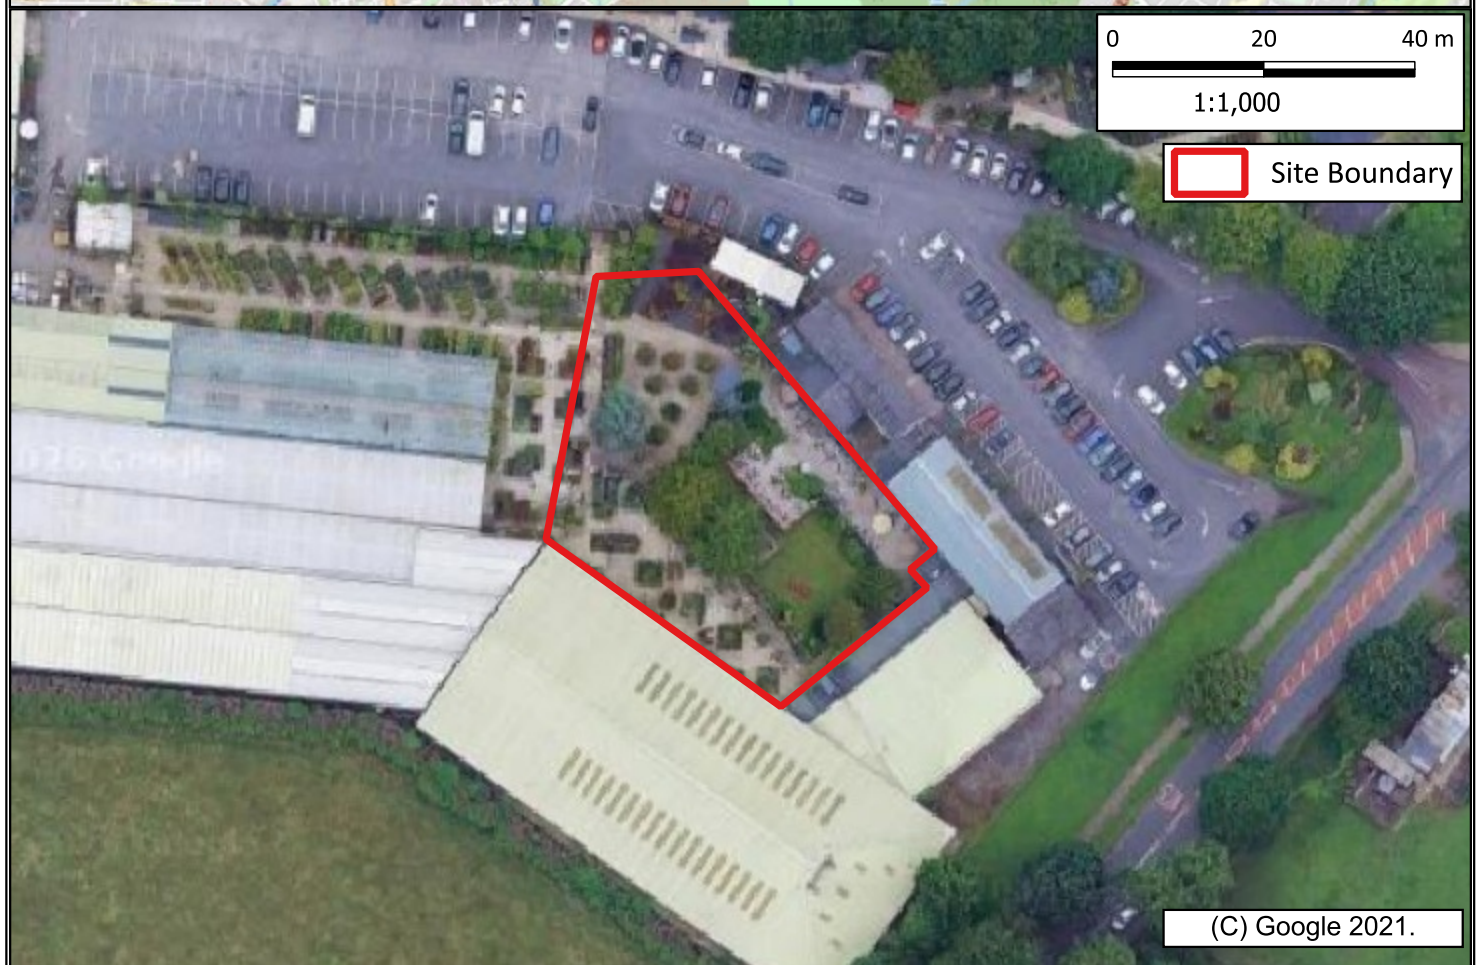
| Job No.:<br>LKC261155<br>Drawn By:<br>CD<br>Checked By:<br>RP<br>Drawn:<br>May 2026 | | | | Figure:<br><br>1<br><br>Revision: | | |

| Client:<br><br>Newbank Garden Centre | | | | Title:<br><br>Site Location &<br>Boundary Plan | | <br><br><b>LK CONSULT</b> |
