**Angela Graham Bat Consultancy Service Limited**

**Bat Method Statement for  
Lake Hill,  
Bolholt,  
Walshaw,  
Bury,  
BL8 1PU**

**Date: 10/8/21**

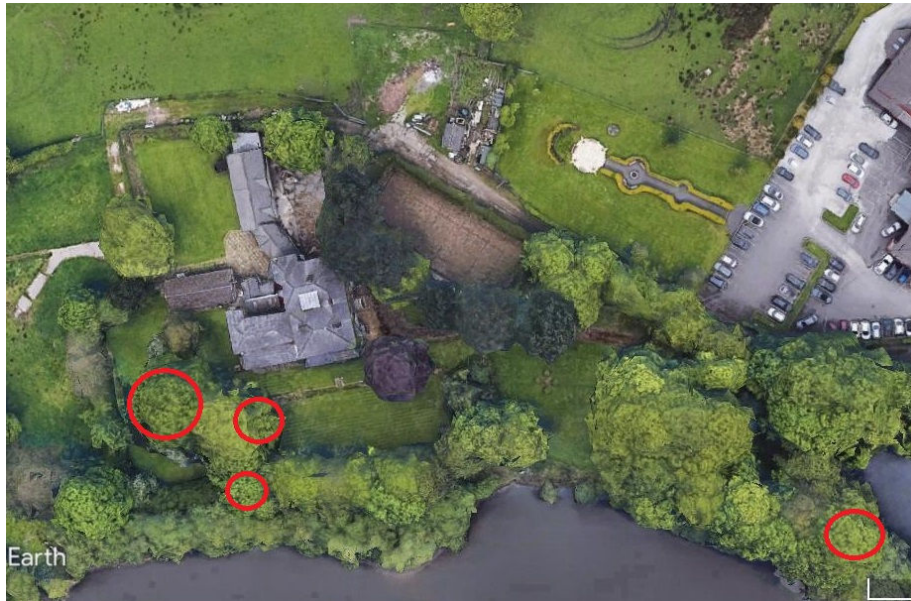
Fig. 1. Trees where bat boxes located shown in red.

In the past it was thought individual bats might be roosting in association with the roof of the main house. Following its re-roofing, bat boxes x 9 were put up in mature trees near the house:

This was done in April 2021.

- Bat boxes x 9 (2 small hollow, 2 medium hollow, 3 double crevice and 2 modified-hollow Greenwood boxes) have already been put up in trees in April 2021; mainly to compensate for re-roofing works but also to provide alternative roosting places while development is undertaken.

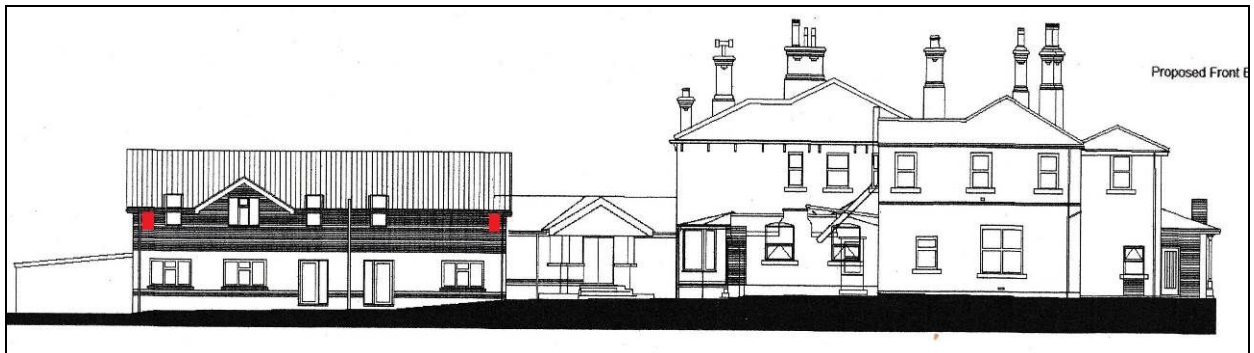
Fig. 1. West-elevation. Position of boxes shown in red.

- Integrated bat boxes will have more stable conditions than tree mounted boxes and are more of a like-for-like measure, as bats can currently access cavity walls. Accordingly, provision for bats will be made in the building via installation of integrated bat boxes as shown in Figs 1 to 3 below. *N.b. Integrated boxes are incorporated into walls and sit flush with them.*

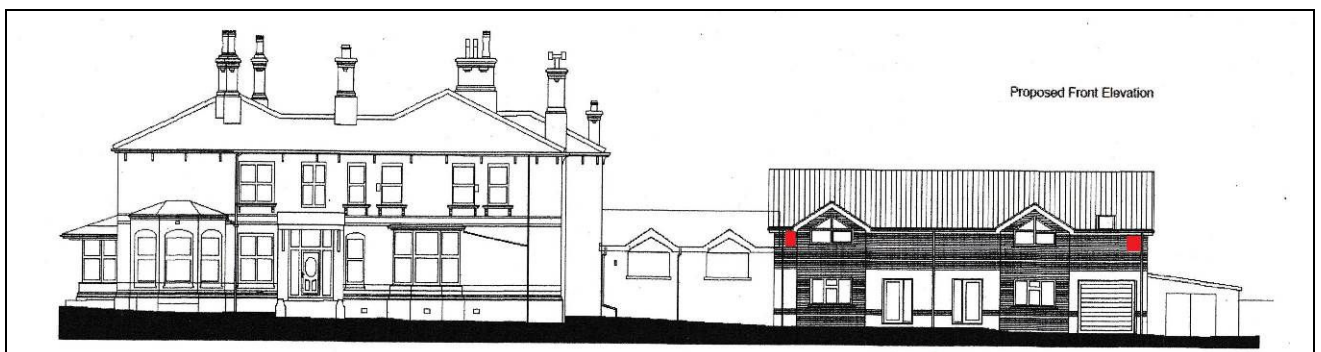
Fig. 4. East-elevation. Position of boxes shown in red.

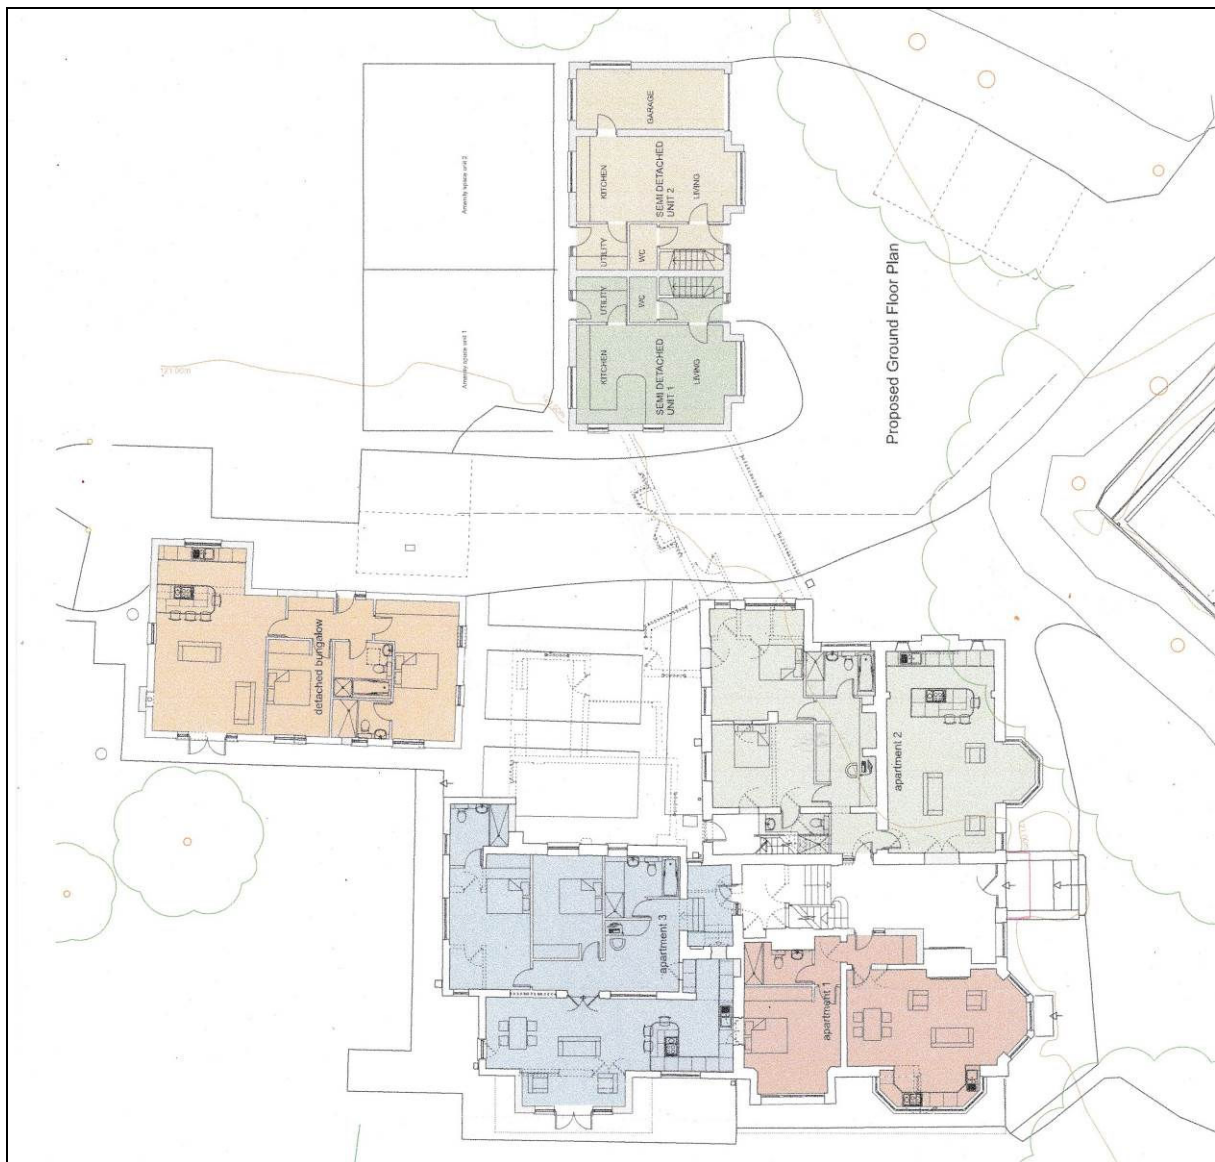
Proposed layout: north to top, main house in south

I understand some smaller elements on the north side of the property will be demolished; along with the part of the large single-storey extension on that side of the building, that connects it with the main house. What remains is to be made two-storey. See Appendix 1.

I understand internal refurbishments are planned for the interior of the main house, along with demolition of single-storey elements. See Appendix 1.

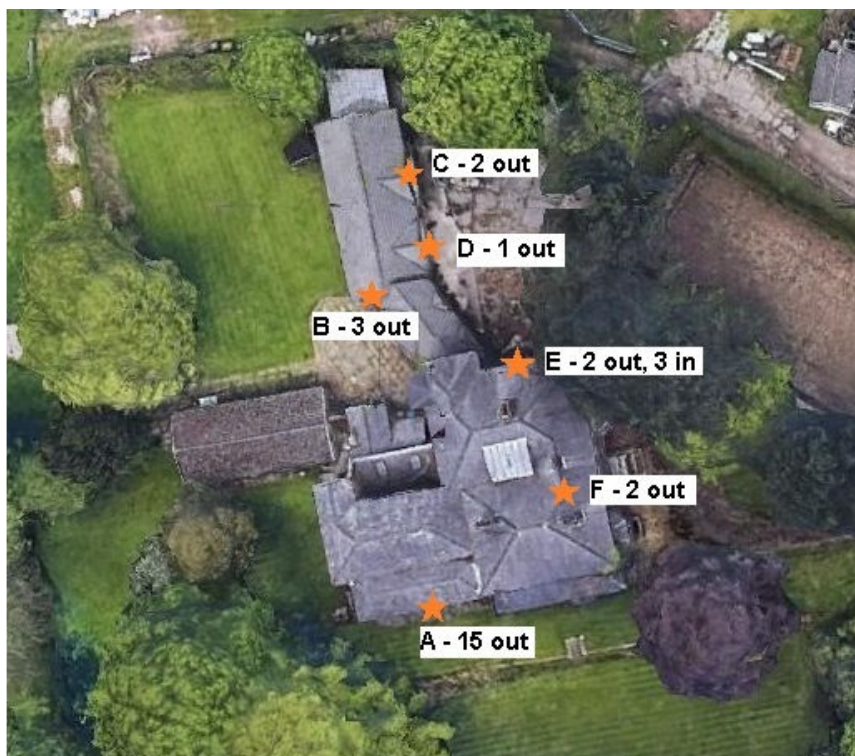
Key: Approximate locations of roosts indicated by letters A-F. See Table below

At a dusk emergence survey on **19/8/20**, 3 roosts were discovered in the main house, including what appeared to be a maternity colony roost, and 3 roosts were discovered in the single-storey extension to the north of the main building. See Appendix 2. This is to be replaced with a two-storey house. See Appendix 1. This will impact only roosts of small numbers of common pipistrelles and should not impact directly any roosts associated with the older part of the house, including the maternity colony roost. This allows the site to be registered under Natural England's Low Impact Licencing scheme.

| Area:<br>See Fig. 1 | Number of bats<br>seen to<br>emerge/enter | Comments<br>19/8/20, sunset 20.28 |
|---|---|---|
| A | at least 15 out | Above window, from 20.45. |
| B | 3 out | From gap in verge, 4 <sup>th</sup> tile up, from 20.55. |
| C | 2 out | From soffit at 20.53 and 20.56. |
| D | 1 out | From gap in verge at 20.50 |
| E | 2 out, 3 in | From 20.50. Only apparent entry place available is an air-vent, thought previously unlikely to be suitable for roosting. Bat seemed to be considering entering at this location at a previous survey. |
| F | 2 out | From 20.42. Thought unlikely due to recent re-roofing but Plate 10 shows an apparent gap which fits with where bats were thought to emerge. A concern is that the roof is now probably lined with breathable membrane, which can cause bats' to become trapped when they can't extricate their claws from it. |

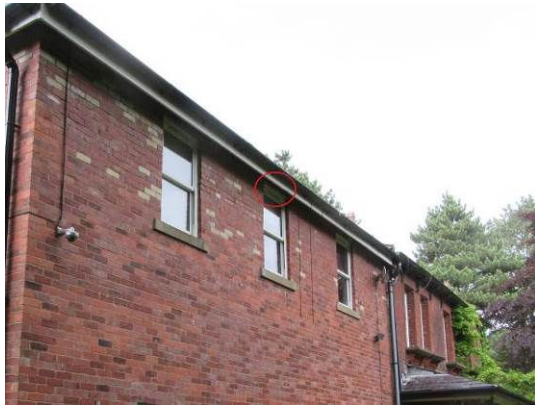
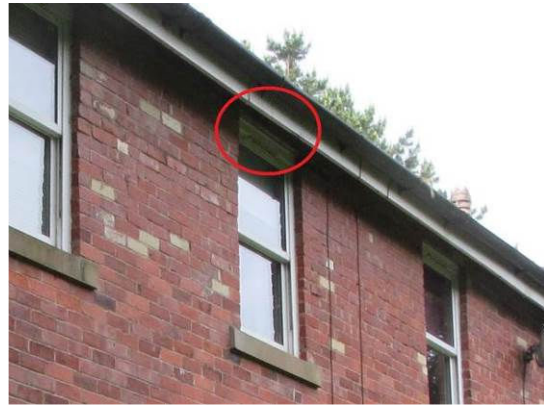
Plates 1 and 2. Roost A, south-facing. Bats emerged from other locations along this soffit in 2021.

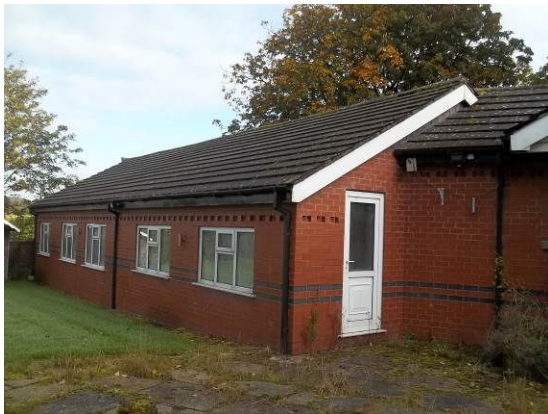
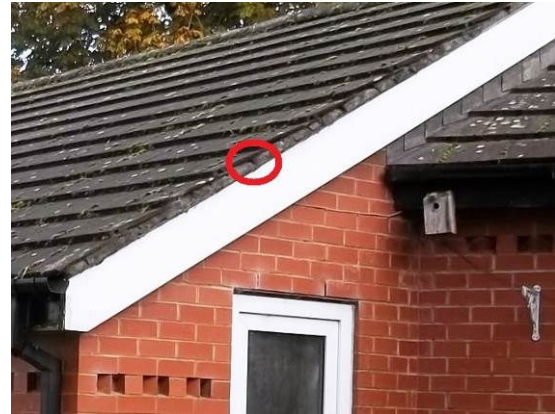
Plates 3 and 4. Roost B, south-facing (south-west corner)

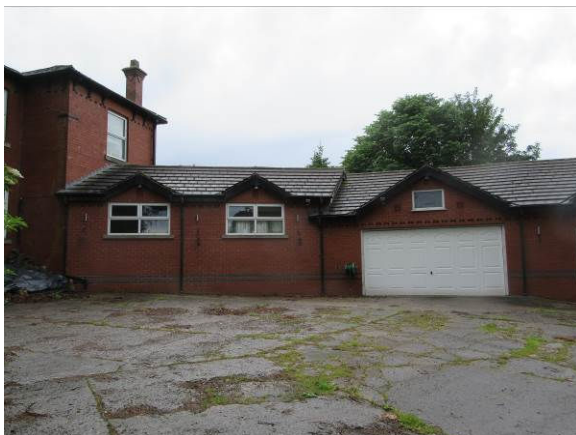
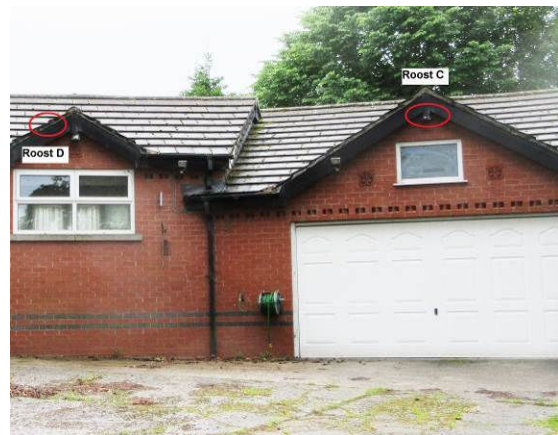
Plates 5 and 6. Roosts C and D, east-facing

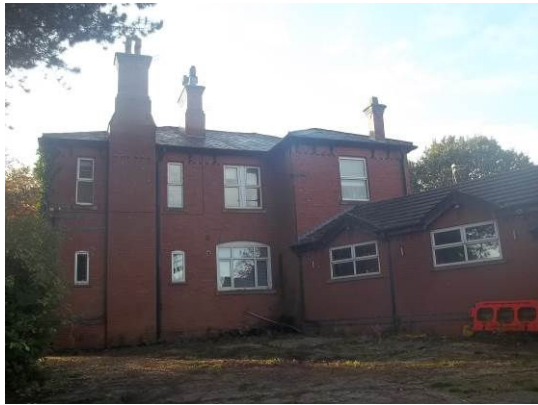
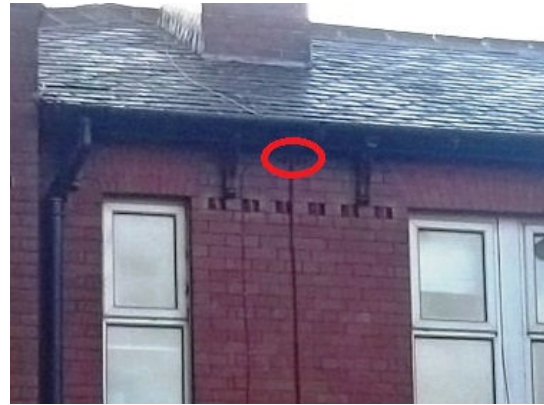
Plates 7 and 8. Roost E, north-facing

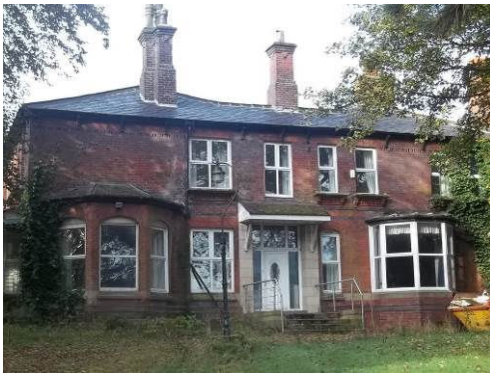
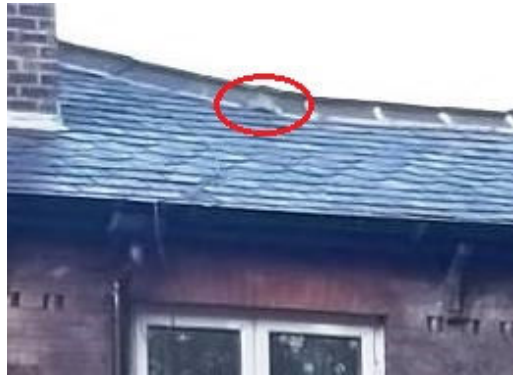
Plates 9 and 10. Roost F

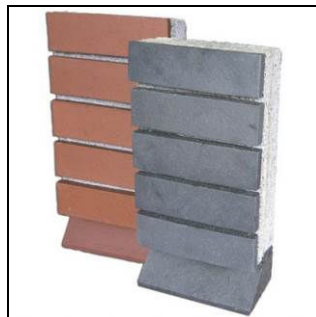
“Designed to be built into an exterior wall and is available in a variety of faces to match the building. Standard facings of red or blue brick - ideal for new builds - are normally available from stock, or boxes can be made to your specific requirements with a face of brick, stone, timber, or plain (for rendering). Supplied un-pointed.”

Brick example of Ecosurv Habibat. Can also be faced with stone.

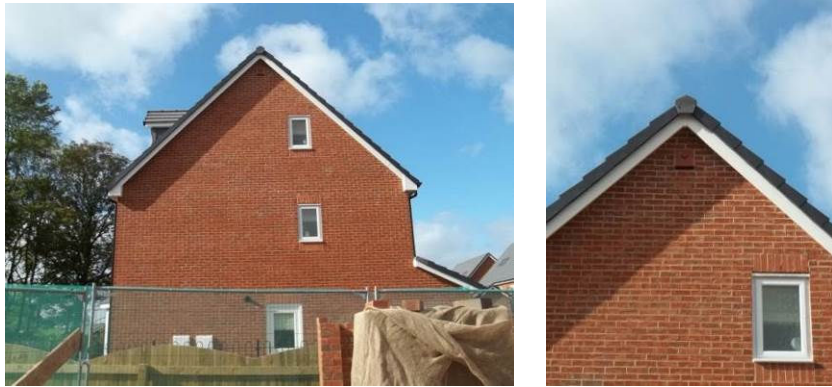
Above: typical unit in situ. Photo © Angela Graham

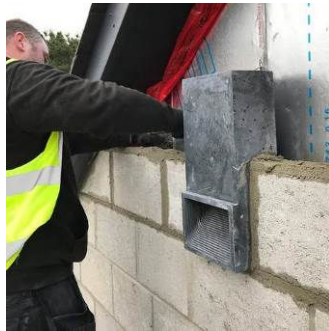
Green and Blue Bat Block/Brick in situ

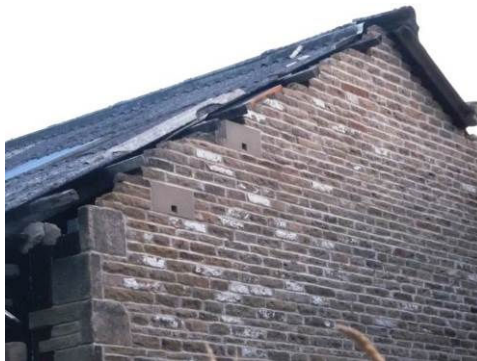
Example of Forticrete boxes in situ

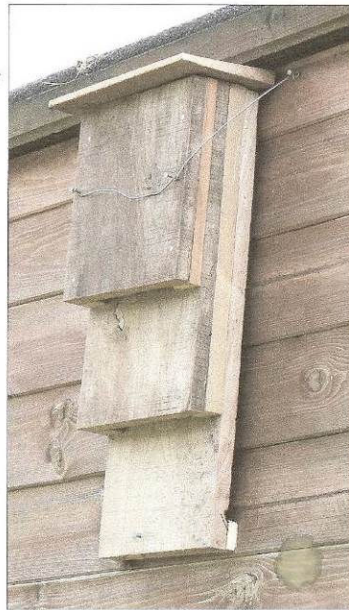
### The Kent bat box

Simple to construct, self-cleaning and low maintenance.

The only critical measurement is the width of the crevices—these should be no larger than suggested. Other measurements are approximate.

Box to be made from untreated rough-sawn timbers  
Timber should be c.20mm thick  
The box should be rainproof and draught-free  
Crevices can be between 15 and 25 mm wide  
Fixing may be by use of brackets, durable bands or wires

Boxes are best fixed as high as possible in a sheltered wind-free position, exposed to the sun for part of the day.  
They can be fitted to walls, other flat surfaces or trees  
A clear flight line to the entrance is important

Kent bat boxes are also available. An illustration is shown below with instructions for making them yourself. Traditionally inch-thick wood is used for bat boxes, to provide stable conditions, so not less than the 20mm specified below:

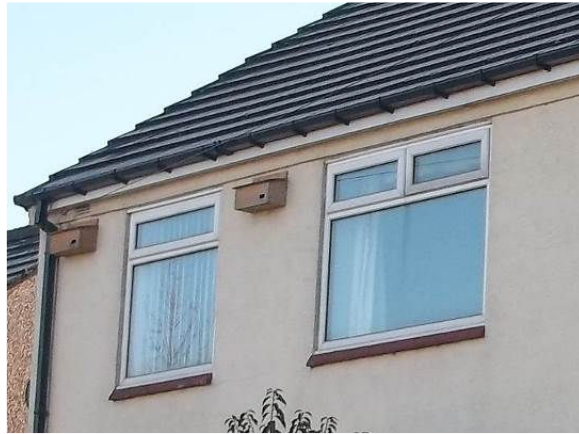
Example of swift nest boxes in situ
