## Phase I GeoEnvironmental Desk Study

Hollingrove Farm

Ramsbottom

**Report No. A4460/21**

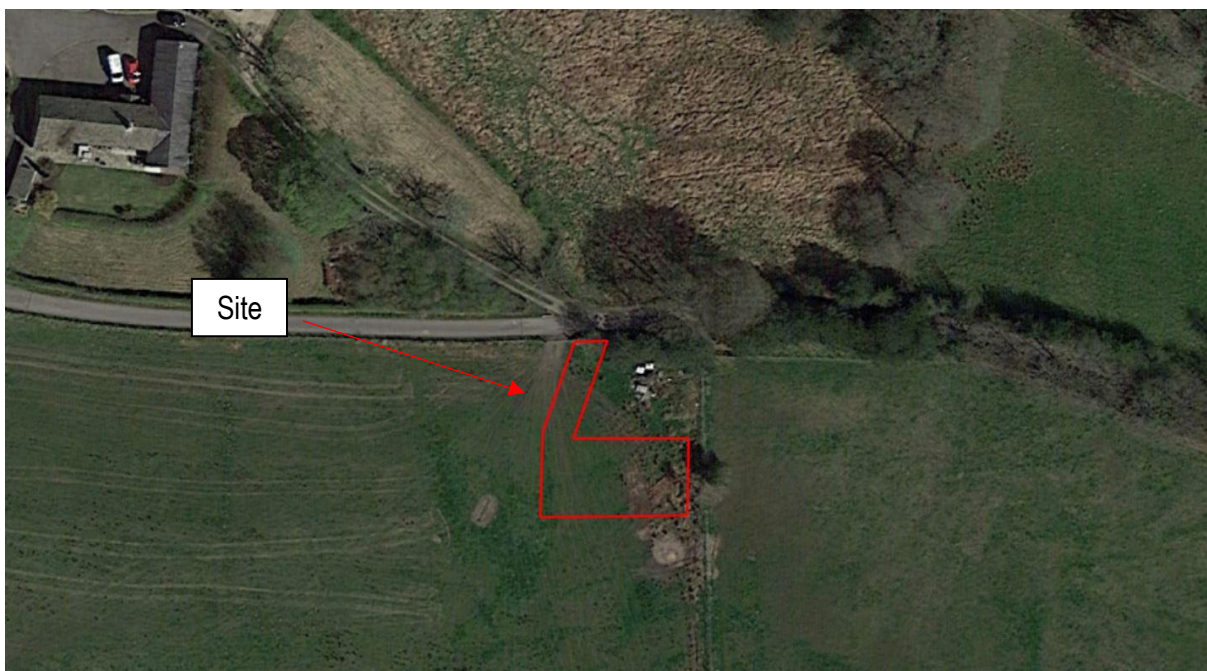
**Figure 2 Site Location Plan**

- 2.5 A location plan is shown below as Figure 2, together with a recent site photograph as Figure 3 (overleaf).

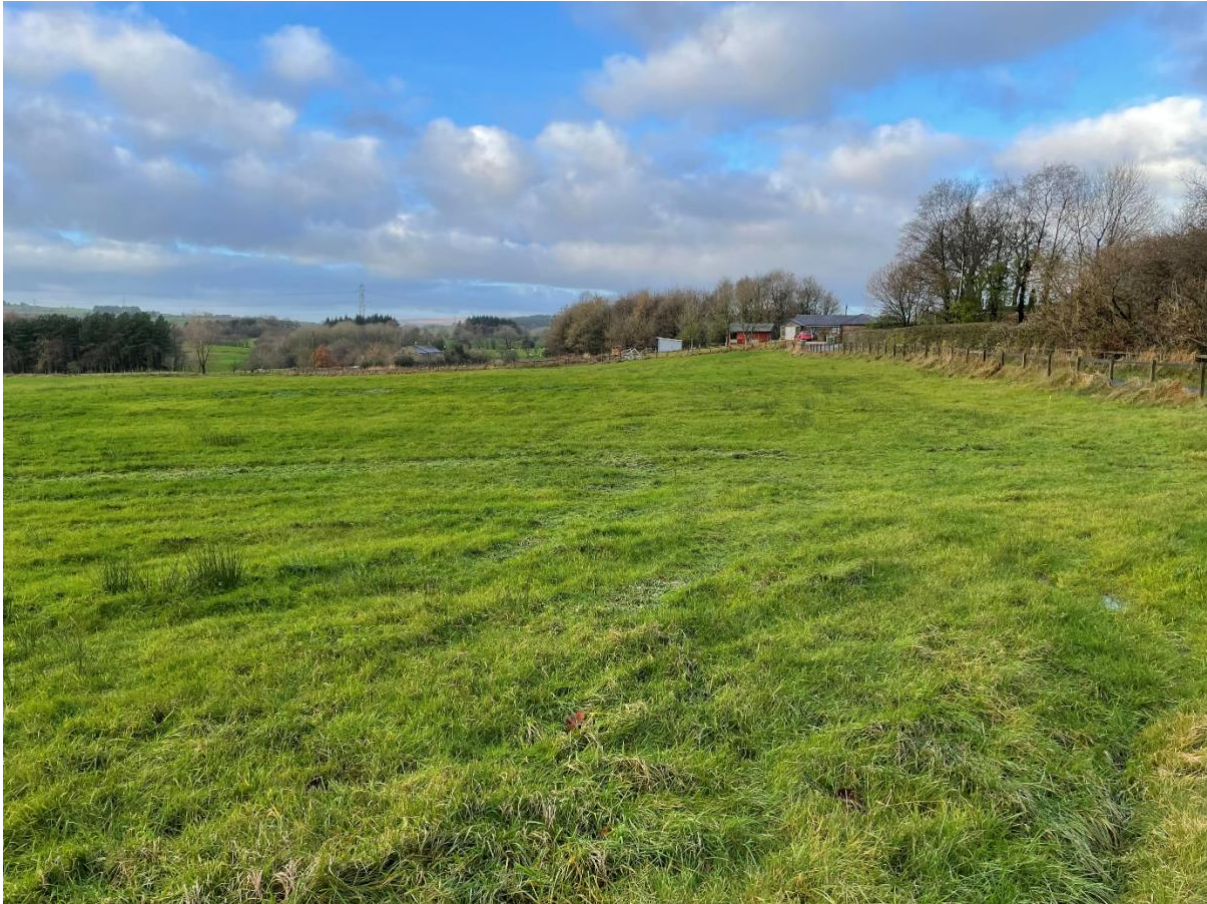
**Figure 3 Site Photograph**

- 2.3 The area being developed consists of agricultural land in the form of a grass covered field.
- 2.4 The north of the site is defined by Redisher Lane, and beyond this is Holcombe Brook. The east of the site is bound by a fence a few metres away from the site boundary, beyond this fence fields continue. The site is in a rural setting with few dwellings found in the local area.

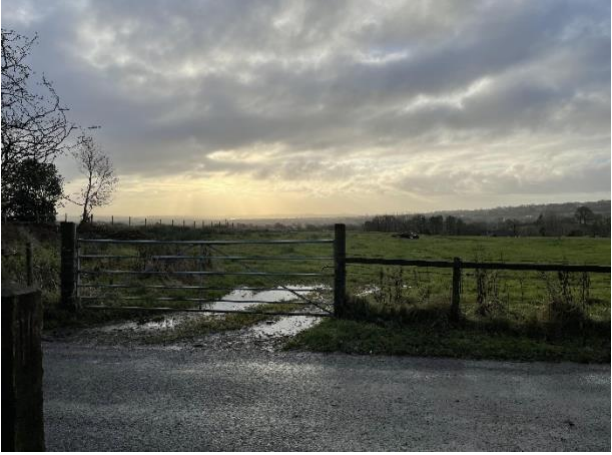
| <p><b>Plate 1 View facing S shows site access from Redisher Lane</b></p> | <p><b>Plate 2 View facing NE showing site entrance, Redisher lane, Eastern fence boundary and associated trees. Fly tipped rubbish is also shown in front of the tree line</b></p> |

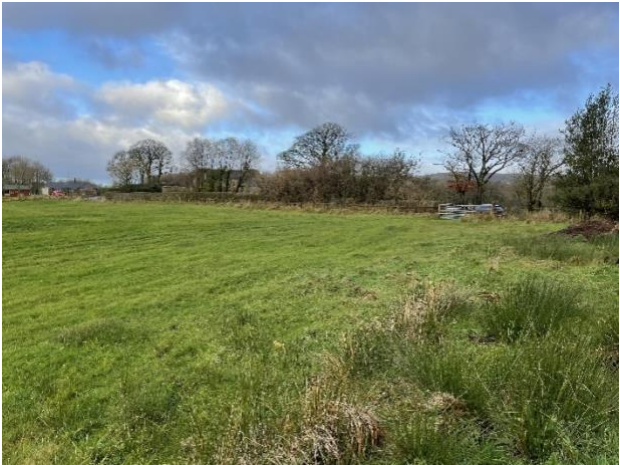
| <p><b>Plate 3 View facing NW showing Redisher Lane to Hollingrove Farm</b></p> | <p><b>Plate 4 View facing SW shows slope away from site to standing water on lower field</b></p> |

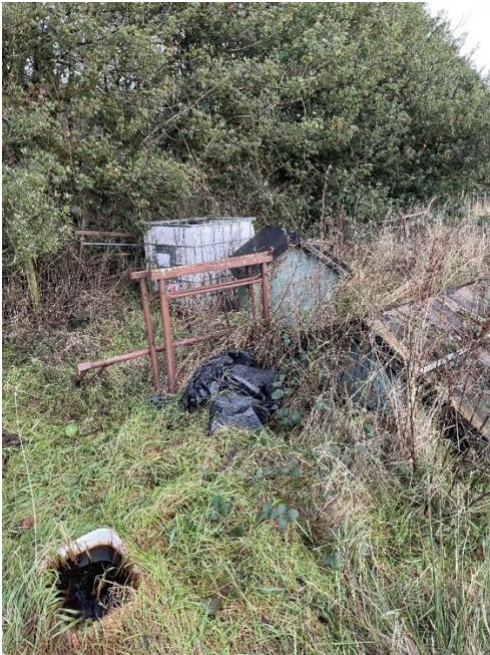
| <p><b>Plate 5 View facing W shows fly tipped rubbish up close</b></p> | <p><b>Plate 6 View facing E showing fly tipped rubbish and boundary fence</b></p> |

| Desk Study features checked during site visit | Feature and Information required | Present | Description / Comments |
|---|---|---|---|
| | Is there any litter/fly tipped material? | Yes/ <del>No</del> | None on site, but some old sheds/ scrap metal found 3m W of entrance |

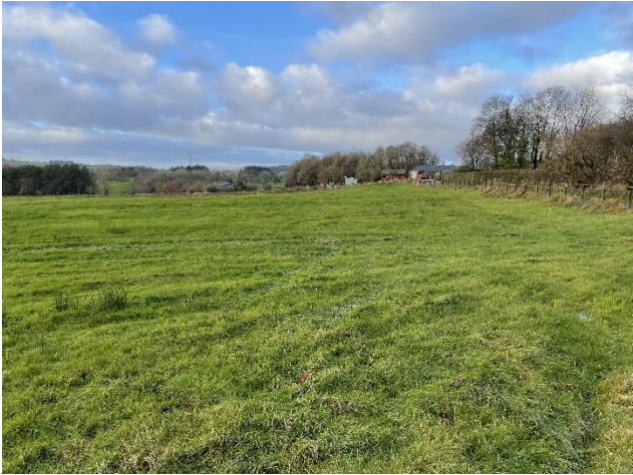
| <p><b>Plate 7 View facing E shows Hollingrove Farm and fence line</b></p> | <p><b>Plate 8 View facing S shows fence line and disused farm equipment</b></p> |
