**Bat Survey Report and Method Statement  
European Protected Species (Bats)**

**Reasonable Avoidance and Mitigation Measures**

**Higher House Farm Barn,  
Hawkshaw Lane,  
Hawkshaw,  
BL8 4LB**

**30.03.2026**

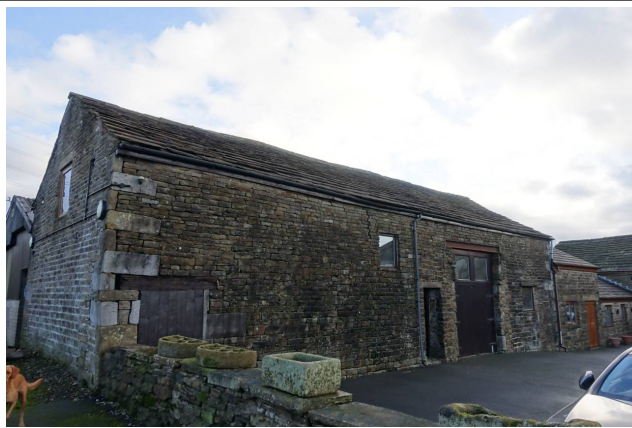
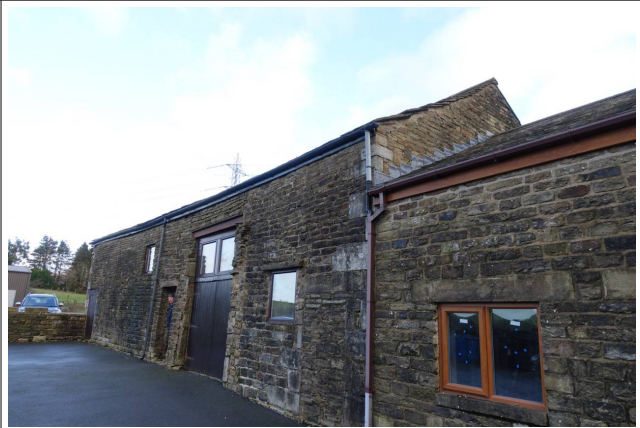
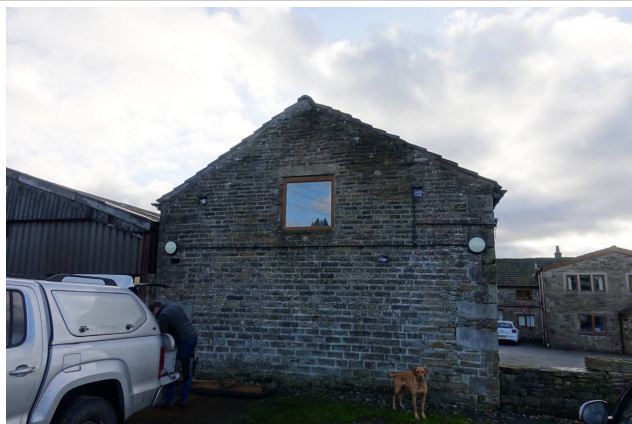
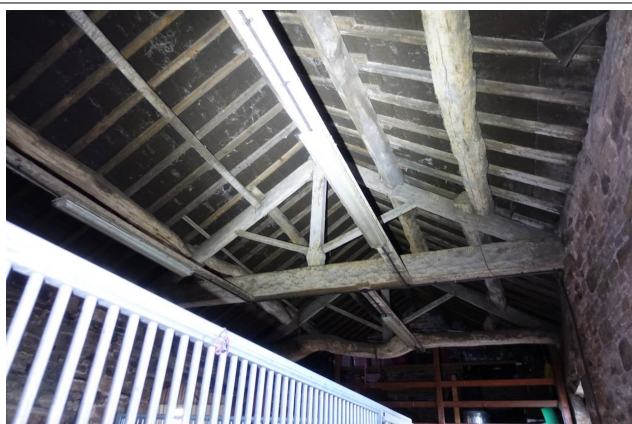
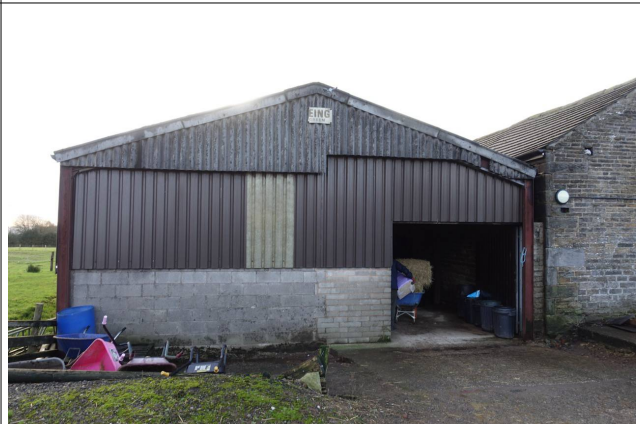
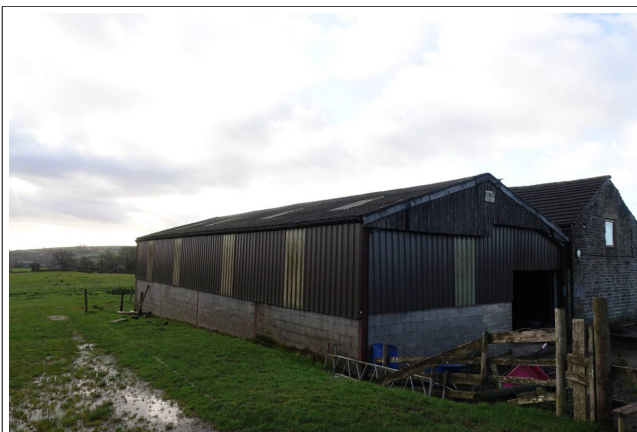
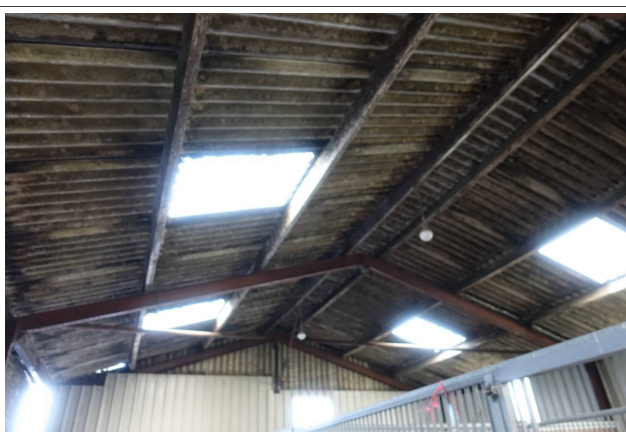
The site consists of a two storey stone built barn with double pitched slate roof, a single skin portal style barn adjoins the rear of the building.

External walls are generally well pointed, however gaps are present at the gable ends. Timber fascia boarding has some gaps behind. Roof slates are generally close fitting, however some lifted slates were observed. Slates are lined with a bituminous roofing felt in good condition.

When condition of the building, location and surrounding habitat are taken into consideration the buildings were assessed as offering low potential for roosting bats.
