## Phase 1 GeoEnvironmental Desk Study

Burch Street

Bury

**Report No. A5782/23**

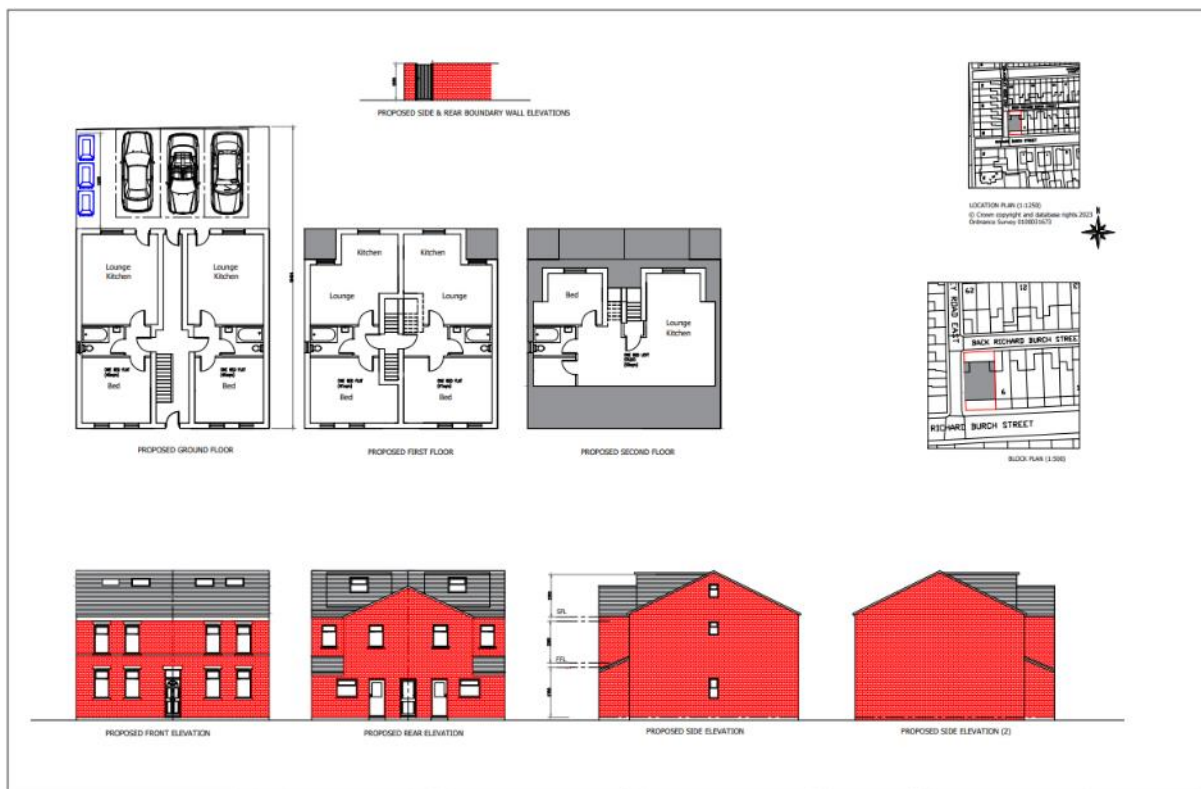
**Figure 1 Proposed Development Plan**

- 1.1 Earth Environmental & Geotechnical Ltd has been commissioned by RA Design & Project Management Ltd on behalf of Mr. Uddin (the Client) to undertake a Phase I GeoEnvironmental Desk Study for the proposed residential development on vacant land on Richard Burch Street, Bury.
- 1.2 It is understood that the client wishes to construct a new three storey residential building adjoining No. 6.
- 1.3 The ground and second floor will each comprise of two one bedroomed flats and the third floor will comprise a one-bedroom flat. The building will also have associated parking for three cars.
- 1.4 A proposed development plan for the site is shown in Figure 1 below.

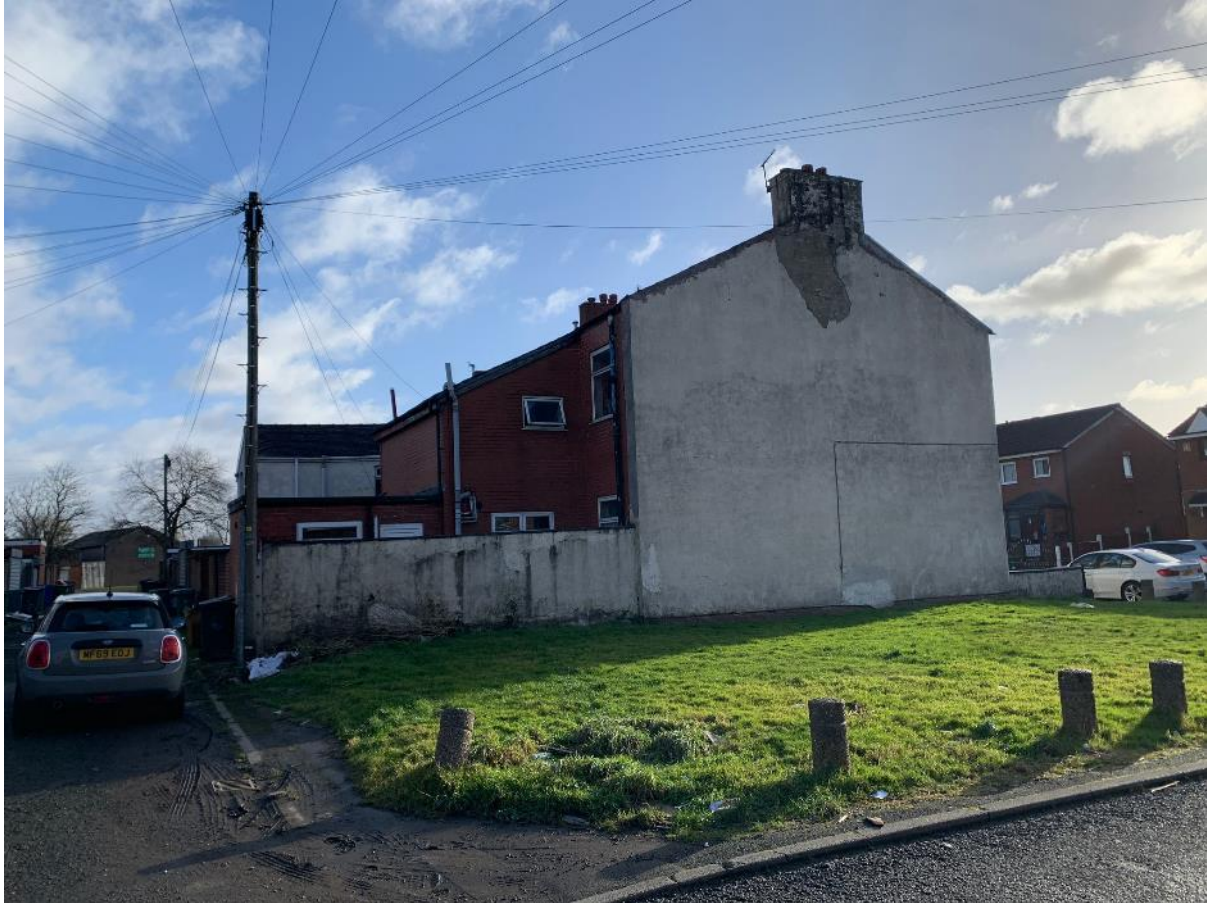
**Figure 3 Site Photograph**

- 2.5 The land is surfaced predominantly in grass vegetation. There is a felled tree in the southwest corner of the site accompanied by slightly raised ground. The boundary of the site is demarcated by concrete bollards.

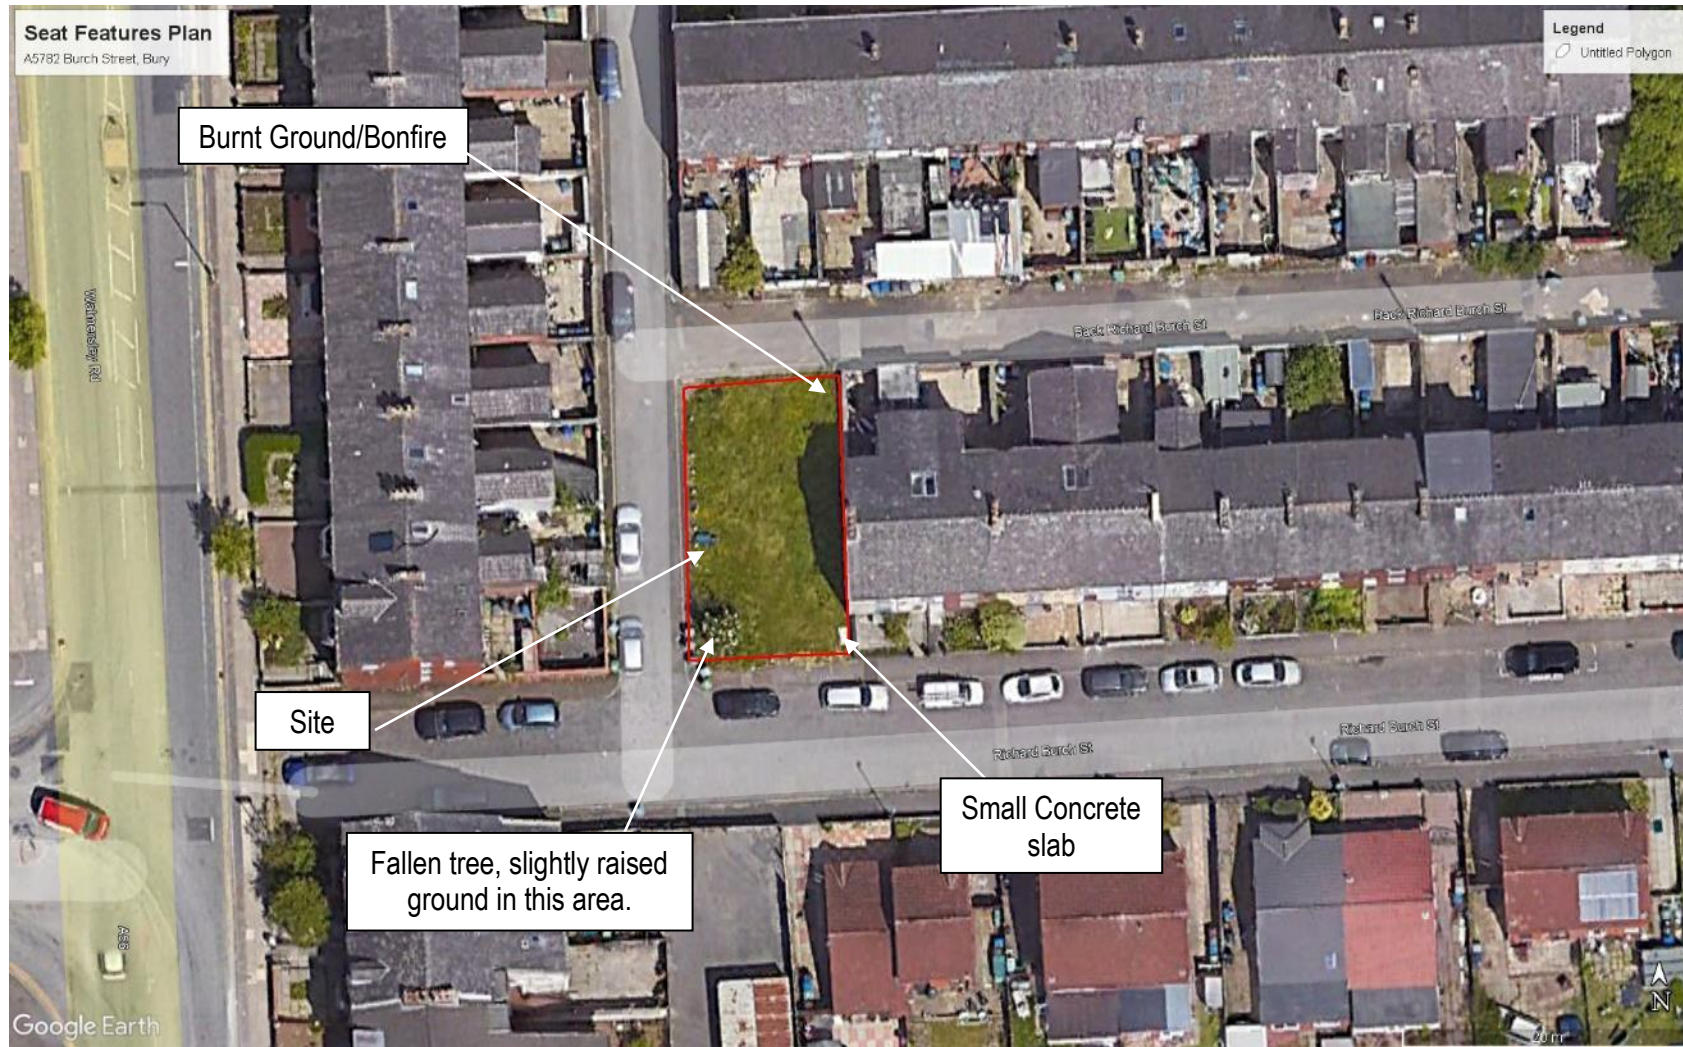
**Figure 8 Site Features Plan**

- 5.5 A felled tree was observed in the southwestern corner of the site, along with some slightly raised ground.
- 5.6 Potential old brick foundations were visible on the ground along the eastern wall, adjacent to the neighbouring property.

- 5.7 There was evidence of a bonfire/burnt ground in the northeastern corner, along with various fly-tipped waste including plastic bags, glass & plastic bottles, coffee cups, clothing, bricks, and a wooden panel.

- 5.8 The site was bordered by the wall of a residential property development to the east. The wall is in poor condition with the rendering flaking off onto the site.

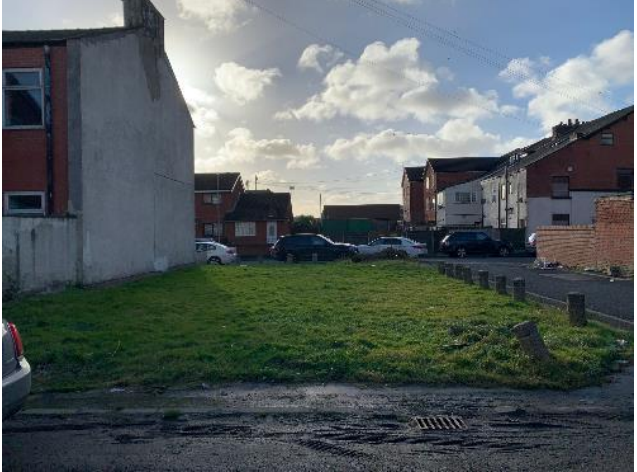
| <p><b>Plate 1 Photo across site viewing south</b></p> | <p><b>Plate 2 Photo of fly-tipped litter along eastern boundary wall.</b></p> |

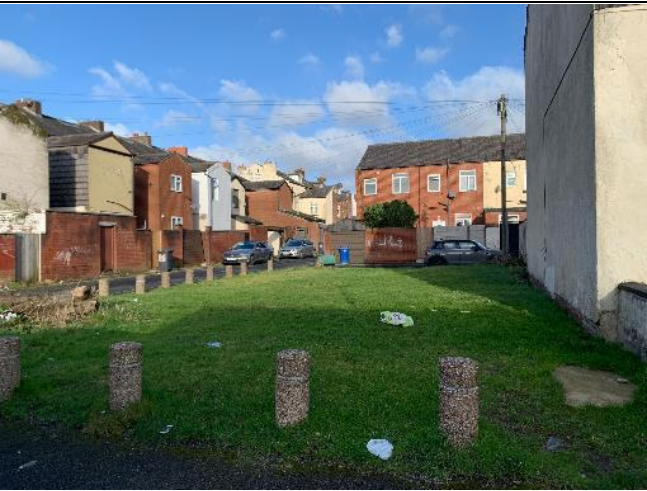
| <p><b>Plate 3 Photo across the site viewing north</b></p> | <p><b>Plate 4 Viewing across site and wall of adjacent building viewing east.</b></p> |

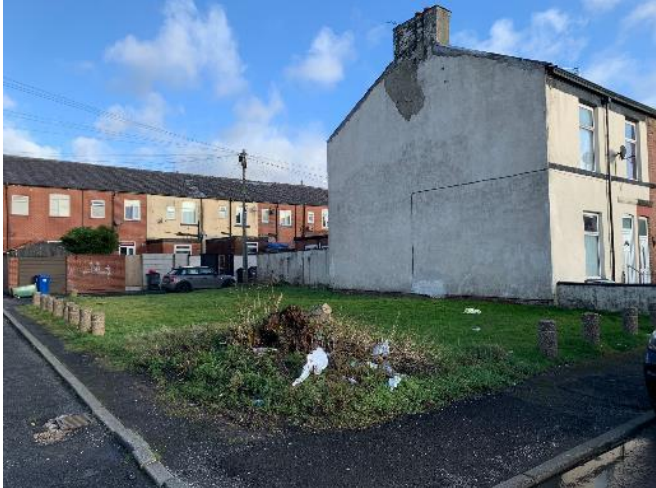
| <p><b>Plate 5 Photo of slightly raised ground in the southwestern corner of the site.</b></p> | <p><b>Plate 6 Photo showing concrete bollard demarcations.</b></p> |

| <b>Geohazards:</b> | |
|---|---|
| Site Clearance | <p>The proposed dwelling site comprises a grassy patch of land which is already largely cleared. Fly-tipped litter, a fallen tree, and remnants of burnt material will have to be removed.</p> <p>The concrete bollard demarcations will also have to be removed pre-development.</p> |

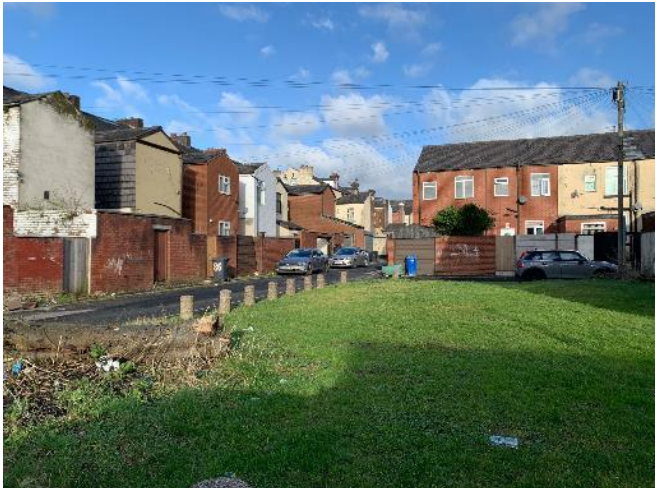
| <p><b>Plate 7 Photo viewing eastwards along Back Richard Burch Street</b></p> | <p><b>Plate 8 Potential red brick foundations from previous onsite development.</b></p> |

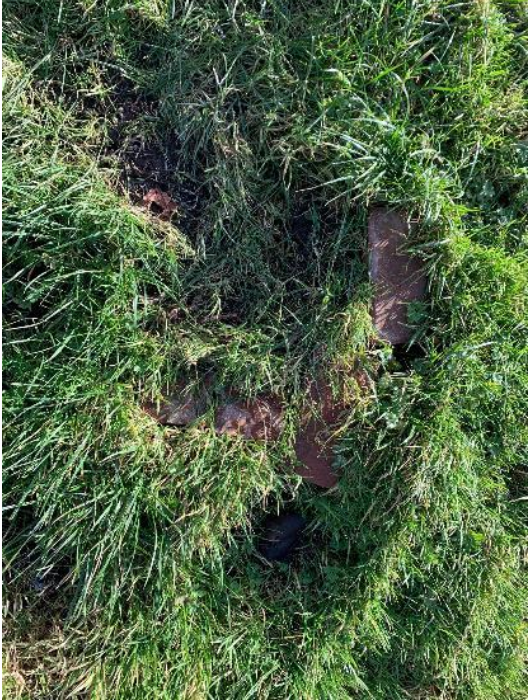
| <b>Geohazards:</b> | |
|---|---|
| Existing Buildings/Obstructions | <p>Potential red brick foundations are present alongside the eastern boundary wall, which may extend into the topsoil below.</p> <p>A small concrete slab is located in the southeastern corner of the site.</p> |
