# AINSWORTH NURSING HOME, RADCLIFFE

## PHASE 1: PRELIMINARY RISK ASSESSMENT

**Job Number: LKC 20 1567**

| <b>LK Consult</b><br><b>Document Verification</b> | | | |
|---|---|---|---|
| <b>Report Title</b> | Phase 1 Preliminary Risk Assessment | | |

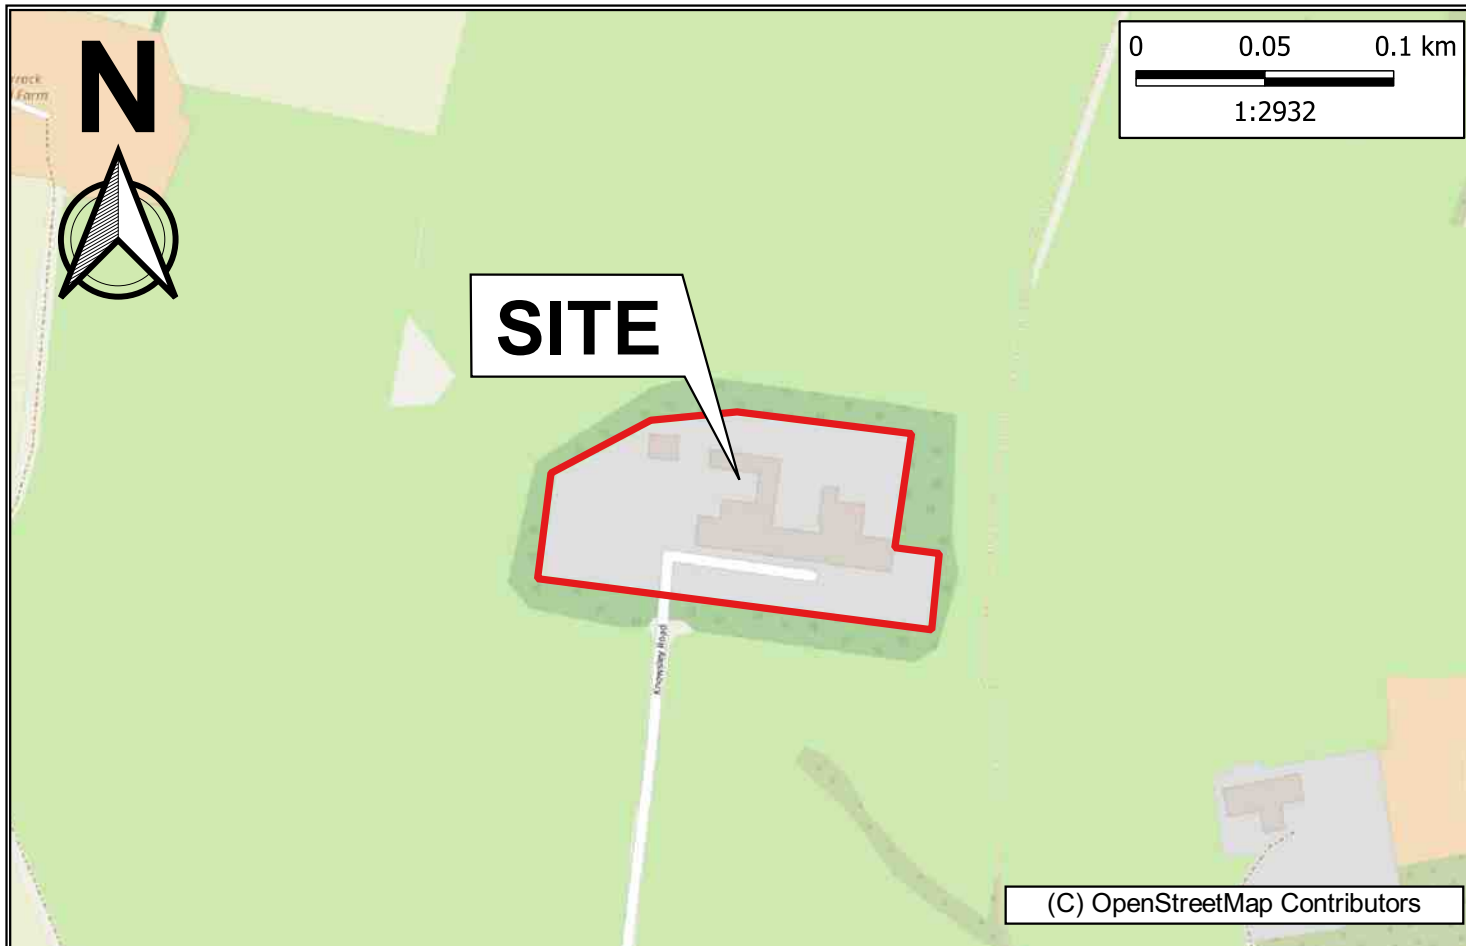
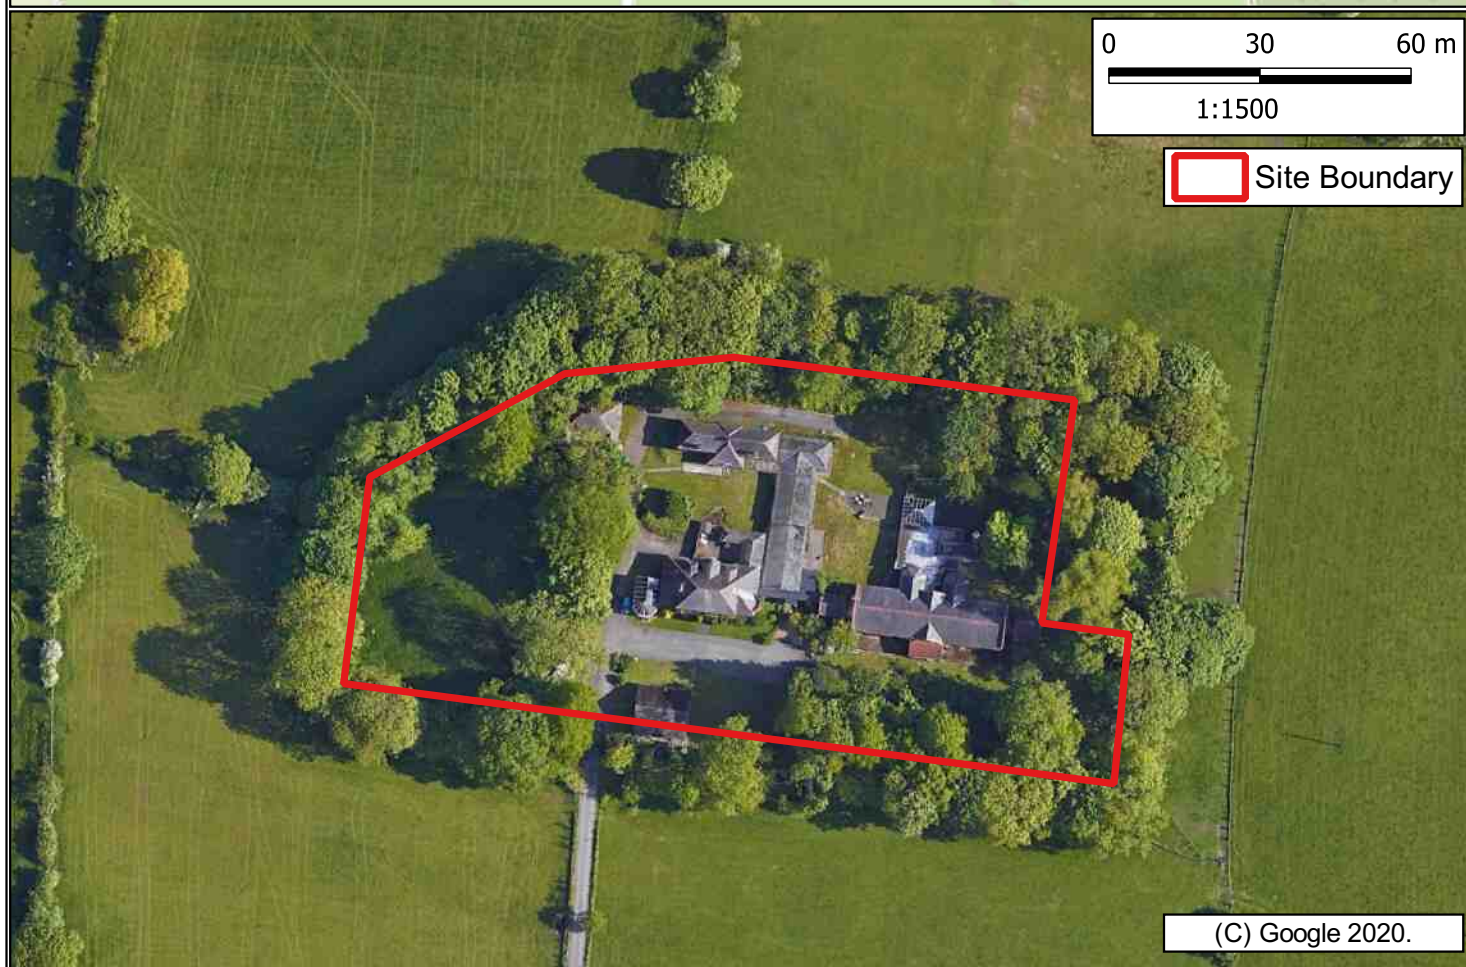
| Job No.:<br>LKC 20 1567 | Drawn By:<br>BR | Checked By:<br>EK | Drawn:<br>July 2020 | Figure:<br><br>1 | Revision: | | |

| Client:<br><br>Mr & Mrs C Brown | | | | Title:<br><br>Site Location &<br>Boundary Plan | | | |

A summary of the site details is presented in Table 1-1. Figure 1 indicates the site location and boundary. Drawing No. R-0517-03 indicates the individual 7no. plots/buildings and plot/building names at the time of sale. Figure 2 and Drawing No. A.01.2.1 indicates the proposed development plan for Plot No.3 'The Wash House' and Plot No. 2 'The Bungalow'. Proposed development plans for the remaining plots have not been made available to LKC.

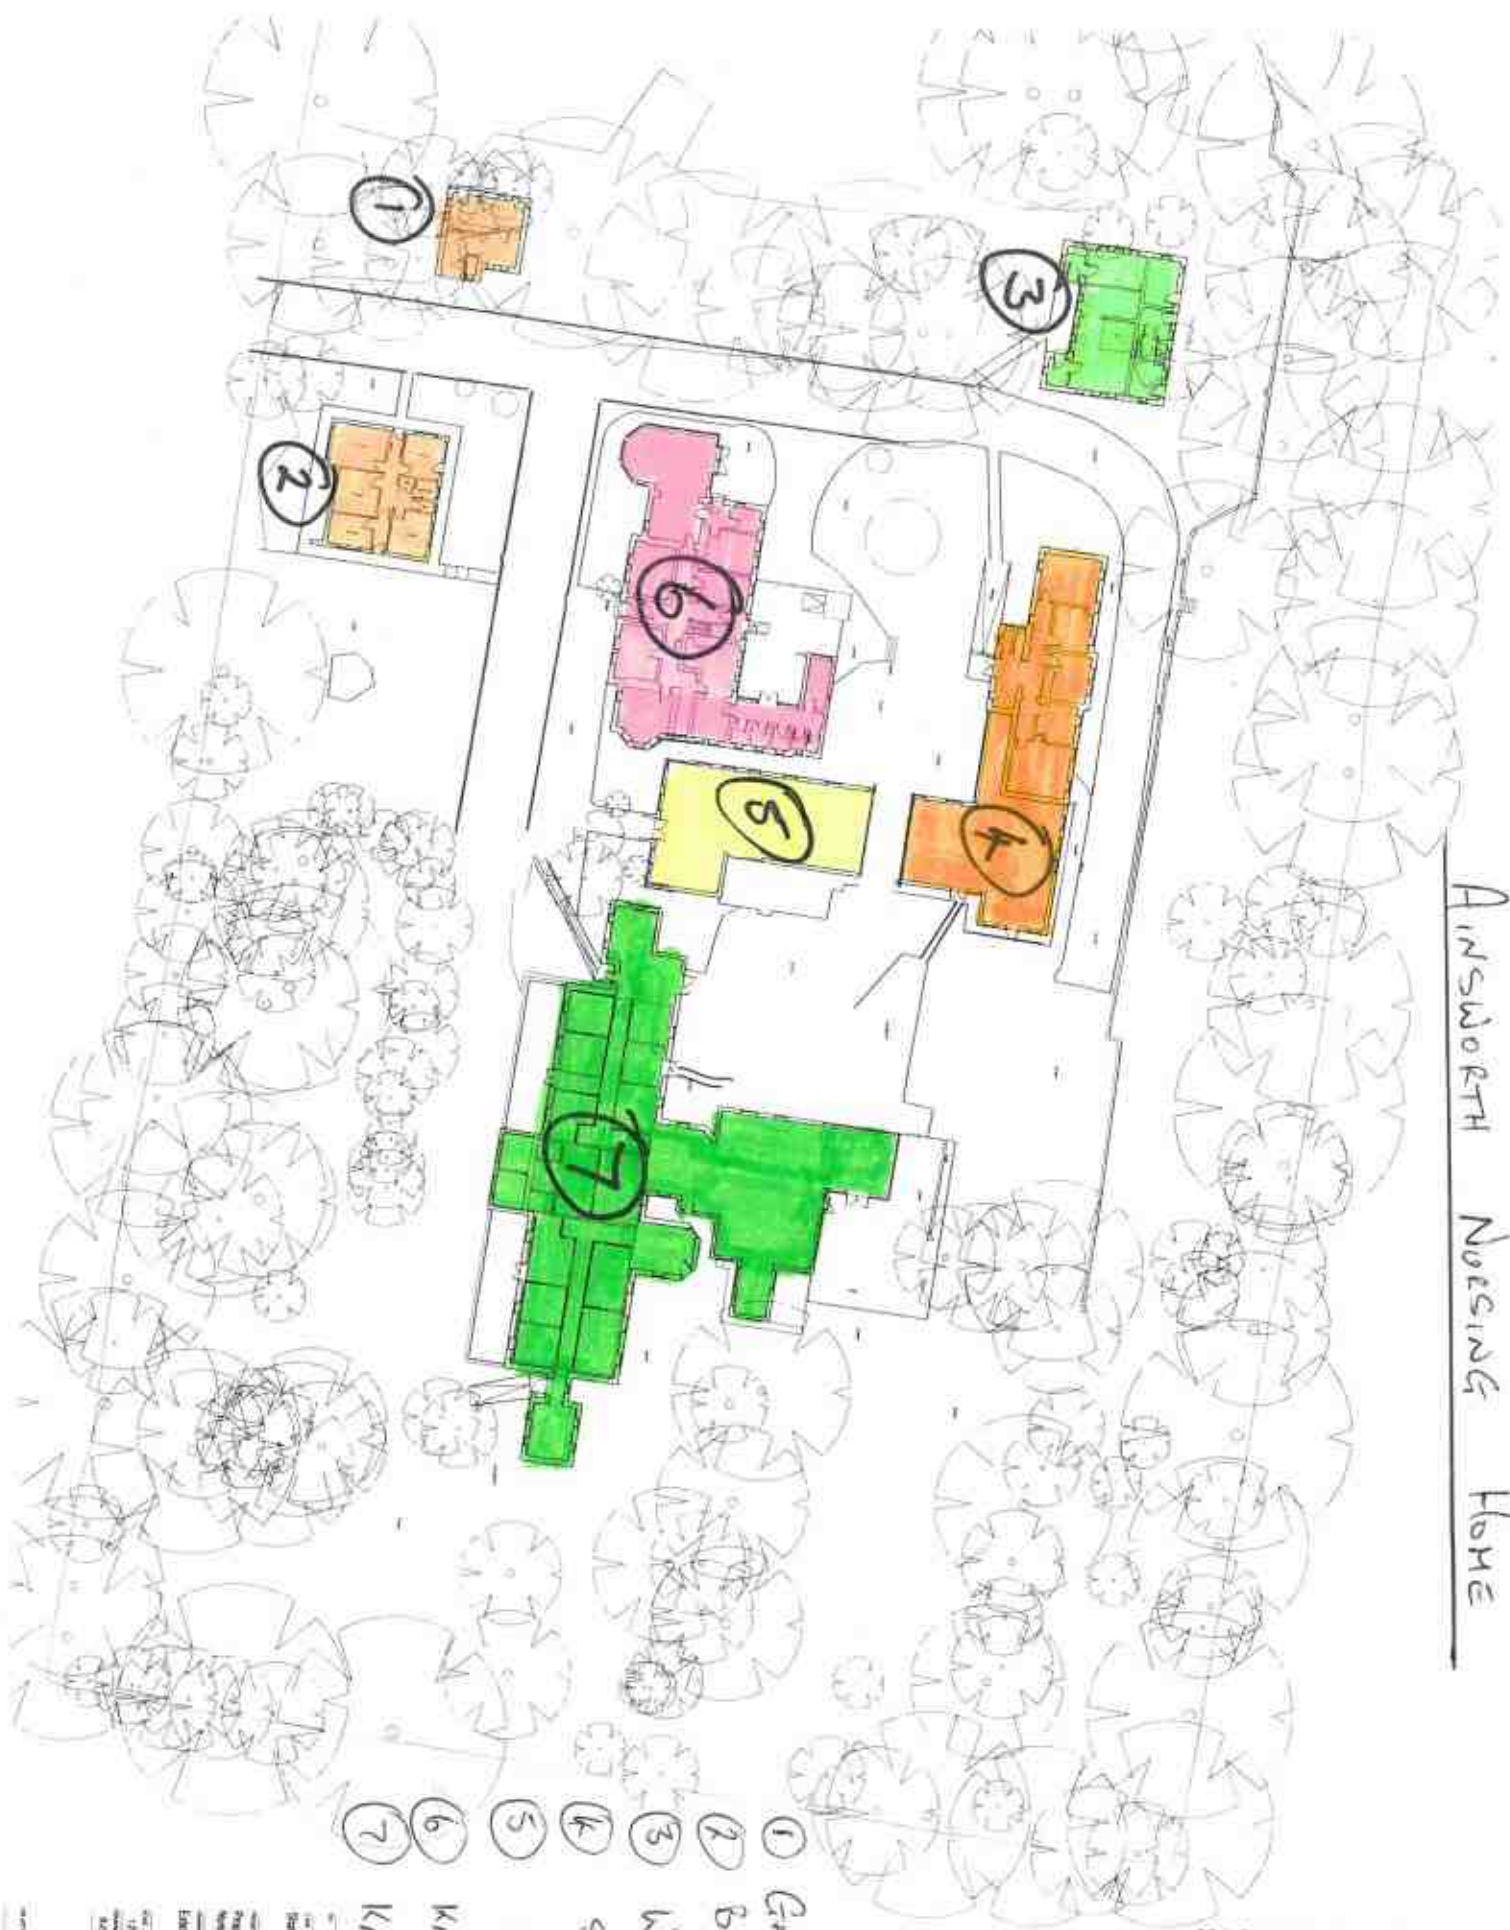
- ① Gatehouse
- ② Boudgarden
- ③ Wash House
- ④ Stables
- ⑤ Haven
- ⑥ Knowledge Hook
- ⑦ Knowledge Hook
