**PFAS TESTING IN CONCRETE AT FORMER MONDI/HOLCOMBE MILL, BRIDGE STREET, RAMSBOTTOM, BURY, BL0 0BS**

| PROJECT: ECCLESTON HOMES<br>MONDI MILL<br>RAMSBOTTOM | REV | DATE | BY | DESCRIPTION | CHK | DRAWING STATUS: DRAFT |
| TITLE: WORKING AREAS<br>FEB 2025 | DATE: 13/02/2025 | SCALE: 1:100 | SIZE: NTS | DRAWN: AG | CHECKED: JS | <br>Unit 6, Old Marsh Farm Barns, Welsh Road, Sealand, Flintshire CH5 2LY<br>Tel: 01244 288178 Fax: 01244 288516 enquiries@betts-associates.co.uk |

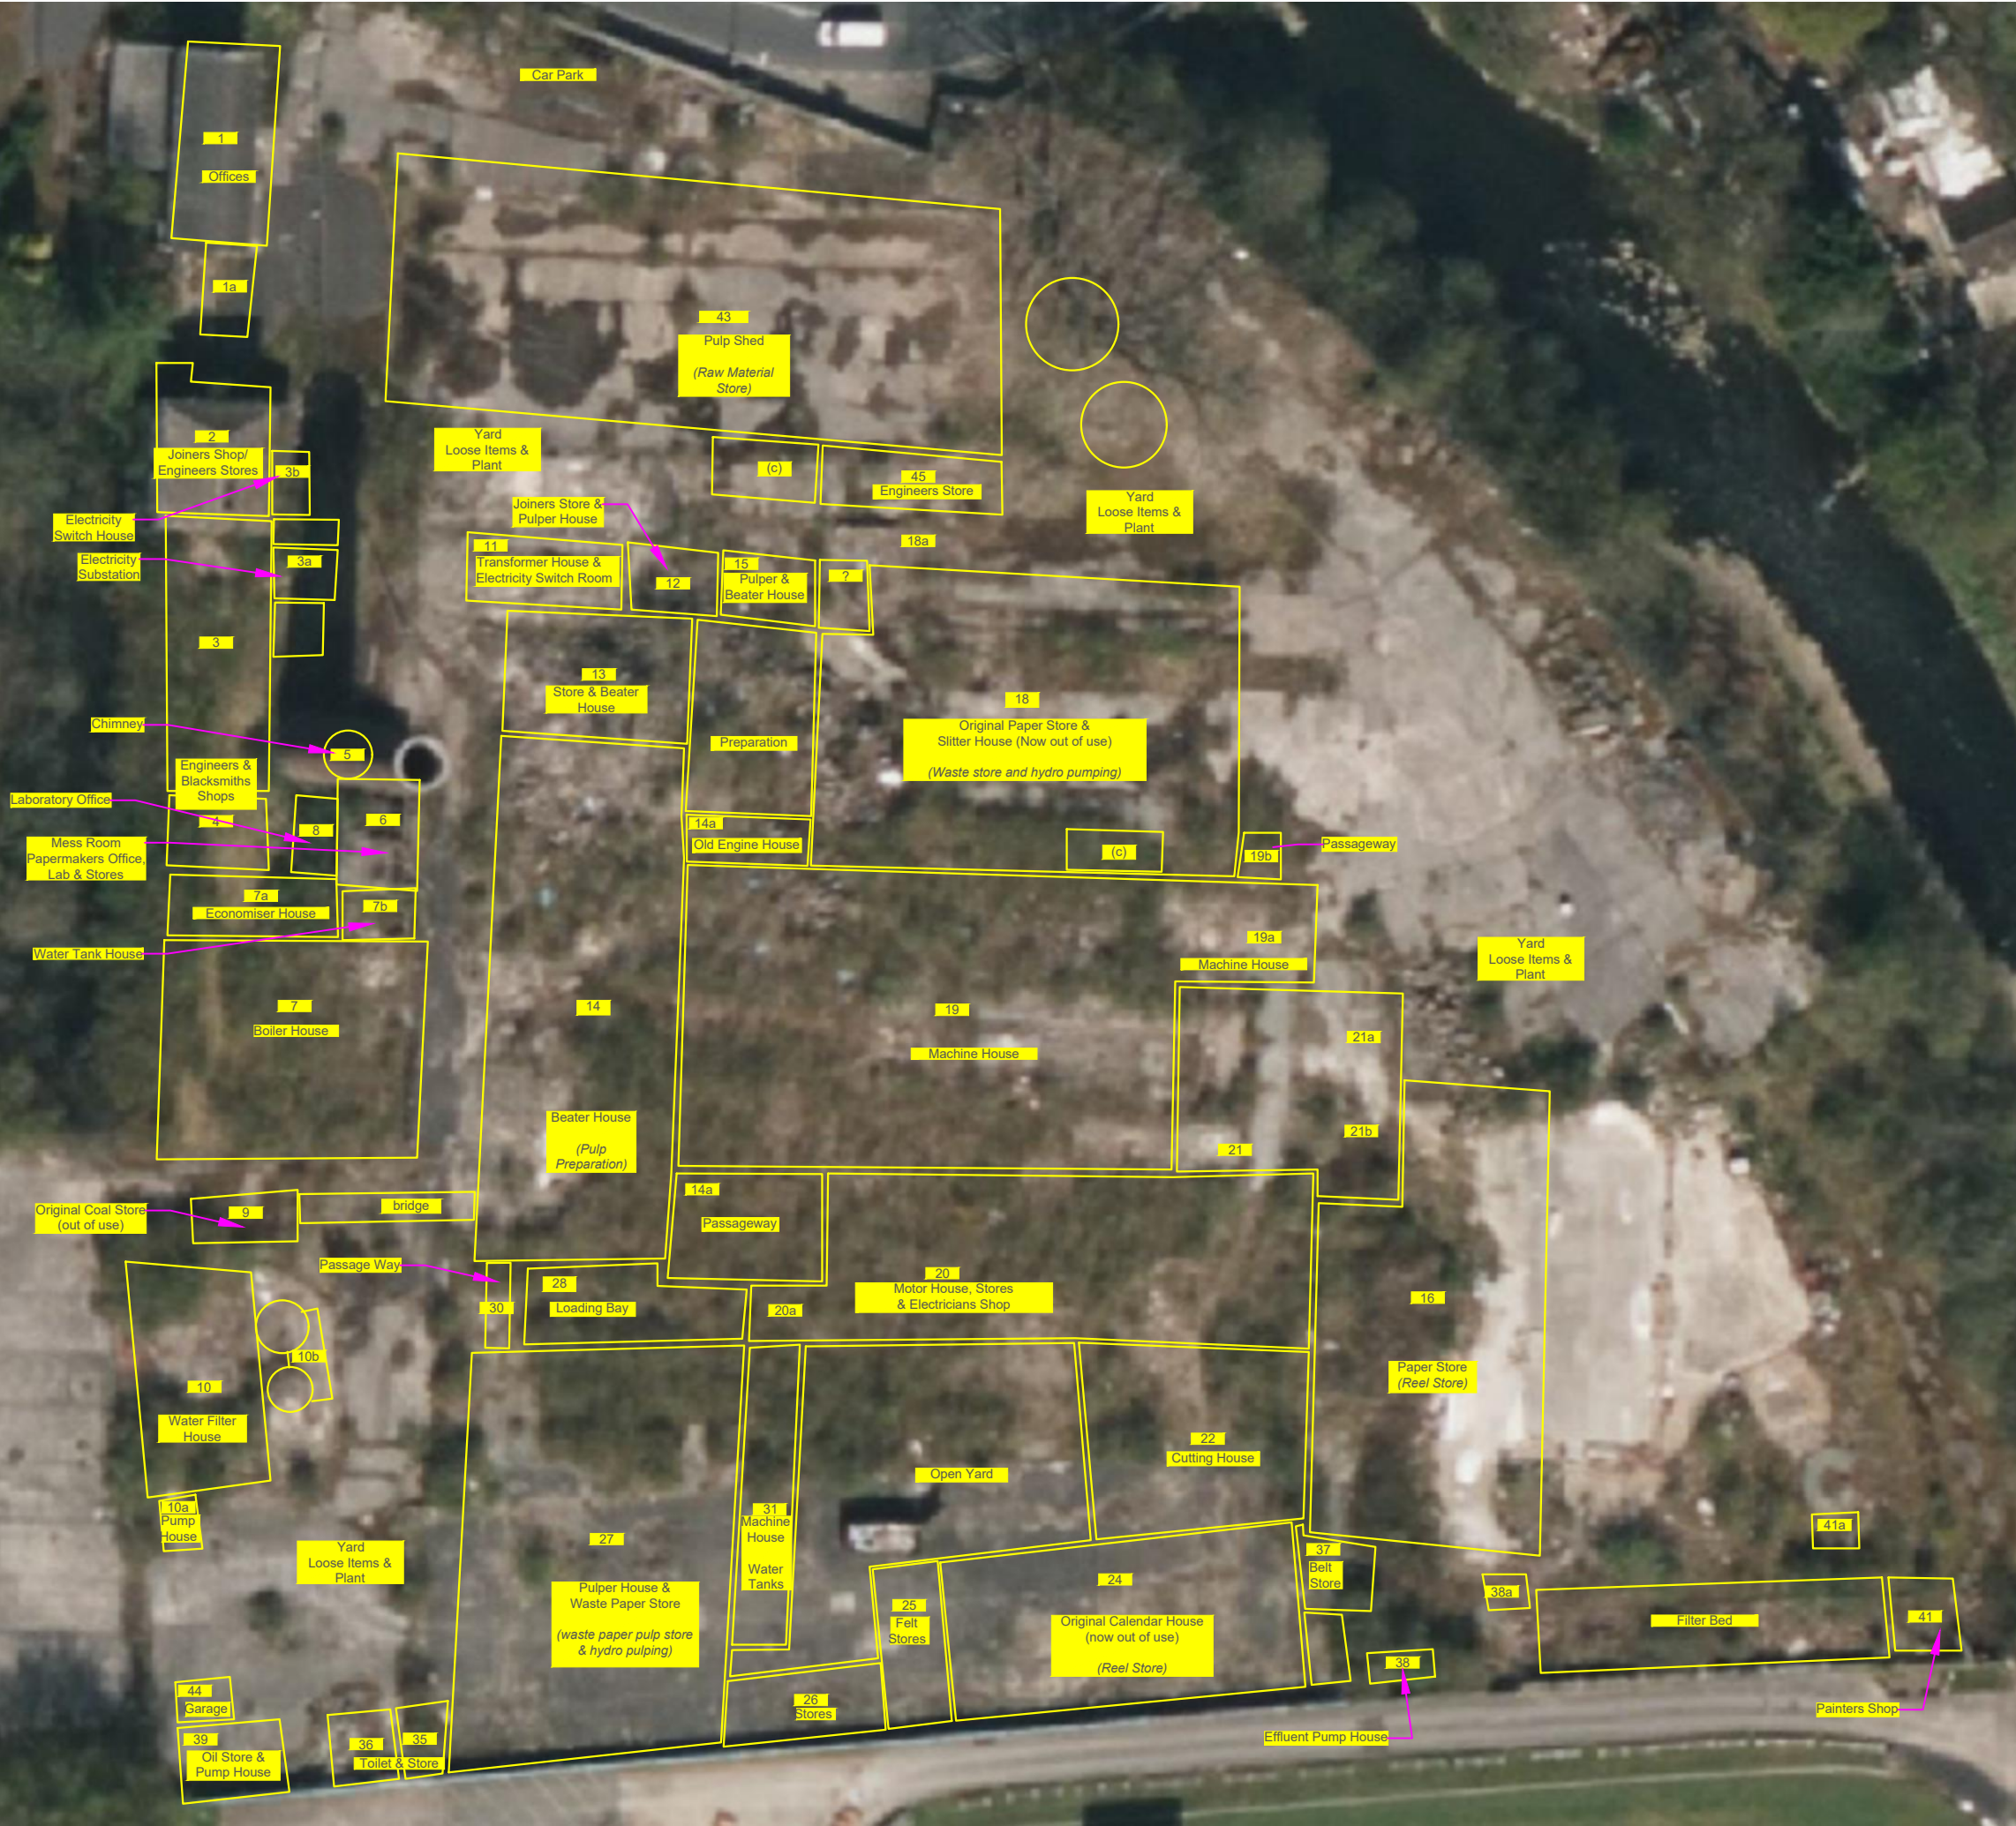
| TITLE: BUILDING USE LAYOUT AND LEGEND | | | | |

INDEX OF BUILDINGS DEPICTED ON 1983 PAPER MILL PLAN

At the request of the EA, Betts Geo have extensively reviewed all the former building areas of site do further risk asses the site (information taken from ‘A Historic Environment Desk-Based and Buildings Assessment of the Former Mondi Site, Holcombe Mill, Bridge Street, Ramsbottom dated 1983’ – available online at
