# **Eccleston Homes**

## **REMEDIATION STRATEGY**

**Mondi Site, Ramsbottom**

**REPORT No: 19ECH016/RS**

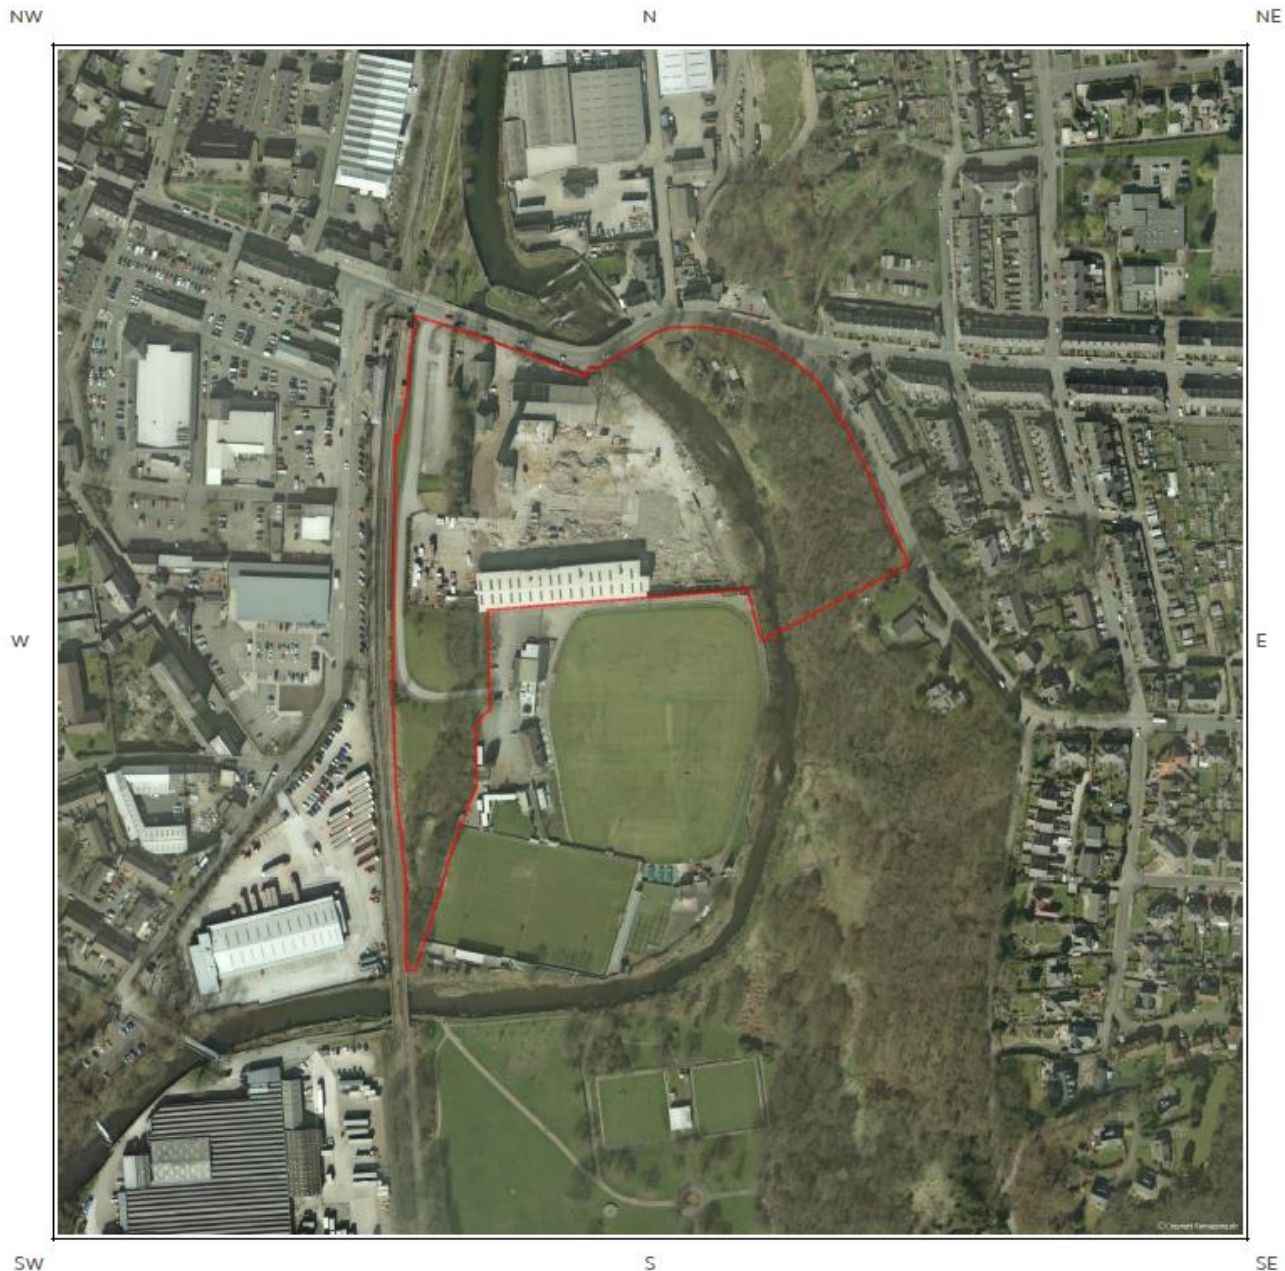
Site Boundary – March 2012

Betts Geo Environmental (Betts) has been commissioned by Eccleston Homes to prepare a Remediation Strategy for the remediation and preparatory works for former Mondi Mill site, Ramsbottom. The plan below shows the site boundary;

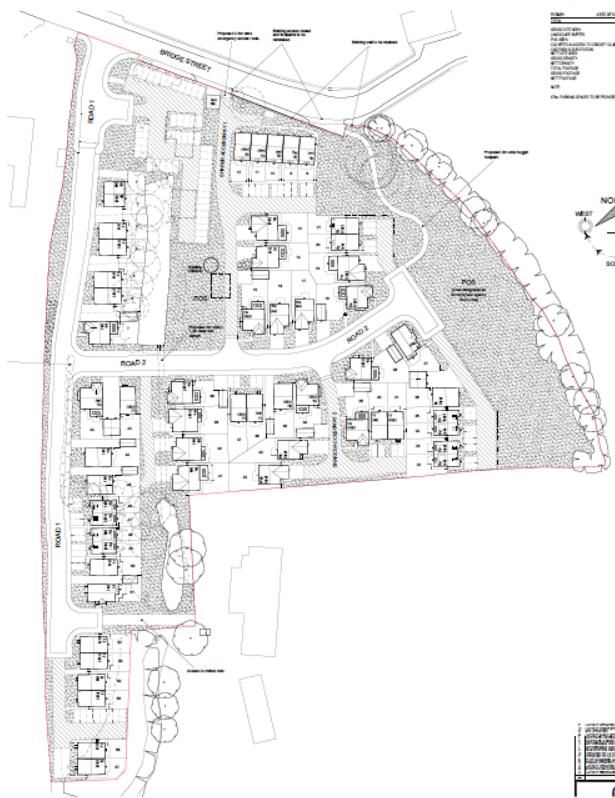
The proposed development at time of issue comprises the construction of residential dwellings with associated gardens, public open space and other infrastructure.

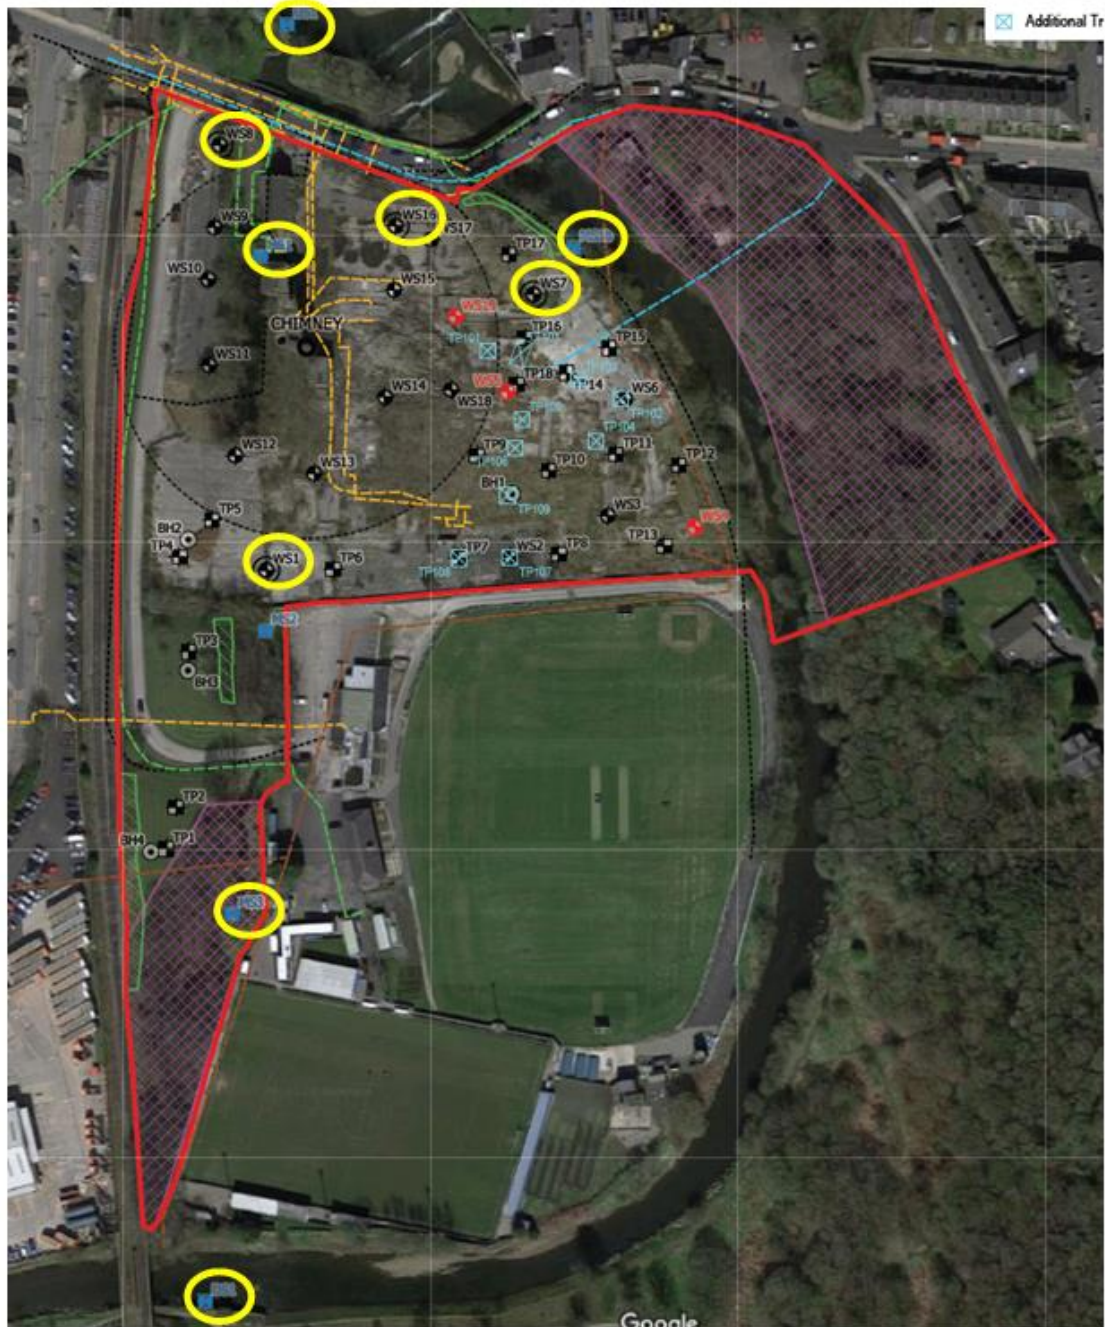
the four existing wells on site – WS1, WS7, WS8 & WS16 and twelve (12 No) samples taken from the onsite/adjacent watercourse – three (3 No) upstream, six (6 No) midstream and three (3 No) downstream.

An extract showing the sample locations in yellow can be seen overleaf;

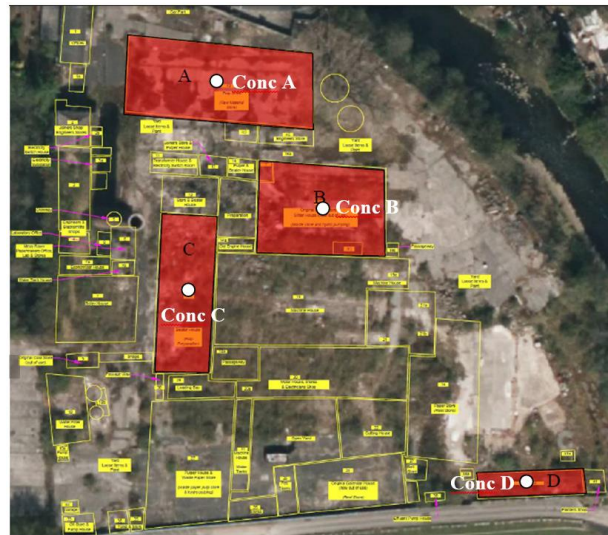
Four different hardstanding surfaces were selected as shown by the red areas and sample points below. These areas were more likely to be affected by PFAS due to processes undertaken in these areas including

raw material storage, waste store and pumping area, pulp preparation and filter beds. For the full rationale behind this area selection please see Betts Geo letter report ref: 19ECH016/MJF/JS/EAResponse2/Rev1 dated 13<sup>th</sup> February 2025.

A total of 8 samples were analysed – two from each of the four identified 'higher' priority areas.

The results for the samples analysed and for all determinants tested were below the method detection limits. The results correlate and supports with the lines of evidence provided by Betts Geo previously.

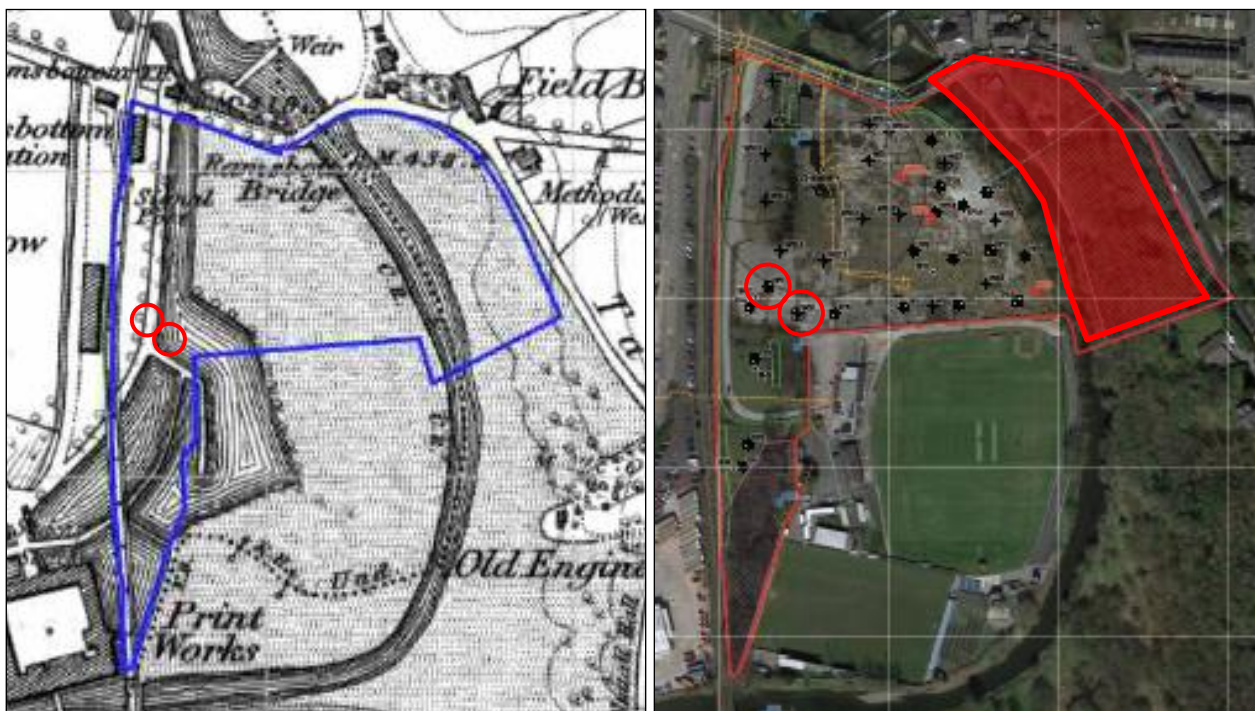
The Made Ground exceedances have been recorded at varying depths between 0.10mbgl and 2.00mbgl. With deeper exceedances at 2.25mbgl (TP5) and 2.75mbgl (WS1), within potential Made Ground strata.

Based on the locations of TP5 and WS1, in relation to the formerly existing reservoirs, it is now considered likely that these are Made Ground samples from backfill / basal reservoir materials. As shown in the sketch below;

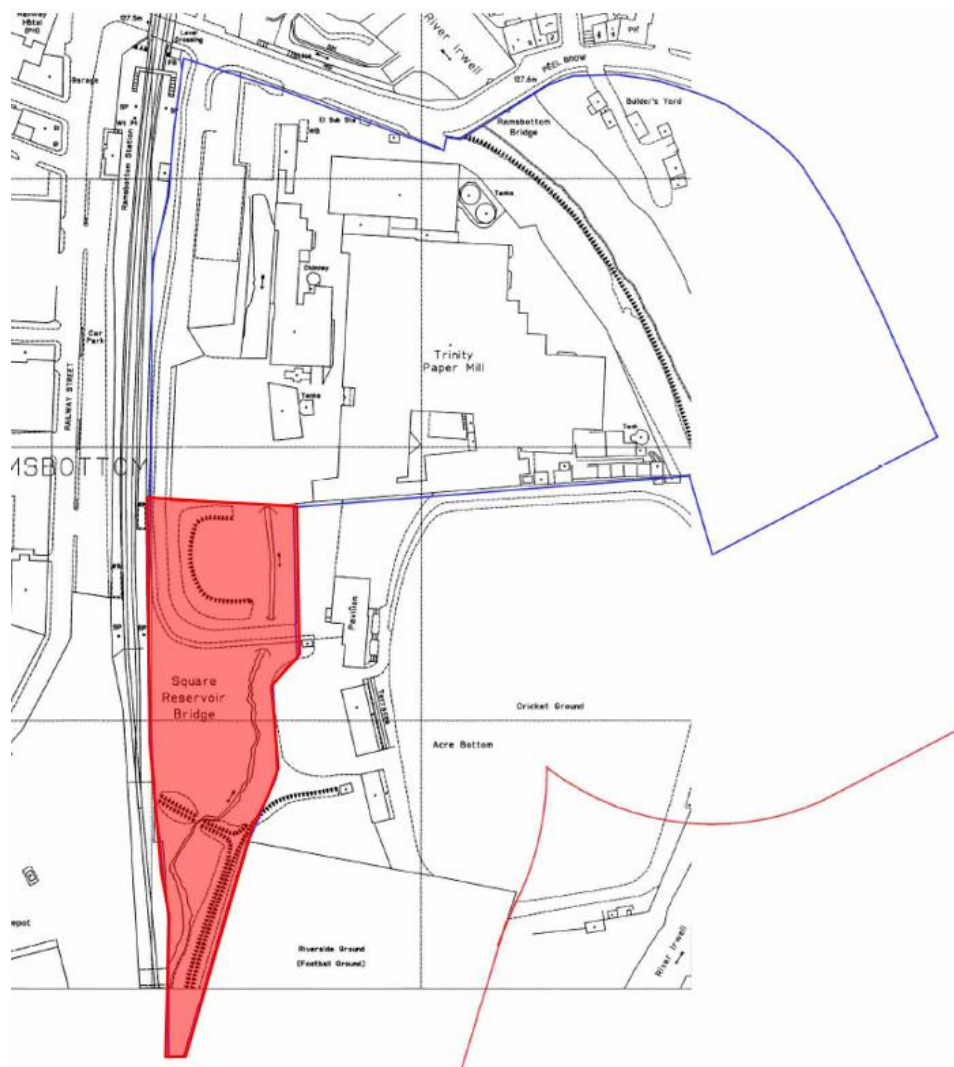
**It is proposed to treat the former landfill area as a separate entity to the main site area, and as such conditions can be phased as such. This has been discussed with both the EA and the LA who were both in agreement. An extract showing this area can be seen below:**
