# Bat

# Presence-Absence Survey

Coach house at

33 Sunny Bower Street

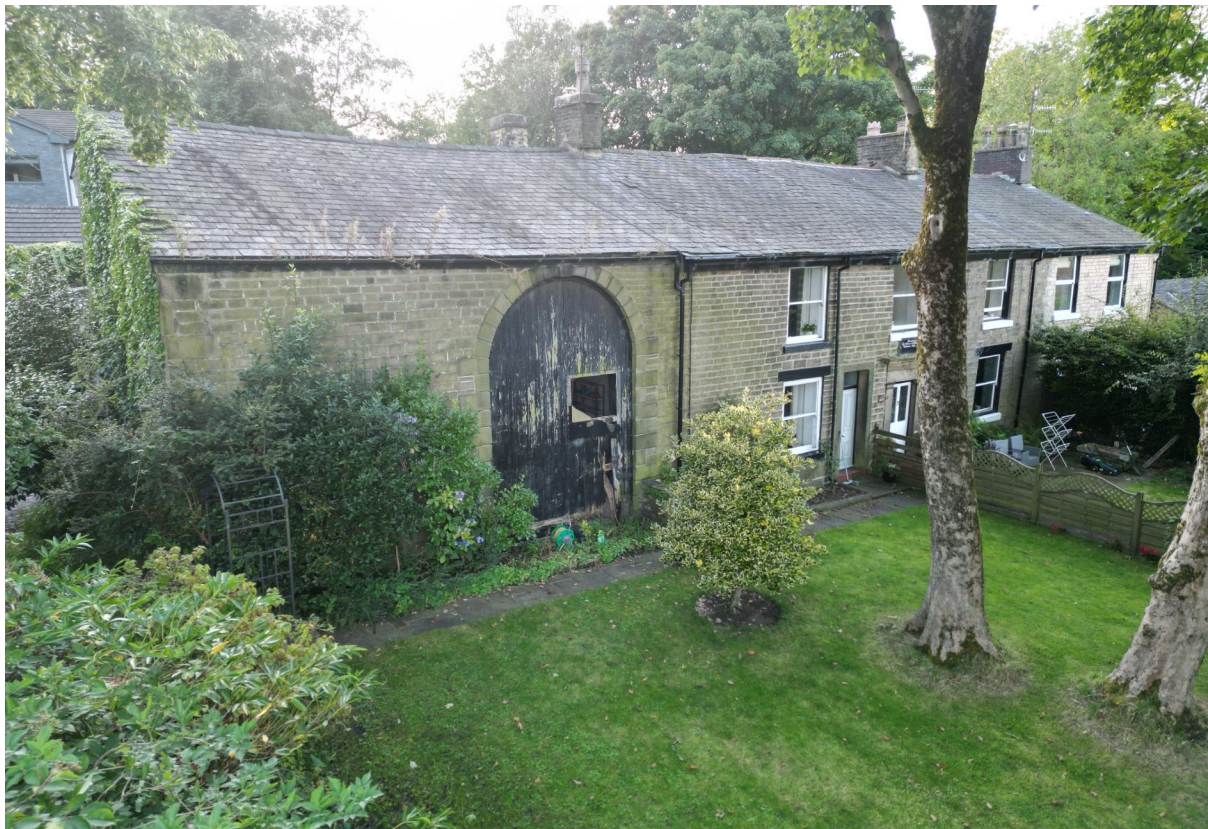
3.1a - The front of the house and coach house from the garden.

Nº33 Sunny Bank Street, and the coach house, have pitched roofs, covered with slate roof tiles and a mixture of ceramic & stone ridge tiles. Roof pitches face east and west. The gable end of the coach house, which is in different ownership, faces south. Walls are solid stone. Lintels are stone, window and door frames are wooden, all glass is intact. The coach house has large arched wooden doors to the front and rear.

Internally the roof void of the house has been converted to living space. The coach house consists of a single large open space with no enclosed roof voids. The roof has a timber rafter and purlin structure with supporting timber trusses, and is lined with bitumen felt.

The building is in good general condition, however there are a number of features which could be used by roosting bats including: gaps beneath roof and ridge tiles, gaps at the eaves, holes and gaps around timber doors of the coach house.

The gaps could give access into the barn, and into smaller crevices within the structure of the building.
