# **LOWER CHESHAM HALL BURY**

## **SIGNIFICANCE ASSESSMENT**

**Kathryn Sather & Associates  
Heritage Conservation Consultants**

**July 2018**

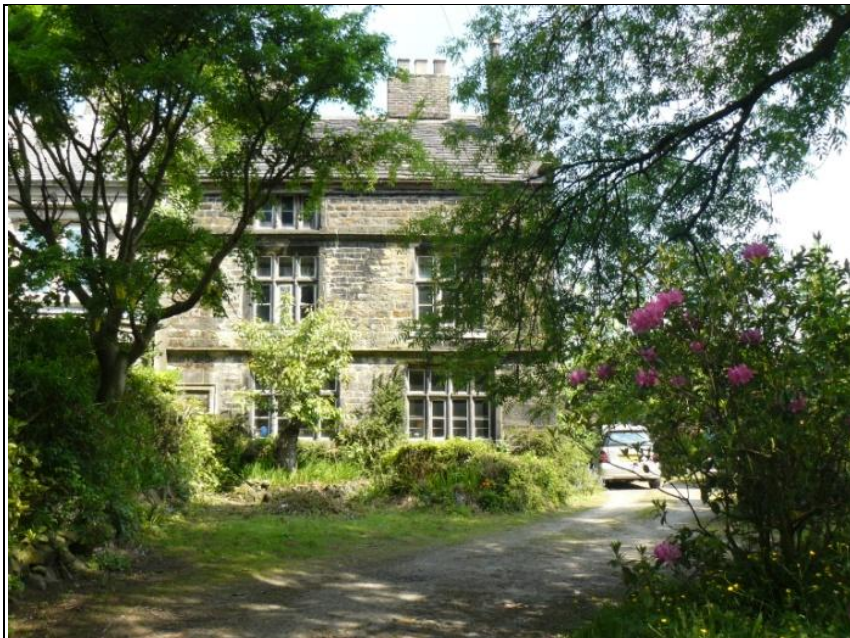
This faces the garden and now (although not originally) the drive. At ground floor there is a pair of four light mullion and transomed windows below a moulded stone string course. At first floor there is a pair of three light mullion and transomed windows, below a second string course; these windows are of similar height to those on the ground floor. To the west is a small stone at first floor level which appears in the 1849 print; this may have carried an inscription but nothing is visible now. Beneath this is a blocked up doorway with stone architrave.

At second floor above the westerly bay is a small three light mullioned window beneath the stone cornice; this is not shown in the later print, there is no evidence that a second window was blocked up. The roof verges are capped with stone copings, embellished by three ball capped finials, one on the ridge and two on the eaves. The one above the cornice to the west may not be in the original position.

*South Elevation*

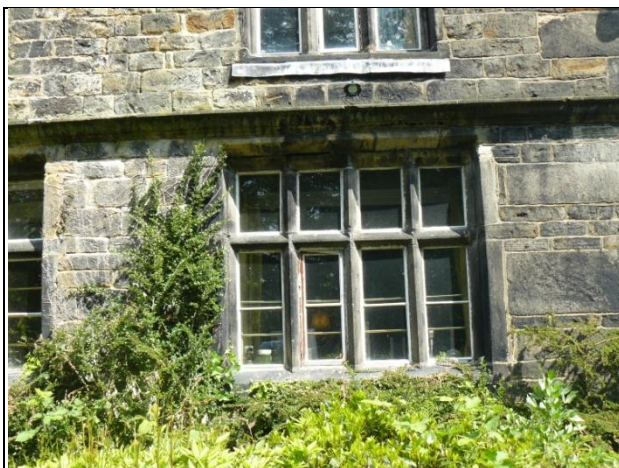
*Window on Ground Floor of South Elevation*

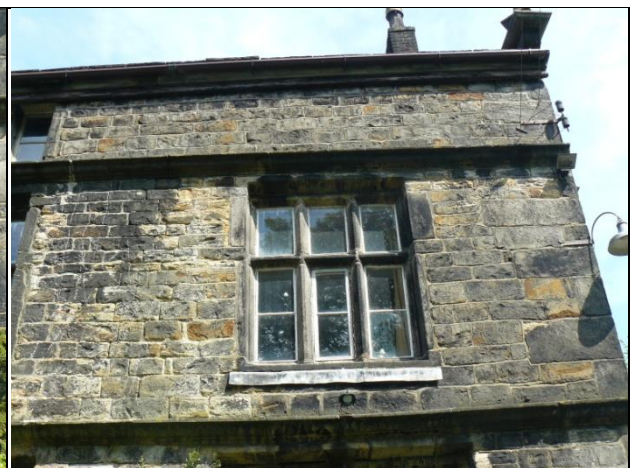
*Window on First Floor of South Elevation*

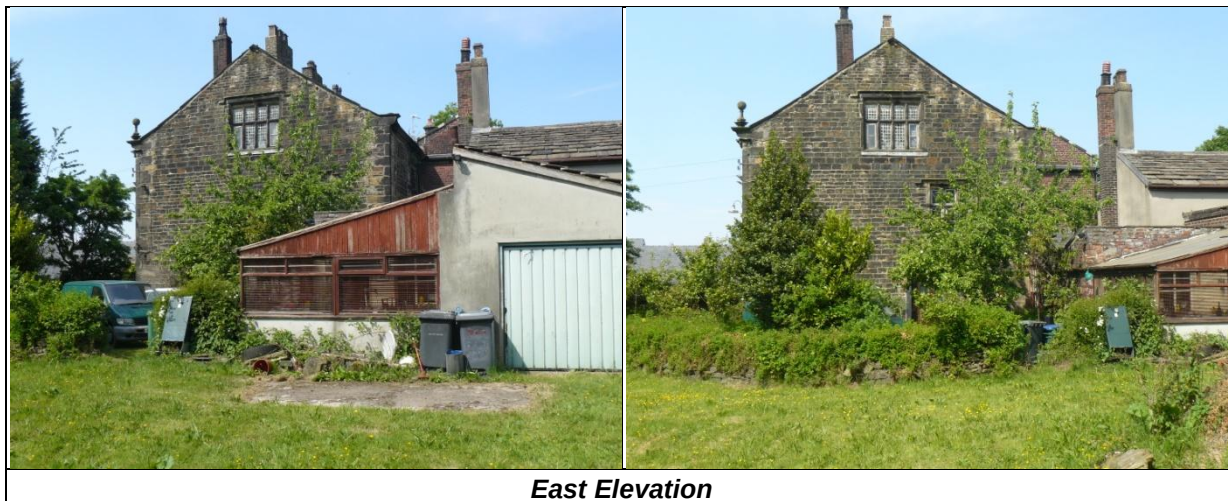
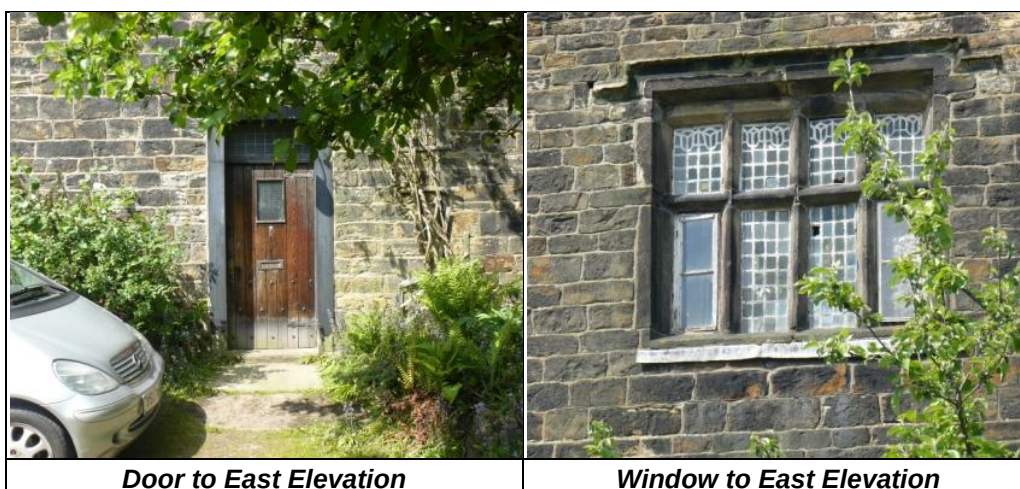
This contains the current entrance to the property, inserted into what appears to have been a window opening. It has a timber door with rectangular fanlight above, set within a stone architrave, positioned in the centre of the ground floor. At first floor level there is a three-light mullioned and transomed window to the northeast; this may have been one of a pair, with the other having been blocked up. At second floor level under the apex of the gable there is a four light window. The single brick chimney stack on this elevation appears to postdate the ridge chimneys and is set in from the gable wall.

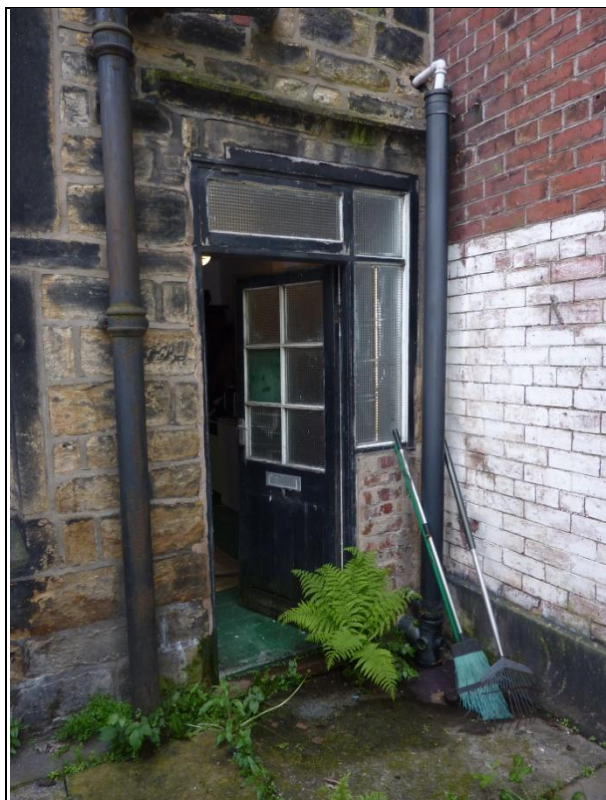
At ground floor level there is much altered opening of the back door. The door is timber with six glazed panes to the top half, and glazed panels above and to the west. This immediately abuts the wall of the western house. Above this is a 2 over 2 sash window with leaded lights set in a stone architrave whose western edge and hoodmould is interrupted by the western house wall. Immediately under the eaves at second floor level is a small square window with stone architrave similarly interrupted. To the east of these is the characteristic feature of the north elevation, the

*Door and Altered Opening in North Elevation*

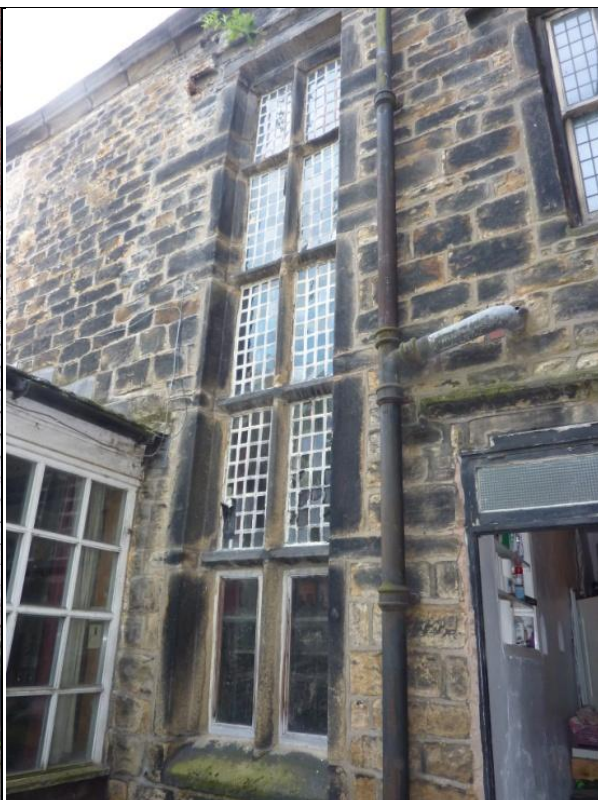
vertical sequence of five levels of two-light mullioned windows, featuring small panes, illuminating the staircase, separated by stone cills. At ground floor the original window frames and small panes have been replaced with timber frames. Above this many of the leaded lights are broken and the lead-work is buckling.

*Staircase Window*

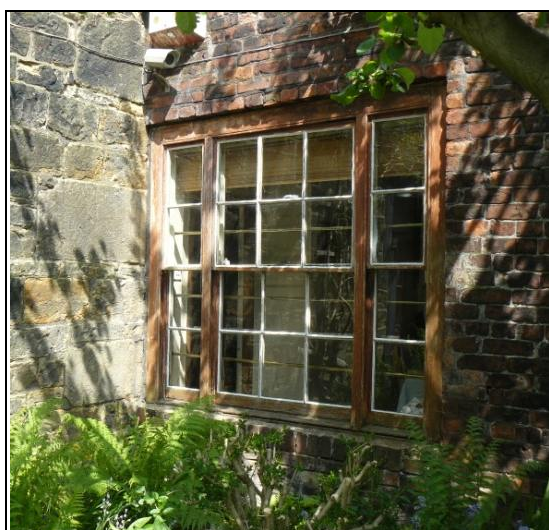
The single-storey extension to the northeast corner shows evidence of several phases. The pitched roof extends north from the north elevation, with the ridge centred on the edge of the original house. This constitutes the earliest section but may have replaced an earlier structure. There is a timber framed window in its south elevation beneath the slope of the eastern pitch of the roof, a 6 over 6

***East Extension South Elevation***

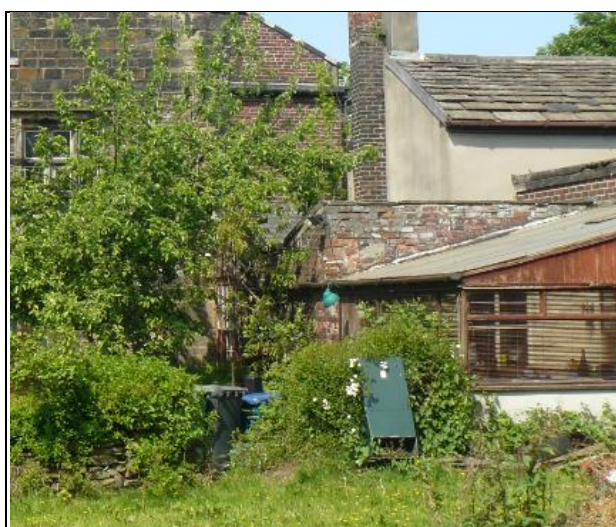
East of this beyond a valley gutter is a second single-storey brick extension under a lean-to tiled roof extending up to its east elevation which is brick (in poor condition). This phase of the extension has a transom window with a timber frame in the south elevation and, visible through the glazing of the third phase, the painted wall and a four-pane window and door in the east elevation.

***Later Brick Extension with Conservatory Extension in Front***

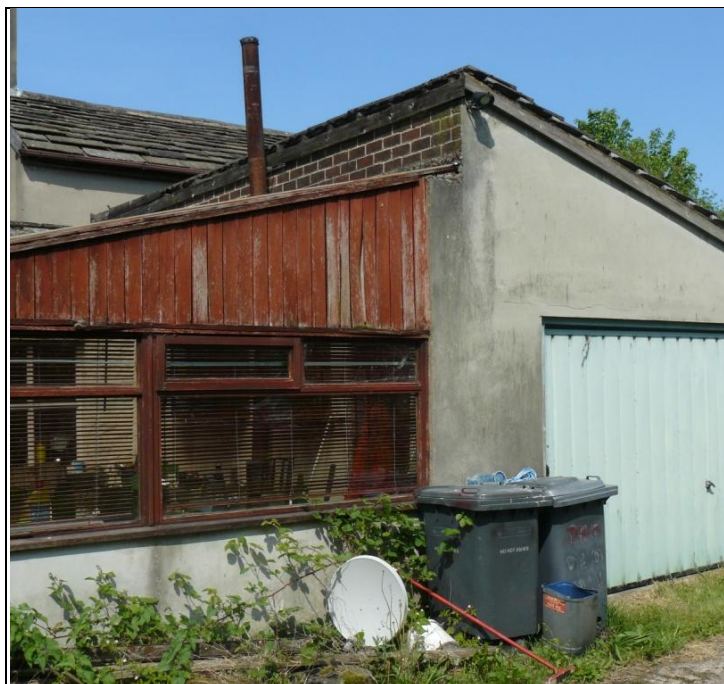
To the east of this are two further abutting structures, comprising a conservatory-style glazed space; this has a brick base and a glazed and timber structure above; and a garage. Both are used for storage and have single pitch roofs. The apex of the garage is slightly higher, so that some courses of brickwork are visible above the roofline of the conservatory area. The garage has a double metal door to the east and a door to the conservatory to the south.

**Modern Conservatory and Garage Extensions**

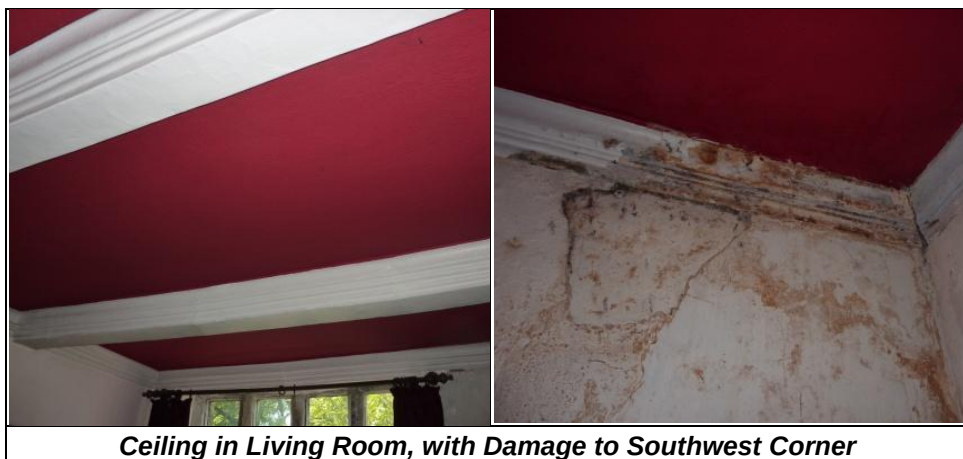
***Ceiling in Living Room, with Damage to Southwest Corner***

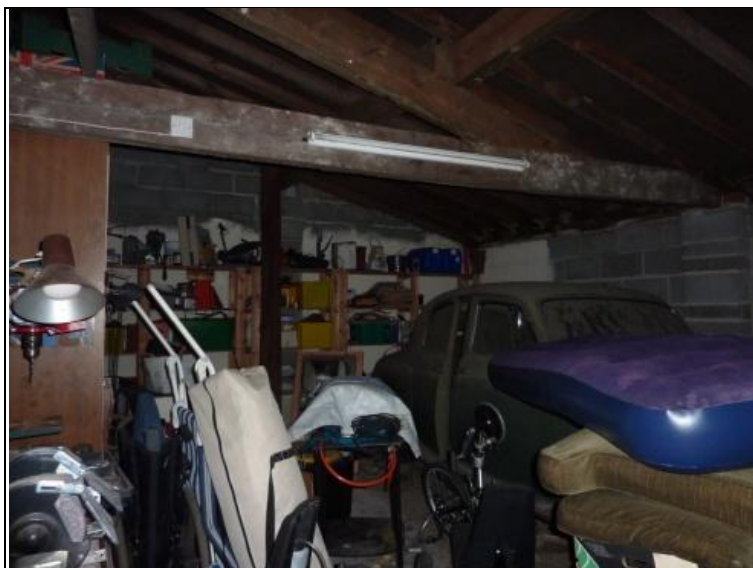
The garage has a wooden truss holding up the roof, the roof is constructed of purlins and rafters. The walls are concrete blocks, with some bricks visible externally.

*View into Garage*

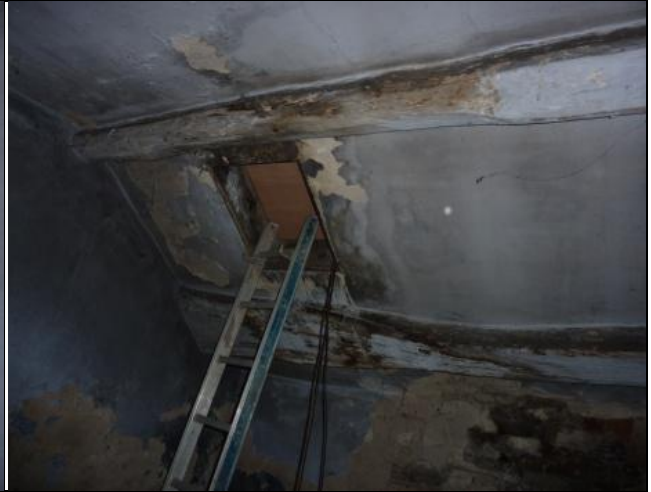
The room to the northwest functions as an attic space. There is damage to the plaster, with much of the walls exposed. The ceiling is sloping, with exposed wooden beams and a blocked up roof light. The ceiling shows signs of significant water ingress. A redundant timber staircase is located along the western wall. A banister separates the stairs from the room. The flooring is wooden and is also damaged. To the north wall there is a single paned window with wooden surrounds.

*Ceiling in Attic*

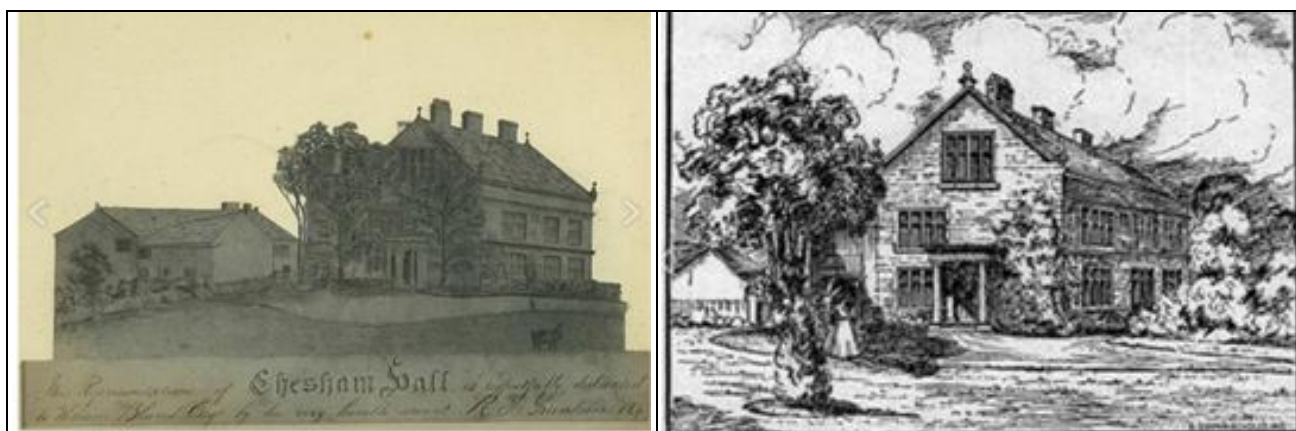
**Two Prints of Lower Chesham Hall 1849**
