Report No. 40275 Rev 1

FORMER WATERSIDE PUB, SUMMERSEAT

Desk Study and Preliminary Risk Assessment

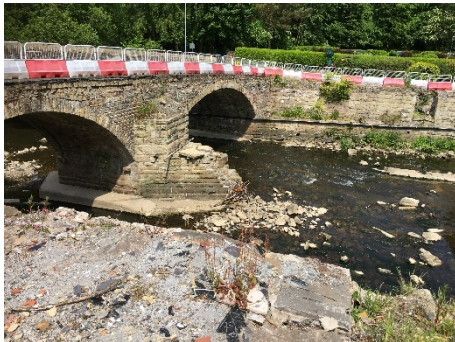
Figure 2: View north of location of the historic Waterside public house and Kay Bridge.

It is understood that the site was previously the car park for The Waterside public house which was located over the River Irwell, adjacent to Kay Bridge, until it collapsed during a flood in December 2015.

The bridge to the northwest of the site is damaged and is closed to traffic and is now for pedestrian use only.

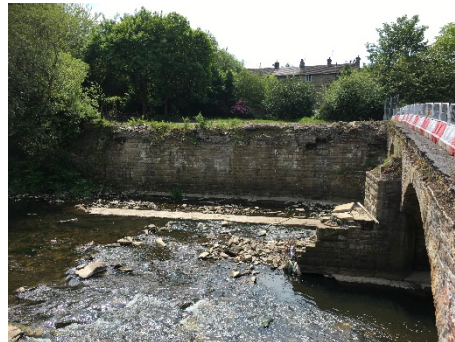
Figure 3: View south of the site and retaining wall.

The River Irwell marks the northern boundary. The site is raised above the river and has a retaining wall marking the site boundary with a metal fence and semi-mature trees and shrubs. There is no metal fence or vegetation marking the northwest boundary where it is understood The Waterside public house was historically located.

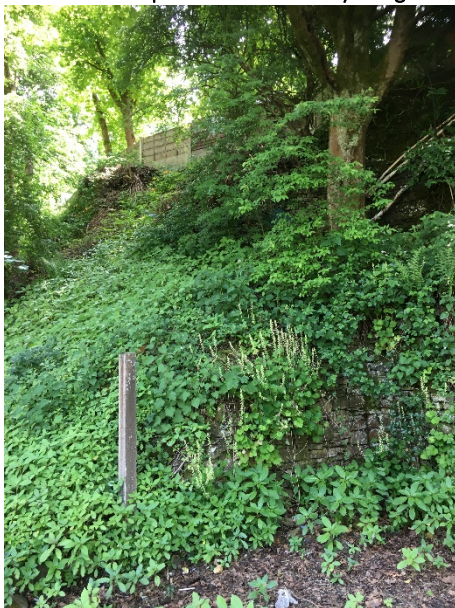
Figure 4: View southeast of slope and retaining wall.

A steep slope marks the southeastern boundary which reduces in height to the west and has retaining walls in places which appear to be dry stone walling. The site is

approximately at 115m AOD, with the top of the slope being up to 119m AOD in the southeast. Mature trees are located across the slope. A mound of logs and branches are noted to the southwest of the site which is thought to be debris from a flood. The site backed onto the gardens of residential properties to the South.

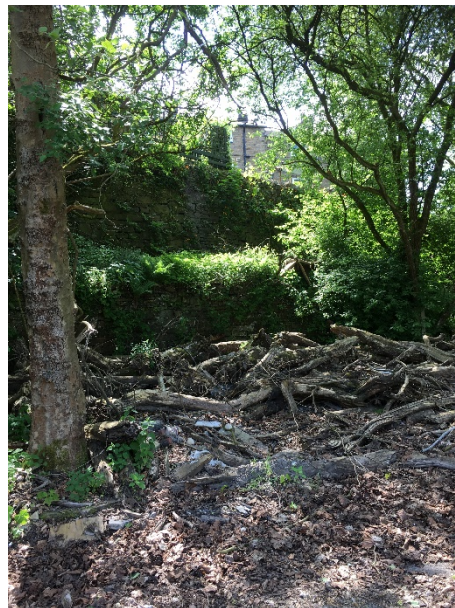
Figure 5: View southwest of debris and retaining walls.

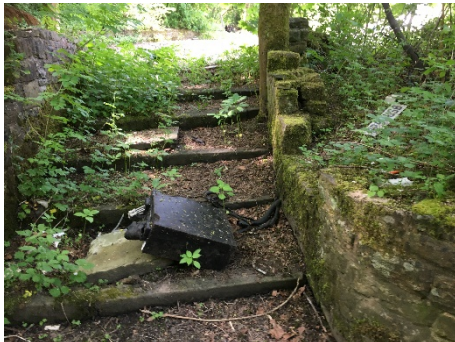
Figure 6: View southwest of stairs in the east of the site.

A stairway leads down towards mature woodland in the east of the site.

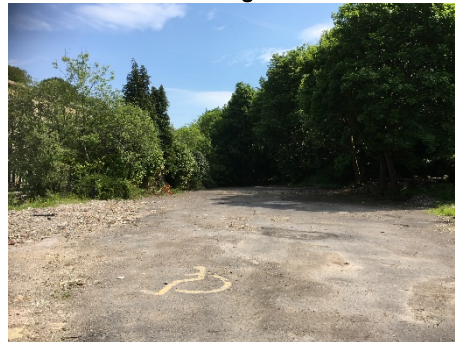
Figure 7: View east from Kay Street of site including hard standing and mature trees.

A walkover was carried out on 24<sup>th</sup> May 2018. The site is predominantly open ground with a ground surface comprising asphalt which was noted to be damaged in places and slopes down gently towards the north.

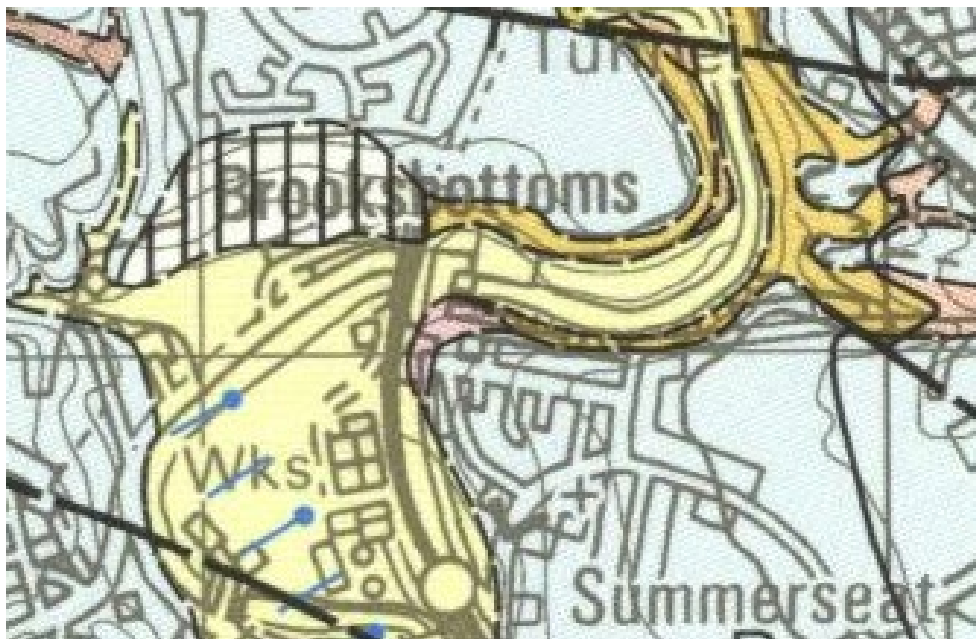
Figure 8: BGS Drift Map

The available geological maps (BGS Sheet 76) indicate the site is underlain by Glaciofluvial Deposits with Glacial Till uphill 19m to the south. Alluvium is associated with the river channel to the north. A landslide is shown to the northwest of the site. The solid geology beneath the site is the Marsden Formation from the Namurian Stage which comprises mudstone and siltstone beneath the site (yellow on the map), however, the lithological description for the formation as a whole comprises sandstone (orange on the map) interbedded with siltstone and mudstone and subordinate marine black shales, thin coals and seatearths.
