## **Phase II Geo-Environmental Assessment**

Site off Bell Lane

**For Pearl Forecourts**

Report ref. 24/1433.2.1

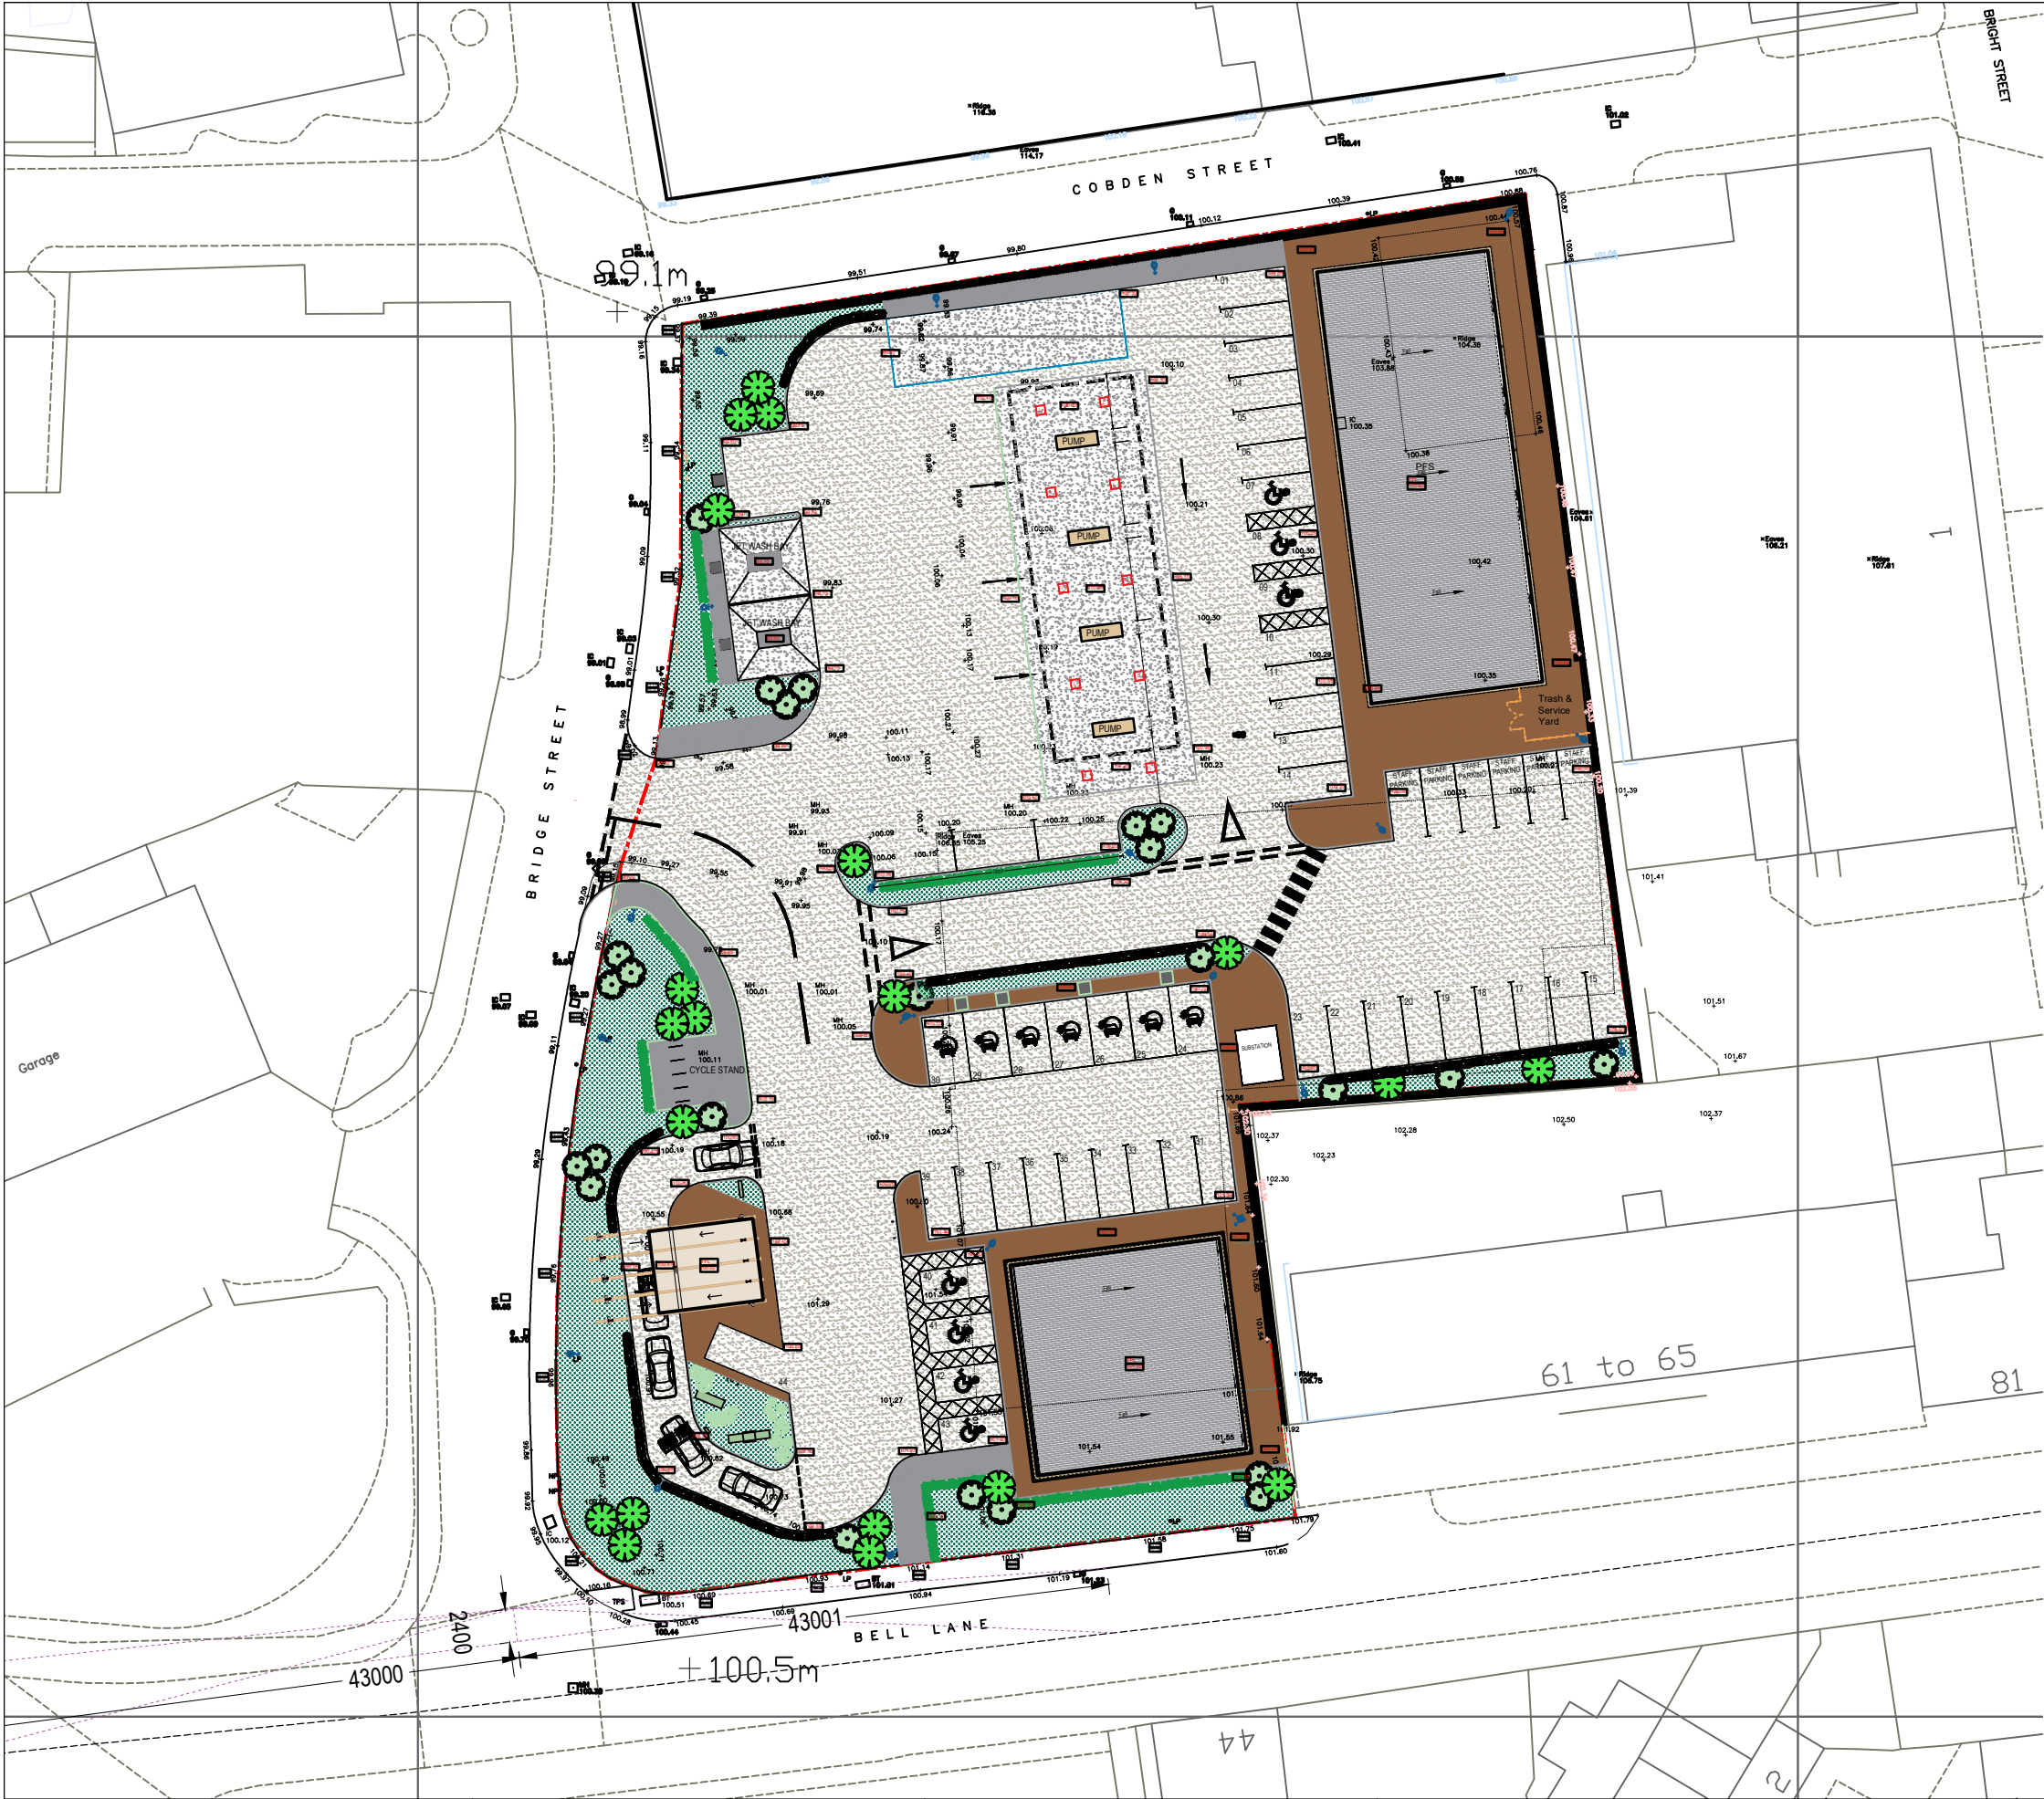
The proposed development plan included in Appendix A shows the outline of the existing buildings with reference to the positioning of the new proposed buildings for easy reference:

- The new PFS building will be located in the northeastern corner of the site, encompassing the existing servicing garage and extending south.
- A retail unit will be added in the southeastern corner of the site, utilising the southern end of the existing car sales showroom building.
- The drive thru' unit will be located in the southwestern area of the site, currently occupied by hardstanding used for parking vehicles.

Existing and proposed development plans for the site can be referred to within Appendix A.
