## **Land South of Warth Road, Bury**

### **Hydrogeological Risk Assessment**

For: GFIC Properties Ltd

| <b>Report Reference:</b> | | <b>3972-02</b> |

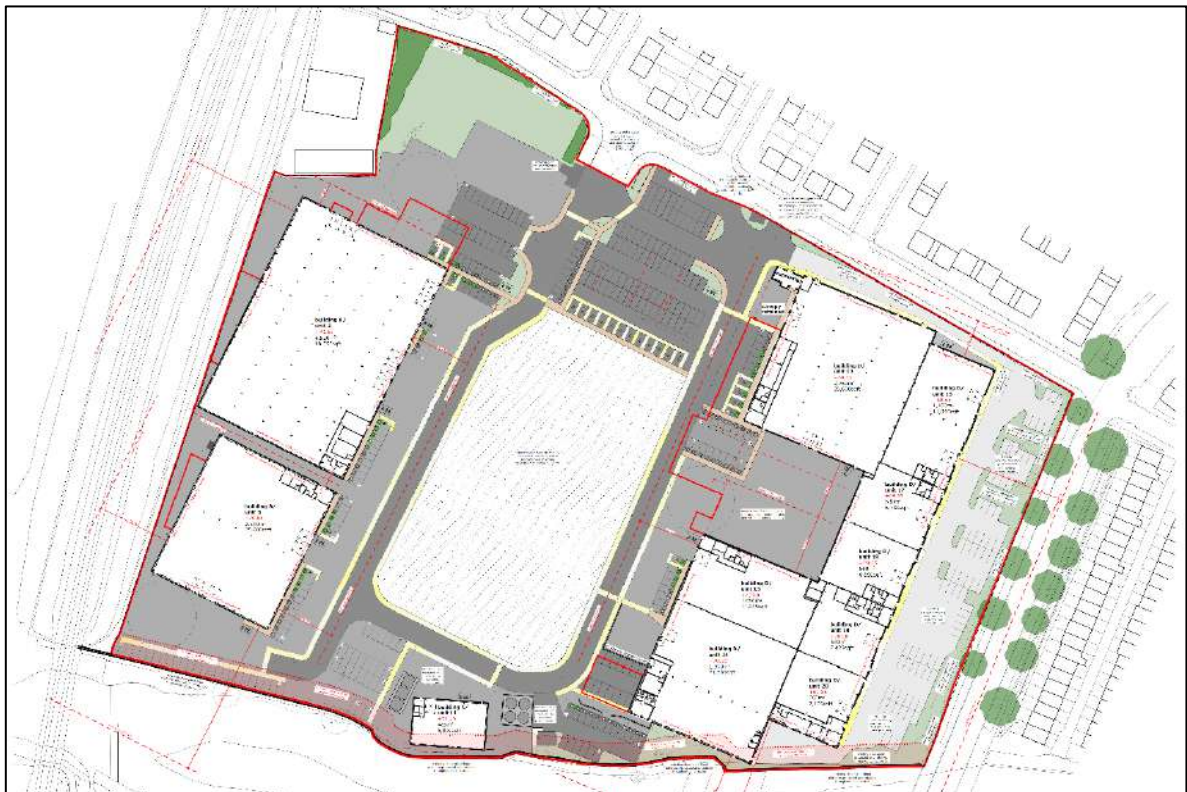
Figure 1: Extract of the Proposed Development Plan, CDP Architects, Construction Site Plan, 24.100.00-CDP-00-DR-A-1005, Rev P04, dated 12.12.2024.

It is the Client's intention to retain the current onsite buildings and partially demolish existing structures to allow for the construction of loading bays and car parking spaces and to construct additional foundations in selected locations. A proposed development plan is contained in Appendix 2 and an extract is included below:

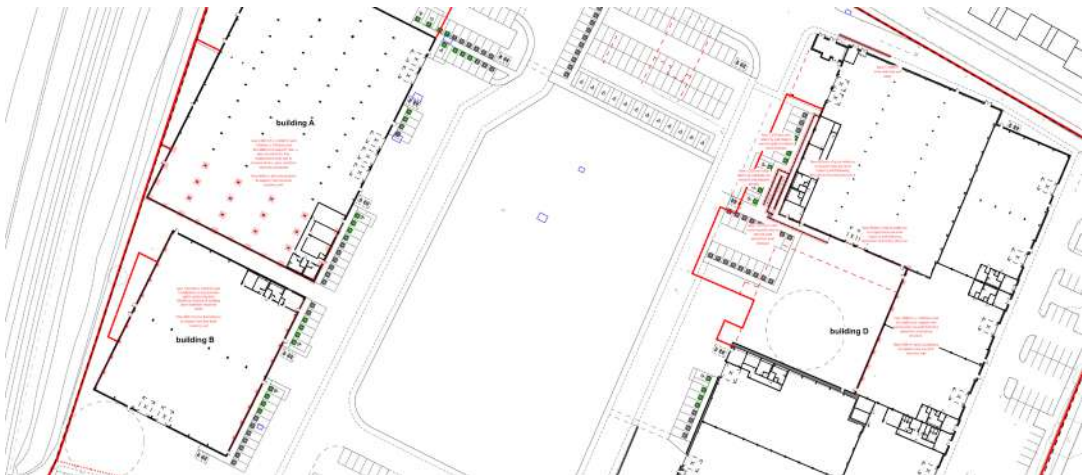
The foundation solution will comprise additional shallow 600mm strip foundations and 1500mm x 1500mm, as well as 2000mm x 2000mm pad foundations, proposed to be constructed within Buildings A and B in the western site section, and Building D in the eastern site section. The proposed works are illustrated on the Ground Penetration Markup Plan contained within Appendix 2.

An extract is noted below (pink shaded area designate new foundations):

The foundation solution for the site at Warth Road, Bury is proposed to comprise the placement of additional 600mm strip foundations and 1500mm x 15000mm and 2000mm x 2000mm pad foundations, constructed within the envelopes of existing buildings.

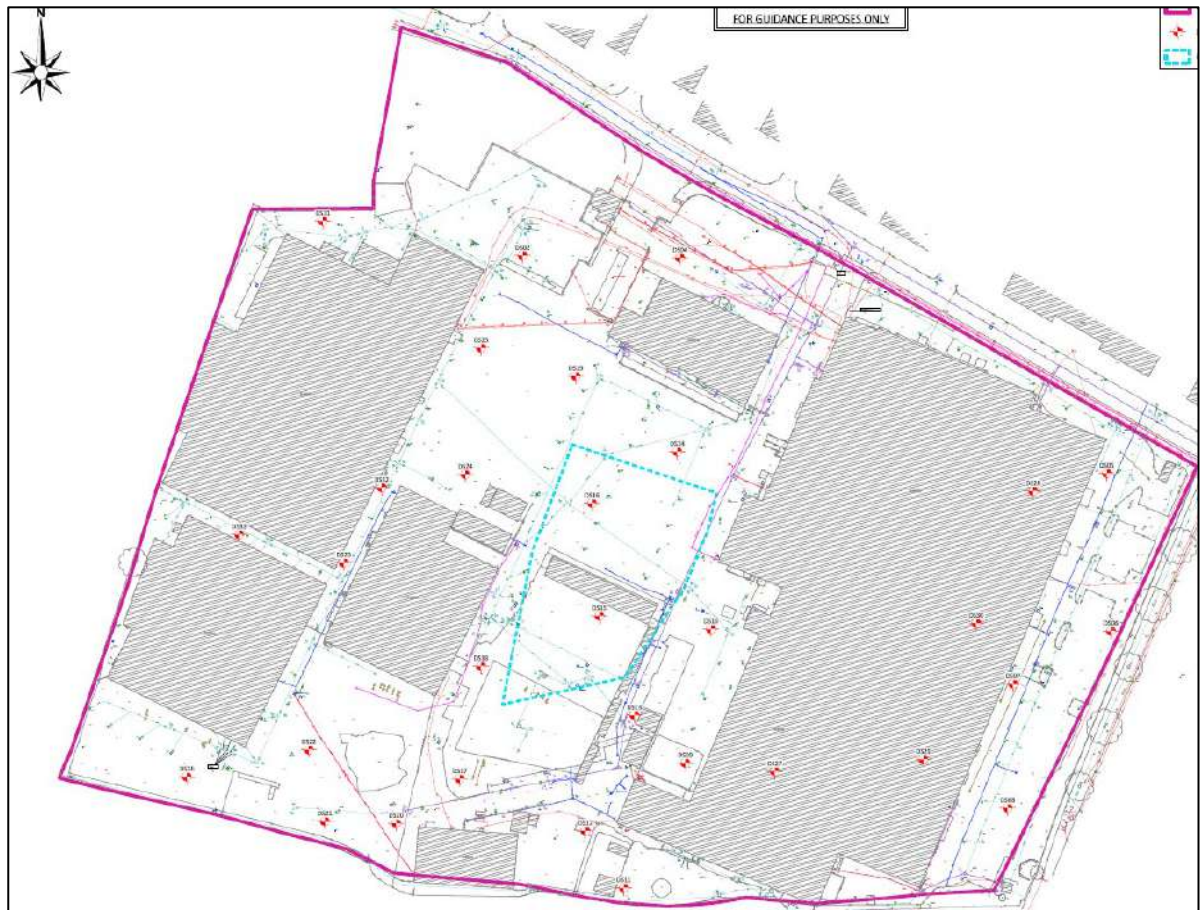
Figure 2: An extract of the exploratory hole location plan (IGE Consulting, Exploratory Hole Location Plan, Ref. SI-02, dated Sept 2023) .

IGE completed 31 No. dynamic sampling boreholes spatially across the site and targeting historical features, of which 20 No. have been installed with a groundwater monitoring well. The exploratory hole logs are contained in Appendix 2 and the borehole locations are shown on Figure 2 below.

The exploratory holes revealed a general succession of Made Ground overlying River Terrace Deposits which were in turn underlain by Glacial Till. Alluvium was also recorded, however it was noted to be present in the south-western site section only.

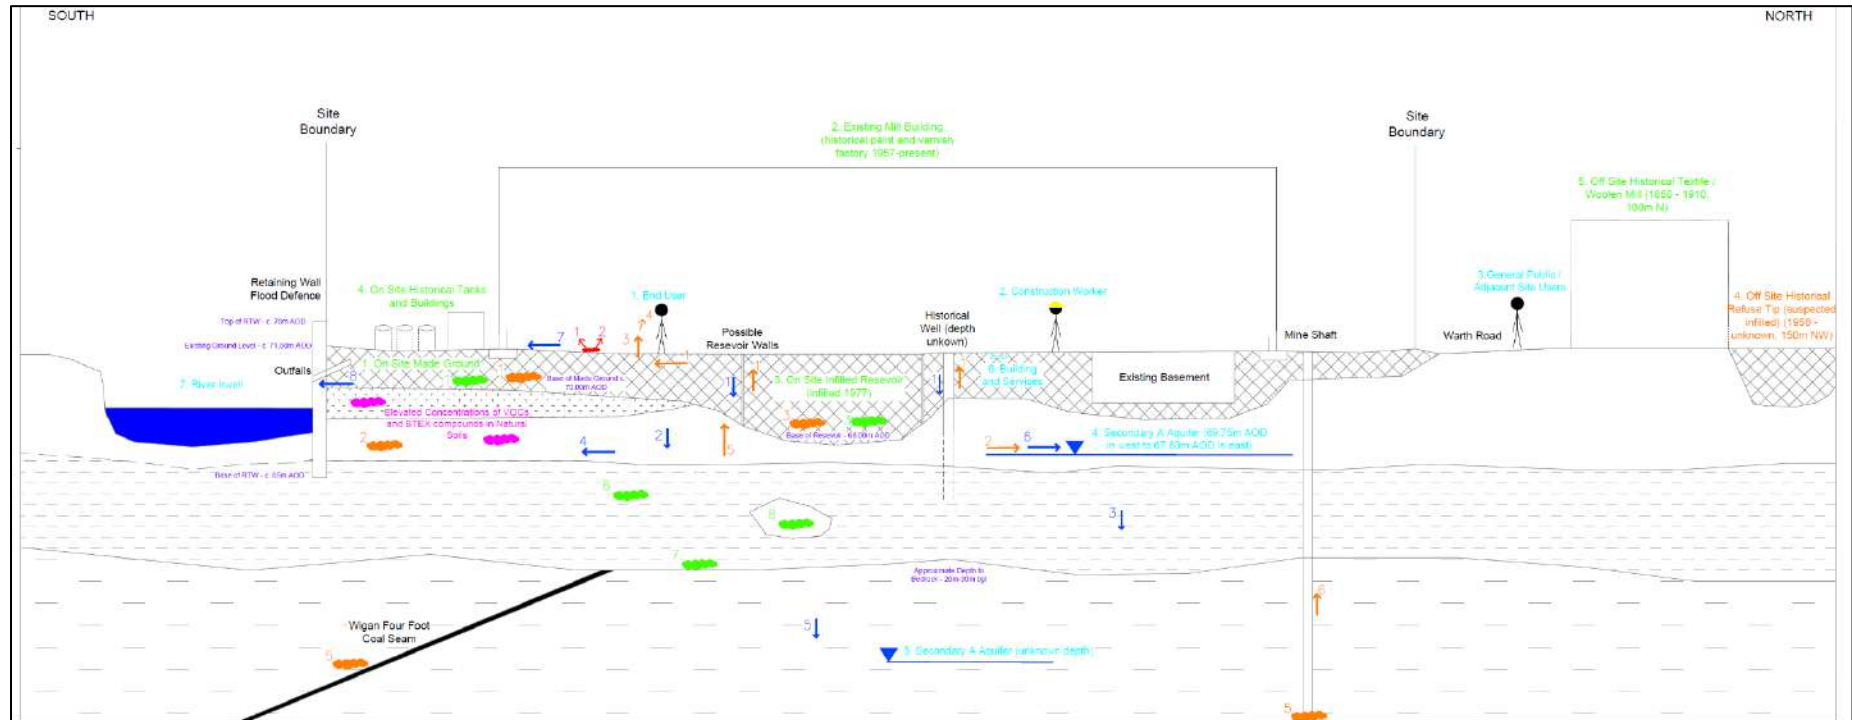
Figure 3: Conceptual Site Model extract.

The Phase 2 report contains a Conceptual Site Model. The feasible pollutant linkages with relation to foundation construction works included in the hydrogeological Conceptual Site Model are contained in the CSM extract below. The diagram is included in Appendix 2.

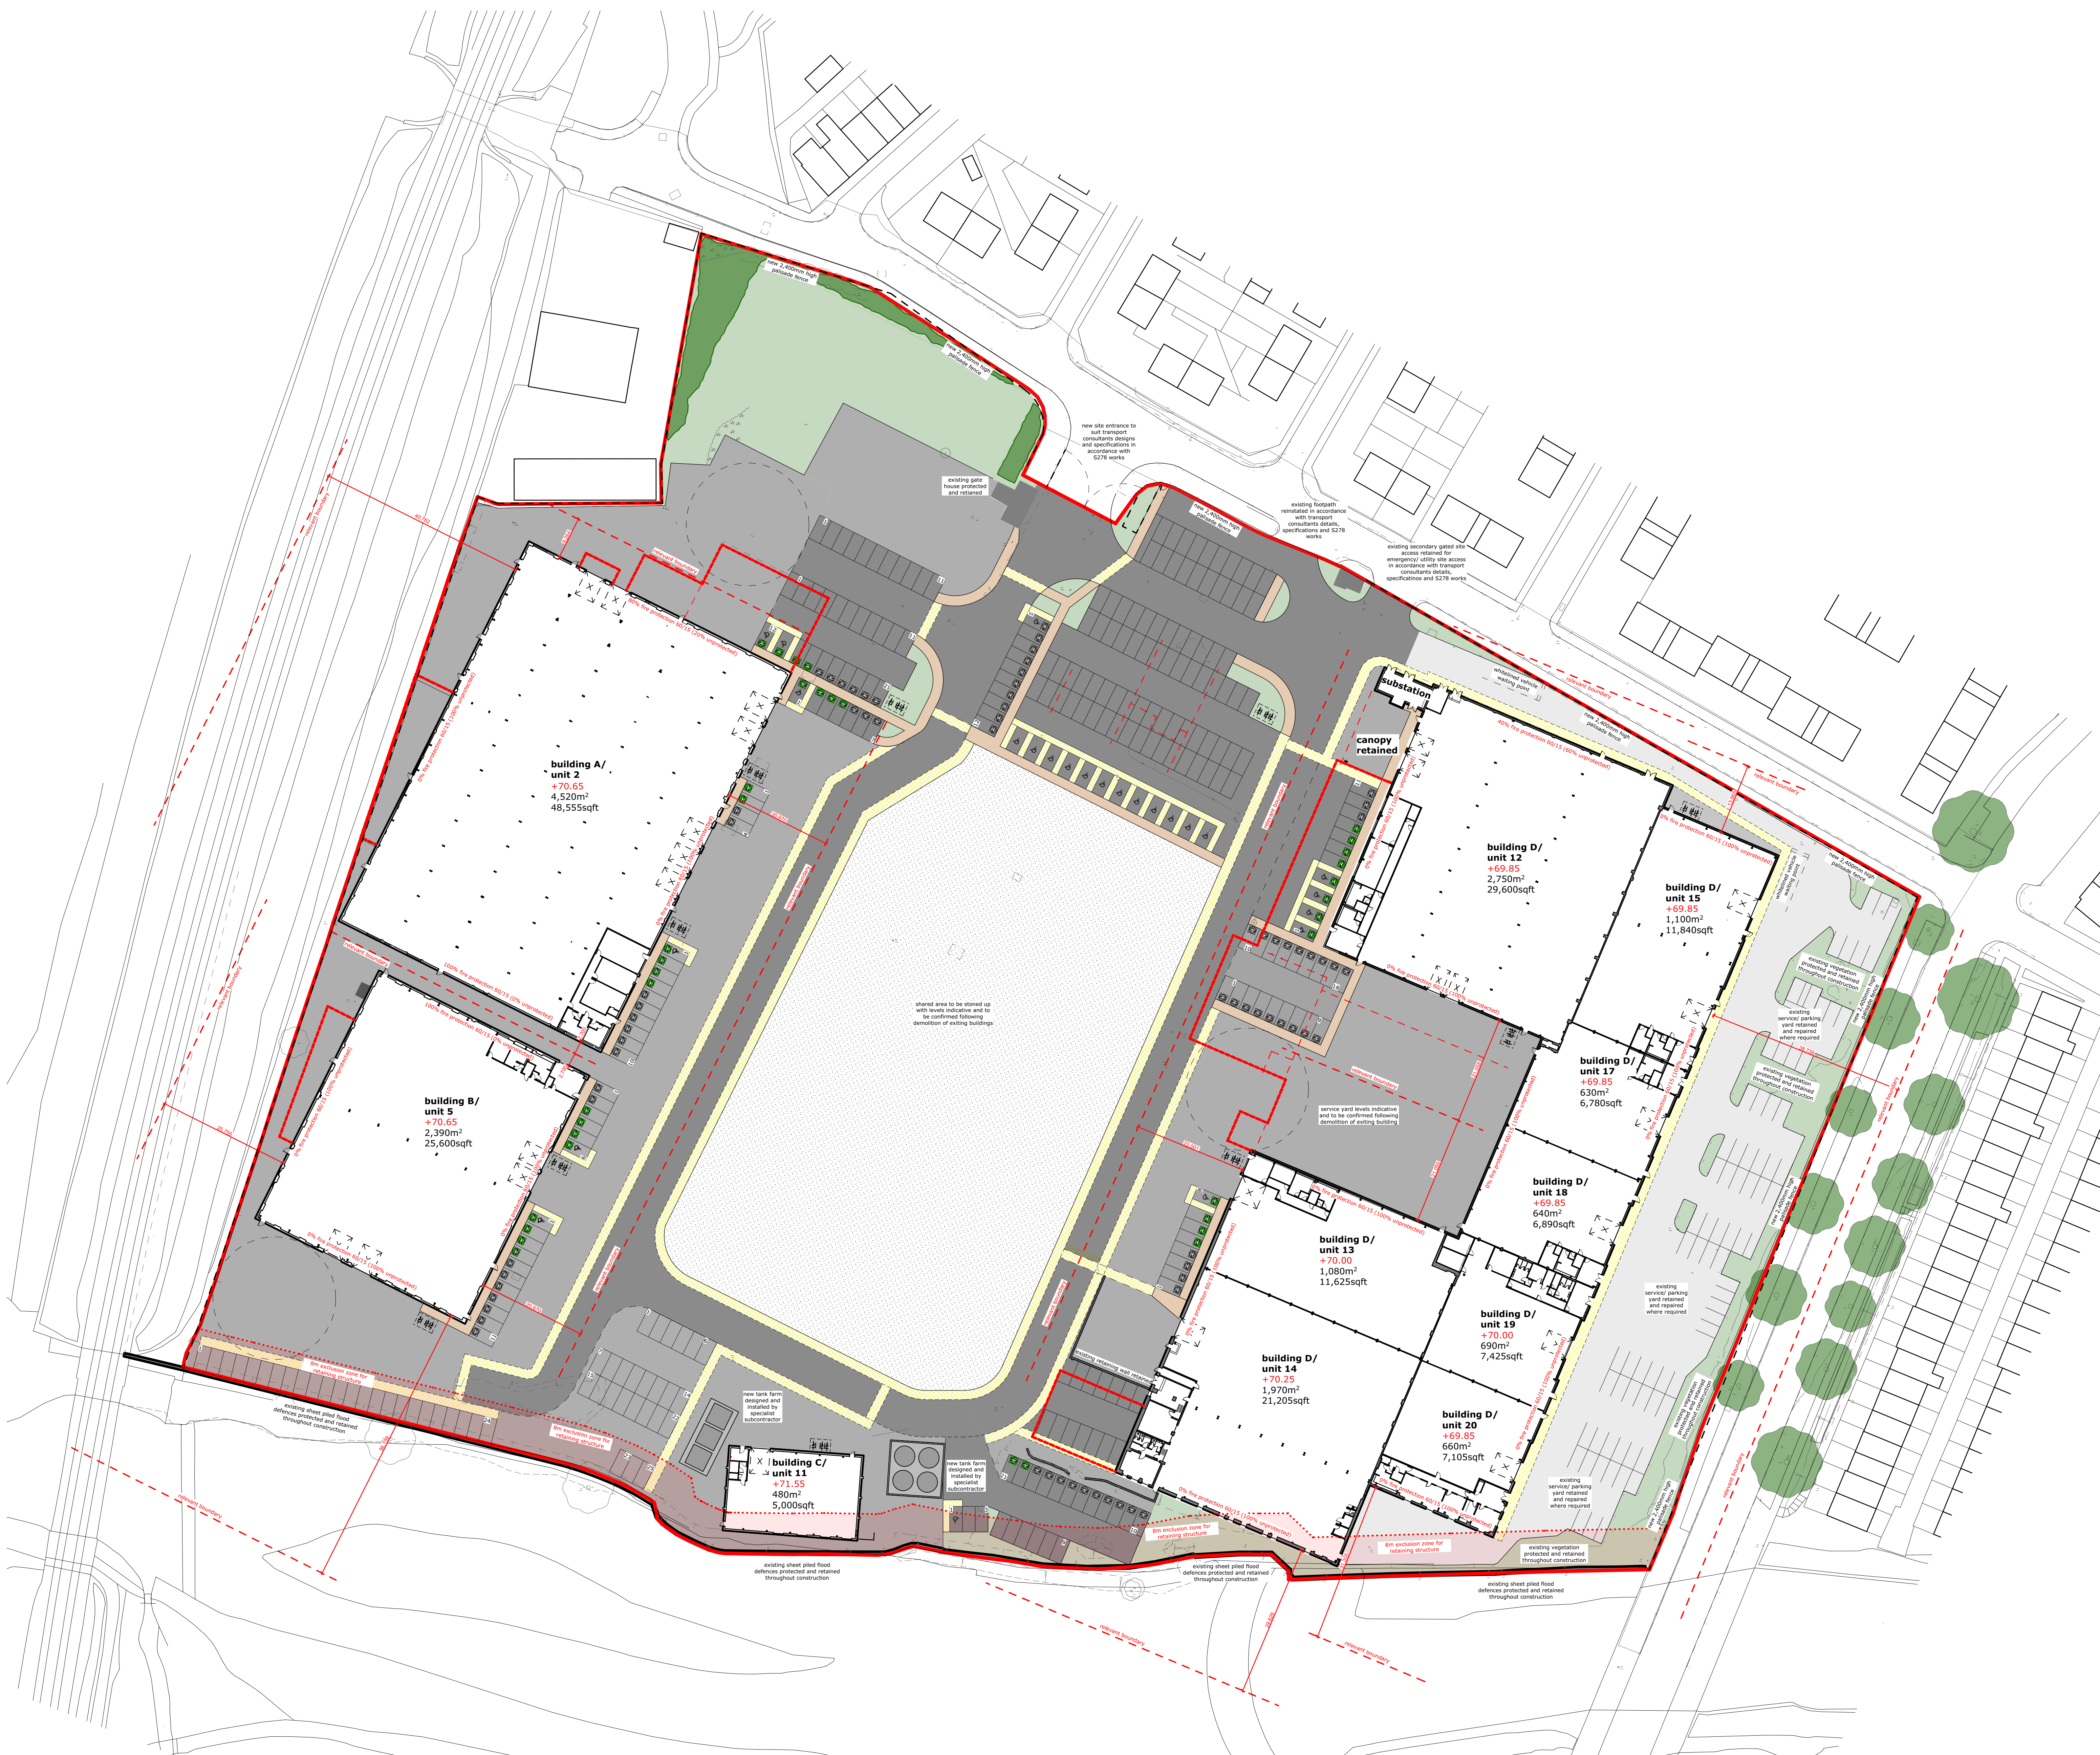
site plan surfacing key

| | existing retained surface, repair works where required | | soft landscaping | | crushed and compacted stone surfacing |

| revision notes | | | |
|---|---|---|---|
| 03: | 15.12.25 | lg | revised to suit structural engineers foundation markup plans |

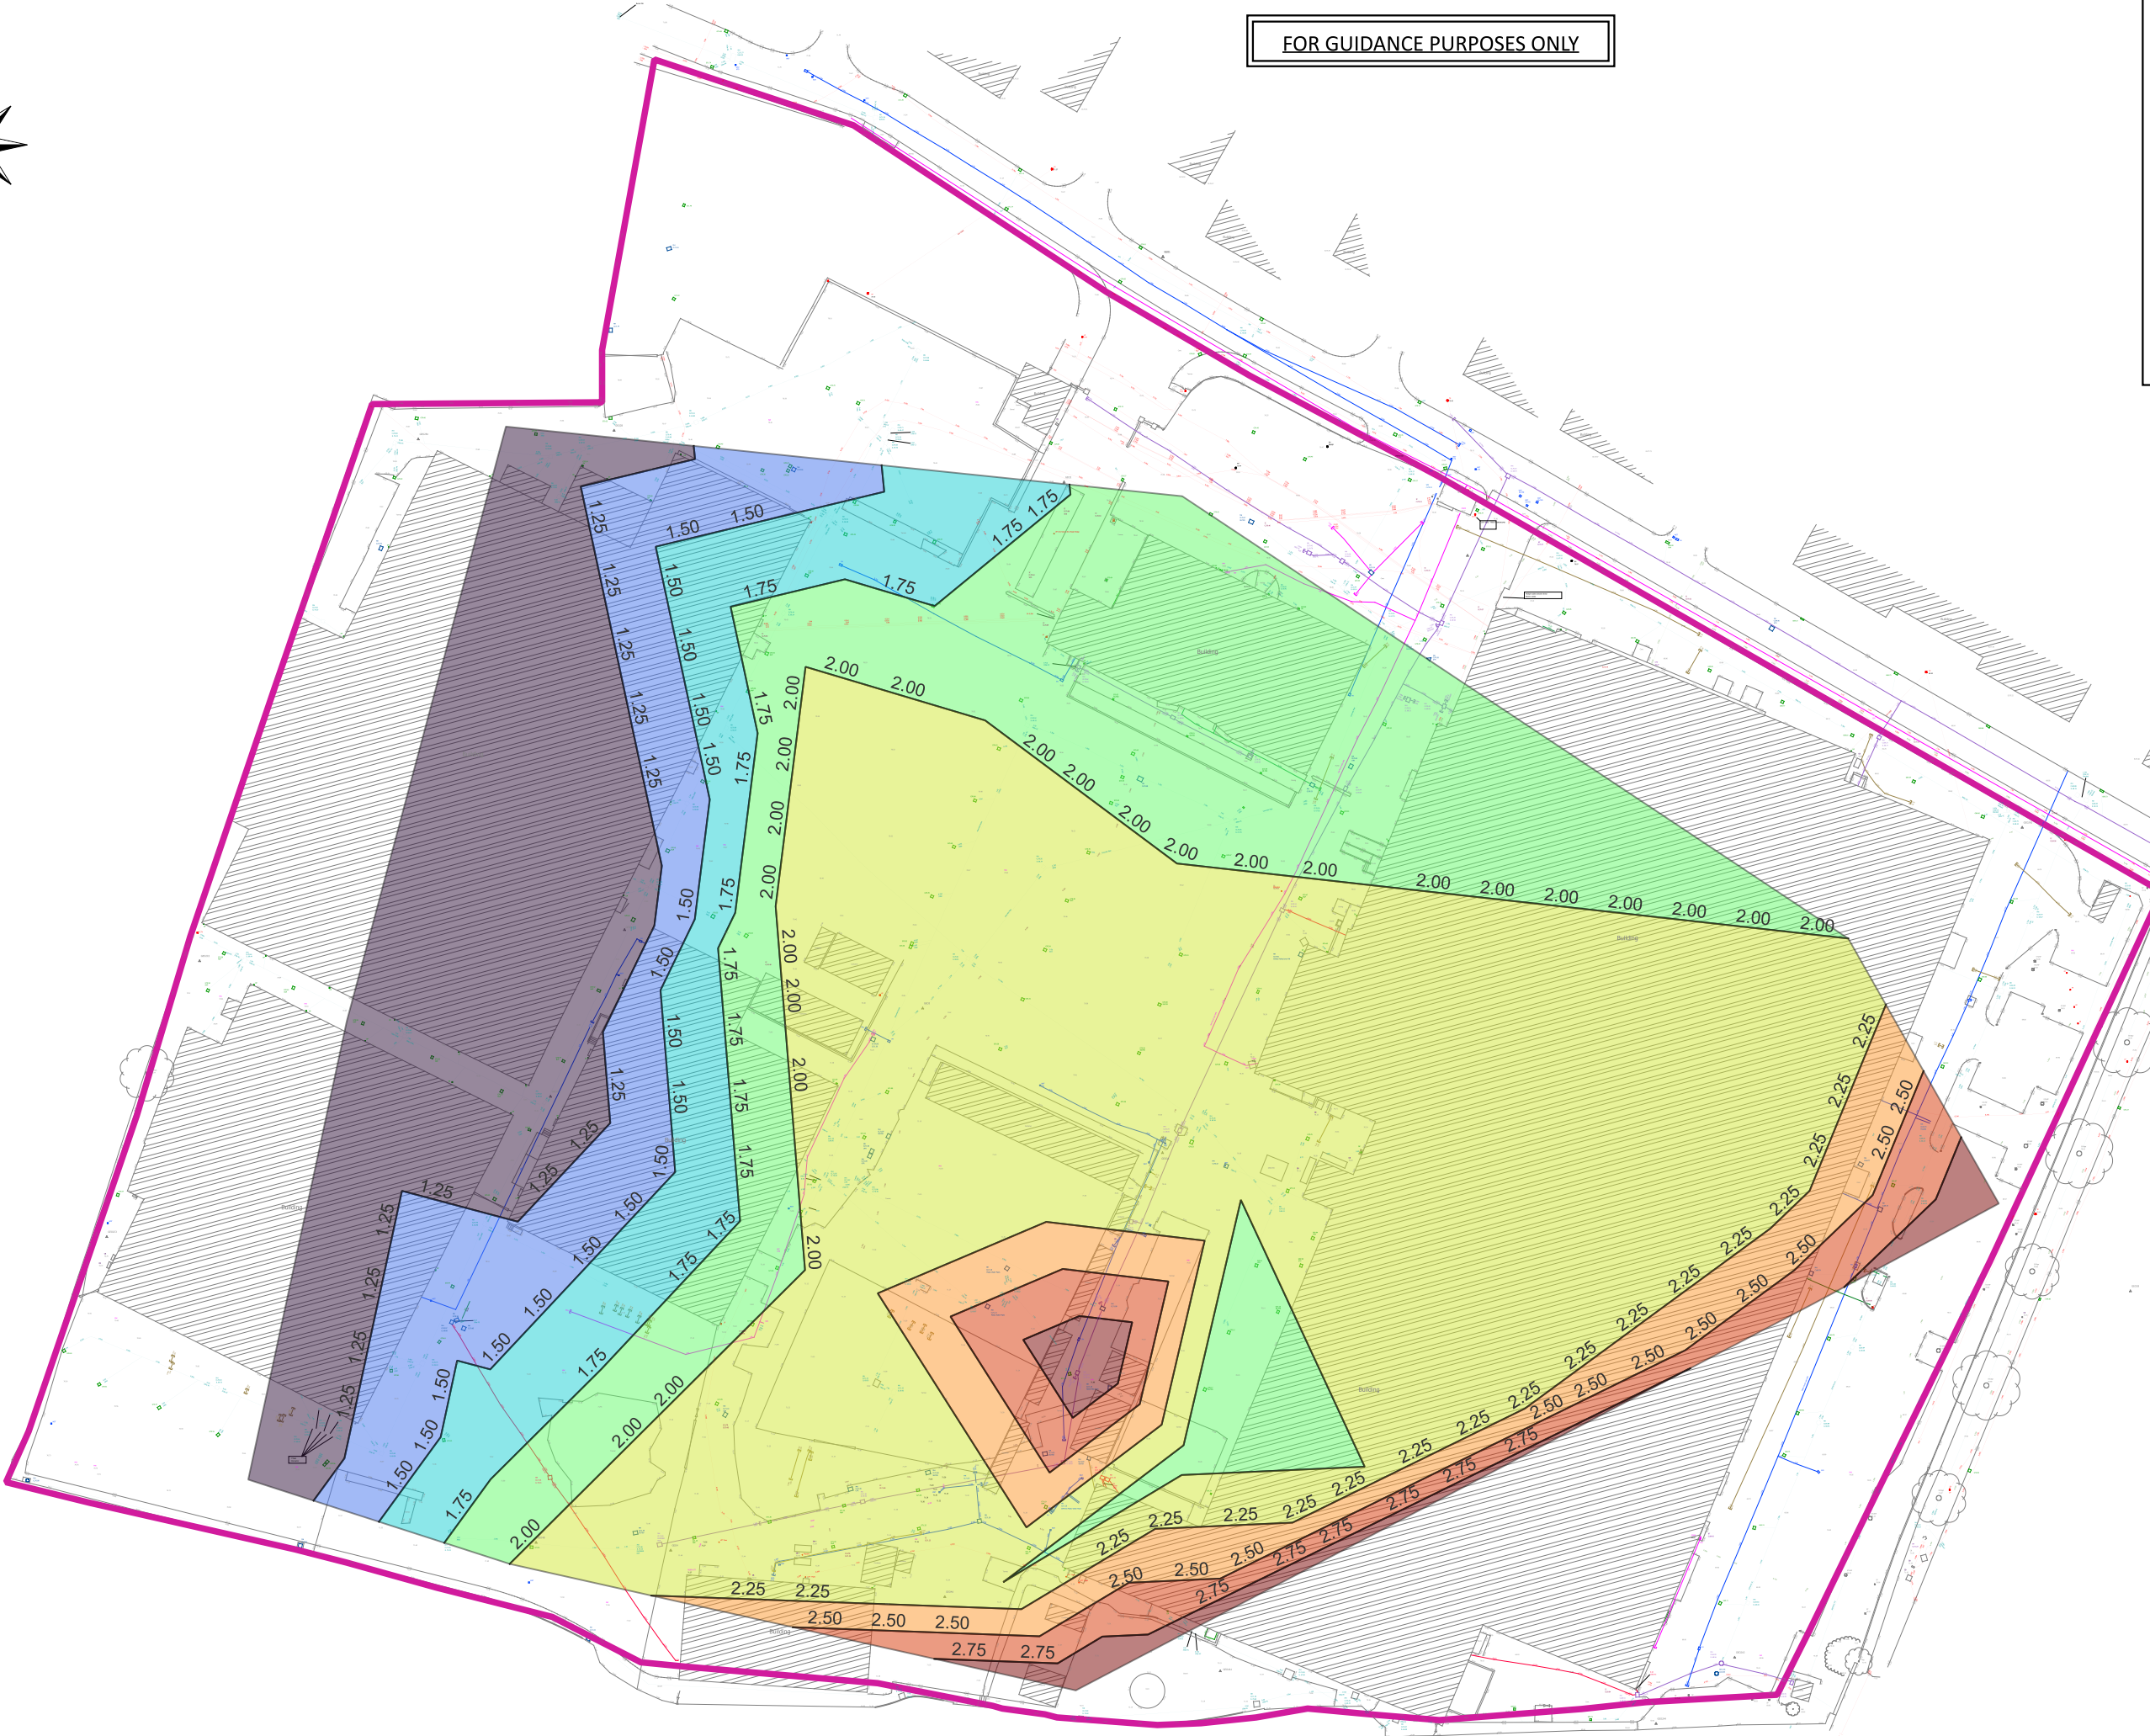
2.50 - 2.75

2.75 - 3.00

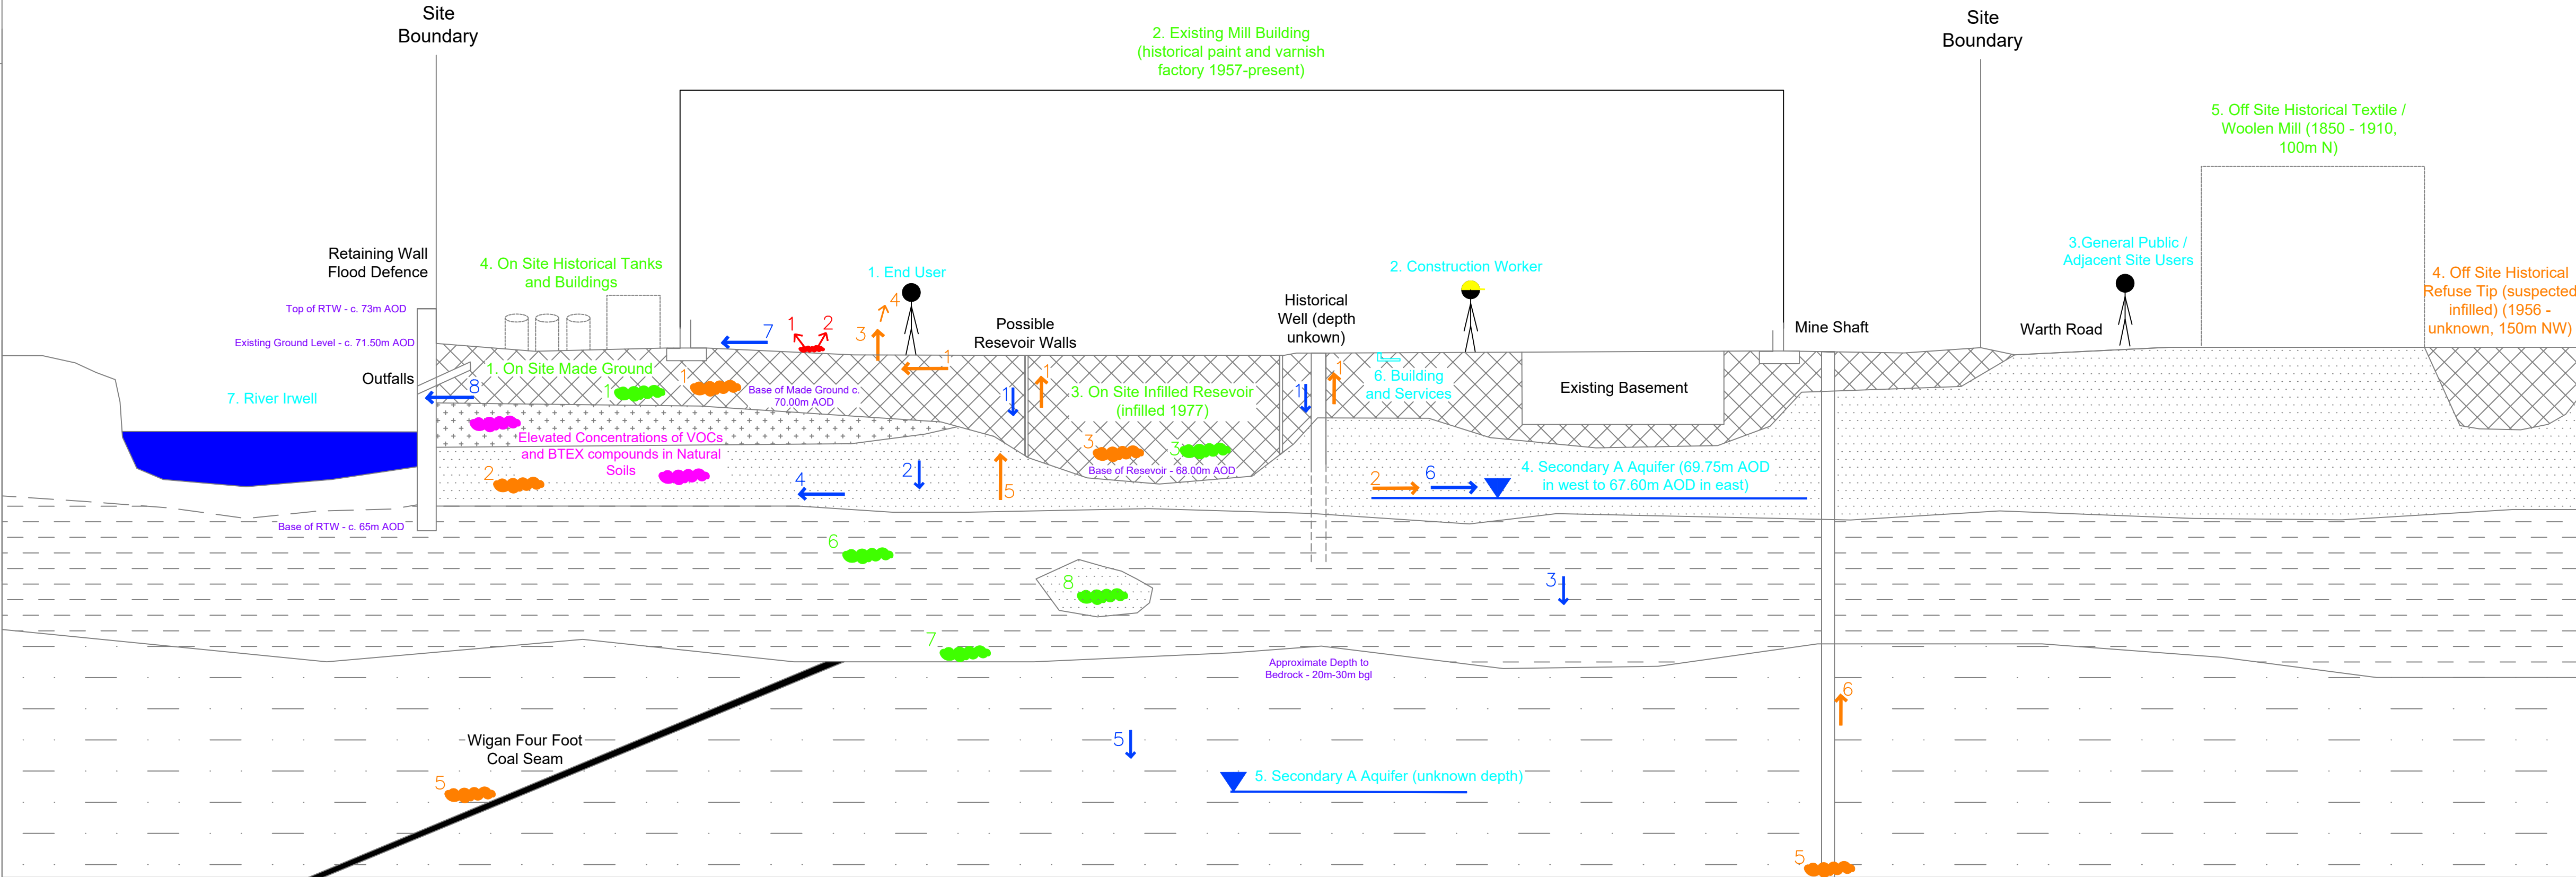
6. Pooling beneath future foundations
7. Pooling in relative low points above low permeability deposits
8. Pooling within granular lenses within low permeability deposits

1. Vertical migration along current foundations
2. Vertical migration through coarse natural deposits (River Terrace Deposits)
3. Negligible infiltration through low permeability natural fine deposits (Glacial Till)
4. Lateral migration Along low-permeability natural fine deposits (Glacial Till)
5. Migration through fractures and fissures in bedrock
6. Migration along groundwater flow
7. Overland flow
8. Flow through retaining wall outfalls

1. Preferential migration beneath hardstanding, along foundations, service ducts and trenches
2. dissolved gases within groundwater
3. Ingress through wall cavities / floors and subsequent accumulation
4. Inhalation of ground gas and vapours
5. Vertical migration through granular deposits
6. Vertical migration up mine shaft
