Ref: 16-948-L1-1  
Date: 12 December 2023

**First 4 Building Services Ltd**  
Croft Court E13  
Walter Leigh Way  
Leigh  
WN7 3PT

## GEOENVIRONMENTAL SITE INVESTIGATION THE ROCK, BURY

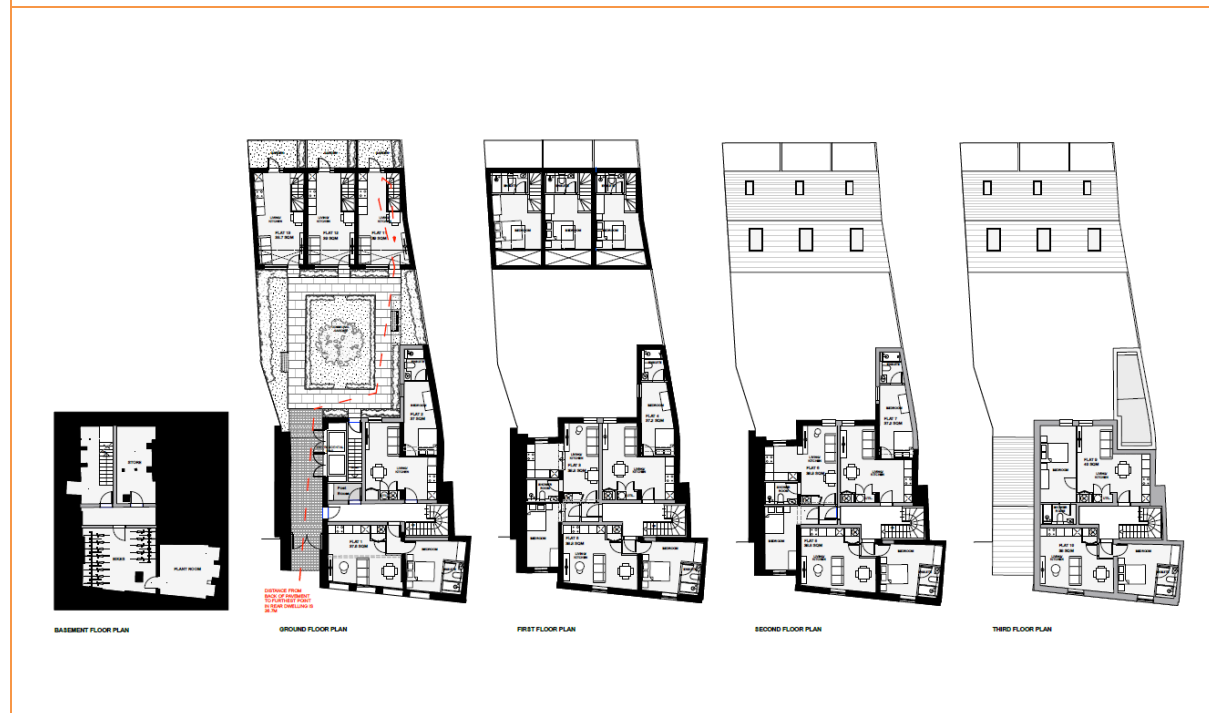
FIGURE 1.1 PROPOSED DEVELOPMENT PLAN

**Part demolition, conversion and extension of the existing building to provide 10 no. supported living units; Construction of detached building to rear containing a further 3 no. supported living units.**

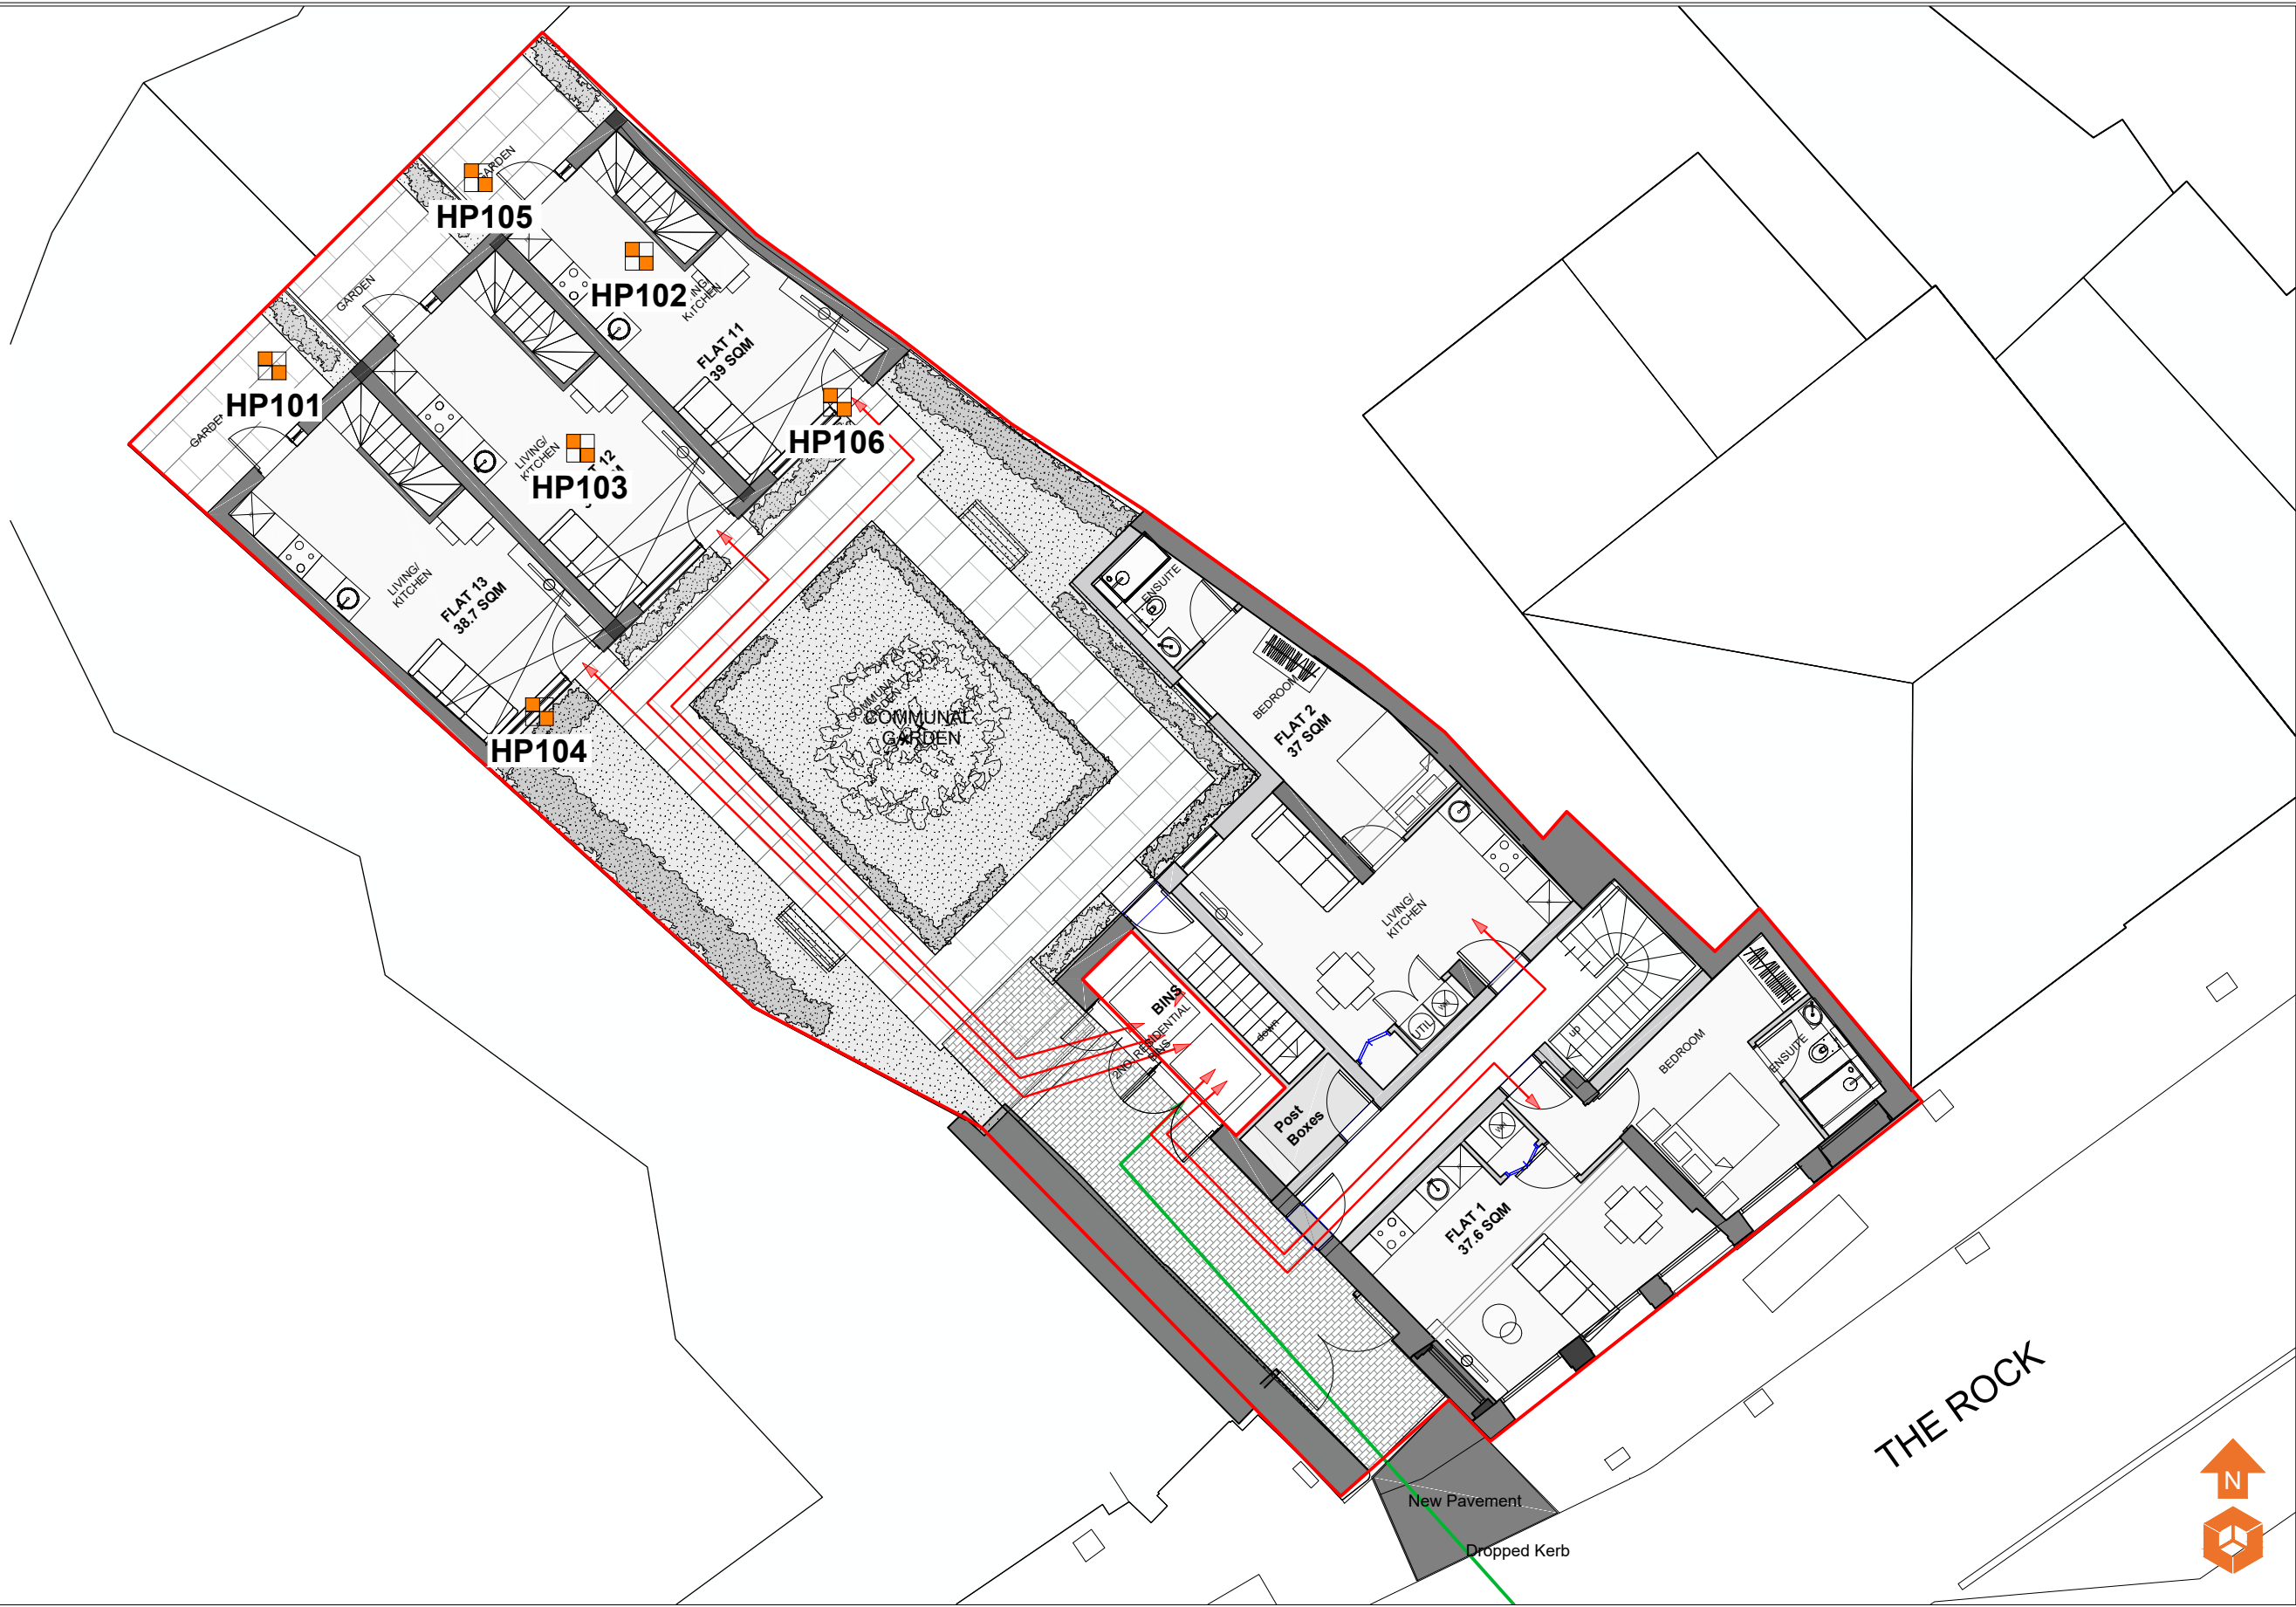
Exploratory Hole Location Plan

The exploratory hole locations are illustrated on Drawing no. 16-948-005 attached to this letter. The ground conditions encountered are summarised in Section 2.2 and presented on the logs, attached to this letter.

Concentrations of heavy metals and non-volatile PAHs were detected in exceedance of the chosen GAC values. The contaminant exceedances were recorded within the identified layer of Made Ground comprising of ash in HP104 (0.20 m bgl), the location of HP104 is shown in Drawing No. 16-948-005.

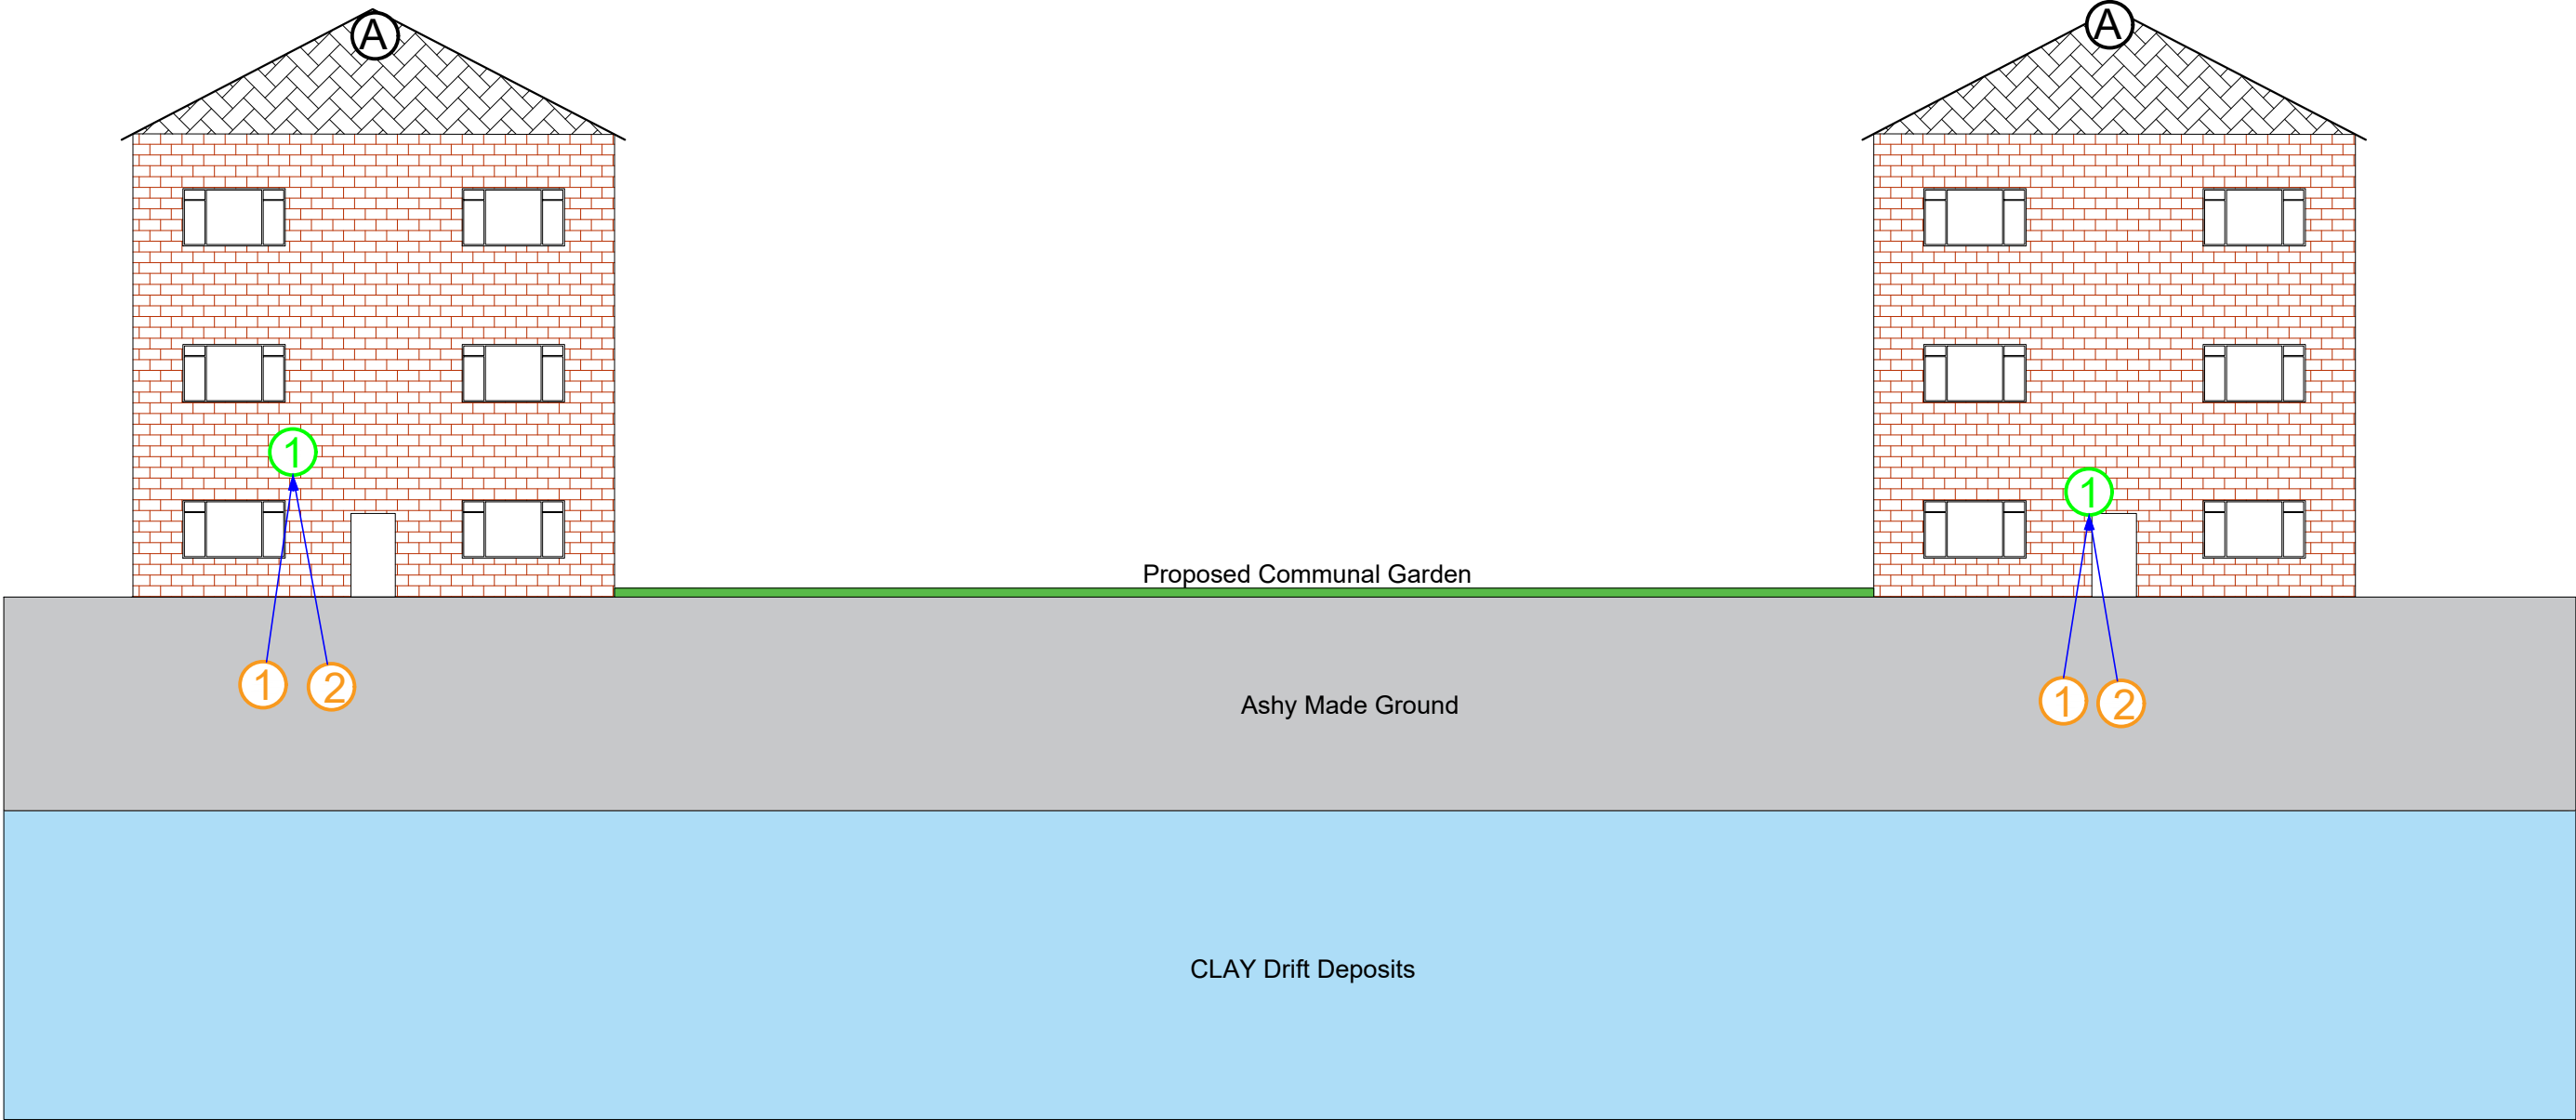
PAH compounds are common derivatives of combustion and are therefore typical in ashy soils. Given this ashy layer was encountered beneath the cobble stones in HP104, it is considered that it may be present in other areas beneath existing cobble stones/concrete hardstanding as a subbase type layer, rather than being an isolated hotspot.

There does however remain the risk from potential mine gas associated with possible workings in underlying coal seams. The risks may be mitigated by low permeability drift, however the thickness of the cohesive deposits is unknown. Nearby BGS boreholes located c. 150 m east of the site record sand/gravel beyond c. 2.00 m, which may present a viable permeable pathway for gas migration, albeit 'capped' with impermeable clay.

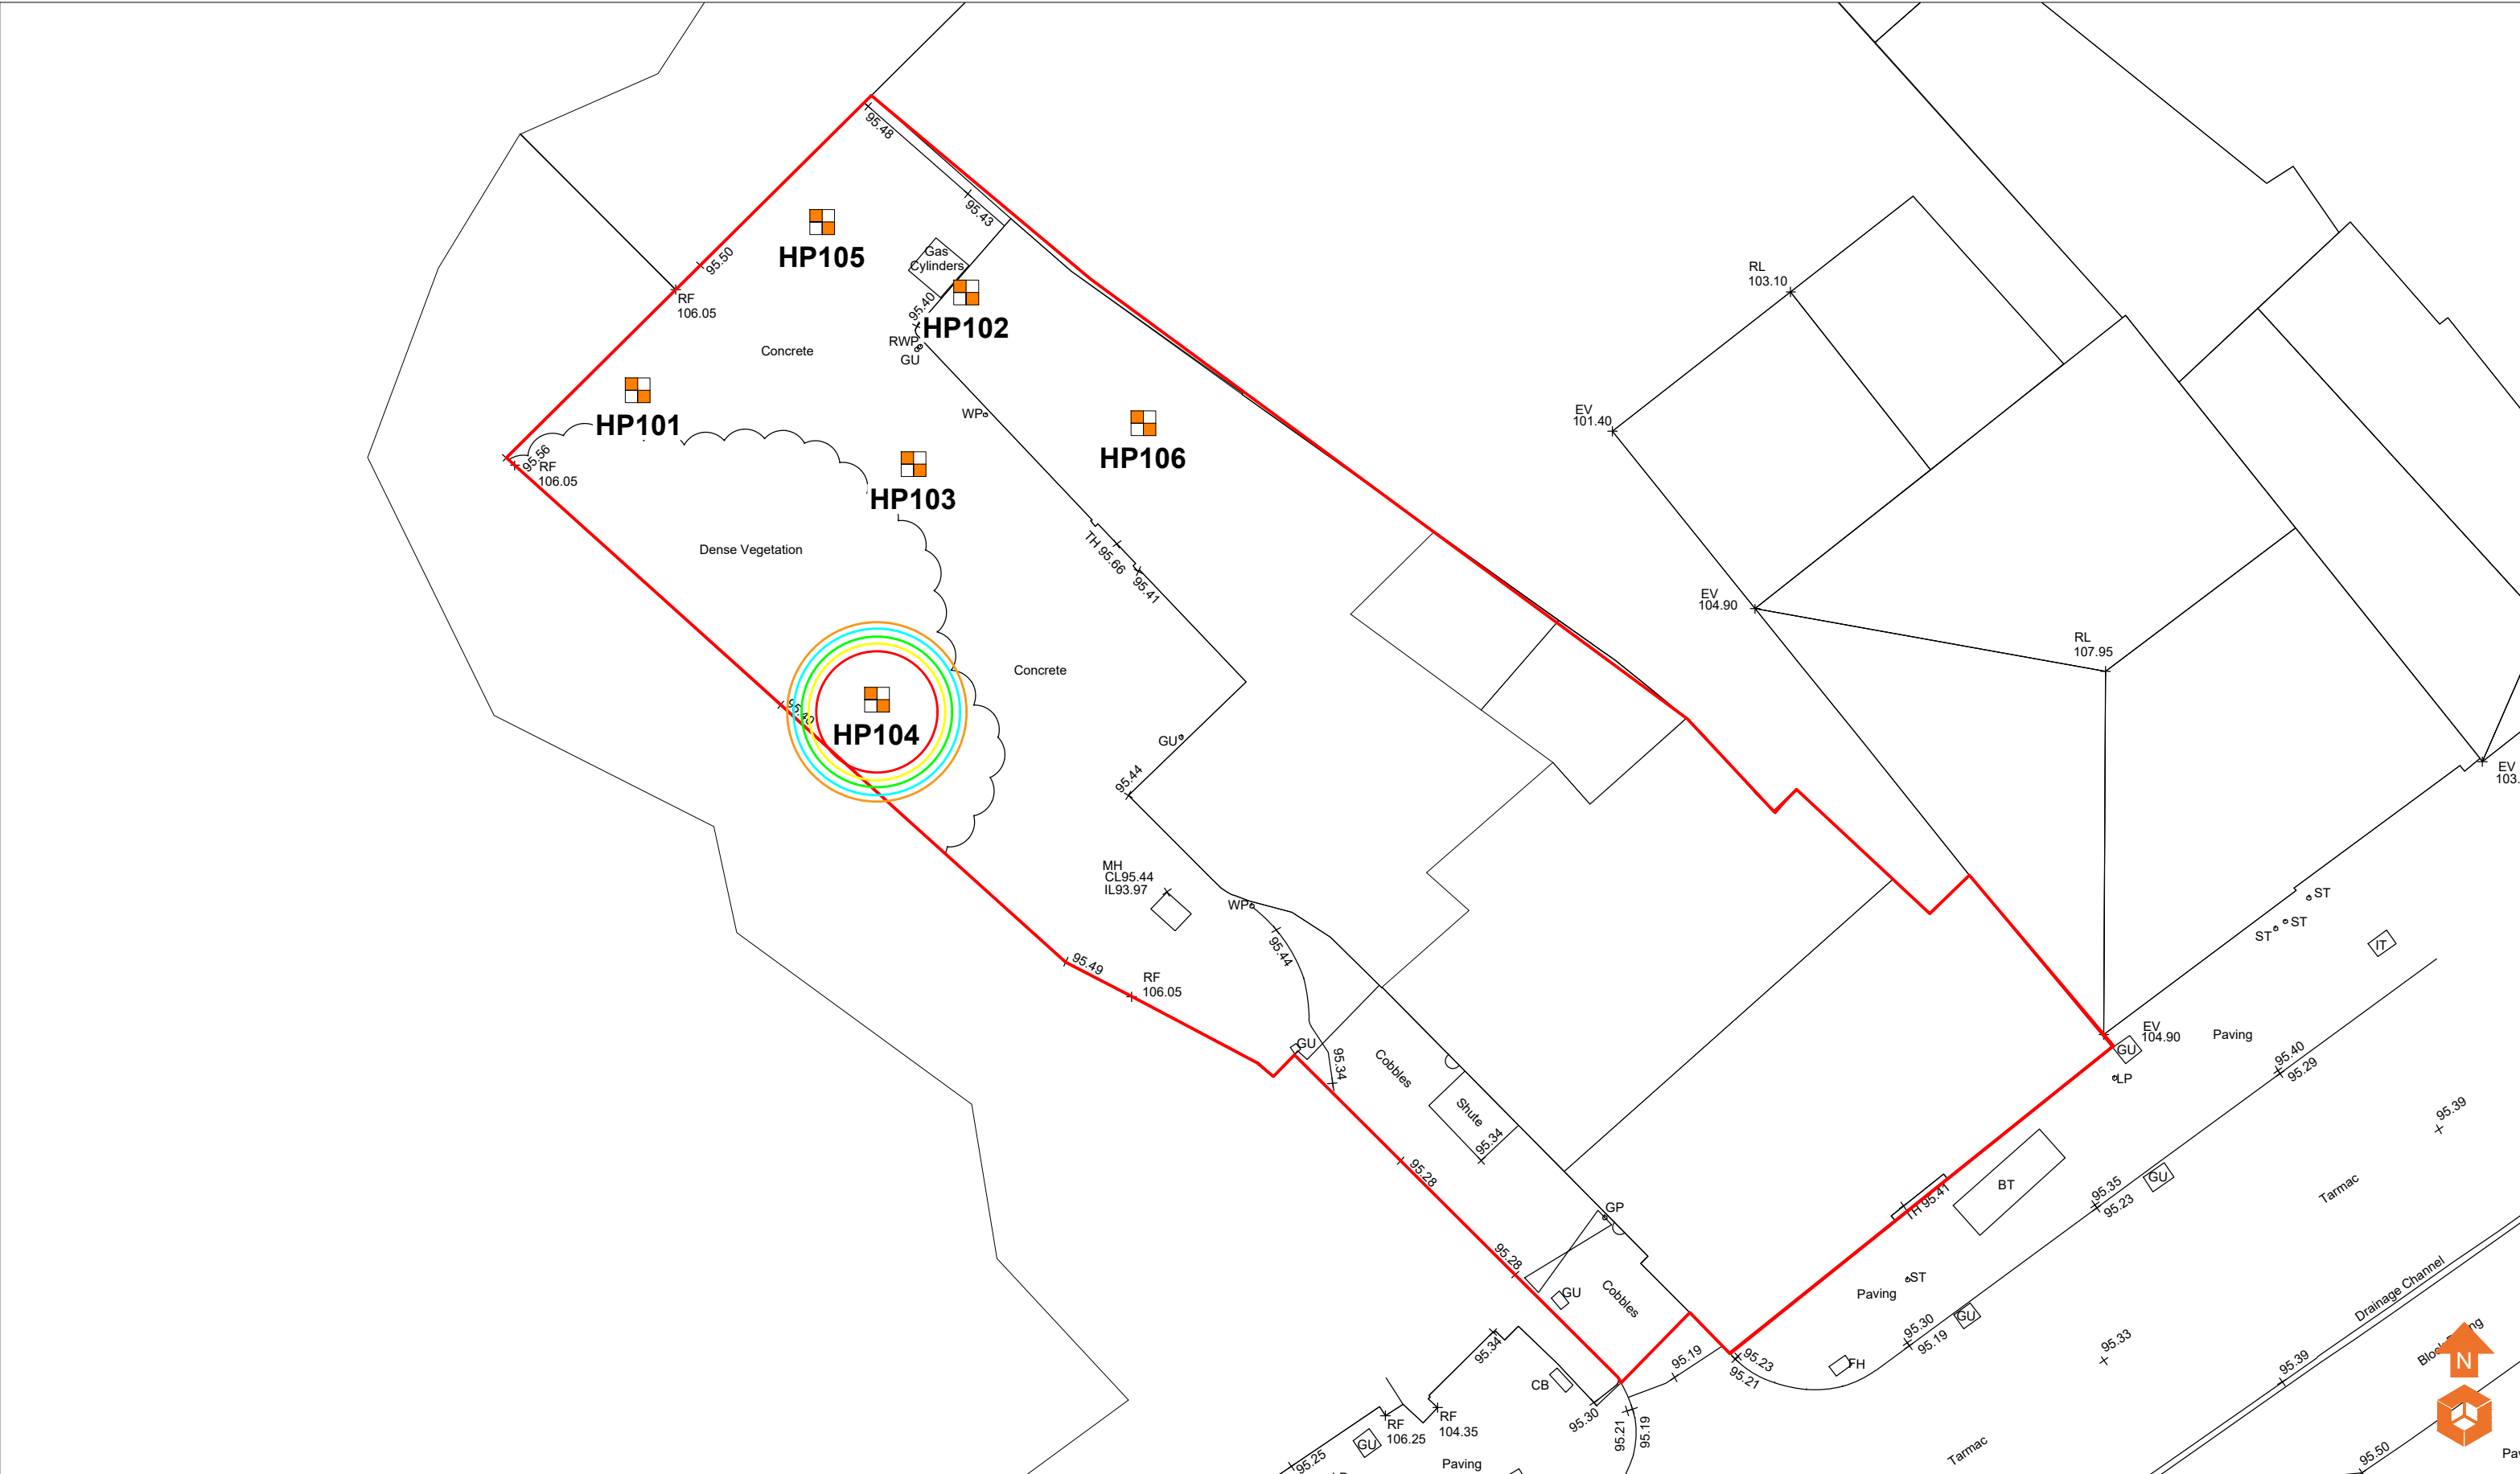
- ✿ Exceedances of heavy metals and non-volatile PAH compounds have been found to be present in HP104 at 0.20 m bgl in a layer of ashy Made Ground. This ashy layer may be present beneath hardstanding in other areas of the Site.
- ✿ It is recommended that any ashy material, if encountered on removal of hardstanding, is carefully stripped/removed and segregated for off-site disposal or placement in an area of no future sensitivity. A watching brief to ensure these materials are removed would be recommended, along with a validation report.

It is therefore recommended that on removal of cobbles/hardstanding, any ashy material, if encountered, is carefully stripped/removed and segregated for off-site disposal or placement in an area of no future sensitivity e.g. below a plot or beneath hardstanding where the pollutant pathway is broken. A watching brief to ensure these materials are removed would be recommended, along with a validation report.

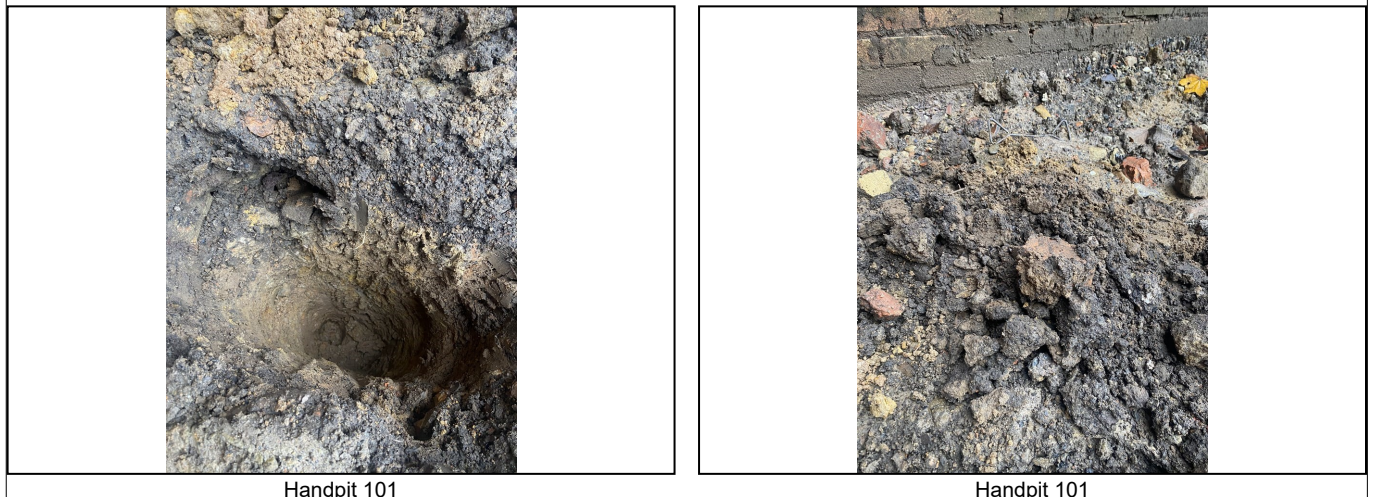
Handpit 101

| Water Strike | Samples & In Situ Testing | | | Depth (m) | Level (m) | Legend | Stratum Description | |
|---|---|---|---|---|---|---|---|--|
| | 0.10 | ES | | 0.10 | | | MADE GROUND: Greyish black gravelly clay. Gravel of fine to coarse brick, concrete and shale. Yellowish brown sandy gravelly CLAY. Gravel is fine to medium subrounded sandstone. | |

Stability: STABLE

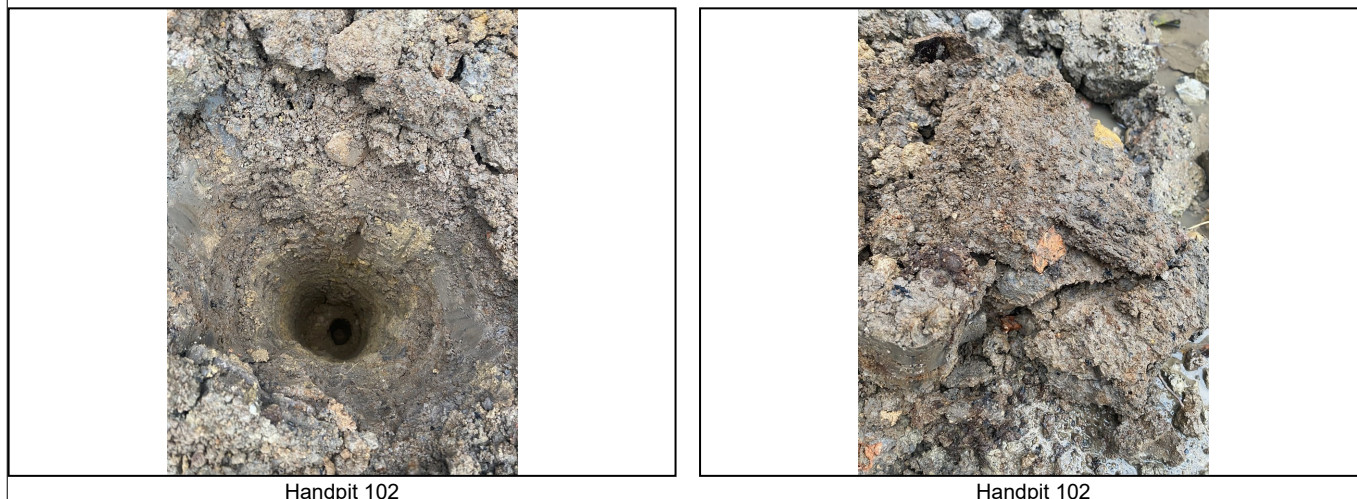
Handpit 102

| Water Strike | Samples & In Situ Testing | | | Depth (m) | Level (m) | Legend | Stratum Description | |
|---|---|---|---|---|---|---|---|---|
| | 0.10 | ES | | 0.20 | | | MADE GROUND: Greyish brown sandy slightly gravelly clay. Gravel of fine to medium subrounded sandstone and occasional brick fragments. | |
| | 1.00 | ES | | 1.00 | | | Yellowish brown sandy gravelly CLAY. Gravel is fine to medium subrounded sandstone. | |

Stability: STABLE

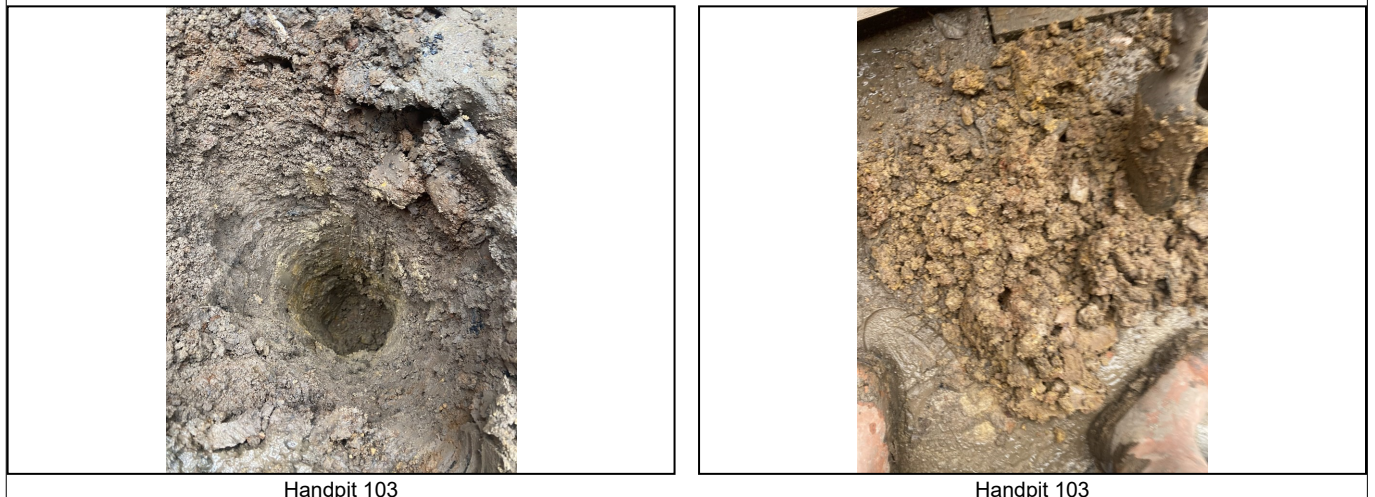
Handpit 103

In HP103, the gravelly clay was overlain by cobble stones and a greyish black ash layer.

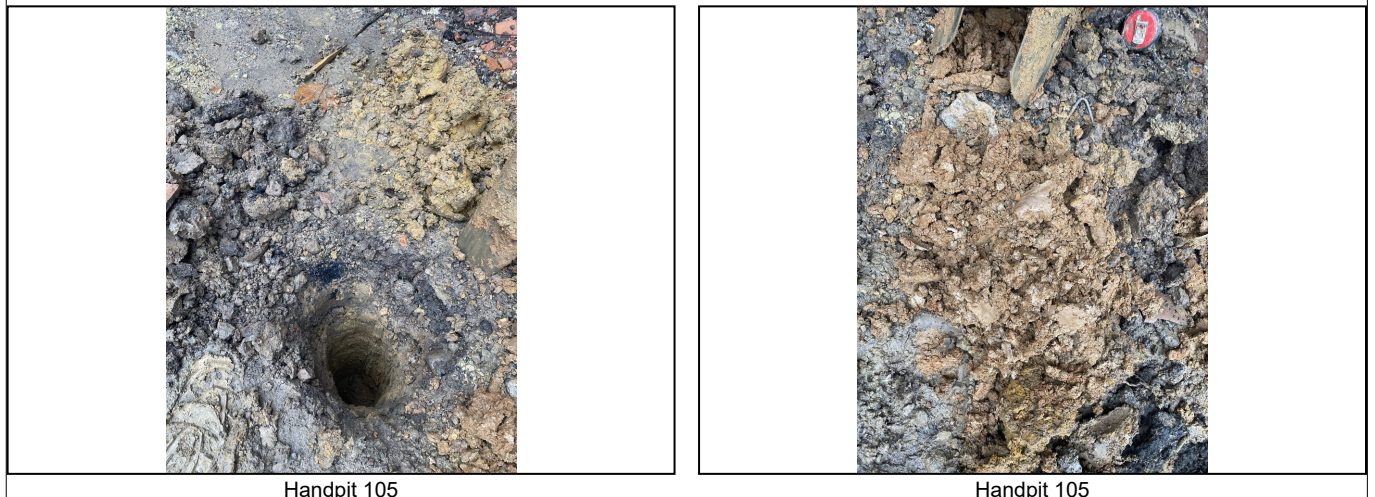
Handpit 105

The drift generally comprised yellowish brown sandy gravelly CLAY. Inferred soft yellowish grey and brown CLAY was encountered in HP104 and HP105.
