# East Lancashire Paper Mill, Radcliffe

## PRELIMINARY BAT ROOST ASSESSMENT

784-B038963 – V2

Morris Homes

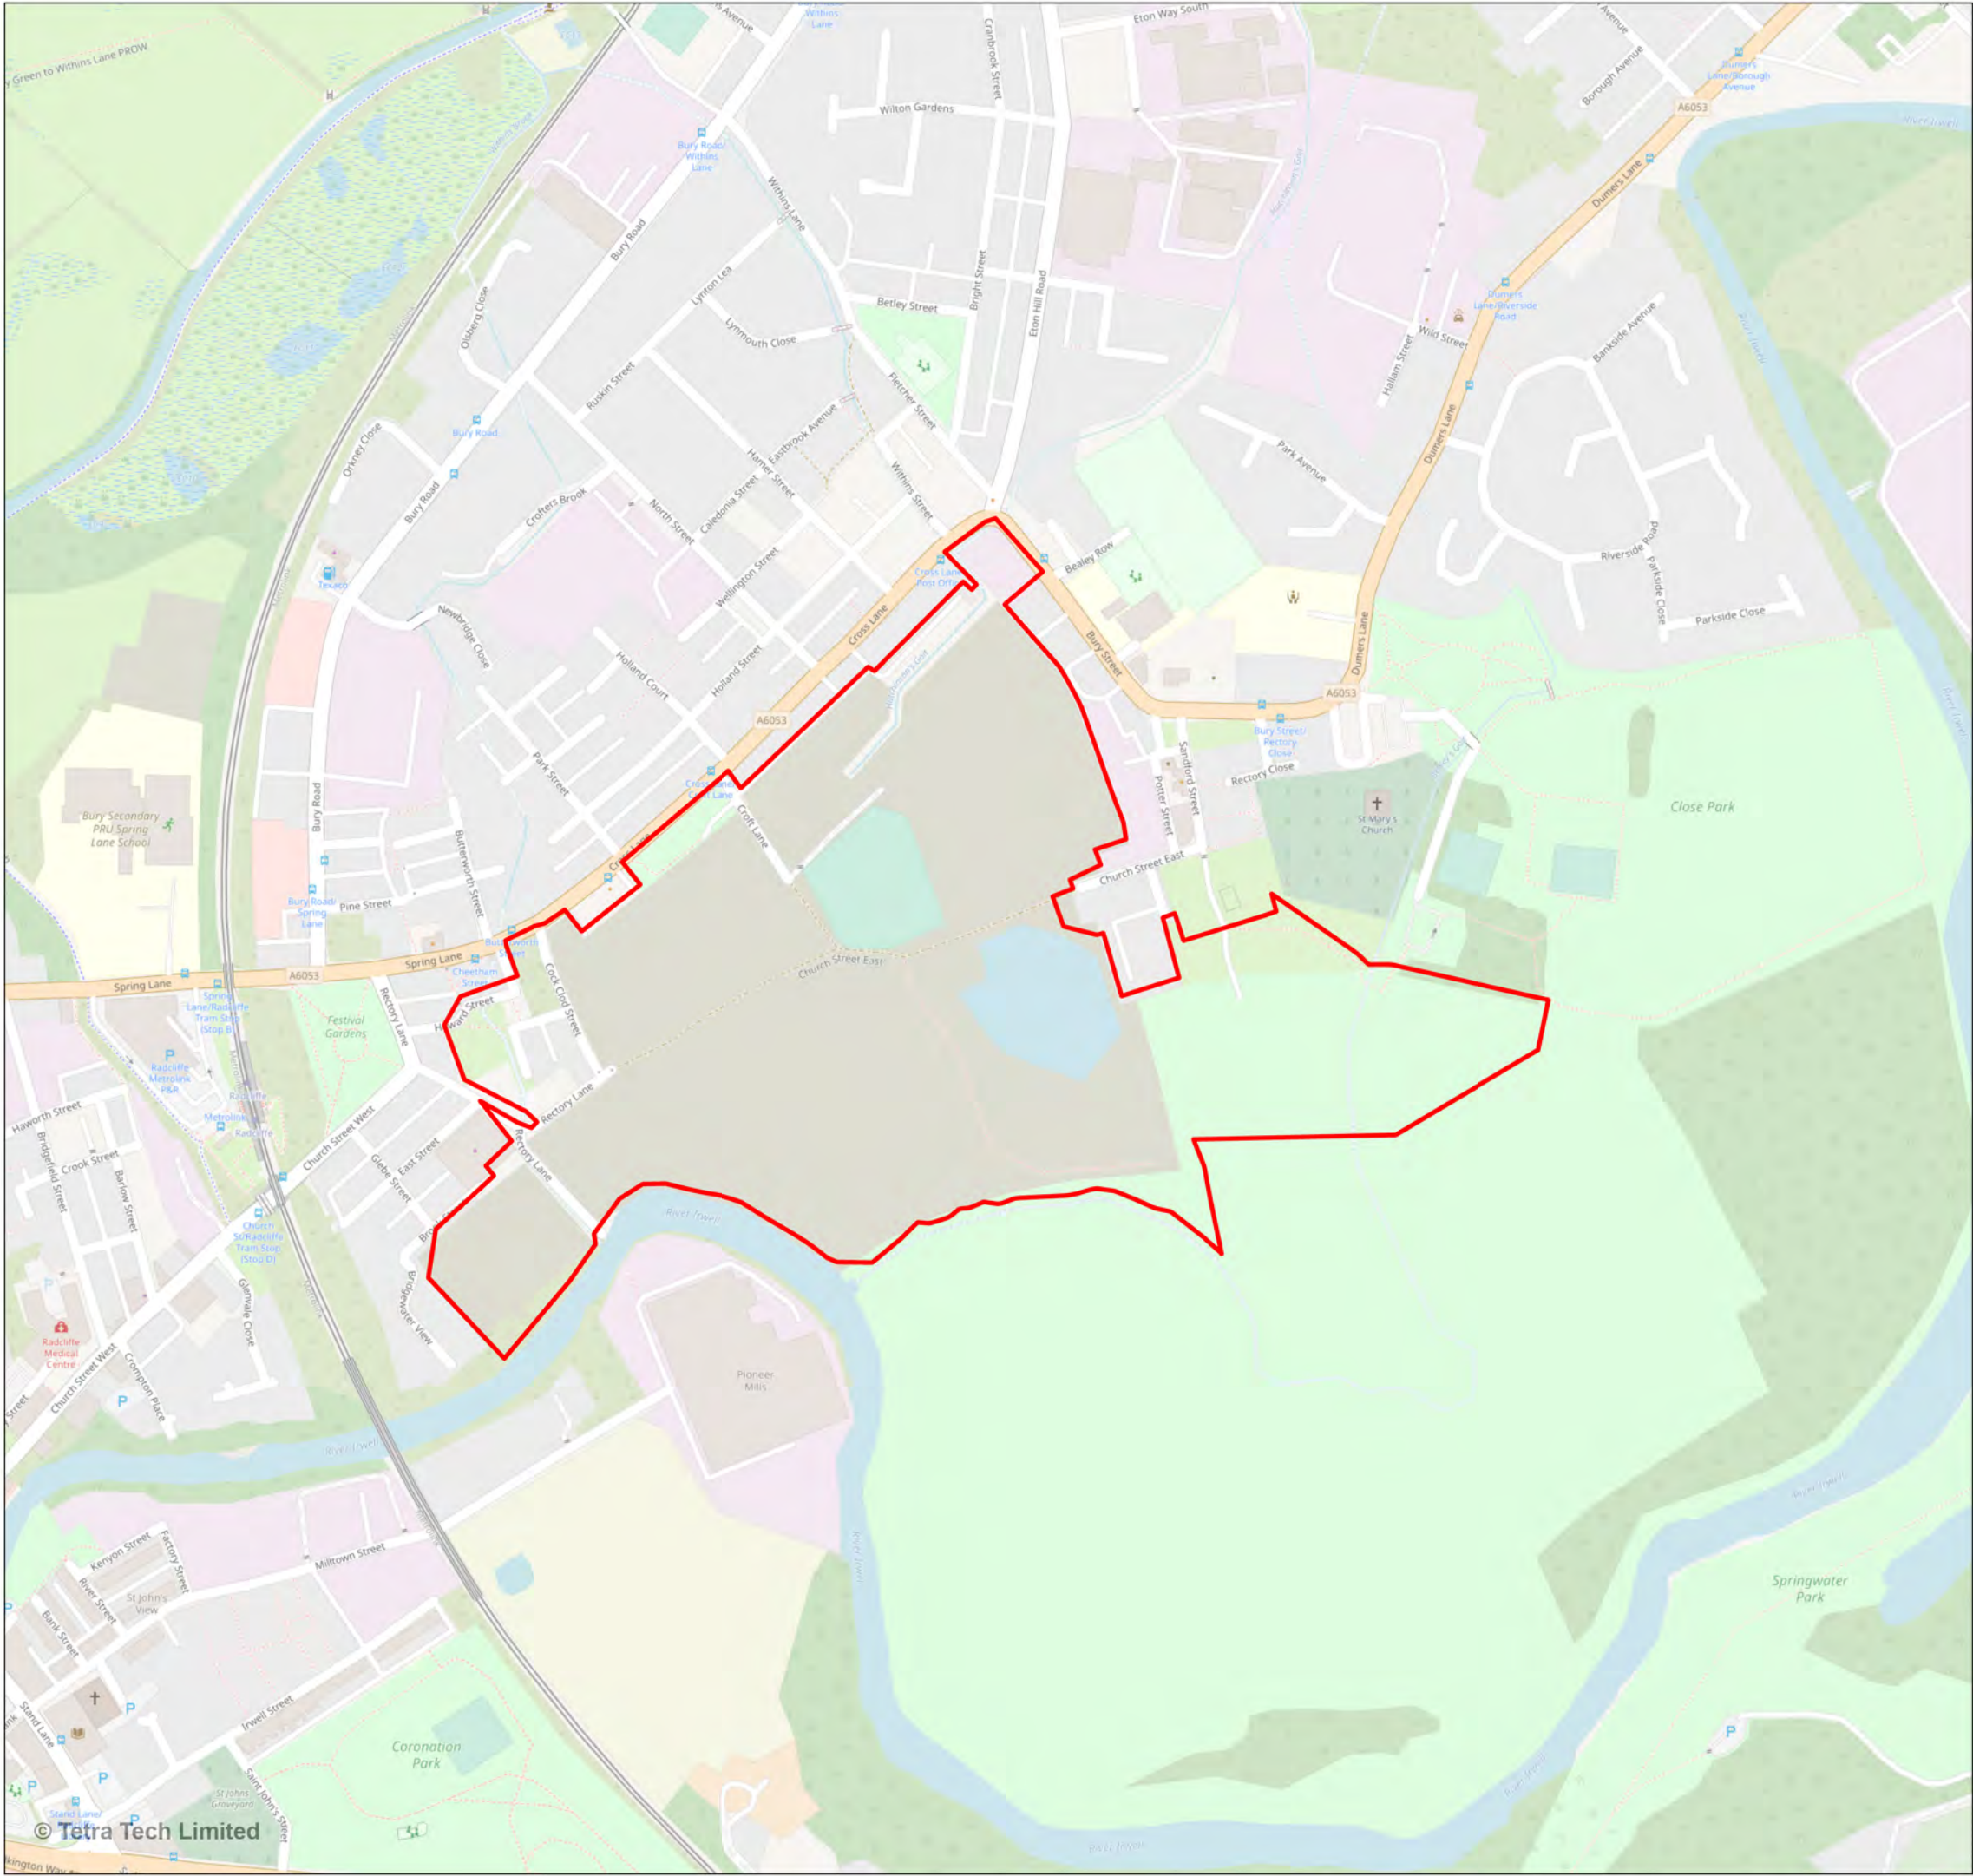
Figure No. 1  
Revision No. A  
21 October 2022

The ‘site’ is located in the small town of Radcliffe (approximately 4.8km south of Bury) in Greater Manchester. The central Ordnance Survey Grid Reference of the site is SD 79296 07445 (Figure 1).

# Site Location Plan

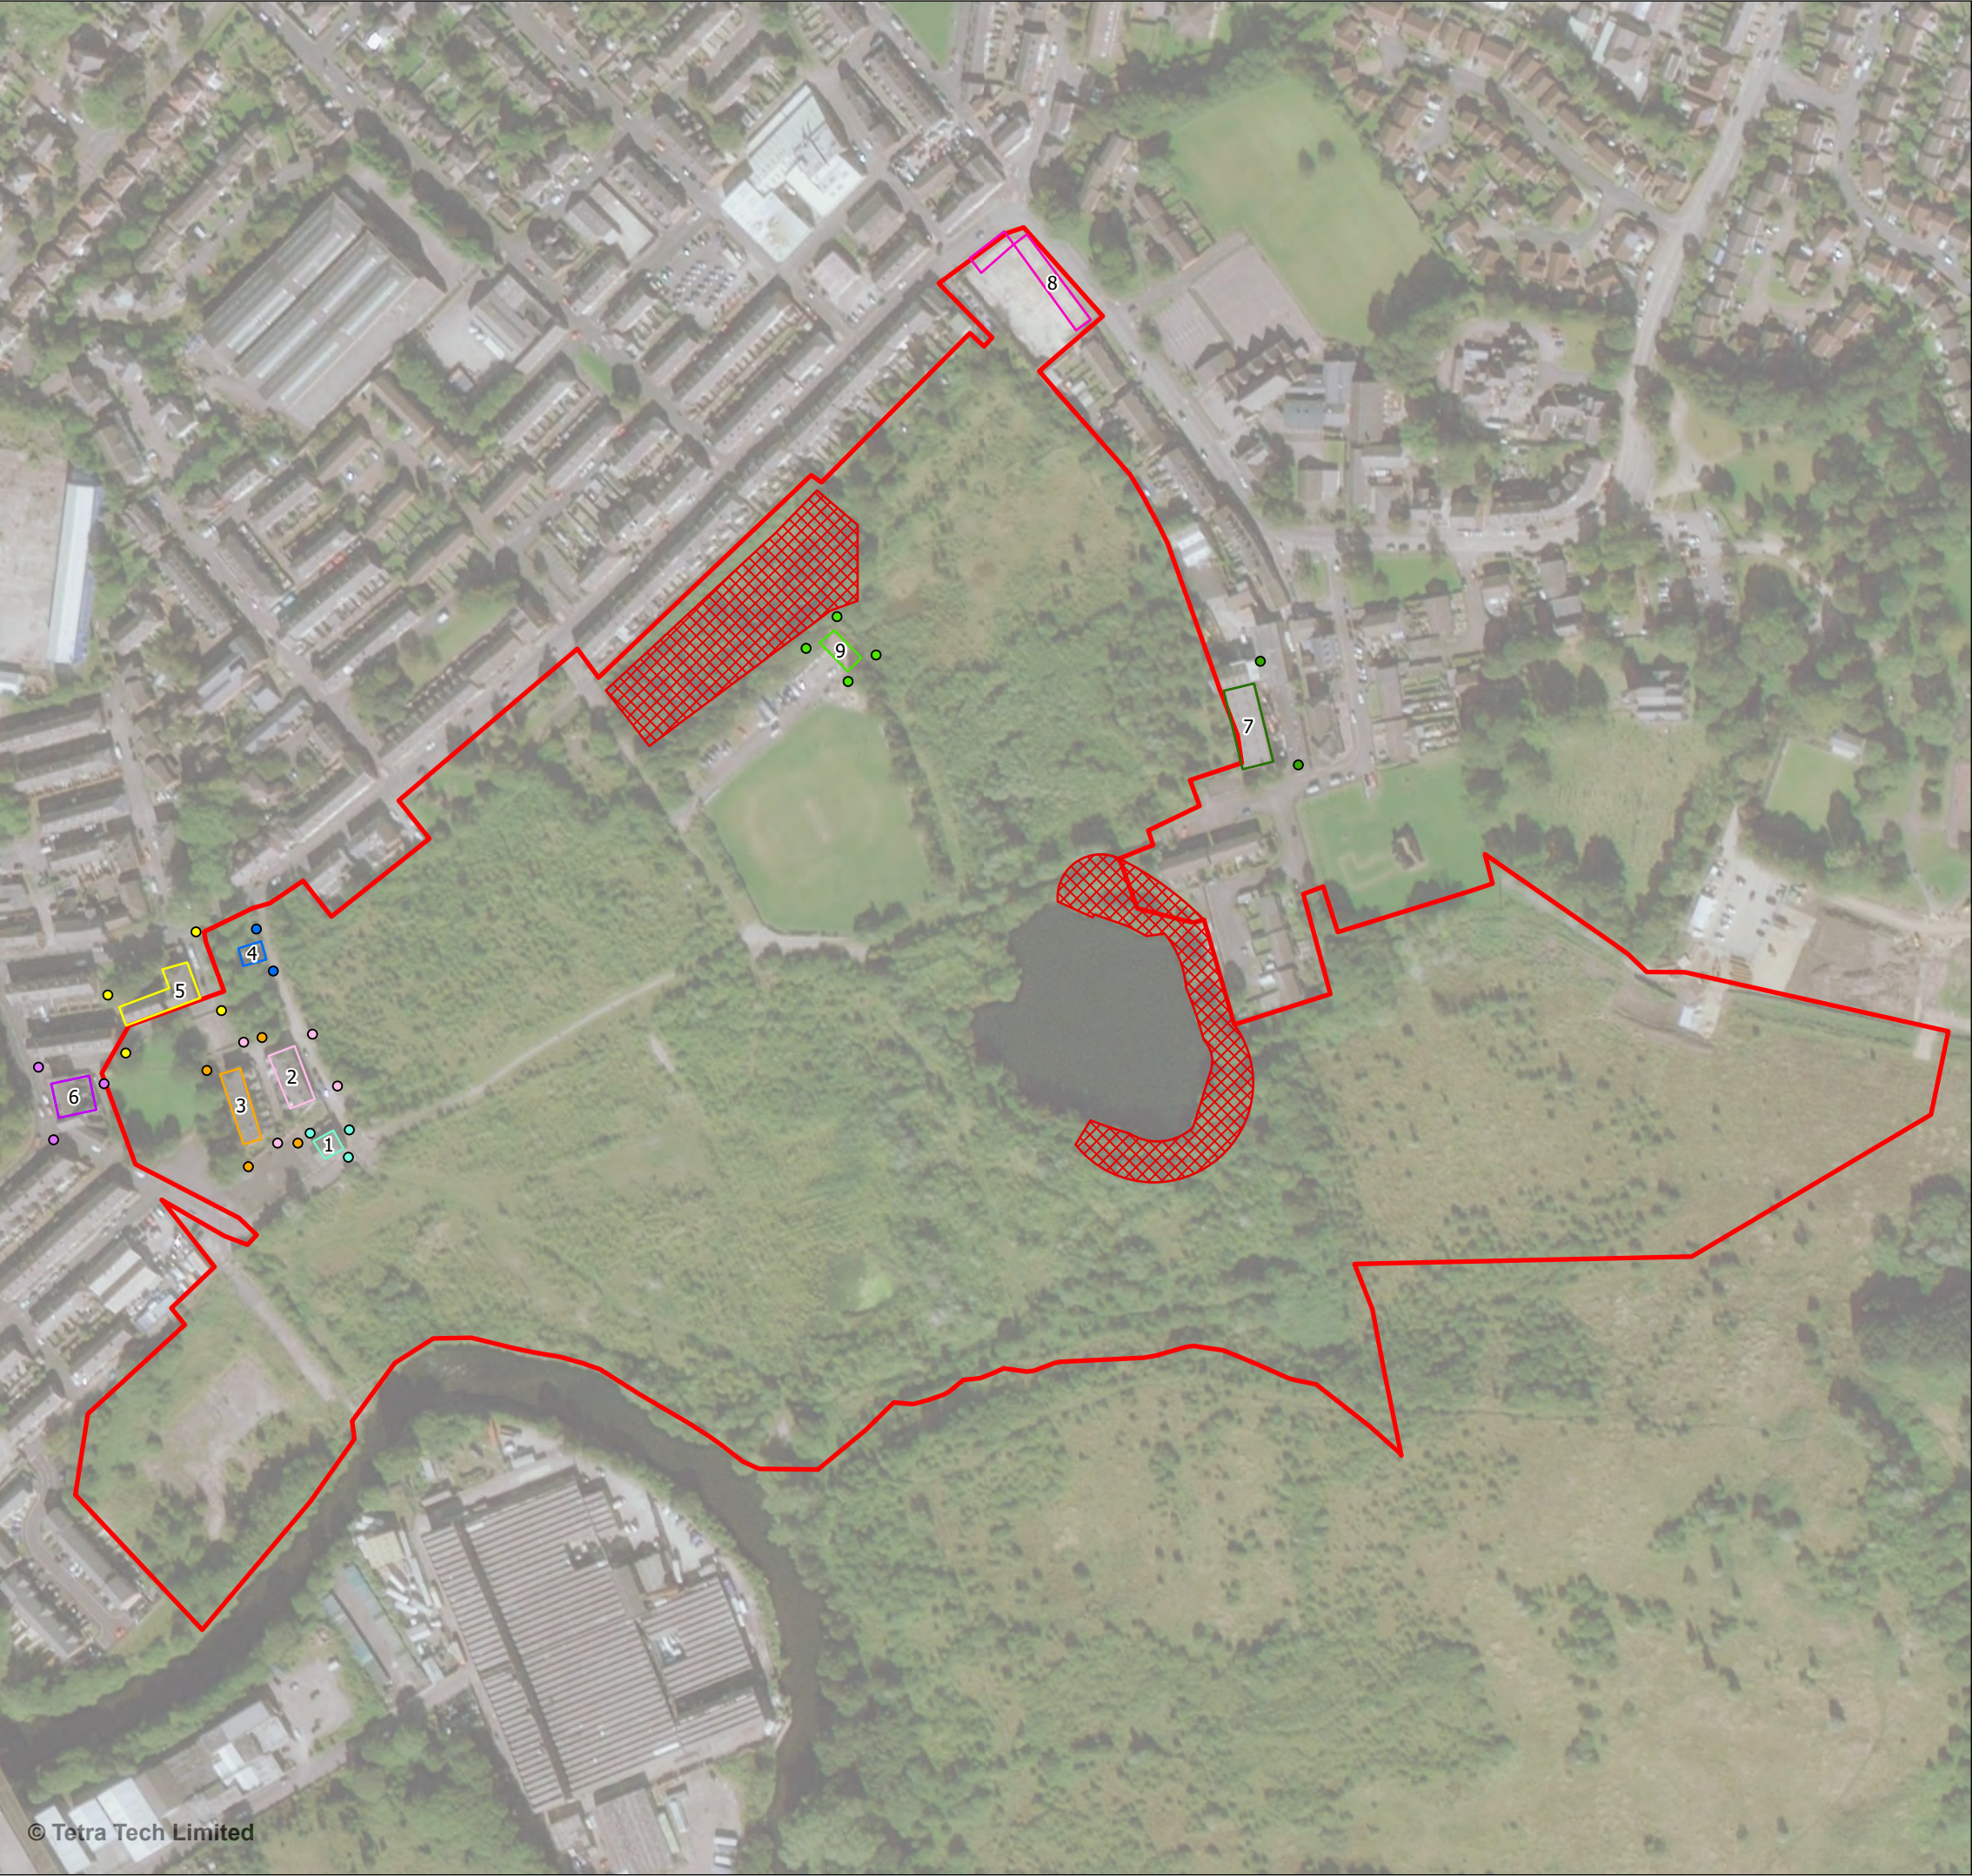
# Recommended Surveyor Vantage Points

**Figure 2 – Recommended Surveyor Vantage Points**

A minimum of three presence / likely absence bat surveys is required for Building 5. A minimum of two presence / likely absence bat surveys are required for Buildings 1, 2, 3, 6, 7 and 9. As there was no internal or external access to Building 9 during the inspection, if there are any emergences / re-entries during the first two surveys, a minimum of three surveys will be required. A minimum of one presence / likely absence bat survey is required for Building 4. Due to the nature of the buildings, a minimum of two and maximum of four surveyors are recommended for each building (refer to Table 4 and Figure 2 for locations).

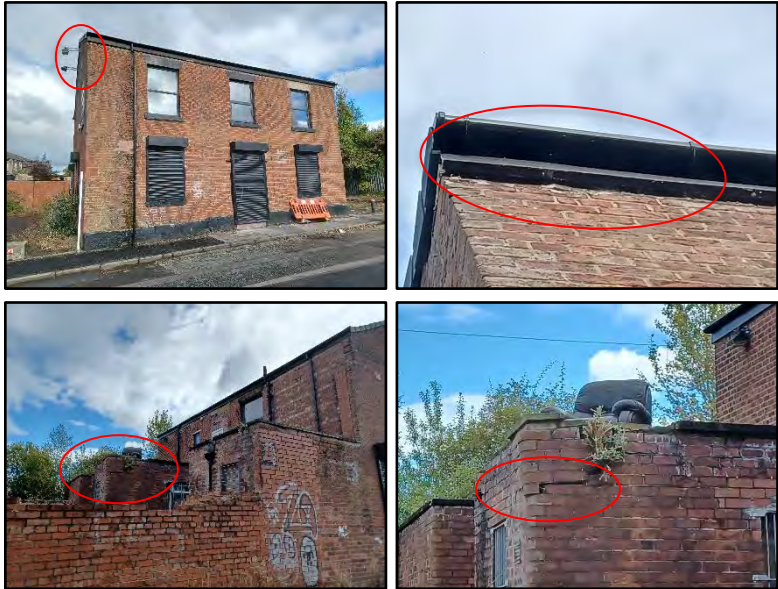
| Building Number | Building Description | PRF | Grading | Hibernation (Y/N) | Photograph |
|---|---|---|---|---|---|
| B1 | <p>It was a two-storey building constructed of red brick with pitched and hipped roof clad in interlocking concrete tiles. The roof was relatively new and in good condition. The ground floor windows and doors were obscured by metal roller shutters that were tightly fitted. The first-floor windows were intact with no broken windows and were tightly fitted to the brickwork and lintels. There was a barge board present below the guttering on the northwest, east and southeast facades. The southwest façade was a gable. To the rear of the property</p> | <p>Barge boards on northwest, east and southeast facades with gaps suitable for roosting and access to the wall head.</p> <p>No roof cap ends on southeast gable.</p> <p>Significant brickwork cracks on northwest extension.</p> <p>(No internal access, therefore increased survey effort recommended)</p> | Moderate | Y | |

| Building Number | Building Description | PRF | Grading | Hibernation (Y/N) | Photograph |
|---|---|---|---|---|---|
| | (northwest façade) was a single storey extension that was in poor repair. | | | | |

Building 1 looked to be disused at the time of survey. The building was assessed as offering **moderate suitability for use by roosting bats** due to gaps under the barge boards, cracks within the extension and absence of internal inspection (increased survey effort recommended). The building **may be suitable for use by hibernating bats** as the building is not immediately surrounded by other buildings and was not occupied at the time of survey, as such no heat fluctuations from heating would be present.

Buildings 1 and 4 both have potential for hibernating bats. The building's interior was not inspected, therefore humidity and internal PRF's were not identified. As such, it is recommended that an internal survey should be carried out to rule out hibernation status.

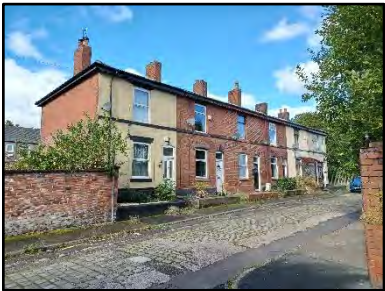
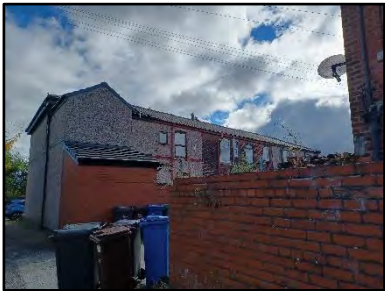
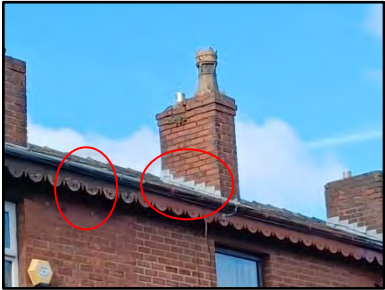
| Building Number | Building Description | PRF | Grading | Hibernation (Y/N) | Photograph |
|---|---|---|---|---|---|
| B2 | <p>A row of terrace residential properties which were occupied at the time of survey. The building was two-storey building constructed of brick with some properties rendered and some not. The roof was pitched and hipped and clad in slate tiles. Chimney stacks were present and constructed from brick with lead flashing. The windows were uPVC and tightly fitted to the brickwork and lintels.</p> | <p>Potential gaps under the eaves on the eastern façade.</p> <p>Gaps under lead flashing around chimney stacks.</p> <p>(No internal access, therefore increased survey effort recommended)</p> | Moderate | N | |

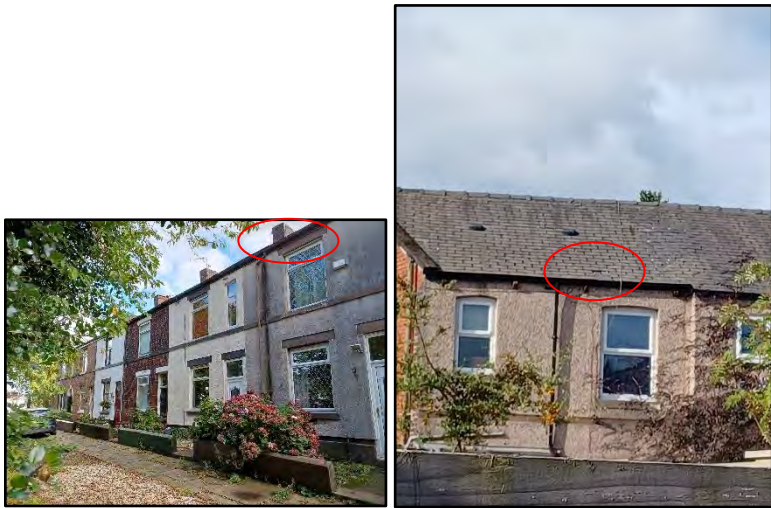
| Building Number | Building Description | PRF | Grading | Hibernation (Y/N) | Photograph |
|---|---|---|---|---|---|
| B3 | Building 3 was of similar construction to Building 2 and constructed from brick with some properties rendered. The roof was pitched and hipped and clad in slate tiles. Brick chimney stacks were also present. There was no internal access or access to the eastern façade of the building | Slipped tile on eastern façade.<br><br>Gap above window lintel on western façade.<br><br>(No internal access, therefore increased survey effort recommended) | Moderate | N | |

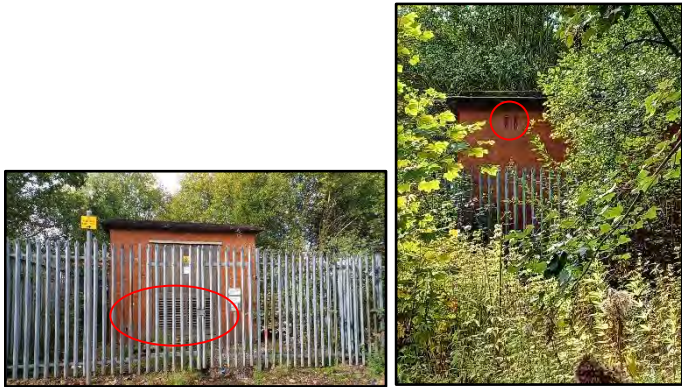
| Building Number | Building Description | PRF | Grading | Hibernation (Y/N) | Photograph |
|---|---|---|---|---|---|
| B4 | The building was small in size and constructed from red brick with a flat concrete roof. There were no windows present, and the door was formed from timber. There was no internal or rear access due to dense vegetation. The lower portion of the door were vent slats and could form an access | Vent slats on timber door.<br><br>Brick air vents.<br><br>(No internal access, therefore increased survey effort recommended) | Low | Y | |

| Building Number | Building Description | PRF | Grading | Hibernation (Y/N) | Photograph |
|---|---|---|---|---|---|
| | point. Brick air vents were also noted. | | | | |

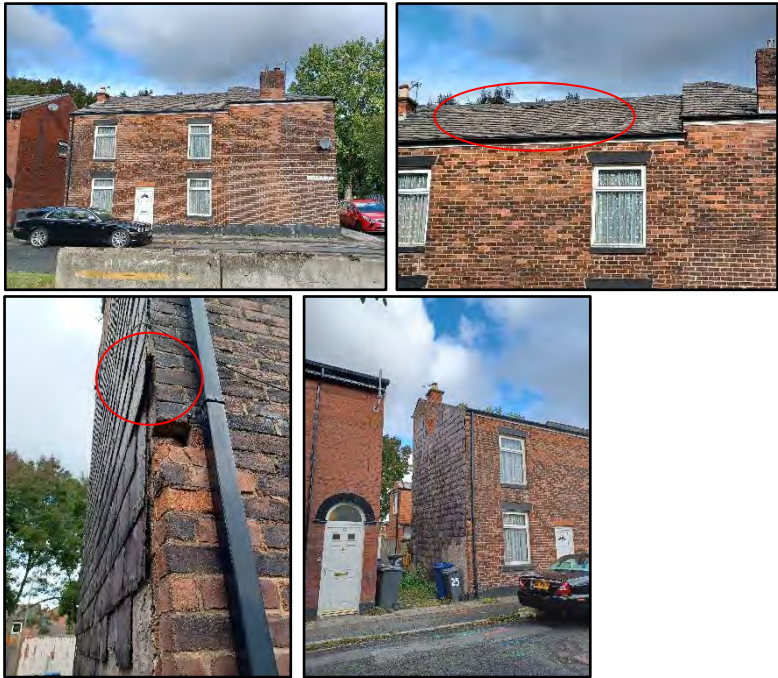
| Building Number | Building Description | PRF | Grading | Hibernation (Y/N) | Photograph |
|---|---|---|---|---|---|
| B5 | <p>An 'L' shaped residential dwelling. The building was a two-storey building and constructed of red brick with a pitched and hipped slate tiled roof. A number of tiles were noted to be slipped or poorly fitted. A gable was present on the western façade that was clad in hanging tiles, some of which were damaged or slipped. The windows and doors were uPVC and tightly fitted. There was no rear or internal access to the building.</p> | <p>Numerous slipped and poorly fitted roof tiles.</p> <p>Hanging tiles in poor state of repair.</p> <p>(No internal access, therefore increased survey effort recommended)</p> | High | N | |

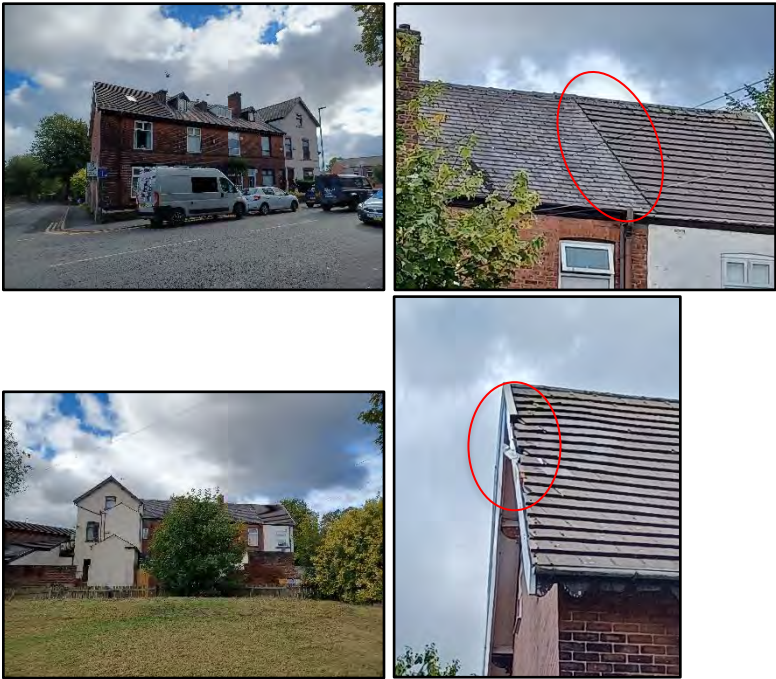
| Building Number | Building Description | PRF | Grading | Hibernation (Y/N) | Photograph |
|---|---|---|---|---|---|
| B6 | <p>An 'L' shaped residential dwelling. The building was a three-storey building, one section of the building the third storey was within the roof void and the other section of the building was three storeys and a roof void. There were multiple two storey and single storey extensions attached to the building. The building was multiple residential dwellings that looked to be occupied at the time of survey. The building was constructed from brick with some areas rendered. The roof was pitched and clad in a mixture of tiles as some areas of the roof looked to have been re-roofed. The</p> | <p>Damage to north gable end.</p> <p>Gaps between different styles of tile.</p> <p>(No internal access, therefore increased survey effort recommended)</p> | Moderate | N | |

| Building Number | Building Description | PRF | Grading | Hibernation (Y/N) | Photograph |
|---|---|---|---|---|---|
| | windows were uPVC and tightly fitted. | | | | |

Building 6 was an 'L' shaped residential dwelling. There was no internal access to the building and the building was assessed as **offering moderate suitability for use by roosting bats** due to a number of areas of damage to the roof and absence of full access. The building was considered **not suitable for use by hibernating bats** as the building was occupied and as such heating is likely to be used which would eliminate the constant low temperatures required for hibernation.

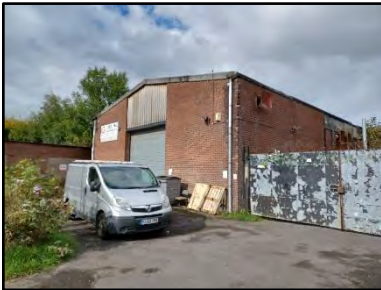
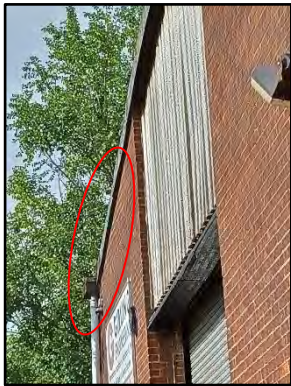
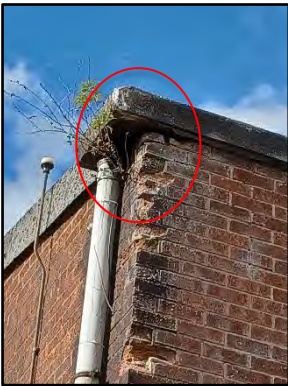
| Building Number | Building Description | PRF | Grading | Hibernation (Y/N) | Photograph |
|---|---|---|---|---|---|
| B7 | A workshop / warehouse style building constructed from brick with a pitched corrugated asbestos roof. There was only access to the southern façade of the building and no internal access. The door was a metal roller door. | <p>Damage to brickwork on eastern corner of southern façade.</p> <p>Gap under asbestos.</p> <p>(No internal or rear access, therefore increased survey effort recommended)</p> | Moderate | N | |

Building 7 was a workshop / warehouse style building. There was only access to the southern façade of the building and no internal access. The building was assessed as offering **moderate suitability for use by roosting bats** due to damage to the eastern corner brickwork of the southern façade and gaps under the gable end asbestos that may lead to internal access.

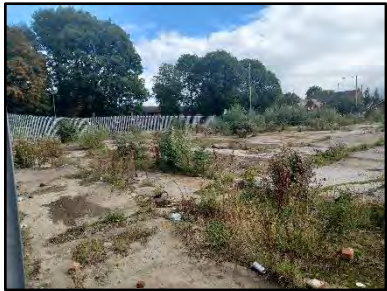
| Building Number | Building Description | PRF | Grading | Hibernation (Y/N) | Photograph |
|---|---|---|---|---|---|
| B8 | Demolished building with only concrete footprint remaining. | N/A | N/A | N/A | |

In the previous ecological appraisal (WYG, 2018b) an eighth building was identified in the northern corner of the site. During this survey the building was found to be demolished with only the concrete footprint remaining. As such no assessment of this building was completed.
