## Bat Nocturnal Surveys

Former Mondi Site (Site 1),  
Holcombe Mill, Bridge  
Street, Ramsbottom, BL0 0BS

Ref: P.1202.19

Date: June 2024

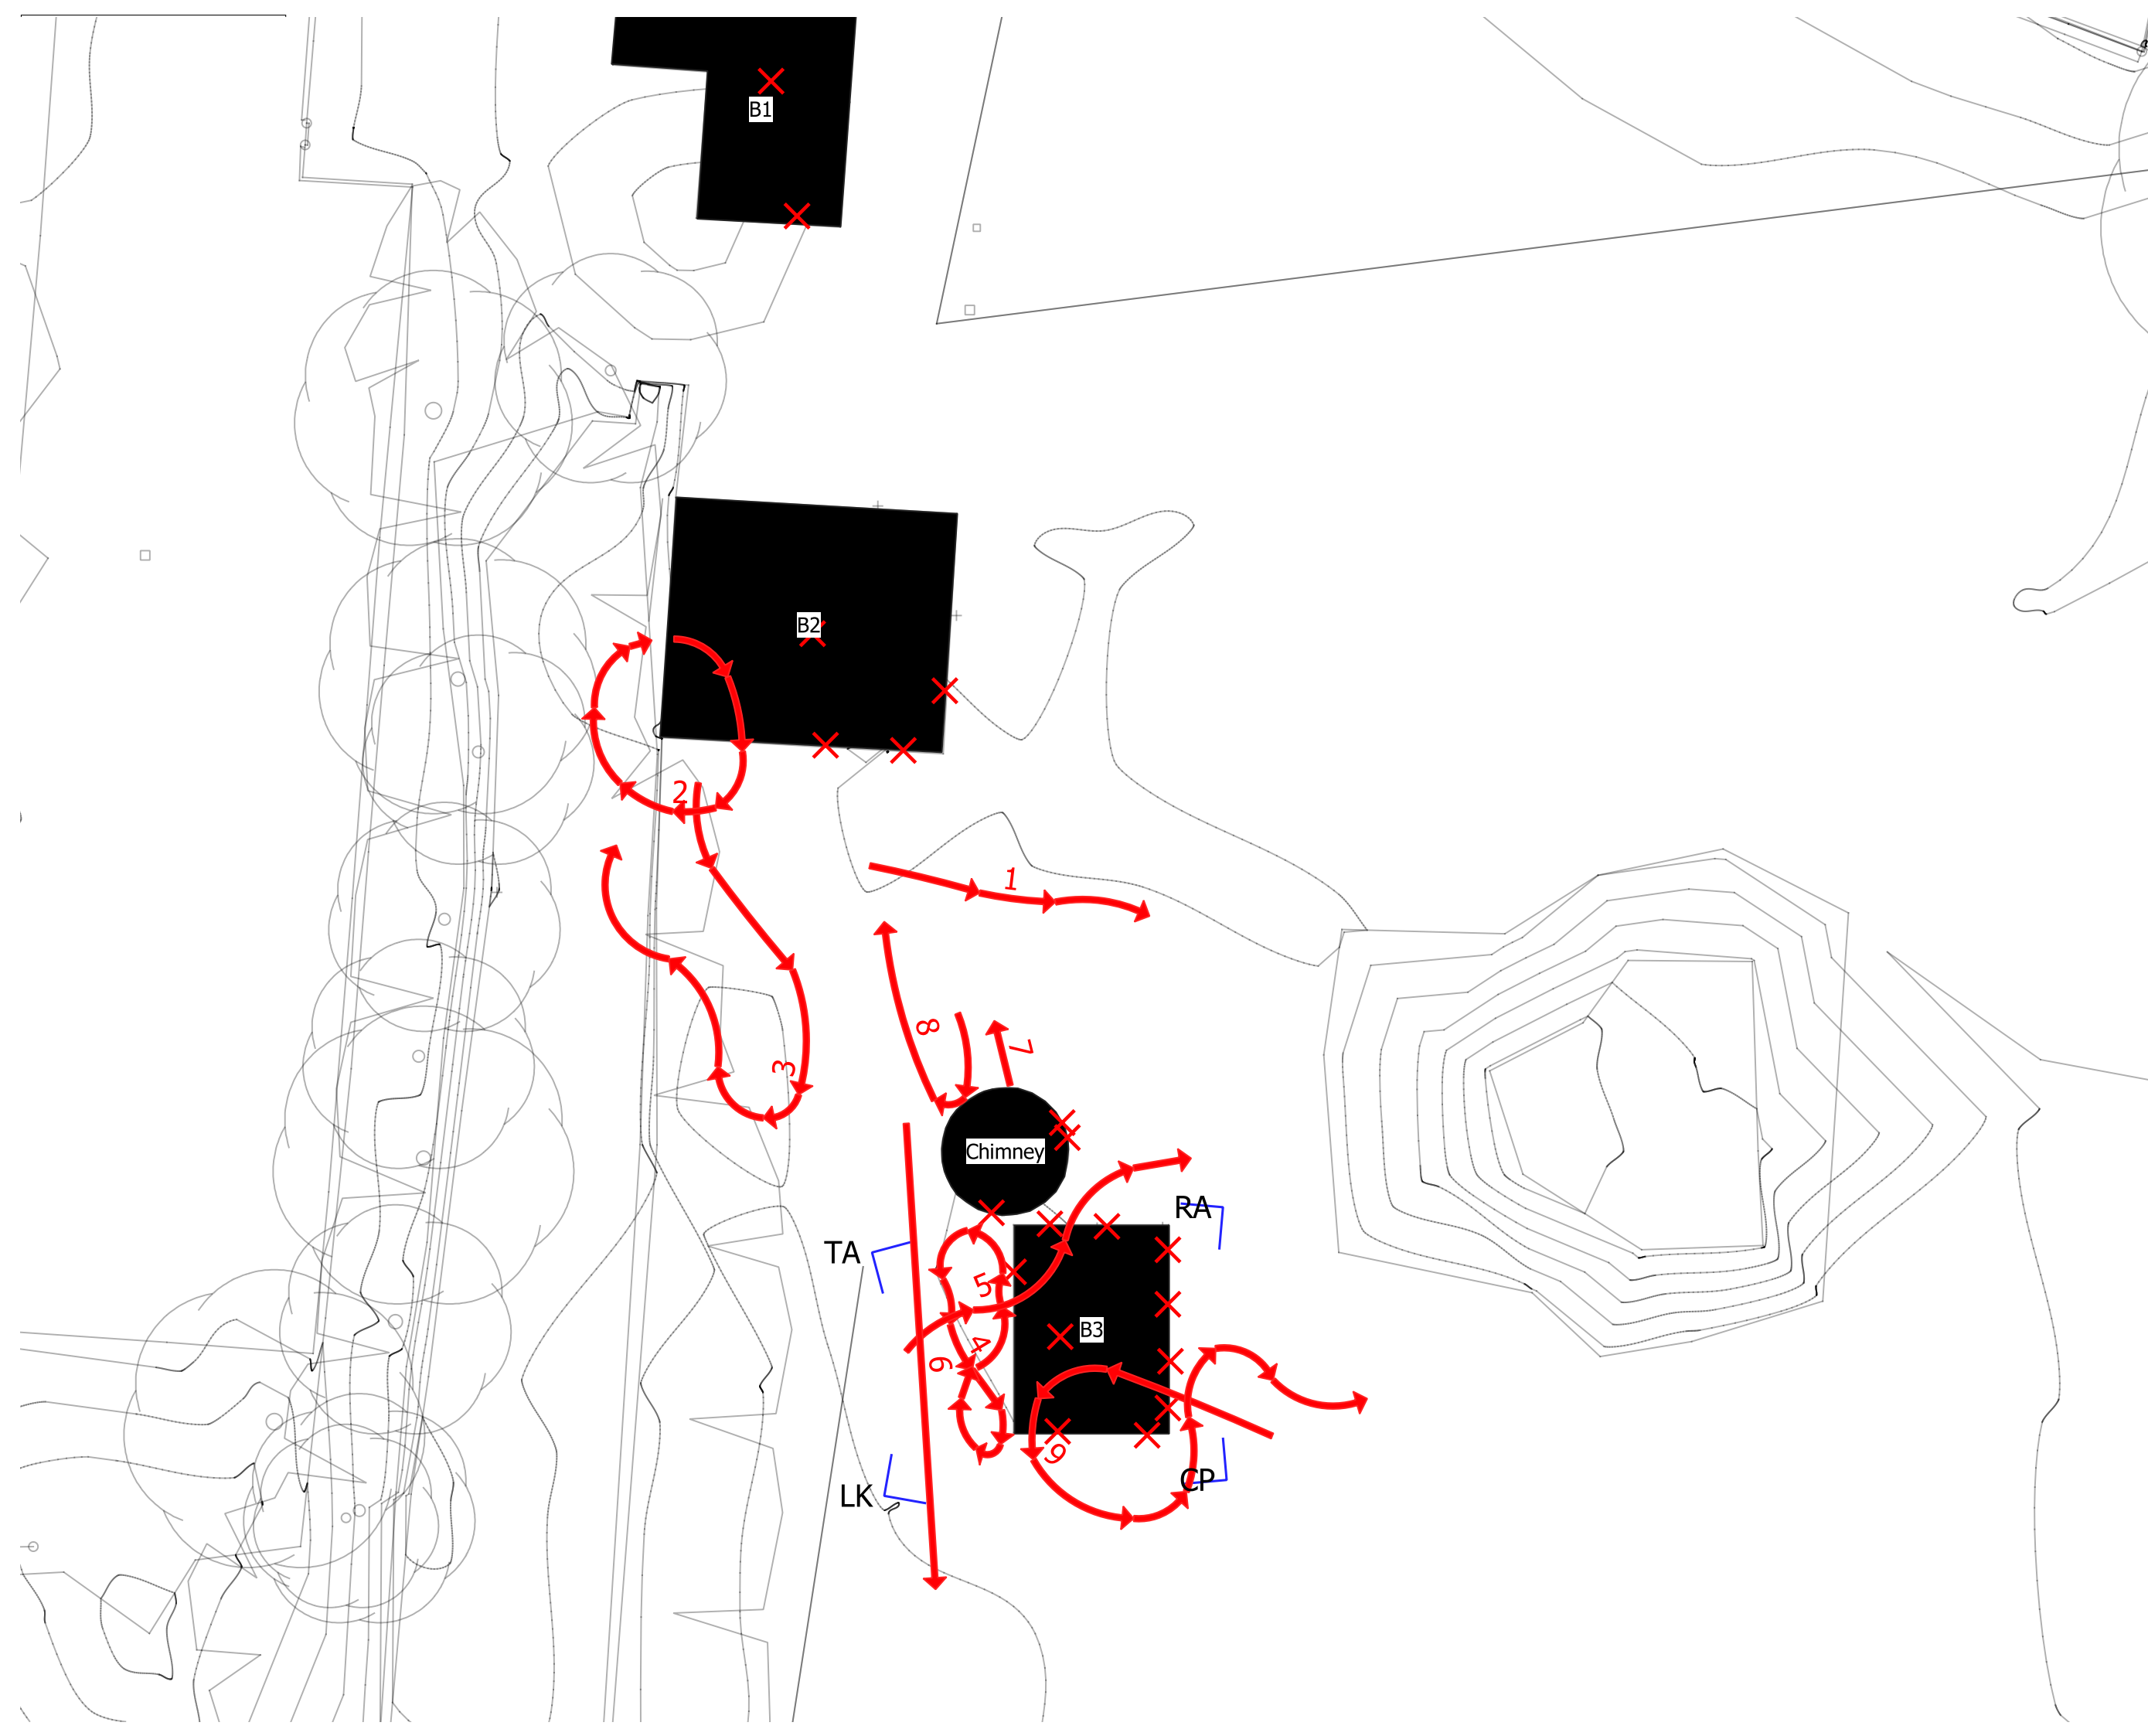
| SCALE:<br>1:250@A3 | DRAWN BY:<br>CP | DRAWING No:<br>P.1202.19.10 |

On 4<sup>th</sup> May 2020, bat activity commenced at 21:00 (14 minutes after dusk). This bat observation was a common pipistrelle (*Pipistrellus pipistrellus*) passing from north-west to east between Building B2 and the chimney. This bat was observed by Tosha Allen who was positioned at the north-west corner of building B3. This bat was heard and not seen by Robert Armitage (positioned at north-east corner of B3) and Ciaran Power (positioned at south-east corner of B3). Liz Kenyon was positioned at the south-west corner of B3 observed a bat pass east to west of the chimney (seen not heard) at 21:02. This bat was also observed by Tosha Allen which was a foraging common pipistrelle, this bat was observed foraging over the scrub adjacent to B2. The bat activity stopped at 22:13 with a distant common pipistrelle pass.

Low bat activity was recorded at the north-east corner of the building with seven common pipistrelle bats observed. Foraging activity was recorded, and bats were also heard and not seen by the surveyor.

Low bat activity was recorded at the north-west corner of B3 with fourteen bat observations recorded. Behaviour included foraging over the scrub and watercourse behind the surveyor location and bat passes were observed. Towards the end of the survey between 21:28 and 22:13 distant common pipistrelle bats were recorded.

- KEY
- bat flight lines  
04-05-20
  - surveyor location  
and viewpoints
  - access points
  - buildings

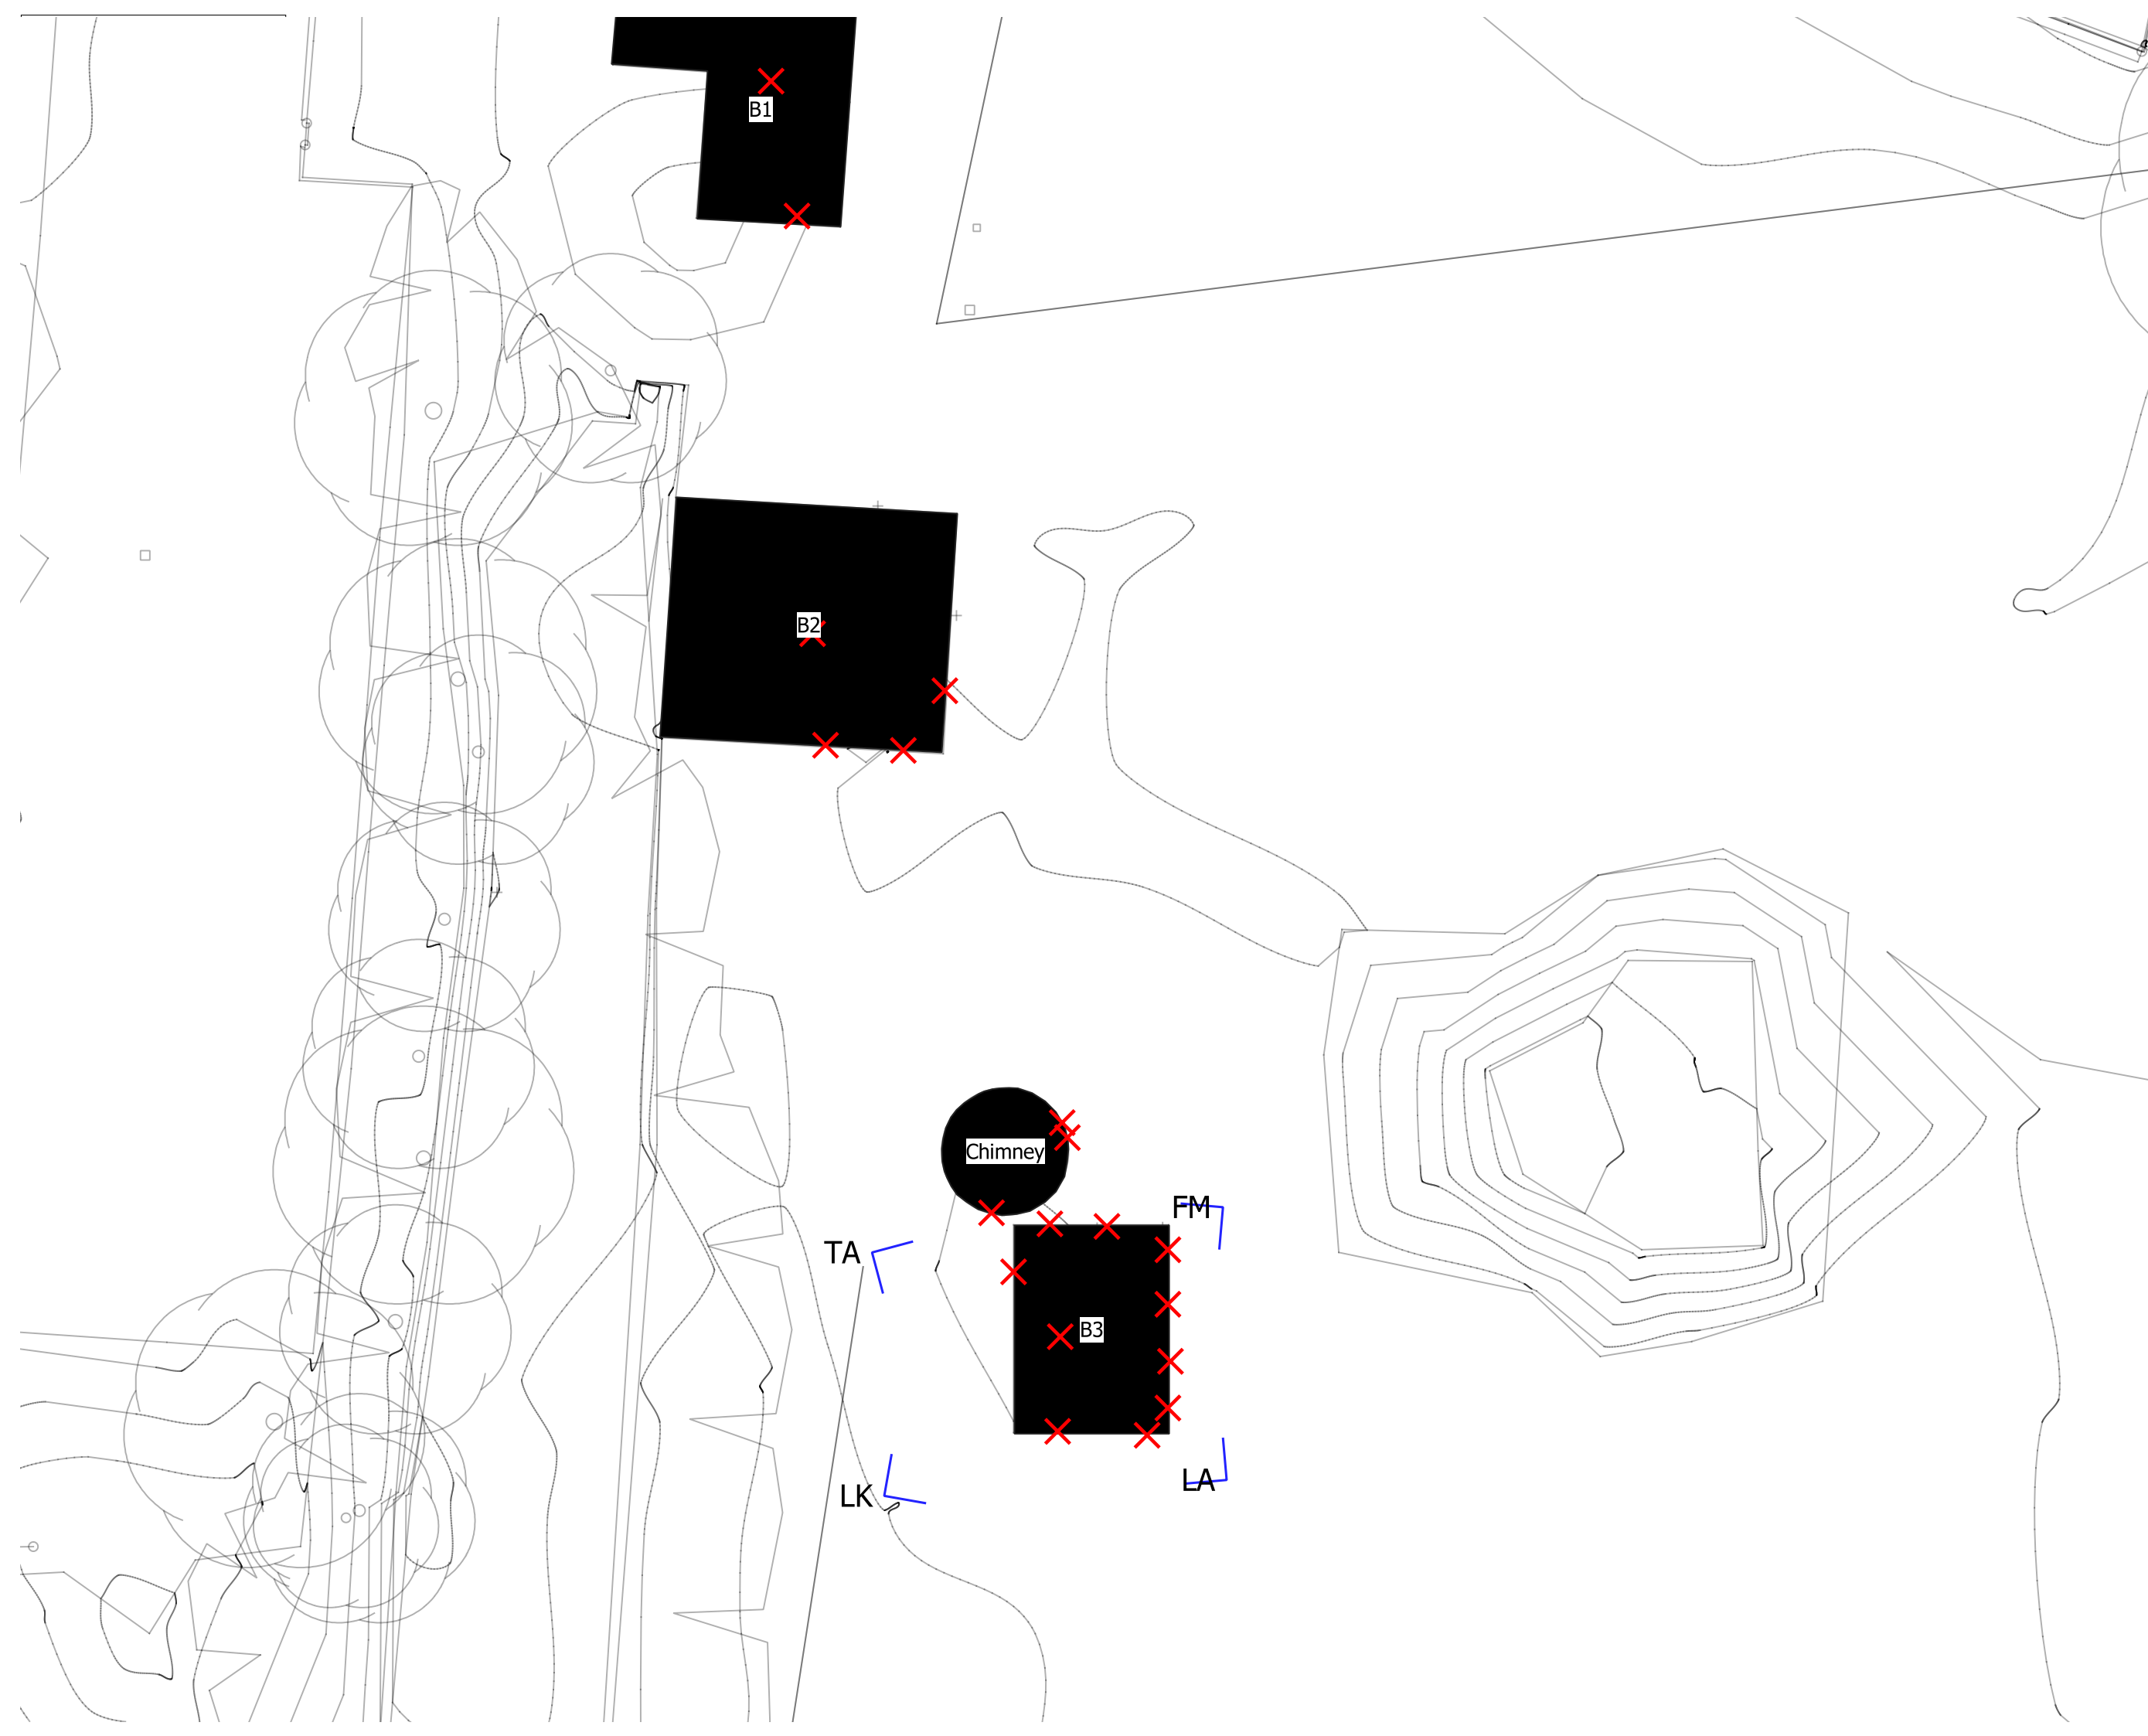
KEY

Surveyor location and viewpoint

access points

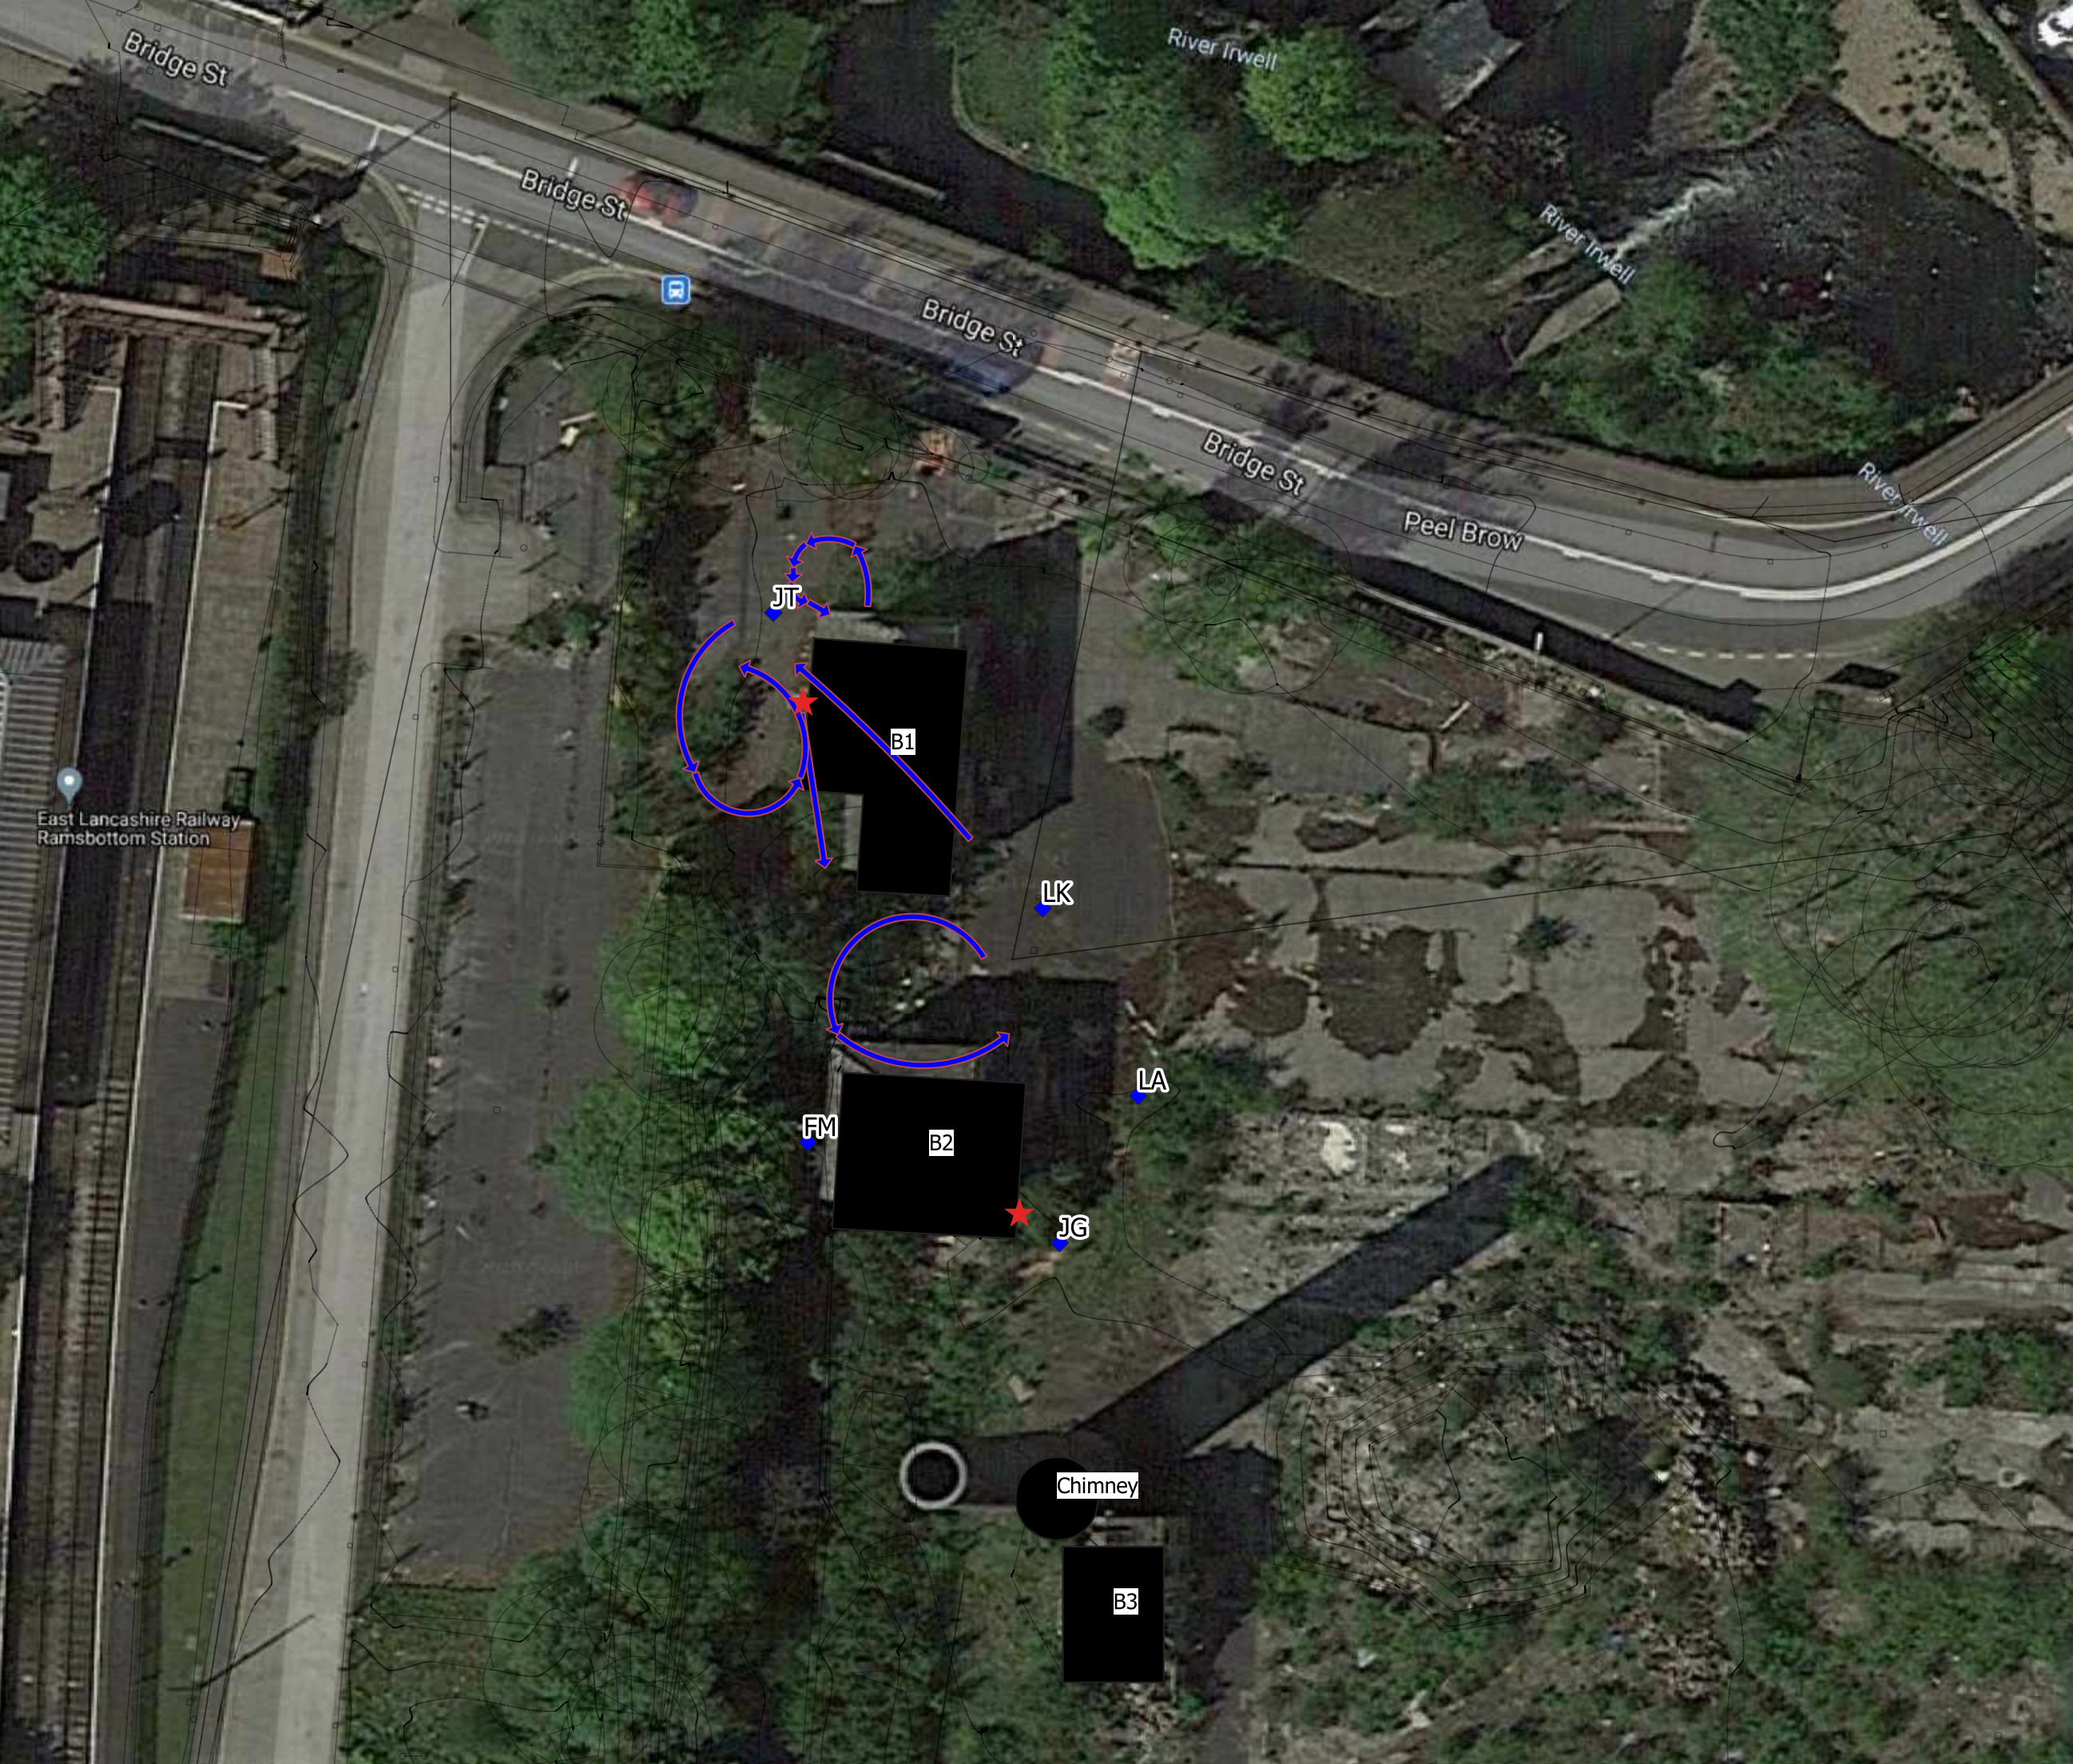
| SCALE:<br>NTS@A3 | DRAWN BY:<br>LK | DRAWING No:<br>P.1202.19.13 |

- ★ Emergence point
- Bat flight lines 27-07-20
- ◆ Surveyor locations 27-07-20
- buildings

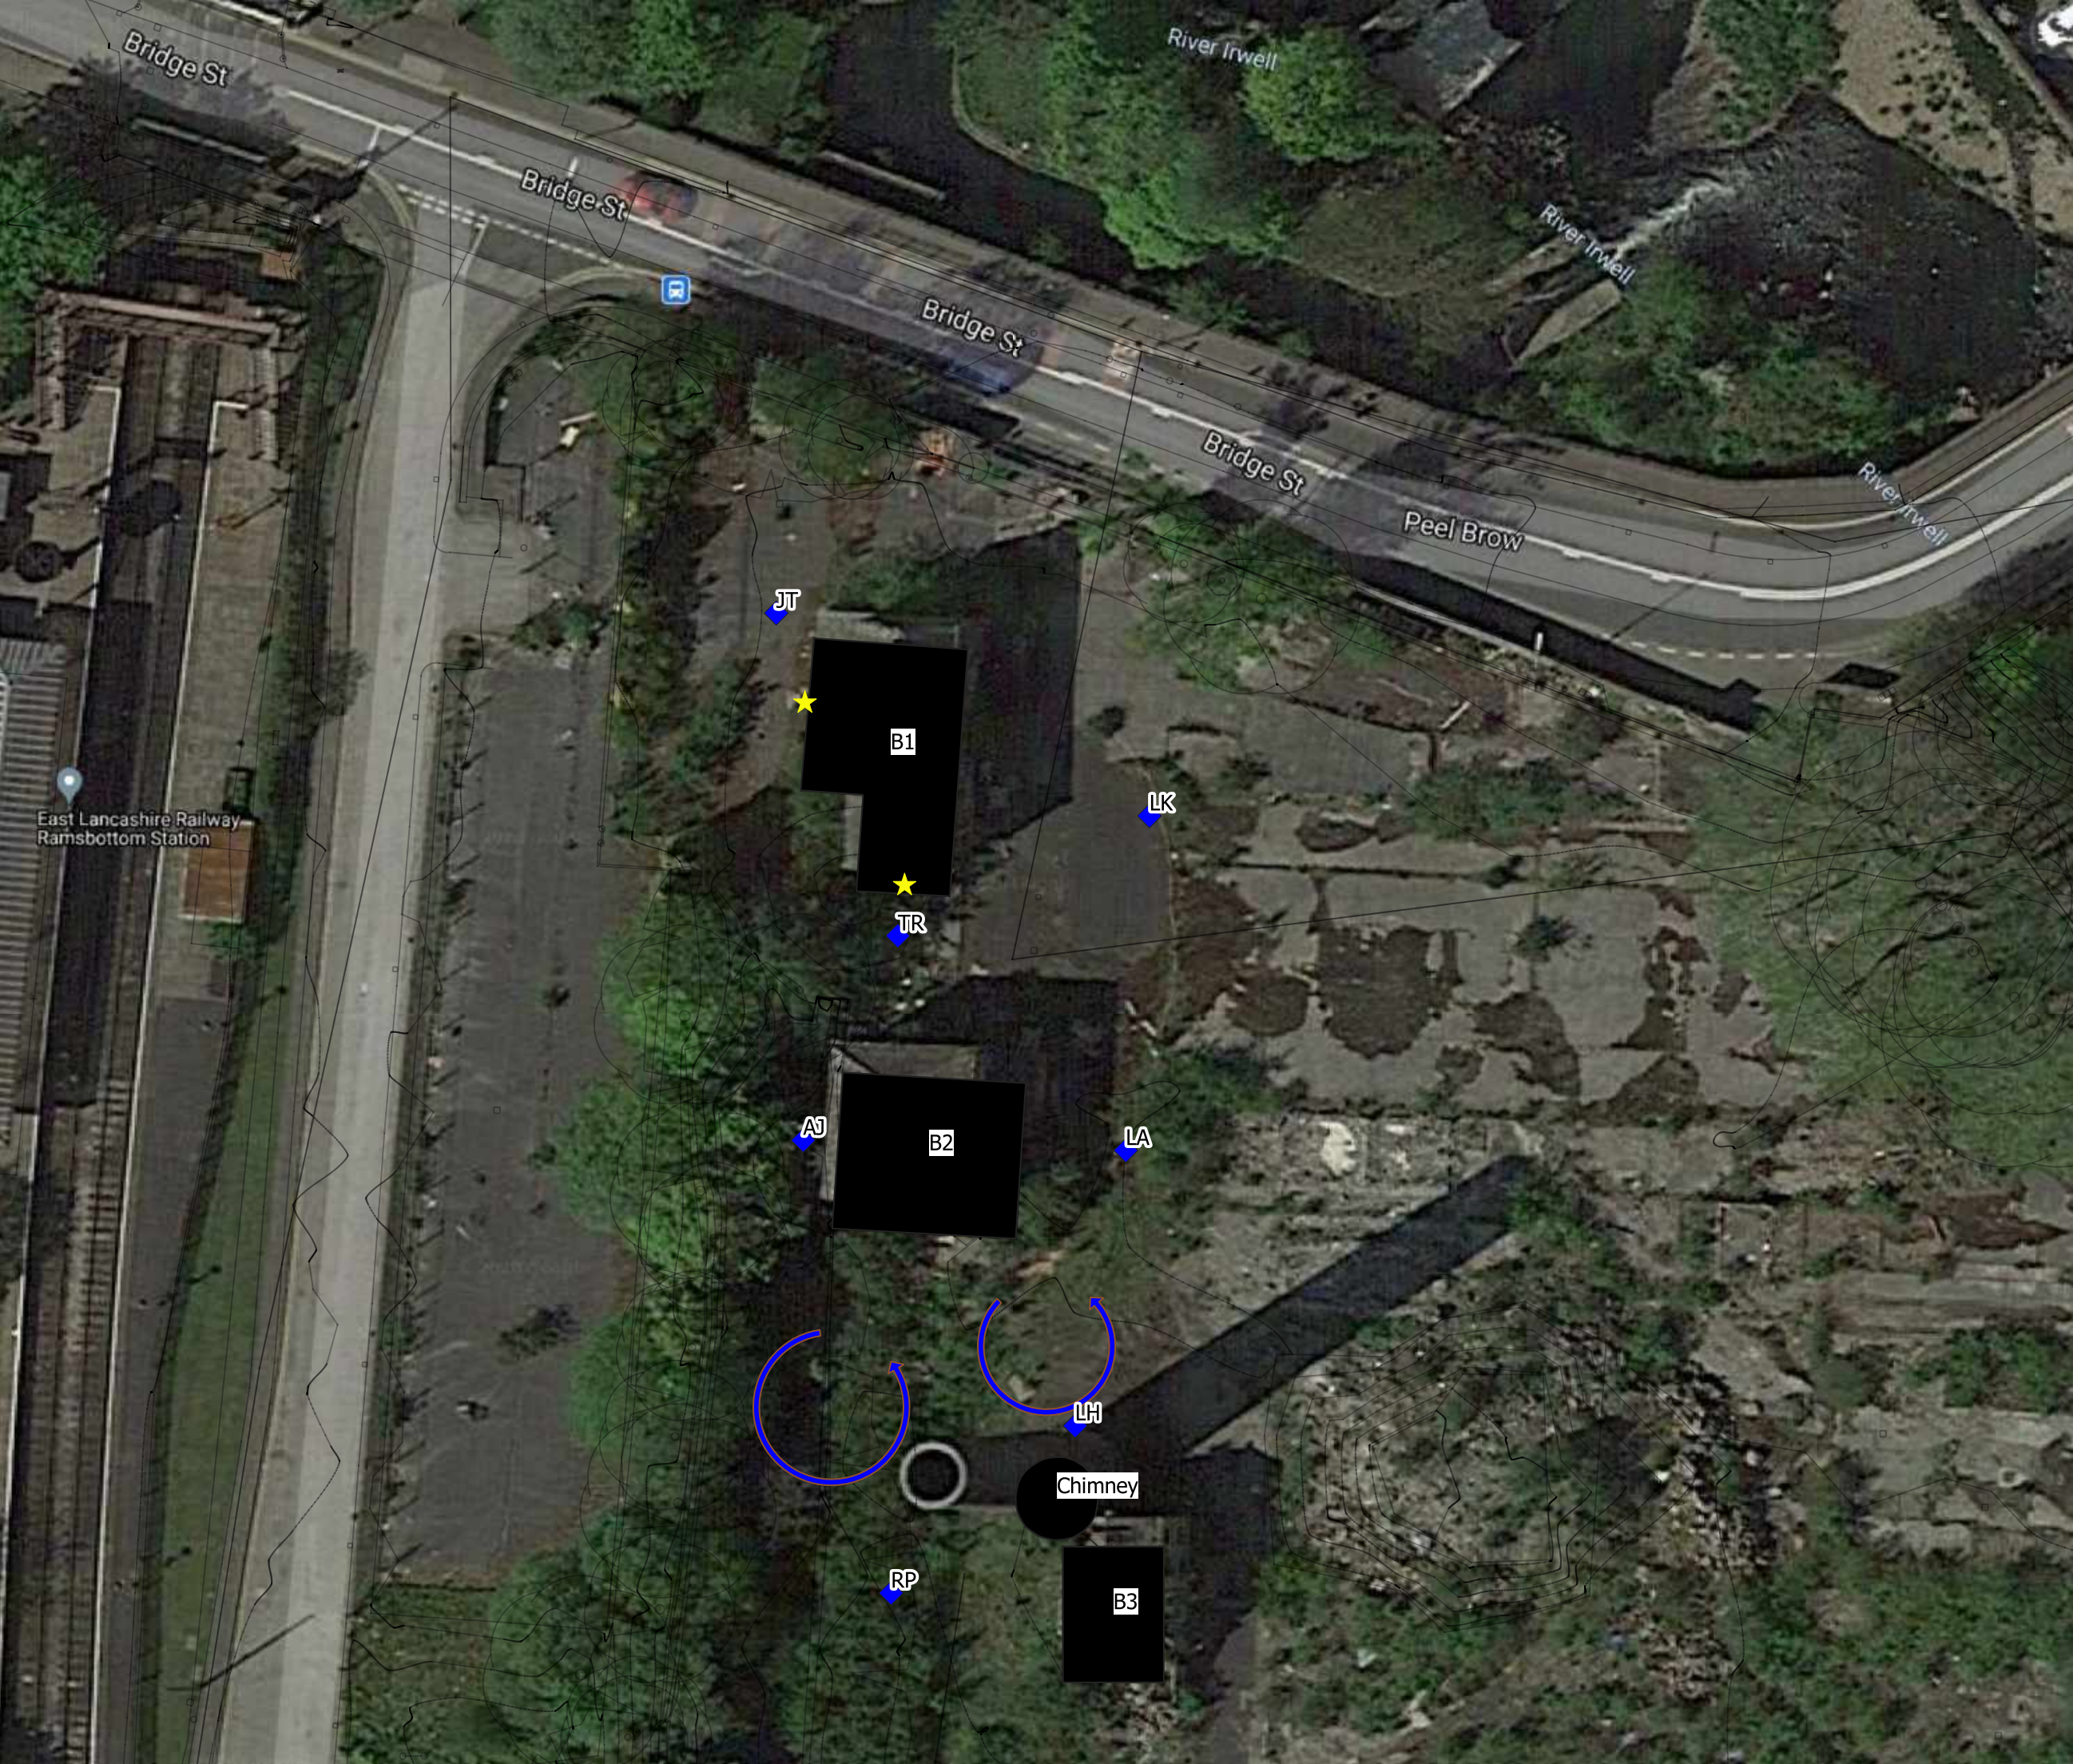
| SCALE:<br>NTS@A3 | DRAWN BY:<br>LK | DRAWING No:<br>P.1202.19.14 |

- ➡ Bat flight lines 20-08-20
- ★ Bat re-entry point
- ◆ Surveyor locations 20-08-20

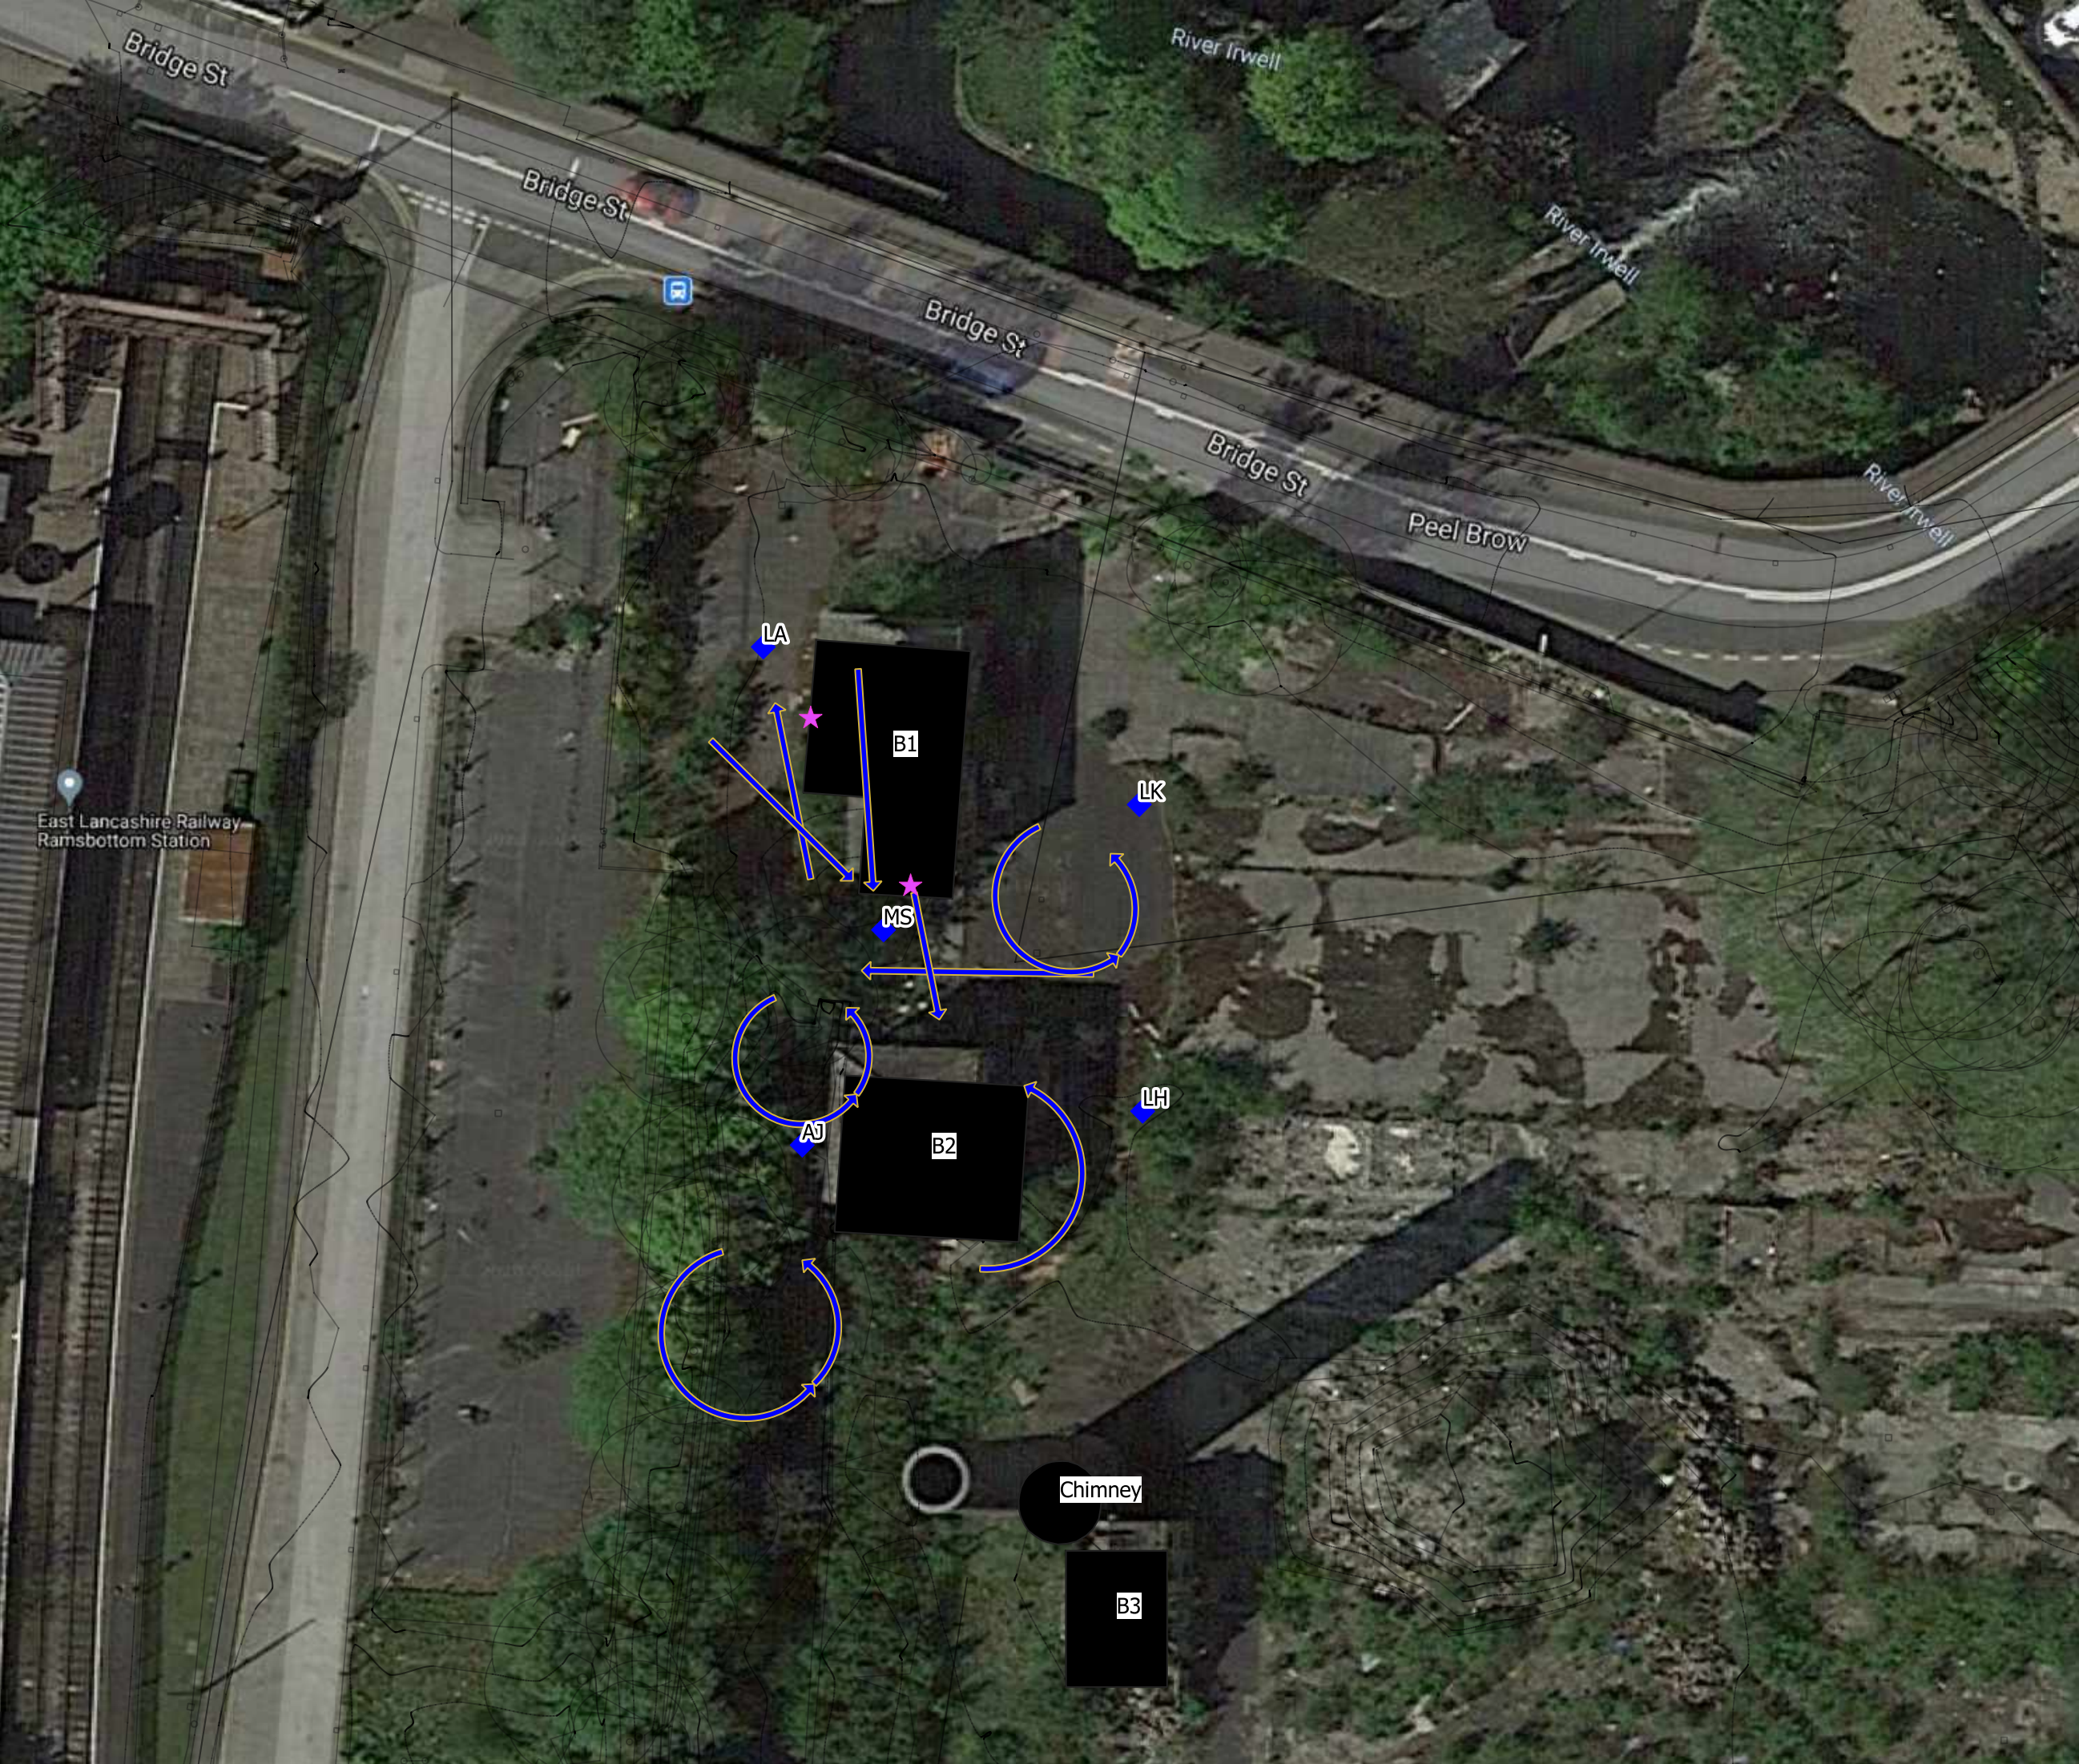
| SCALE:<br>NTS@A3 | DRAWN BY:<br>LK | DRAWING No:<br>P.1202.19.15 |

- KEY
- ★ Bat emergence point 03-09-20
  - Bat flight lines 03-09-20
  - ◆ Surveyor locations 03-09-20

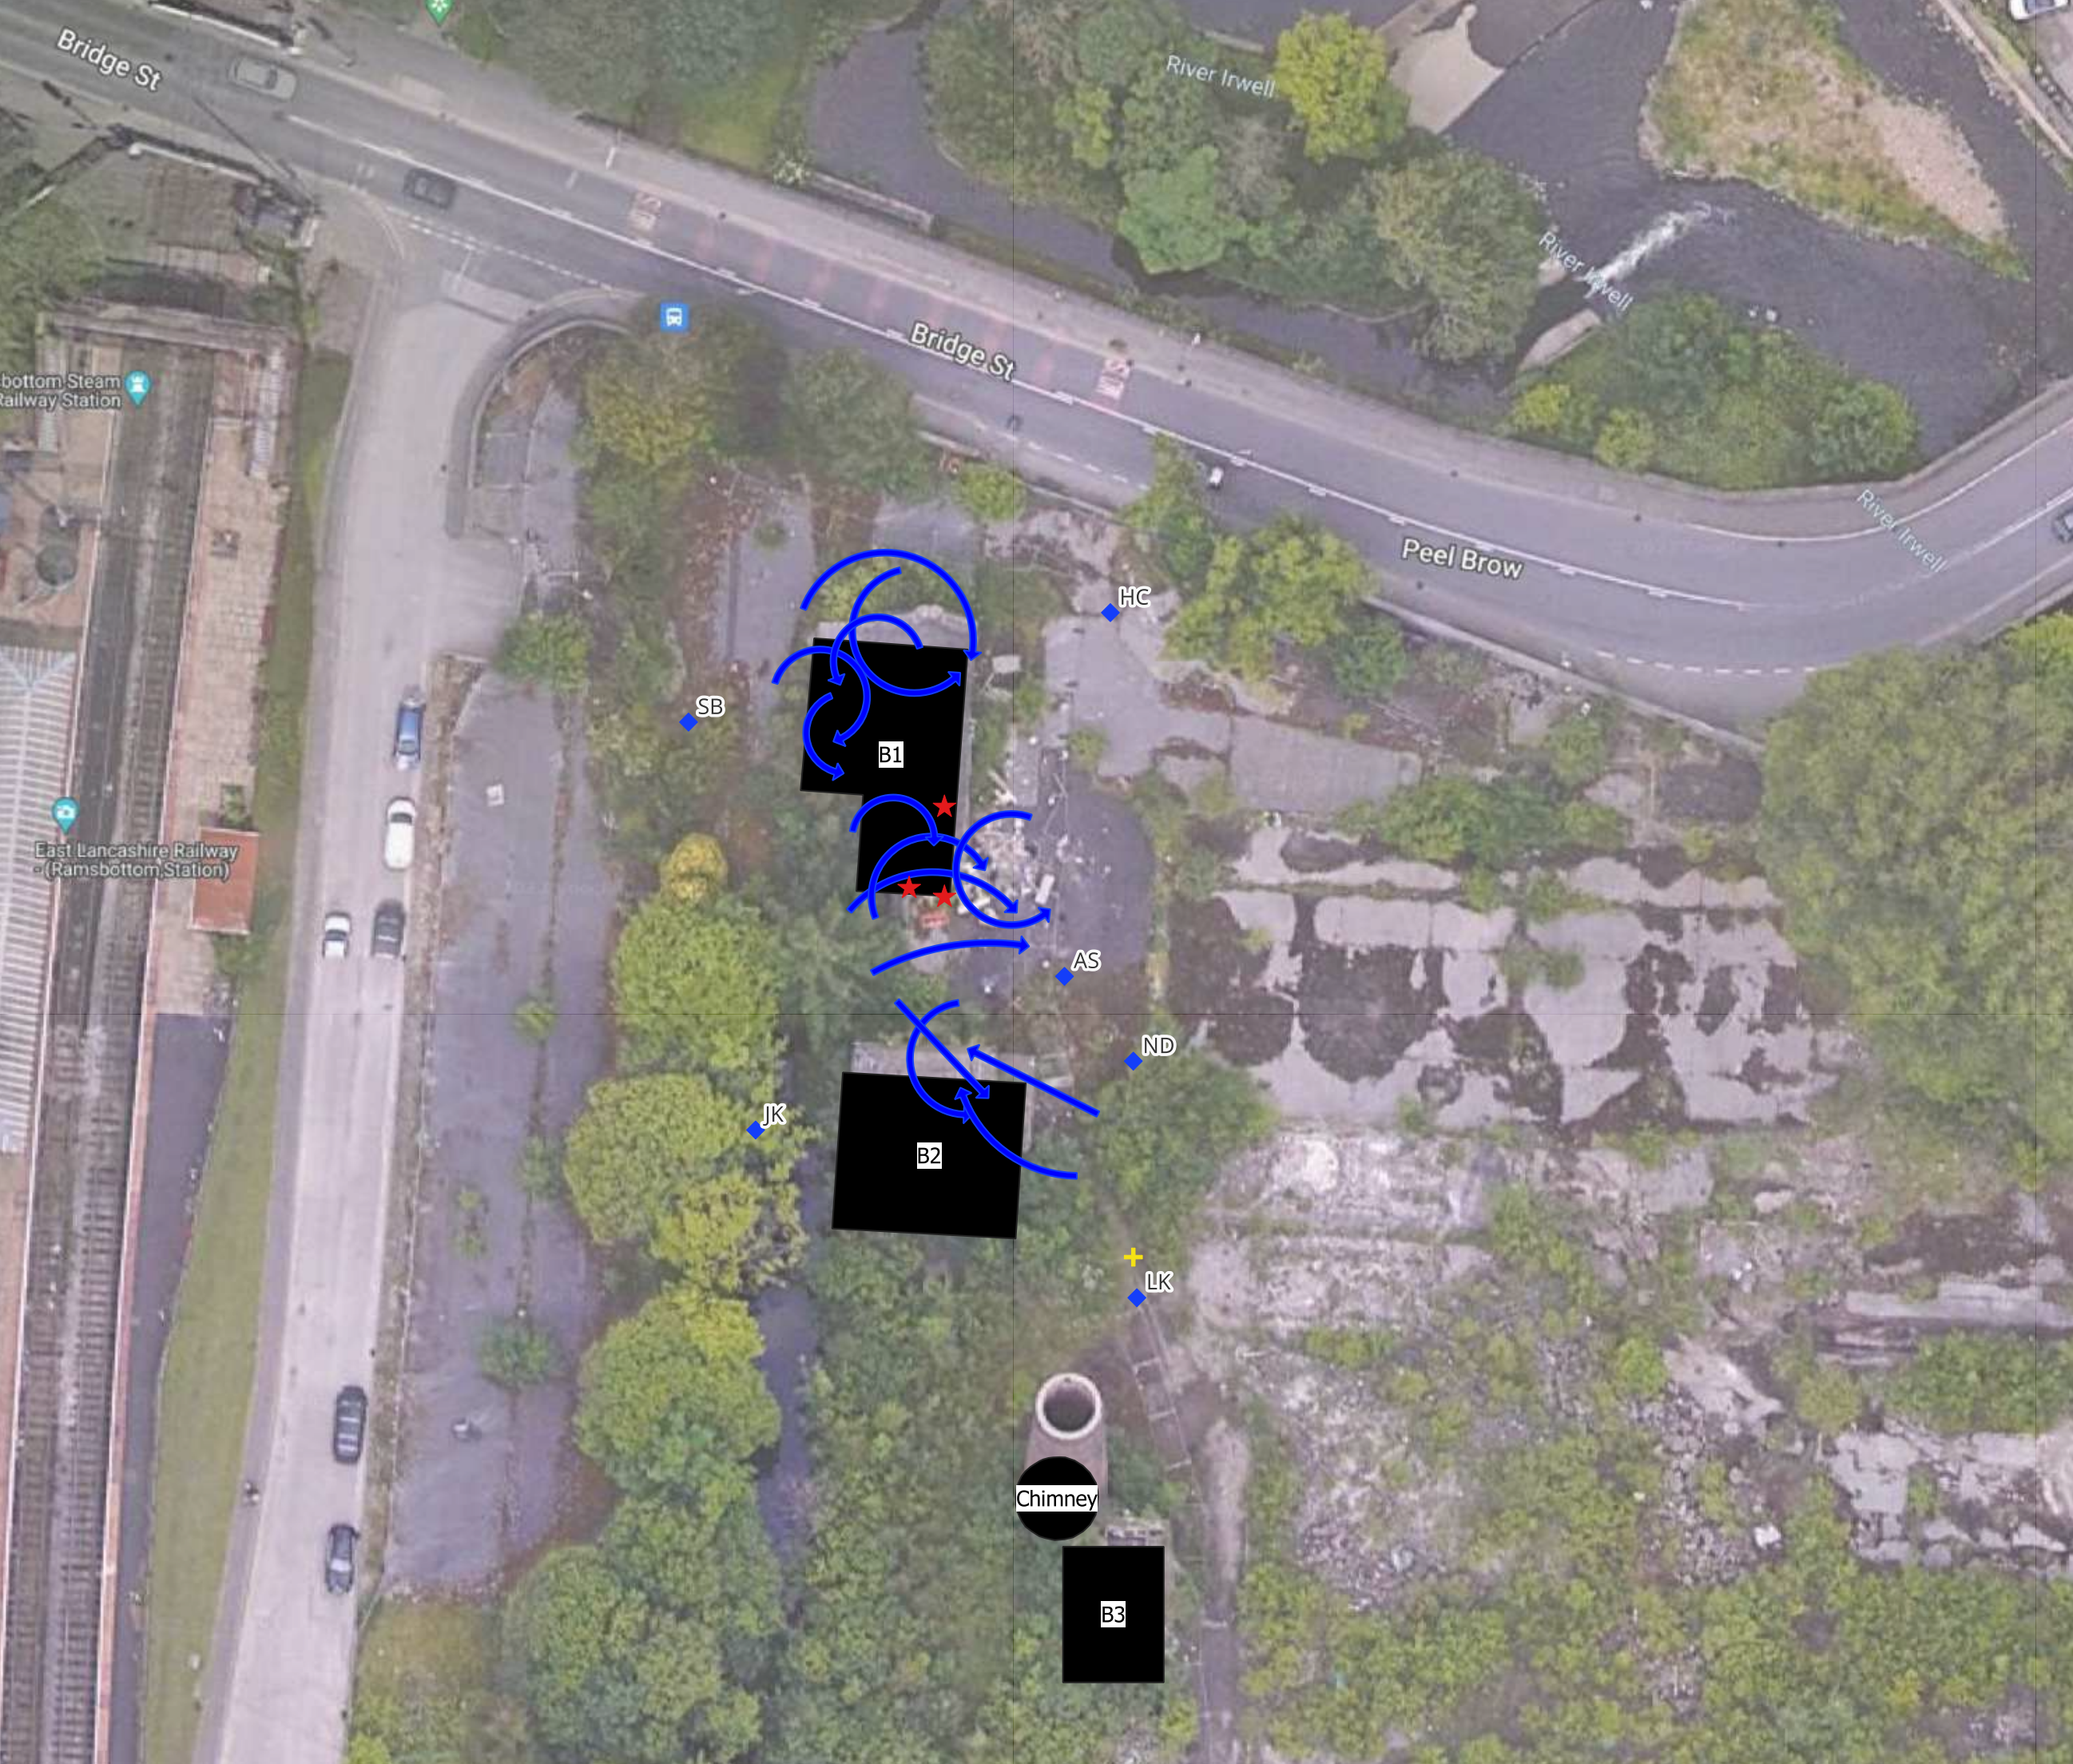
On 25<sup>th</sup> September 2023, bat activity commenced at surveyor Amy Swindells located to the southeastern corner of B1 with a heard but not seen foraging noctule at 19:26 (25 minutes after sunset). Throughout the survey, constant common pipistrelle foraging activity was recorded over the building and to the southern and eastern elevations. Up to three bats were noted to be present and social calling was also recorded.

At surveyor Niall Doherty, located to the north of building B2, activity commenced at 19:31 (30 minutes after sunset) with a commuting common pipistrelle bat flying from the east over the building. Two further commuting bats were recorded flying from the south and north over the site. A fourth heard but not seen bat was also noted. Common pipistrelles activity was recorded to the northeastern elevation of the building at 19:40.

- KEY
- Buildings
  - Surveyor locations 25.09.23
  - Camera location 25.09.23
  - Bat emergence point 25.09.23
  - Bat flight lines 25.09.23
