## Bat Nocturnal Surveys

Former Mondi Site (Site 1),  
Holcombe Mill, Bridge  
Street, Ramsbottom, BL0 0BS

Ref: P.1202.19

Date: June 2024

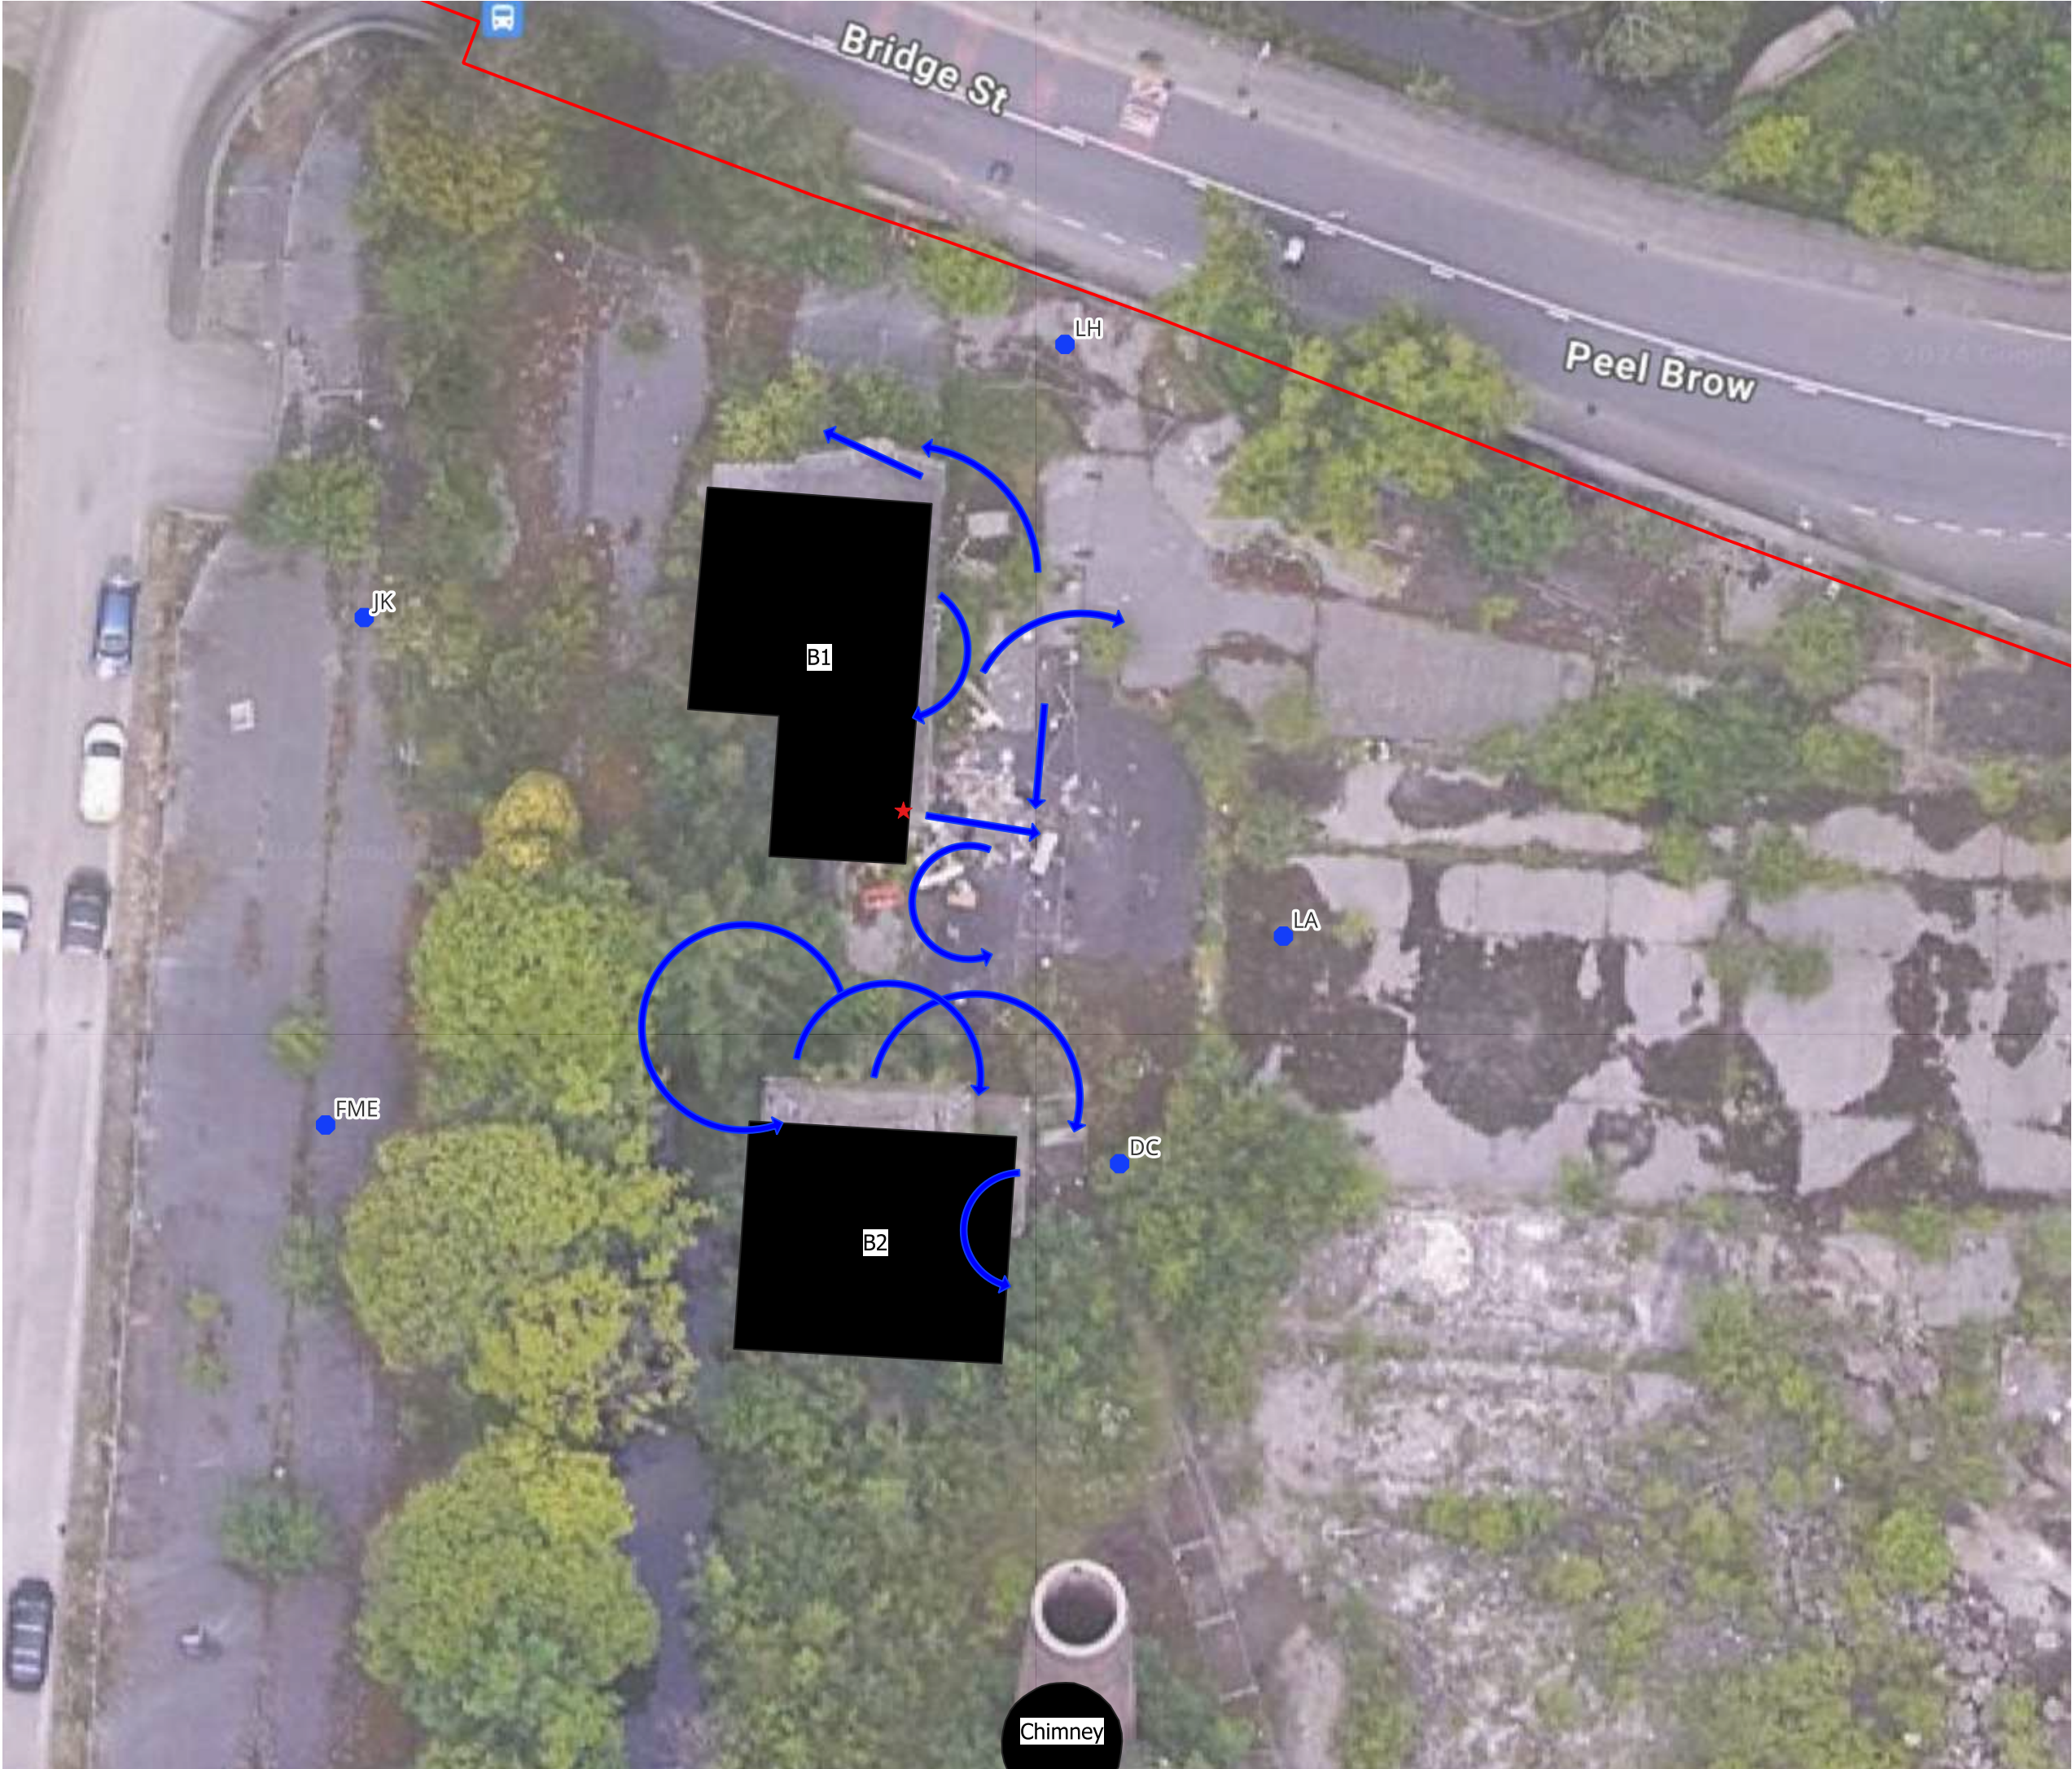
- Key
- Buildings
  - Bat flight lines 01.05.24
  - Emergence point 01.05.24
  - Surveyor locations 01.05.24

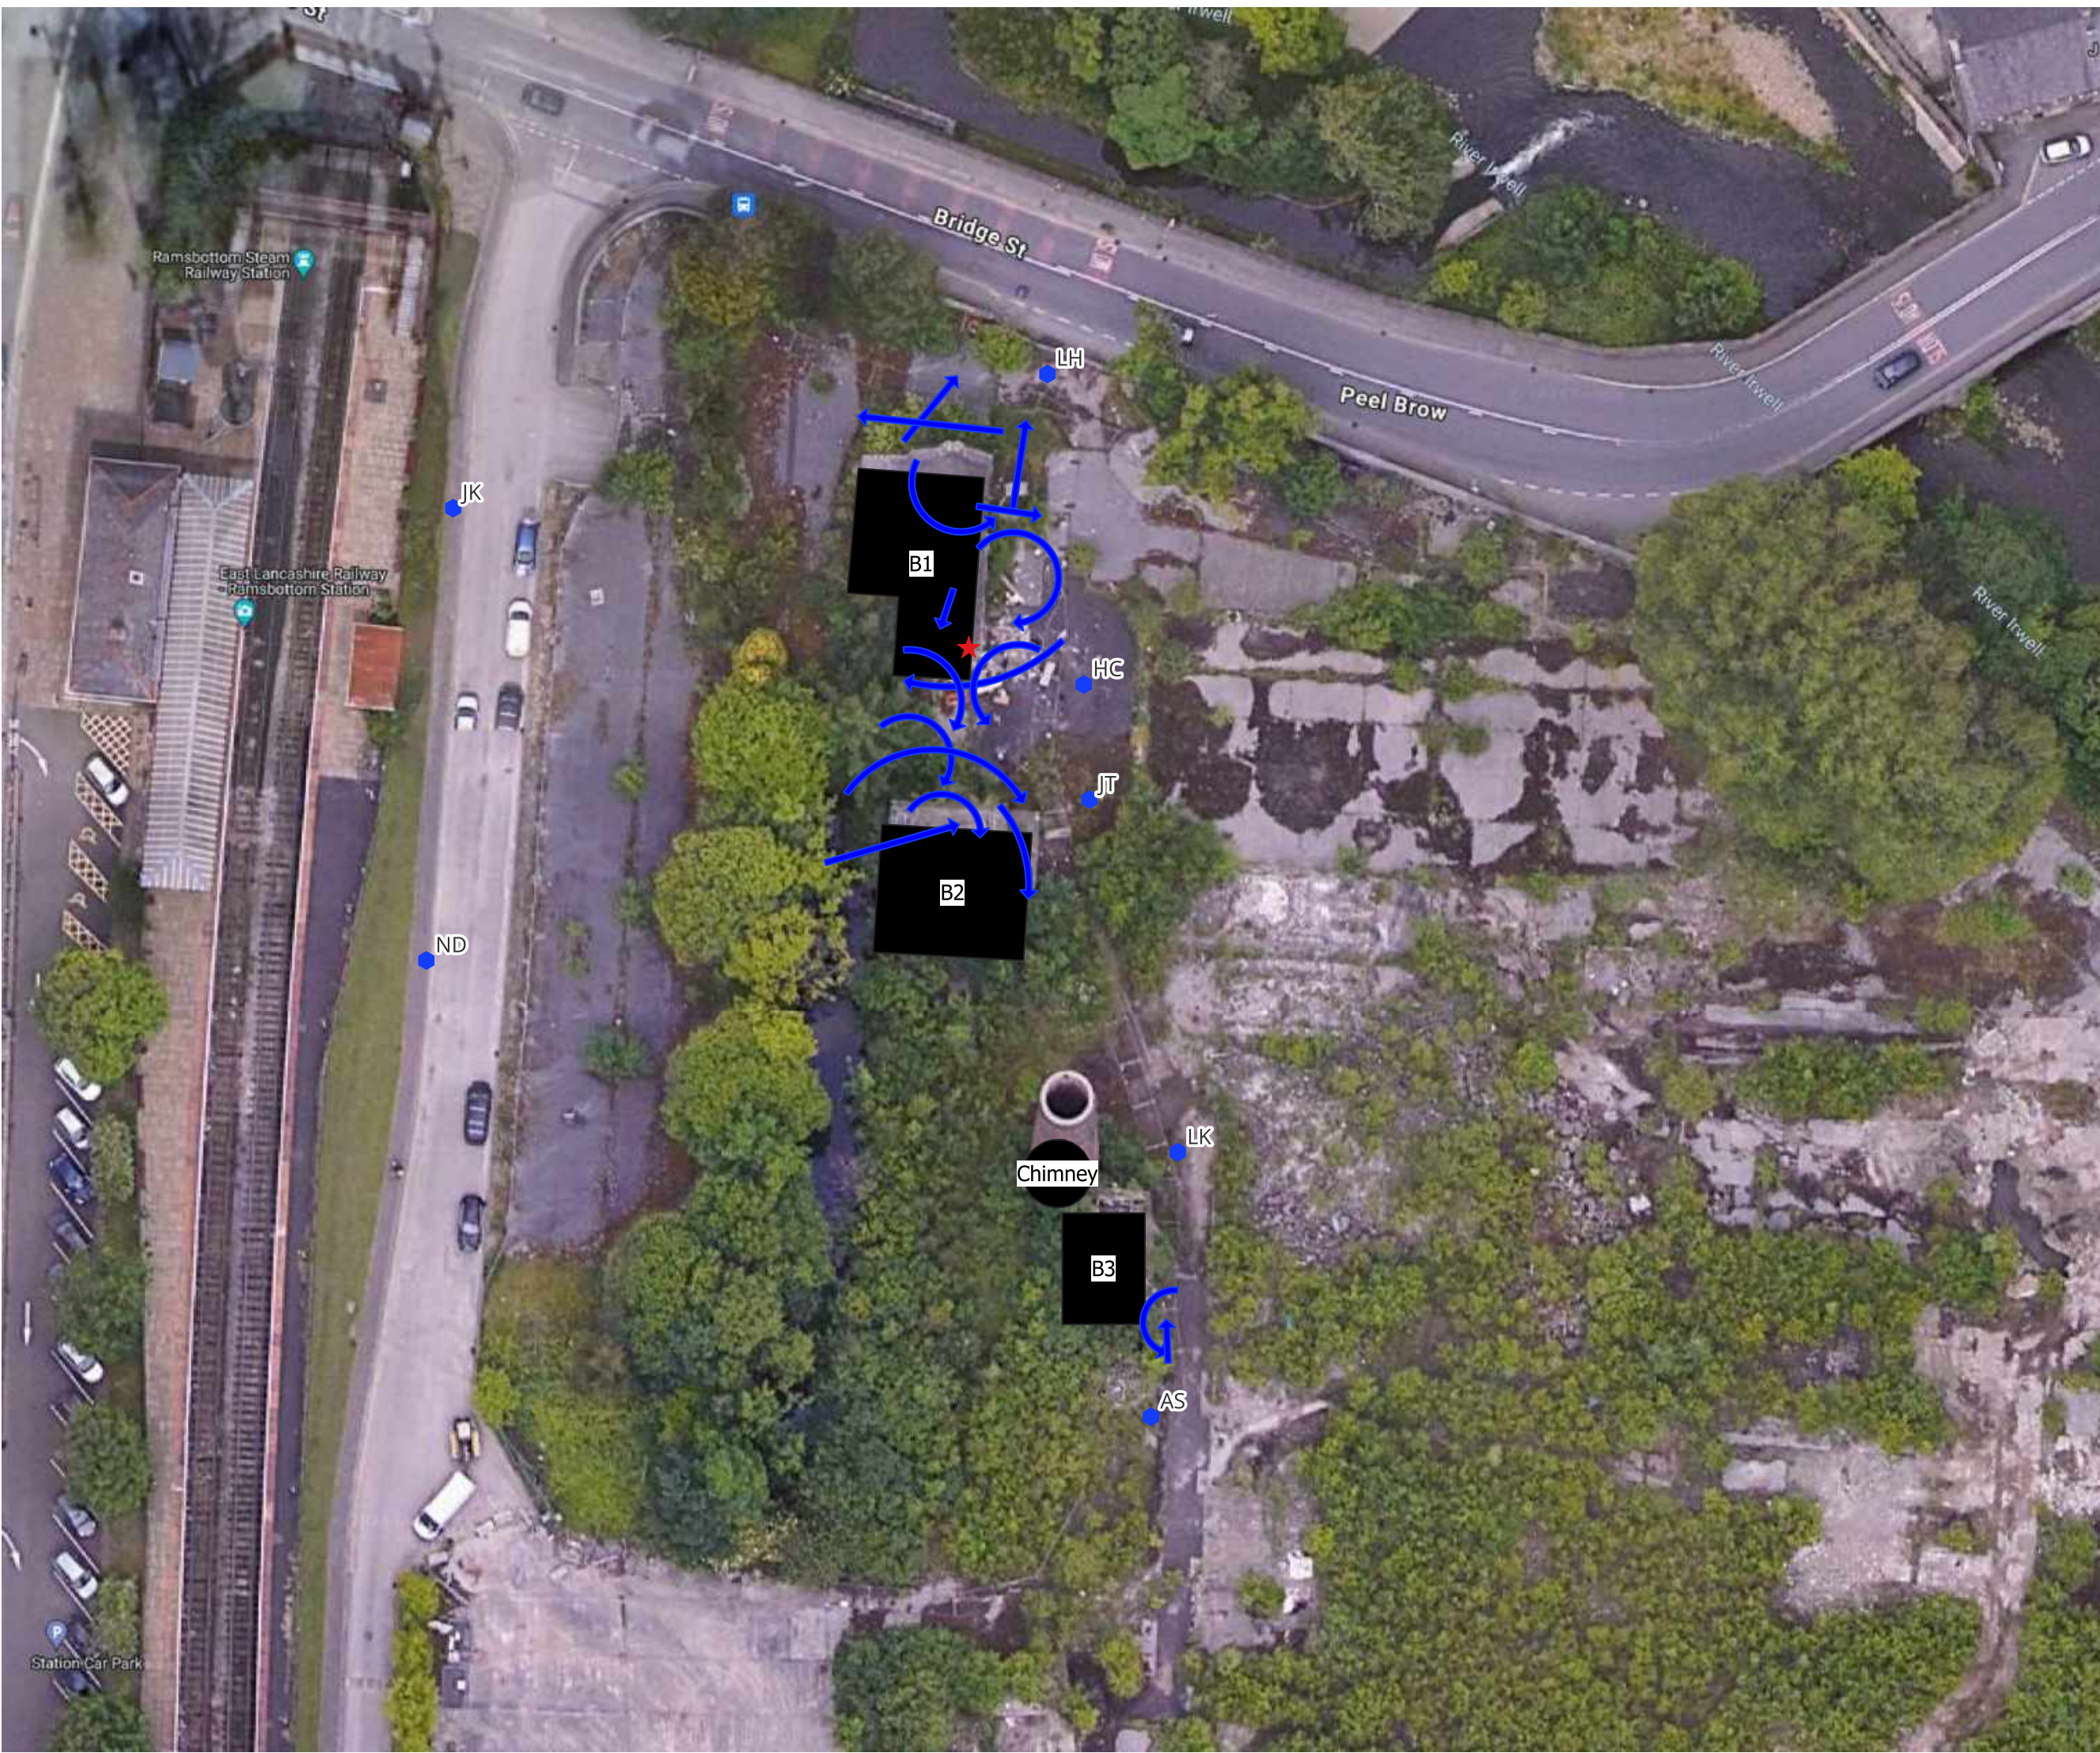
- buildings
- Emergence point 04.06.24
- Surveyor position 04.06.24
- Bat flight lines 04.06.24

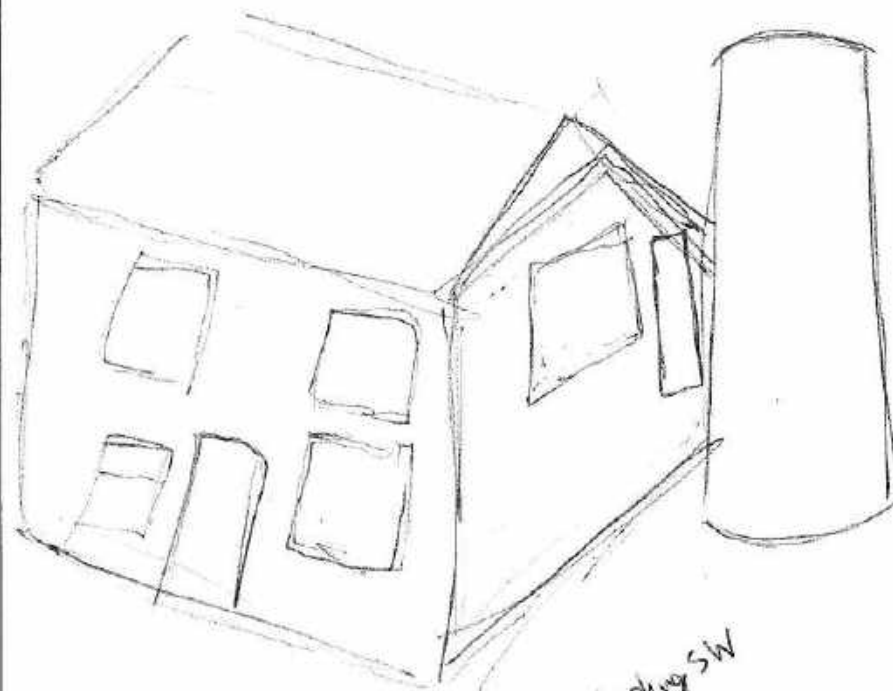
I'm looking SW at the building

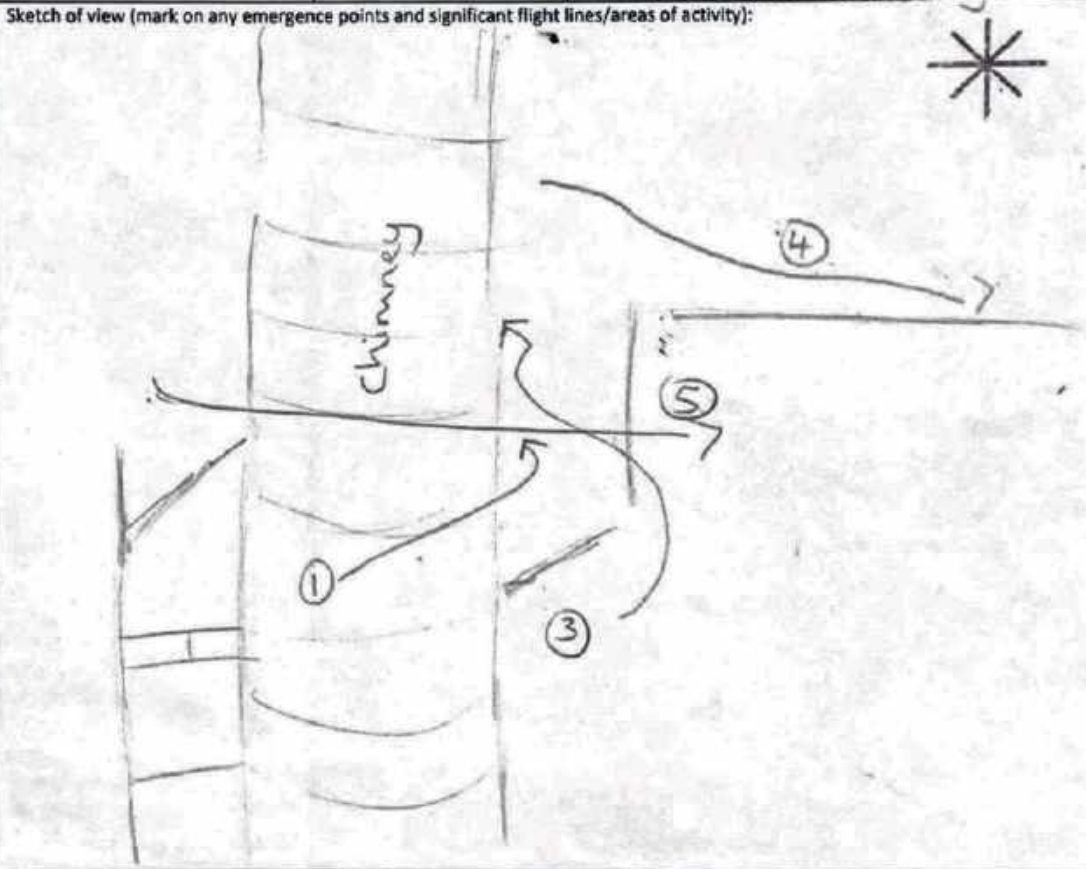
5.55 - finish - right side of chimney

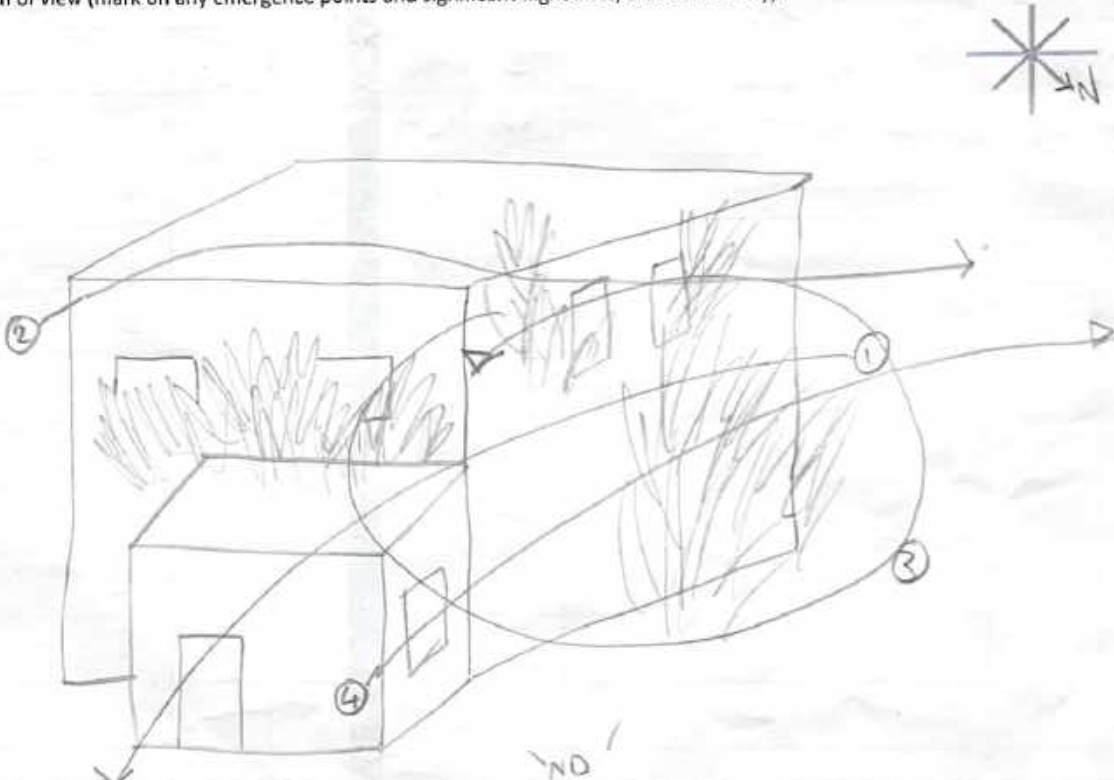
At surveyor Niall Doherty, located to the north of building B2, activity commenced at 19:31 (30 minutes after sunset) with a commuting common pipistrelle bat flying from the east over the building. Two further commuting bats were recorded flying from the south and north over the site. A fourth heard but not seen bat was also noted. Common pipistrelles activity was recorded to the northeastern elevation of the building at 19:40.
