**Cygnnet Hospital Bury, Bury**

**BAT REPORT**

Report Reference Number: FE566/BAT01

November 2025

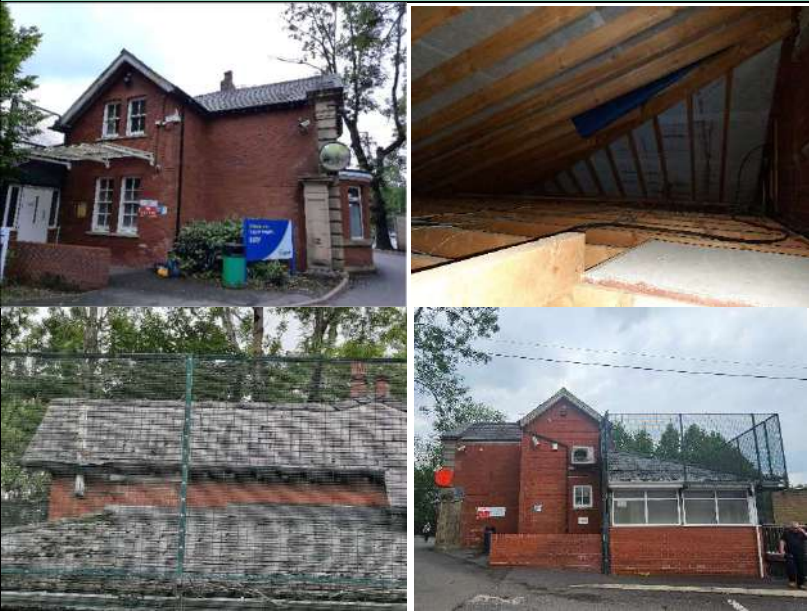
| Building Reference Number | Building External Description / Potential Access Points / Evidence of Occupation | Building Internal Description / Potential Roost Features / Evidence of Occupation | Roost Potential Classification: Negligible, Low, Moderate, High or Confirmed Roost | Building Photographs |
|---|---|---|---|---|
| B1 | <p><b>Description:</b><br/>Brick building with pitched tiled roof and a mono pitched, single storey section on the eastern aspect.</p> <p><b>Potential roost Feature and Access Points:</b><br/>Minor gaps under ridge tiles<br/>A couple of lifted roof tiles<br/>Lifted flashing associated with the chimney stack<br/>Minor gap under fascia on northern aspect of south facing gable</p> <p><b>Evidence:</b> No evidence of bat occupation.</p> | <p>Roof void of second storey not accessible.<br/>No obvious access points externally visible.</p> <p>Roof void of first storey eastern aspect lined with internal beams exposed, no evidence of a bat roost.</p> | <p>Low but main roof void inaccessible so increased to <b>Moderate.</b></p> | |

- 4.4 B1 provided moderate bat roosting potential, so was surveyed twice during the 2025 survey season to ascertain the presence / likely absence of a roost. No bats were observed emerging from the onsite building and therefore roosting bats do not pose a constraint to the demolition of the building.
- 4.5 Due to the transitional nature of bats roosts the bat nocturnal survey data will be valid for a period of one year. Thus, should the demolition works be undertaken after the 31<sup>st</sup> July 2026, an updated nocturnal survey would be required.
- 4.6 As an enhancement, it is recommended that a bat box is installed on a retained building or tree within the wider hospital area to provide alternative roosting opportunities for the local bat population. This should be installed at least 4m high on a south facing aspect and positioned away from artificial lighting.

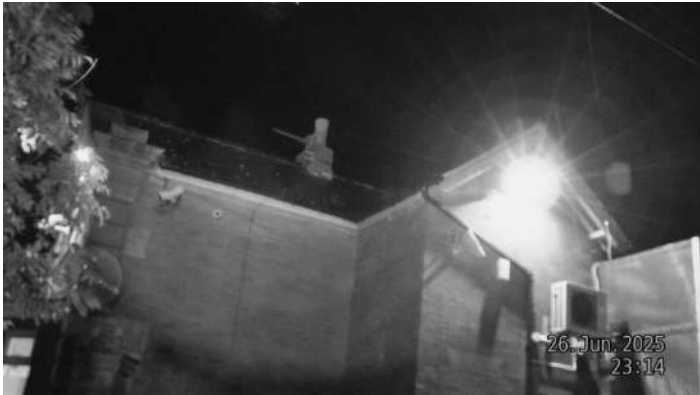
| Date | Surveyor & Reference | NVA Screenshot at the end of the survey |
|---|---|---|
| 26.06.2025 | A. French<br>Assistant Ecologist<br>Position 2 | A black and white night vision image showing a building with a bright light source on the right side, creating a large glare. The timestamp '26. Jun. 2025 23:14' is visible in the bottom right corner. |

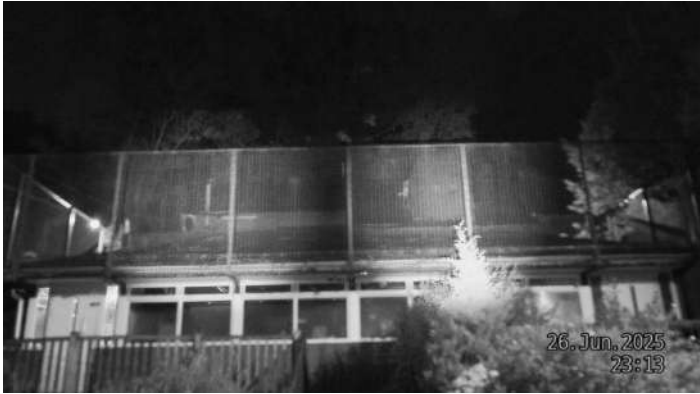
| Date | Surveyor & Reference | NVA Screenshot at the end of the survey |
|---|---|---|
| 26.06.2025 | J. Ginn<br>Assistant Ecologist<br>Position 3 | A black and white night vision image showing a building with a bright light source on the right side, creating a large glare. The timestamp '26. Jun. 2025 23:13' is visible in the bottom right corner. |

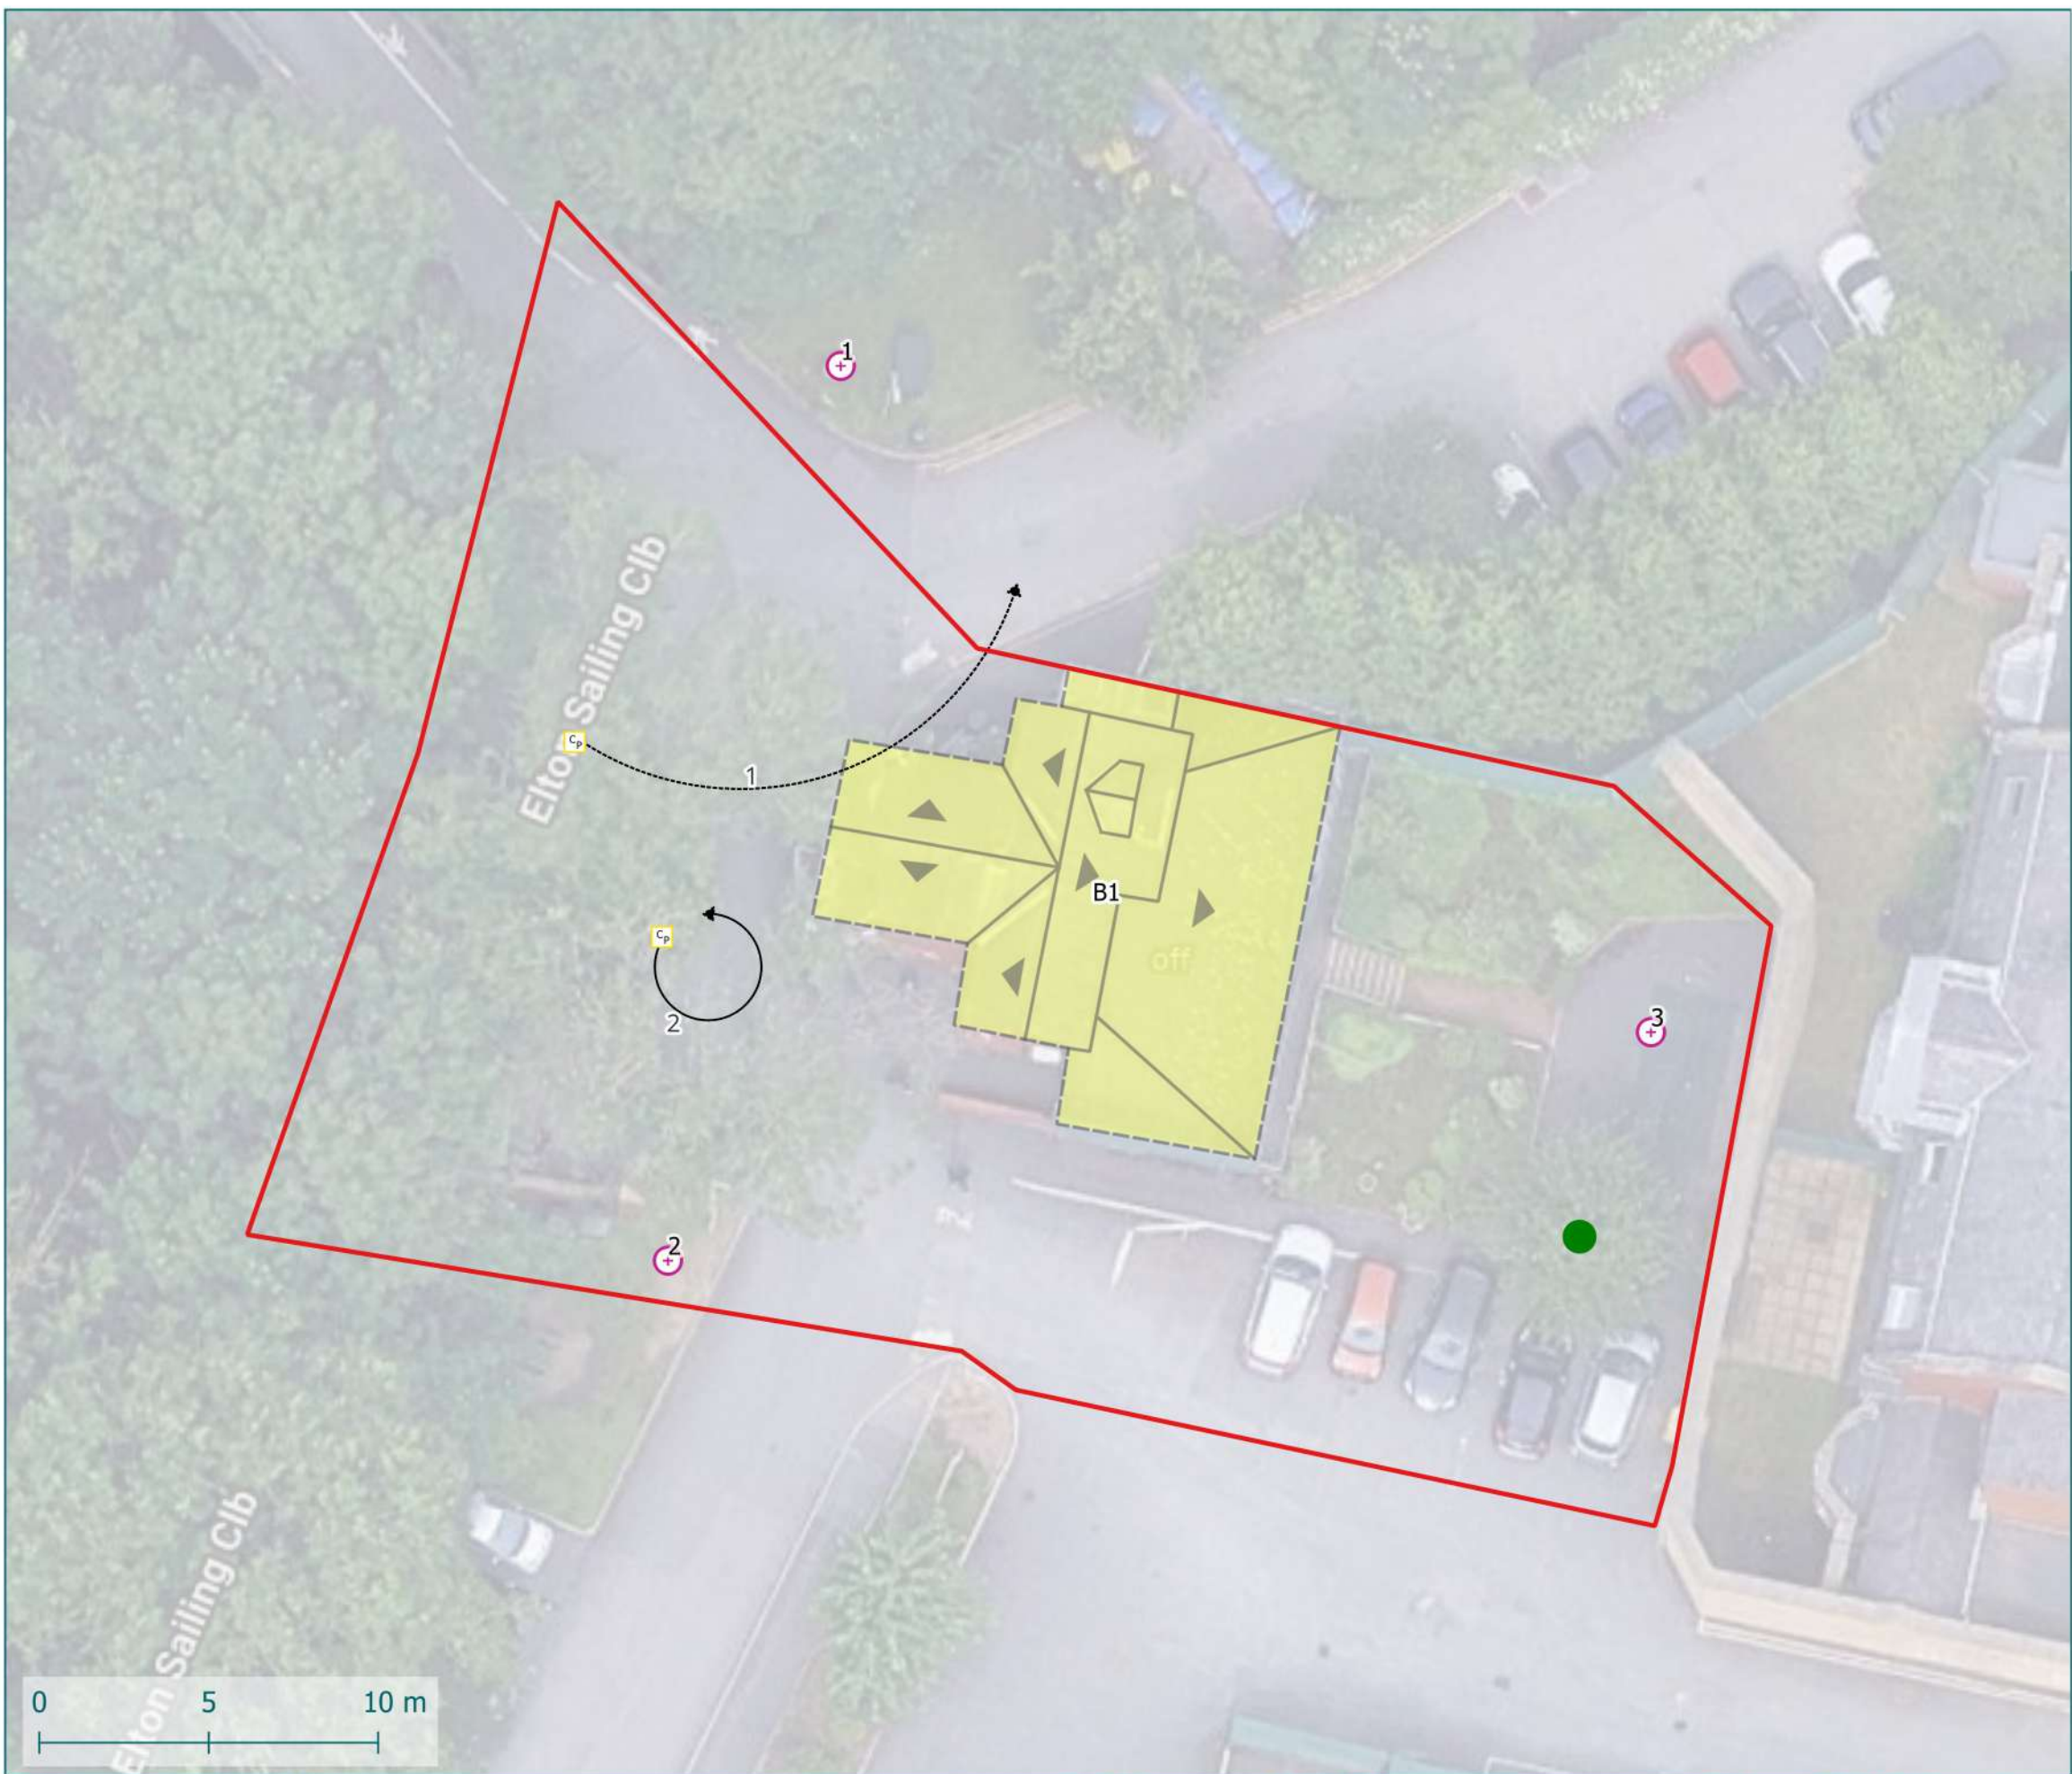
Client: Cygnet Health Care  
Project: Cygnet Hospital Bury, Bury, BL8 2BS  
Title: Figure 1 - Bat Emergence Survey Plan (26.06.2025)

- 3.6 The survey began at 21:28 and finished at 23:13. The first bat detected was a commuting common pipistrelle at 21:53, 25 minutes after sunset. This bat was not visually identified and is likely to have been commuting outside the observed area. Occasional common pipistrelle commuting activity was observed visually and non-visually after this point.
- 3.7 No bats were observed emerging or re-entering any part of the building on this survey.

#### **Bat Nocturnal Emergence Survey – 26.06.2025 (Figure 1)**

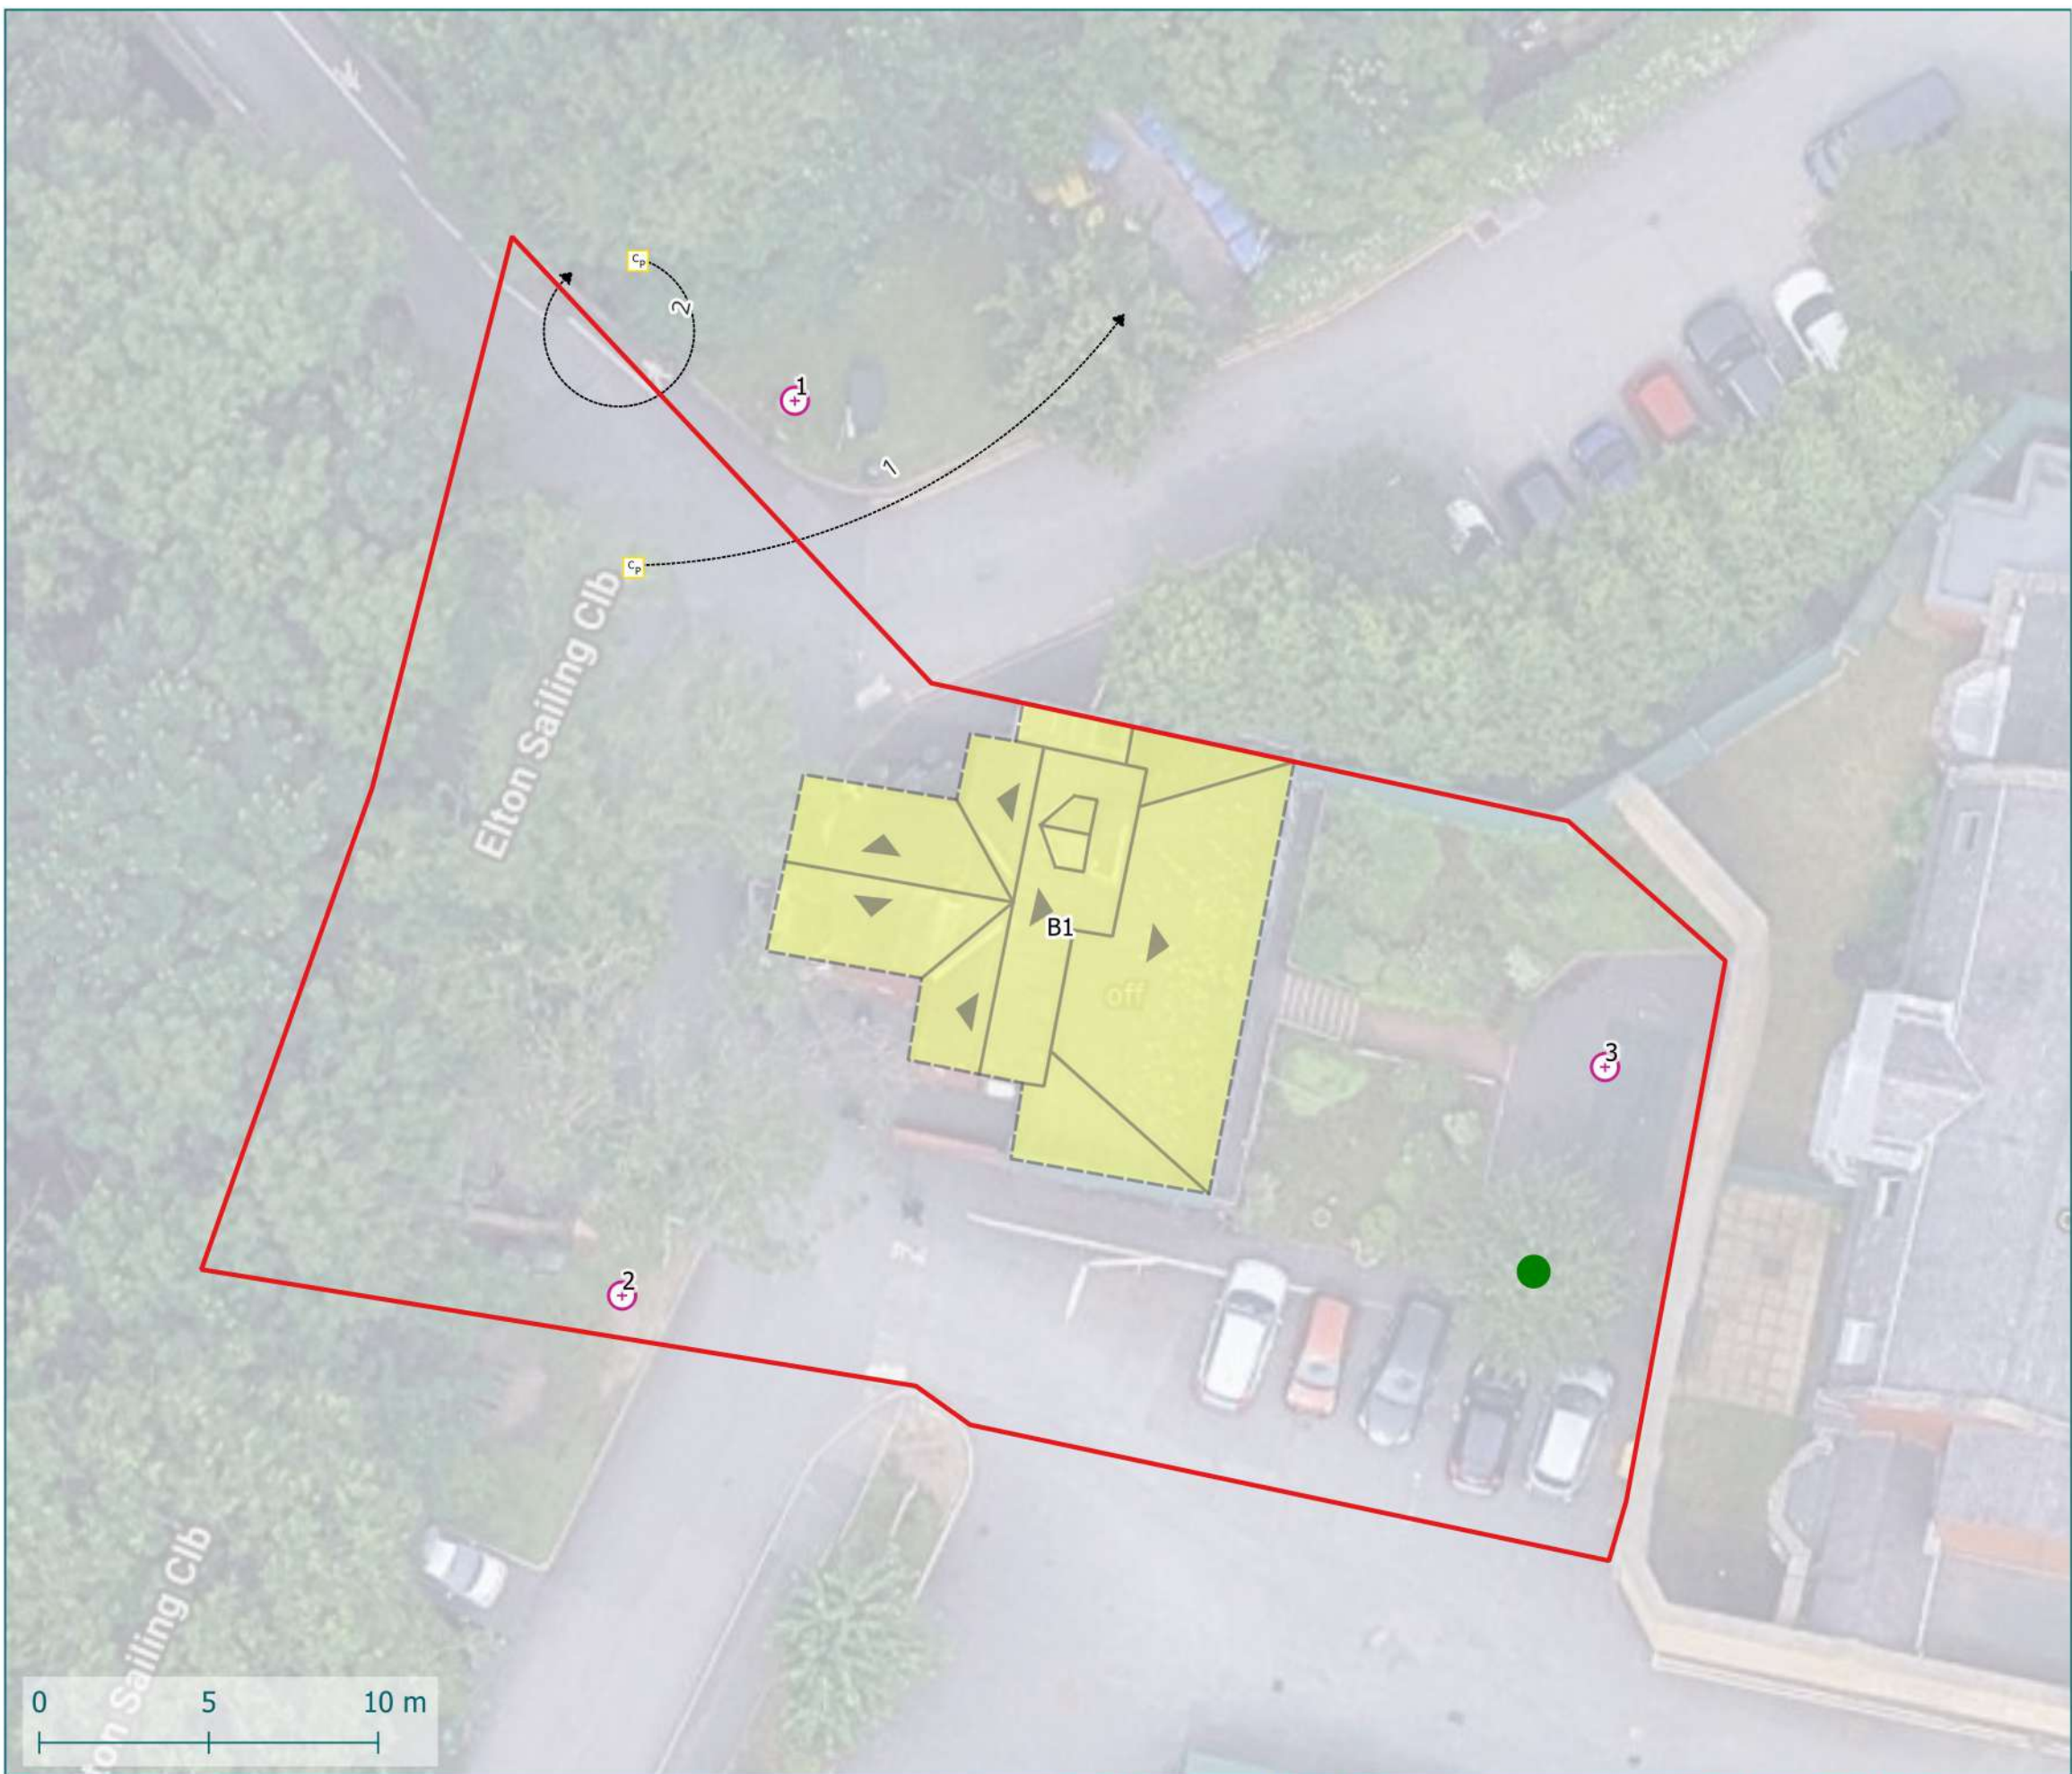
Client: Cygnet Health Care  
Project: Cygnet Hospital Bury, Bury, BL8 2BS  
Title: Figure 2 - Bat Emergence Survey Plan (31.07.25)

- 3.8 The survey began at 20:53 and finished at 22:38. The first bat detected was a noctule at 21:34, 41 minutes after sunset. This bat was visually identified, and was flying high over the site. Common pipistrelles commuting out of the observed area made up the majority of activity detected on this survey, with some foraging within the woodland offsite.
- 3.9 No bats were observed emerging or re-entering any part of the building on this survey.

#### **Bat Nocturnal Emergence Survey – 31.07.2025 (Figure 2)**
