## Phase 1 Preliminary Risk Assessment

25 September 2023

Land adjacent to 26 Wheatfield Close, Bury, BL9 6XD

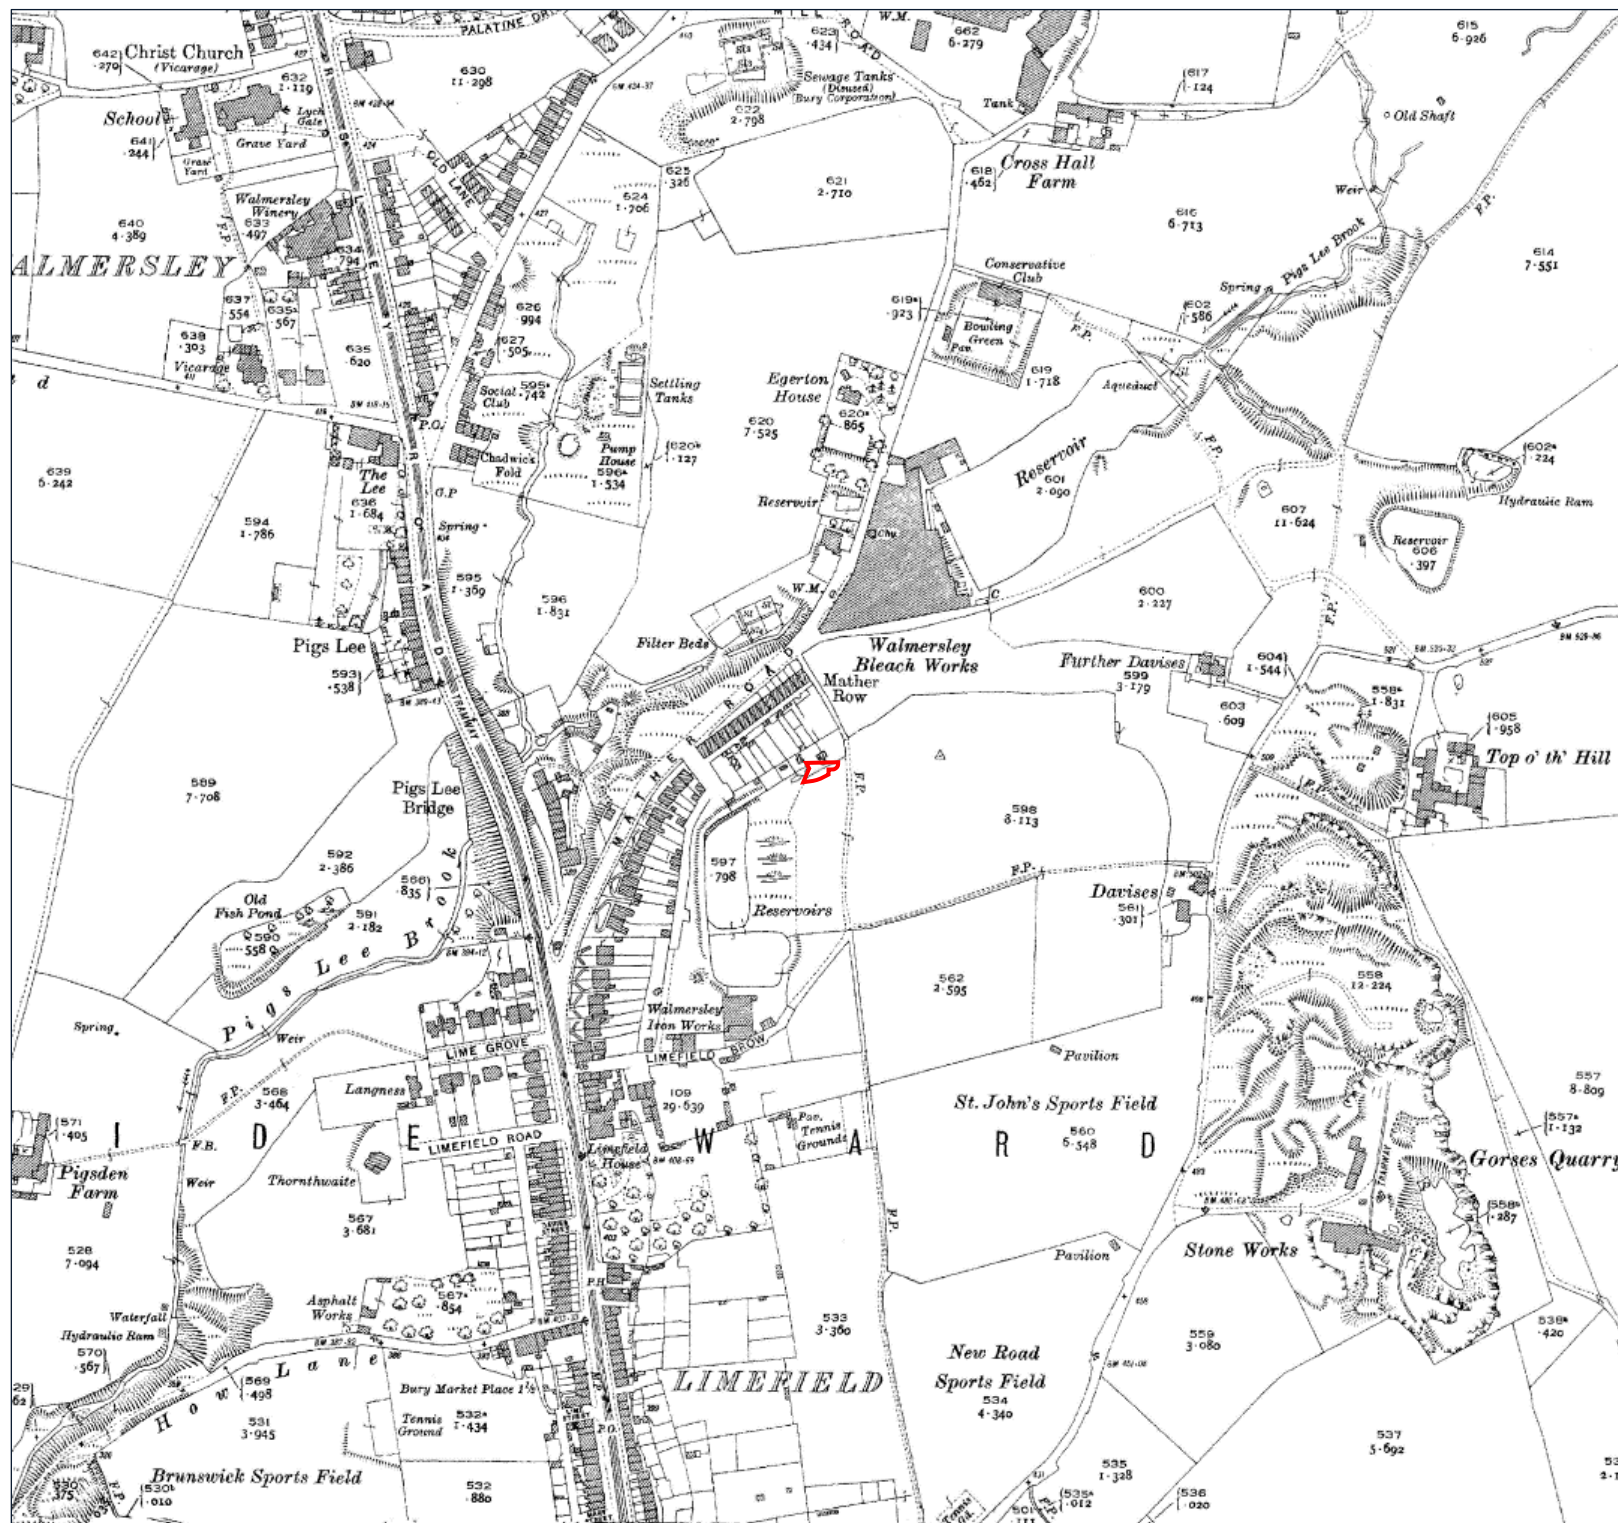
| Appendix – Historical Maps | |
|---|---|
| Historical map dated 1930 | |

| Year | Site Description | Surrounding Area |
|---|---|---|
| 1930 | | <p>Reservoir bordering the site to the south west partially infilled and land bordering the site shown as marshland</p> <p>Cotton Mills to the west removed and redeveloped to semi-detached dwellings and gardens</p> <p>Walmersley Bleach &amp; Dye Works now labelled as Walmersley Bleach Works</p> <p>Walmersley Iron Works 120m south</p> <p>Stone Works at Gorses Quarry 400m south east</p> |

Historical maps show that there was previously a reservoir bordering the site to the south west associated with a nearby cotton mill which had been partially infilled by 1930 and fully infilled by 1961. Where contaminated material has been used as infill, this may impact the site given its proximity to the infilled ground. In addition, where putrescible material has been used as infill, ground gases may be produced when these materials degrade. The land bordering the site was redeveloped to dwellings by 1985 suggesting that significant contamination in this area is unlikely. Furthermore, the significant time elapsed since this infilling occurred (>60 years) suggests that the risk of ground gas production is likely to be low.

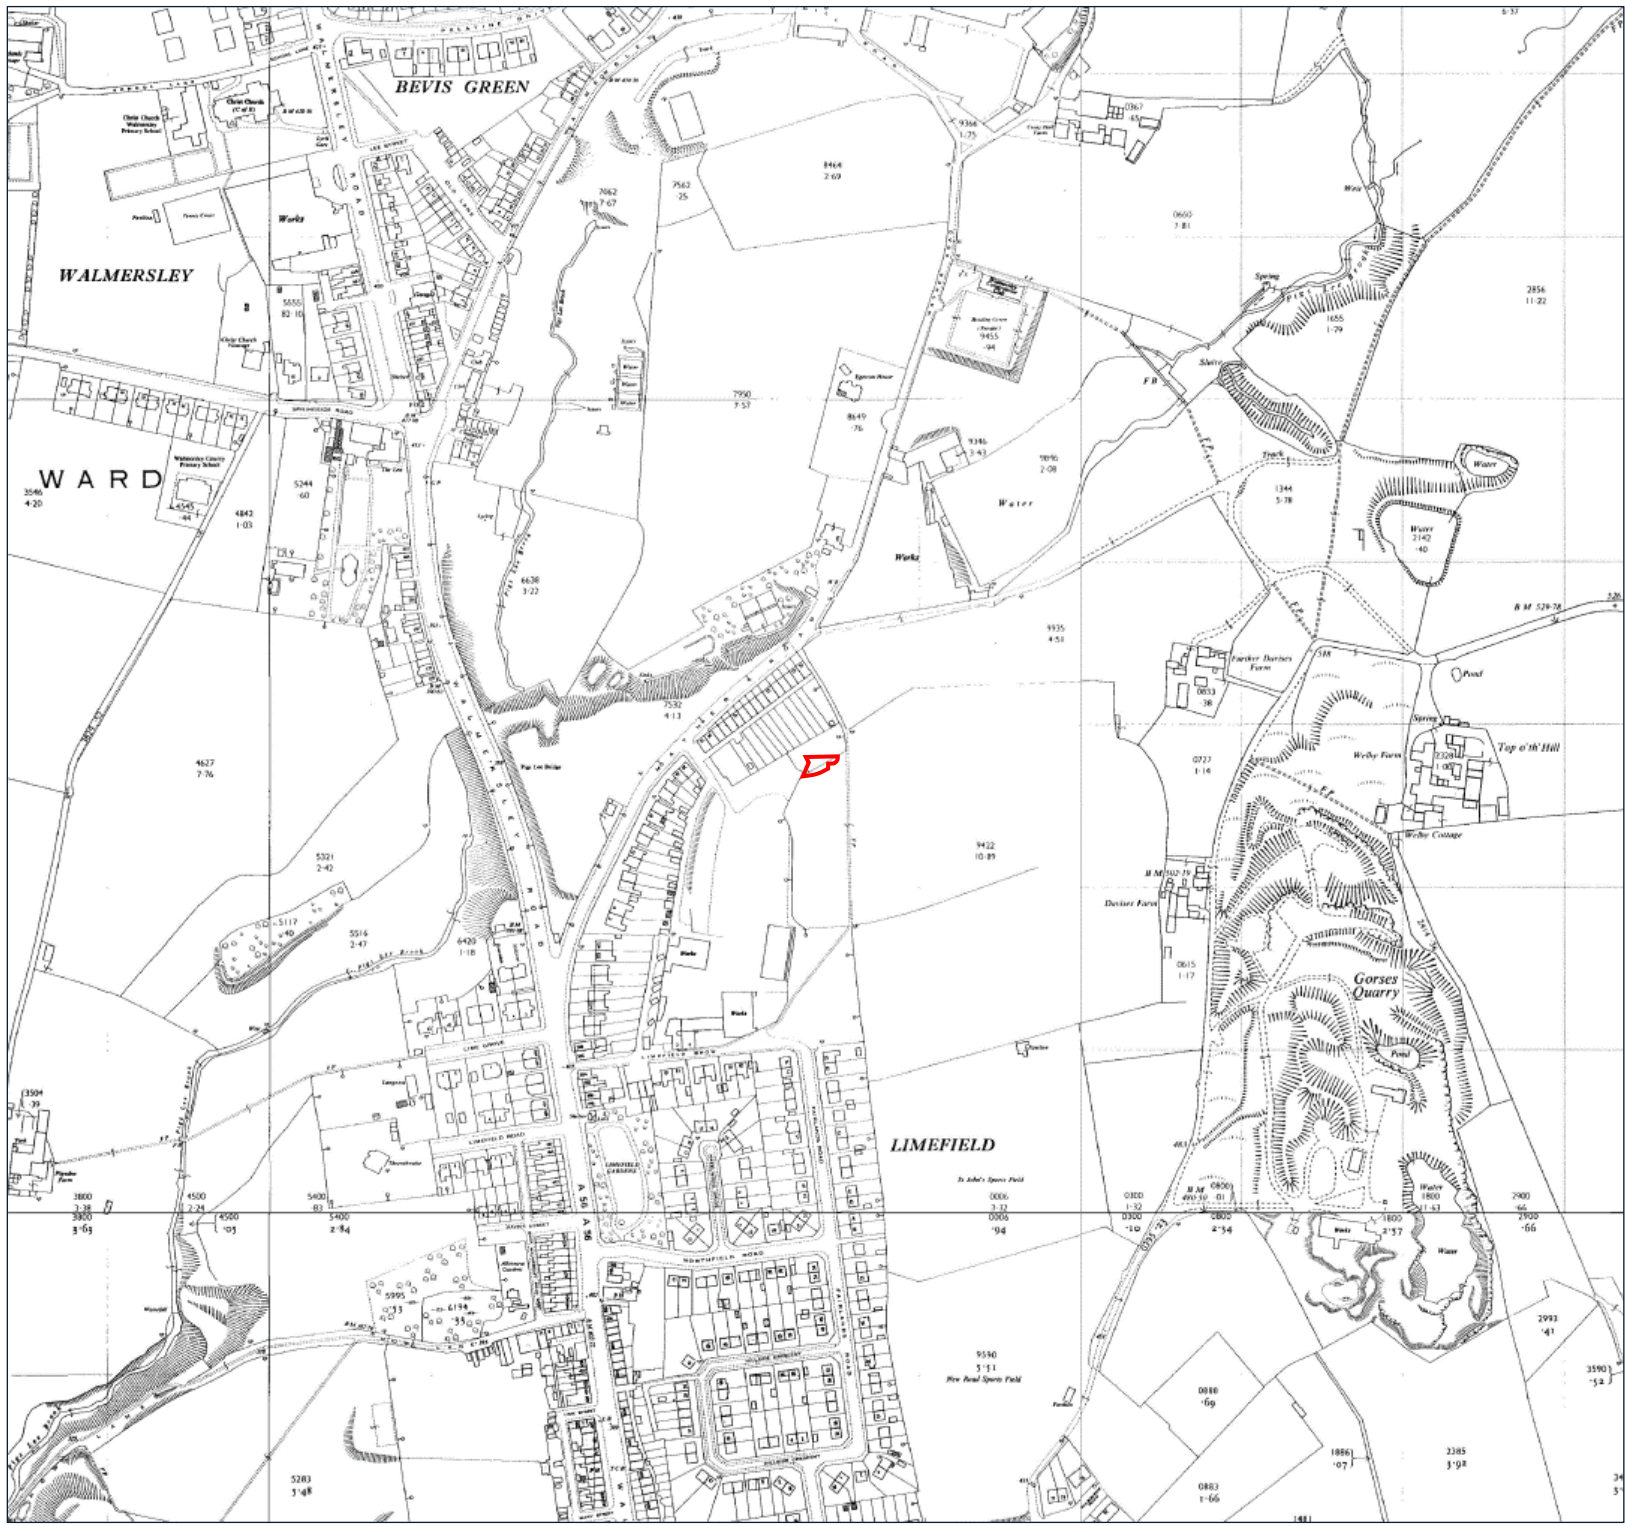
Historical map dated 1961 - 1963

| Year | Site Description | Surrounding Area |
|---|---|---|
| 1961<br>-<br>1963 | | <p>Reservoir to the south west fully infilled</p> <p>Walmersley Bleach &amp; Dye Works now labelled as Works</p> <p>Filter beds to the north no longer labelled</p> <p>Small reservoir to the north infilled</p> <p>Walmersley Iron Works to the south now labelled as Works along with another building 120m south west</p> <p>Significant residential development 170m south</p> |

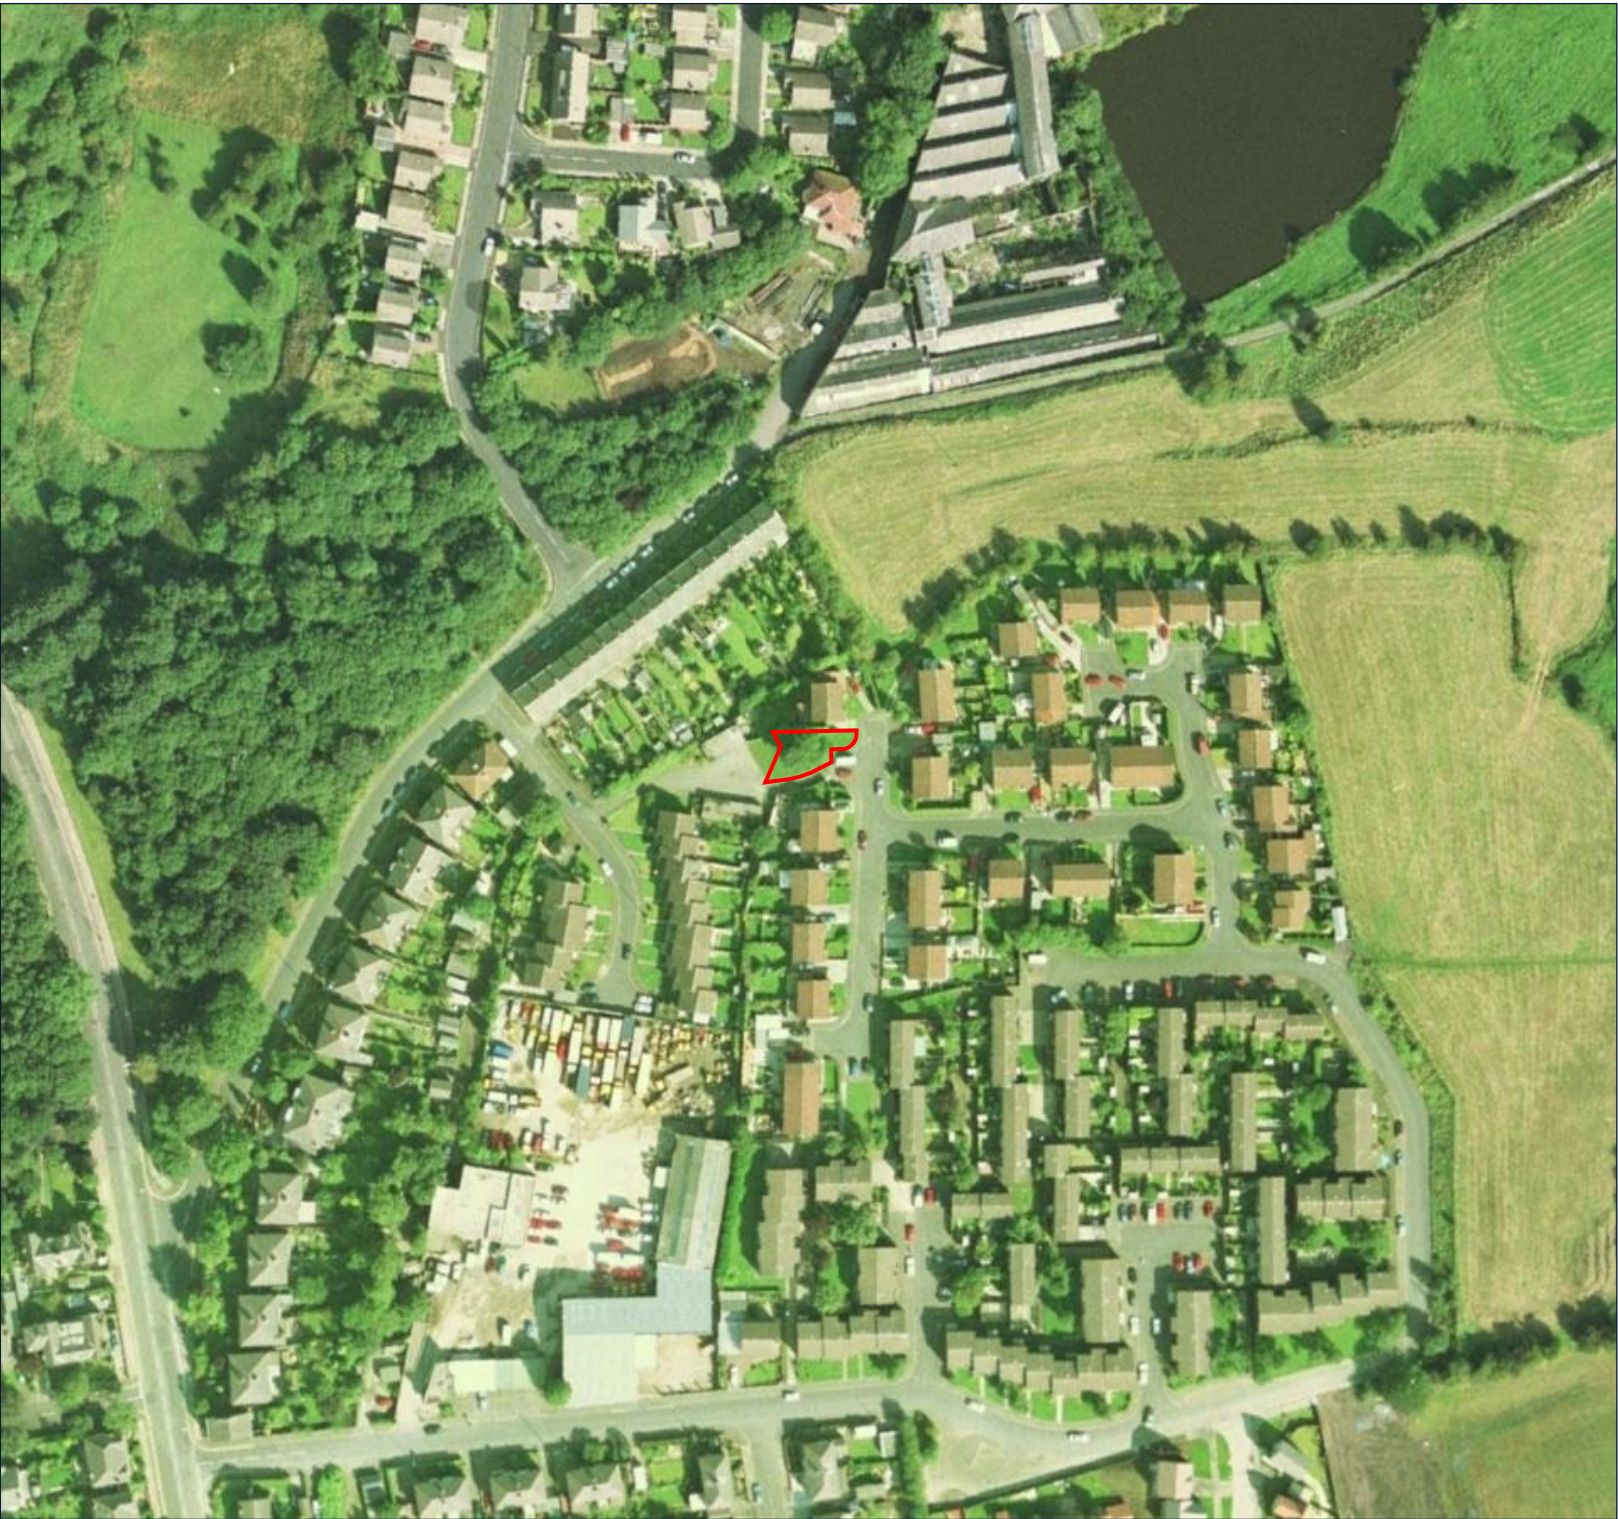
Aerial photograph dated 2000

| Year | Site Description | Surrounding Area |
|---|---|---|
| 2000 | Aerial photo shows that the site is covered by grass with a tree in the centre | Builder's yard with lorries and machinery stored |
