# Clough Farm, Prestwich Protected Species Survey

January 2026

**Dunelm Ecology**  
consultant ecologists

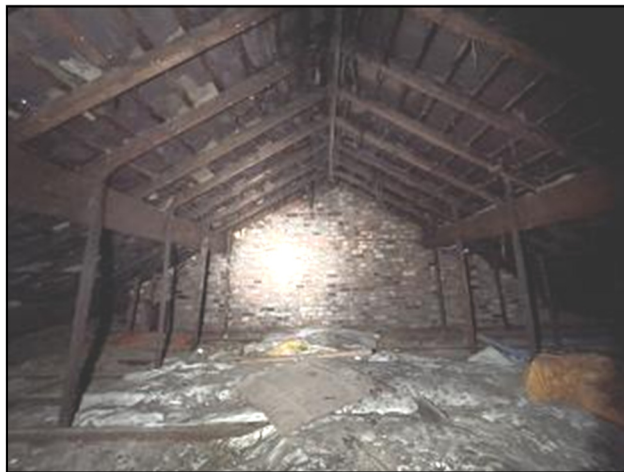
**Plate 1 Main roof void**

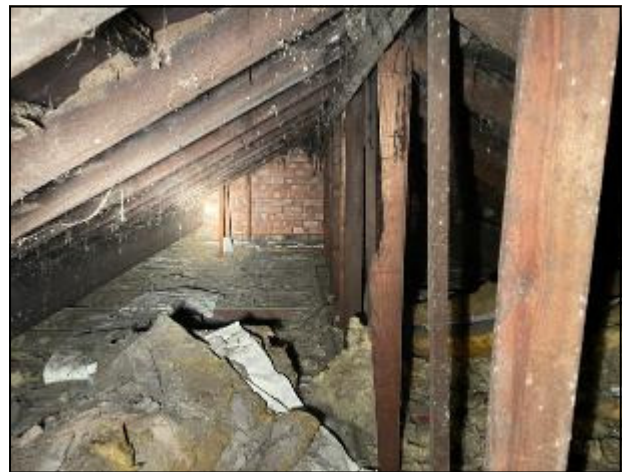
**Plate 2 Outtrigger roof void**

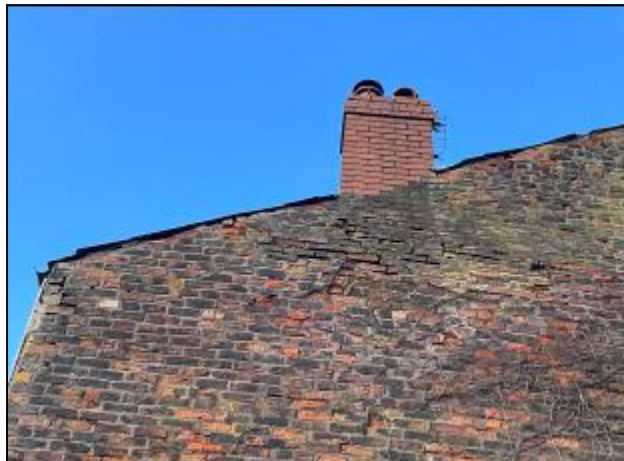
| Building ref | Building Description | Roosting Opportunities & Signs of Bat Use | Roost Potential |
|---|---|---|---|
| B1 | Detached former farmhouse dating from mid-late late 19 <sup>th</sup> century. Constructed from brick cavity walls (two elevations have been rendered) set under two pitched roofs clad with blue slate. The two roof voids are unlined and have floor to apex heights of 2.35 m and 1.45 m, while cobwebs are prevalent throughout. A single storey lean-to (most recently used as an outhouse) with a felt roof protrudes from the southeast elevation while the southeast outrigger gable wall has been rebuilt in the late 20 <sup>th</sup> /early 21 <sup>st</sup> century. Timber fascia boards are present on two elevations with uPVC fascias and soffits on the northwest gable wall. | No evidence of bats was recorded during the survey. The building is in poor condition with gaps recorded the main and outrigger gable end verges on the southeast elevation of the building. Gaps also exist behind timber fascia boards on the south and north sides of the building but the latter are completely cobwebbed indicating no current use by bats. Gaps exist under ridge tiles on the main and outrigger's roof. | Moderate |

**Plate 3 Gaps around verges at southeast gable**

- 4.1.2 Further survey effort in the form of two dusk emergence surveys is therefore recommended to give confidence in the initial negative survey result and to comply with best practice guidelines (Collins 2023). Such surveys can only be undertaken between May and August during suitable weather conditions i.e. warm (>10°C), light winds and dry, with at least three weeks between each survey.

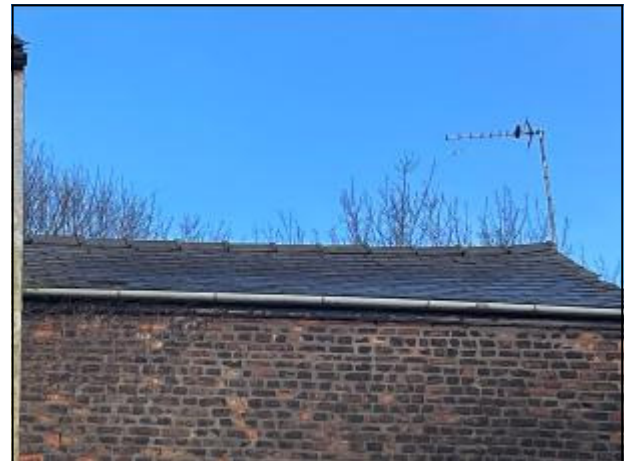
**Plate 4 Gaps exist under ridge tiles and fascia board**

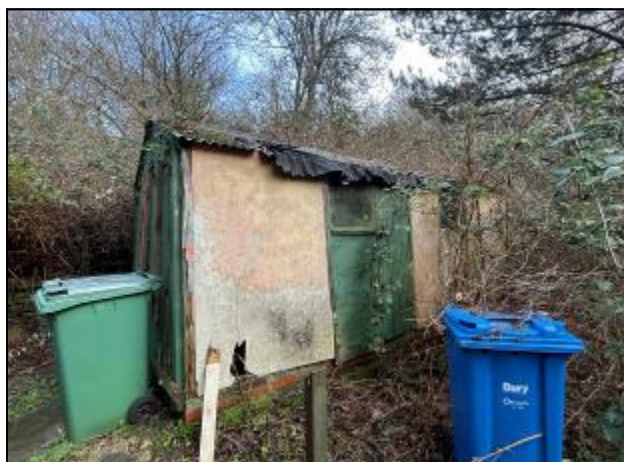
**Plate 5 B2**

| Building ref | Building Description | Roosting Opportunities & Signs of Bat Use | Roost Potential |
|---|---|---|---|
| B2 | Mid 20 <sup>th</sup> century garage/workshop with asbestos clad walls and roof (felt is also present on the roof). | No evidence of bats was recorded and no crevice roosting opportunities were identified. | Negligible |

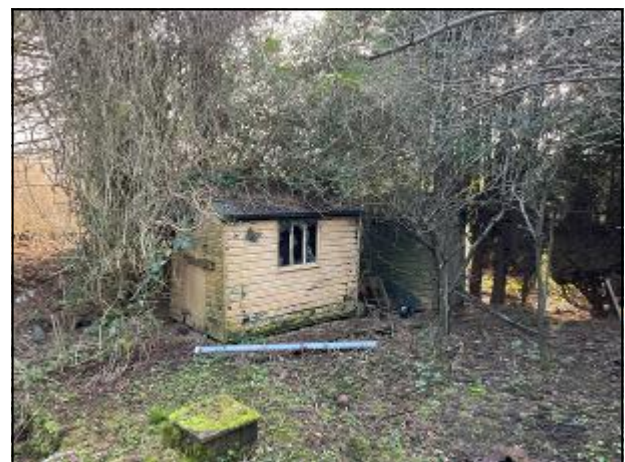
**Plate 6 B3 and B4**

| Building ref | Building Description | Roosting Opportunities & Signs of Bat Use | Roost Potential |
|---|---|---|---|
| B3 and B4 | Two small timber shed structures with pitched felt roofs | No evidence of bats was recorded and no crevice roosting opportunities were identified. | Negligible |
