**78 Church Street West,  
Radcliffe, Greater Manchester,  
M26 2SY**

**Preliminary Survey & Assessment  
in Respect of Bat Species, and Nesting Birds.**

**30<sup>th</sup> November 2023**

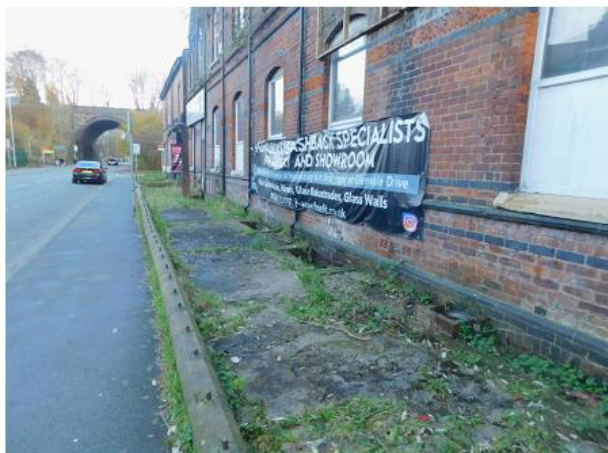
**PHOTO 5**  
**View Along Lower Northern Elevation**

- Positioned along the southern pavement of Church Steet West, adjacent to the main building's northern elevation, at floor level, were two large holes where cellar ventilation had once been, these vents had now been closed off, and offered no bat suitability, (refer to **figs 3, 4 and 5 and photos 5, and 8 to 10**).

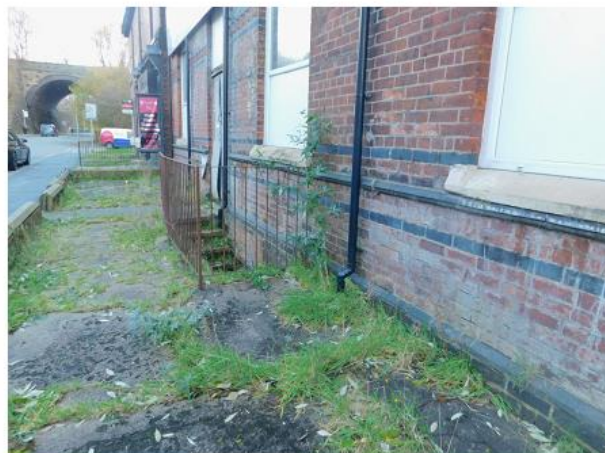
**PHOTO 6**  
**View of Closed Basement Entrance**

- There was an external fire escape connecting the cellar to Church Street West along the northern elevation of the main building, at some time this had been completely boarded up and now offered very low roosting suitability, (refer to **figs 3, 4 and 5 and photos 6 and 7**).

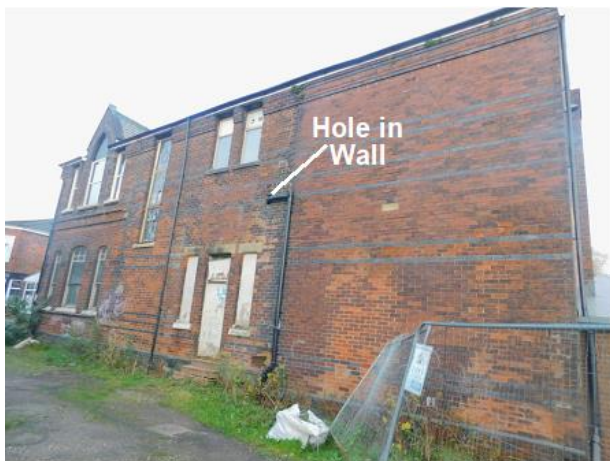
**PHOTO 19**  
**South-western Corner**

- High up on the western elevation, there was a hole in the wall where a drain pipe exited, however this hole was surveyed using close-focus binoculars, whilst the wall and floor beneath were surveyed by eye, but neither droppings, urine staining, or any other evidence of bat usage of the hole was found, (refer to **figs 3, 4 and 5** and **photo 19**).

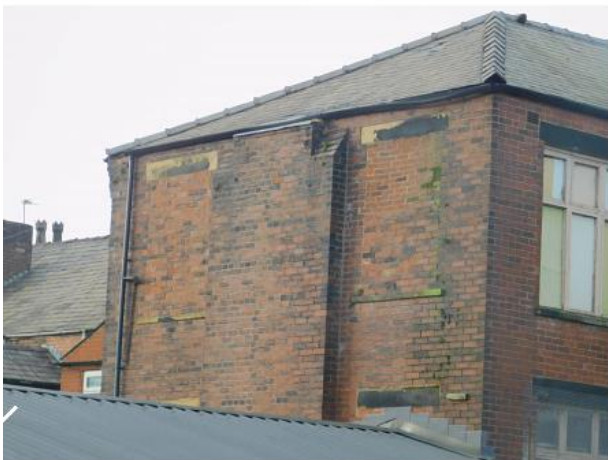
**PHOTO 33**  
**South-western Elevation of Main Building**

The building was in daily use as both a showroom and an office, and was fully heated and insulated, being well-maintained with sound brickwork, doors, roof and gables. As such it was judged to be of low bat roosting suitability, (refer to **figs 3, 4 and 5** and **photos 21 and 33**).

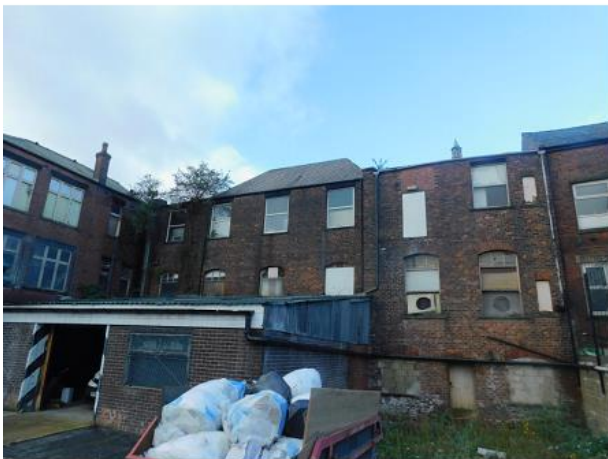
**PHOTO 35**  
**Southern Elevation of Main Building**

- Positioned at first floor level in the southern elevation was a hole in a window frame, where a ventilation fan had once been placed, and had now been removed, but after inspection of the remaining hole and the wall around it using close focus binoculars, the hole was found to be internally meshed, and therefore offered no potential bat access and therefore was of low suitability as a bat roost, (refer to **figs 3, 4 and 5** and **photos 35 and 41**).

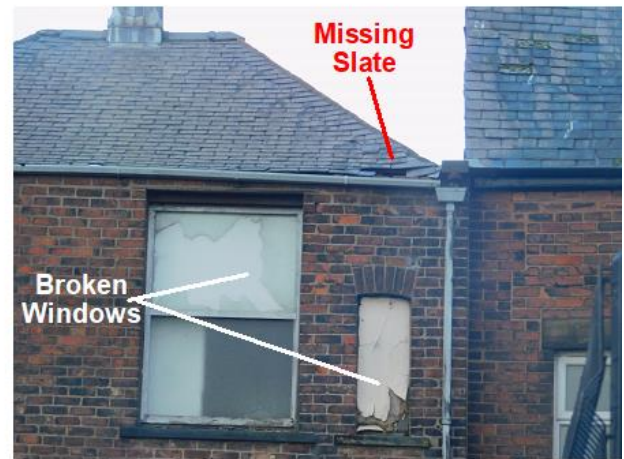
**PHOTO 42**  
**Upper South-eastern Corner**

were the walls beneath them all, both internally and externally, but neither bat droppings, invertebrate prey remains, nor any urine or fur staining found, and therefore all of these were deemed to be of low bat roosting potential, (refer to **figs 3, 4 and 5** and **photos 18, 36, 37, 38 and 42**).

- A roof slate was missing at the upper south-eastern corner of the roof, again an inspection of this using close focus binoculars found neither bat droppings, any invertebrate prey remains or urine staining, nor was there any evidence in the form of fur grease staining found around the area left by the slate, or on the roof around the hole, or on the wall beneath, (refer to **figs 3, 4 and 5** and **photo 42**).

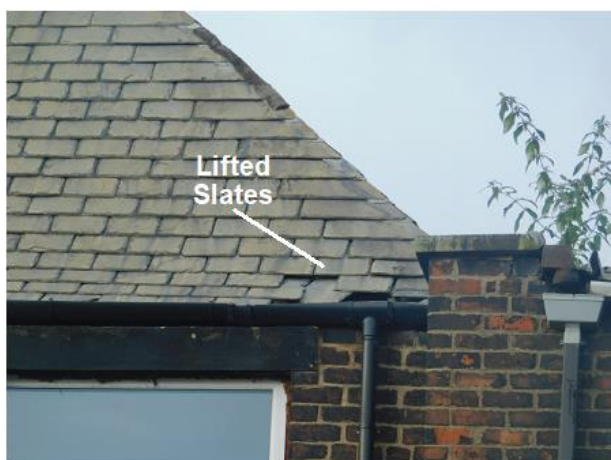
**PHOTO 51**  
**Eastern End of Central Bay Roof**

- A few of the slates had lifted at the eastern end of the central bay roof, and the resulting small hole passed through the roof into the roof void beneath, but a careful look internally within the roof void, around the hole both internally and externally, and around the slates externally, but neither bats themselves, nor any droppings or any other sign of bat usage were found, and therefore the hole was deemed to be of low bat roosting suitability, (refer to **figs 3, 4 and 5** and **photos 51 and 52**).

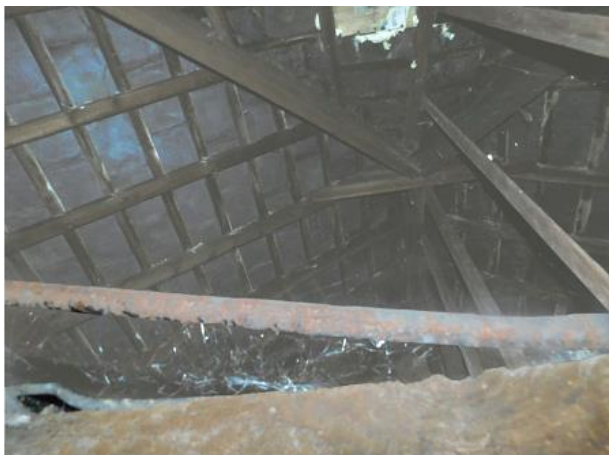
**PHOTO 55**  
**Underside of North-eastern Corner Roof**

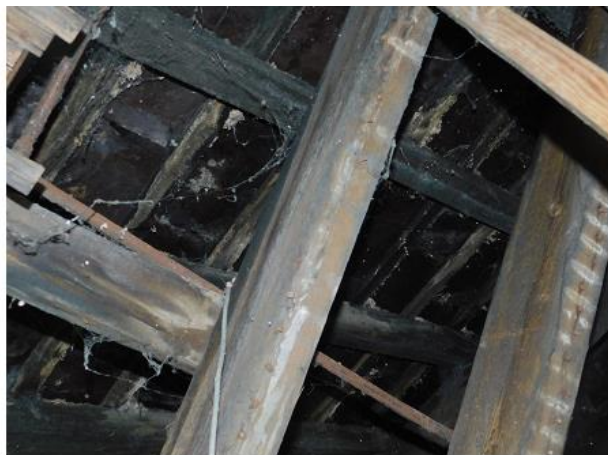
**PHOTO 56**  
**Underside of Eastern Roof Void**

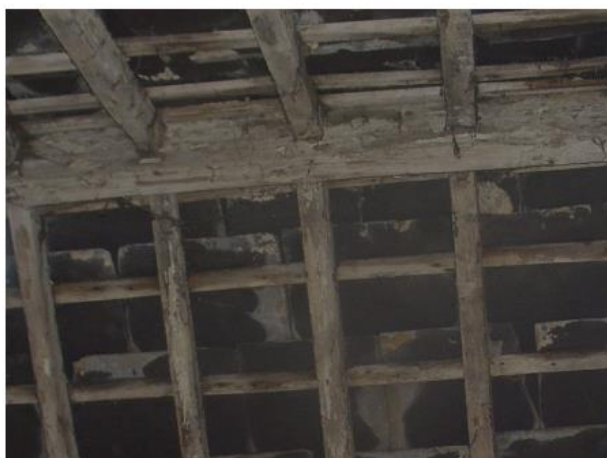
**PHOTO 57**  
**Underside of South-eastern Corner Roof**
