**Bat Survey of Stables at 90 Watling Street, Affetside**  
**Surveyor- Martin Prescott (Licence no. 2015/15466-CLS)**

It is proposed to demolish this block of disused stables. There is the potential to affect bats and their roosts and bat survey was required.

The site was at 90 Watling Street, Affetside.  
Map ref. SD75481380.

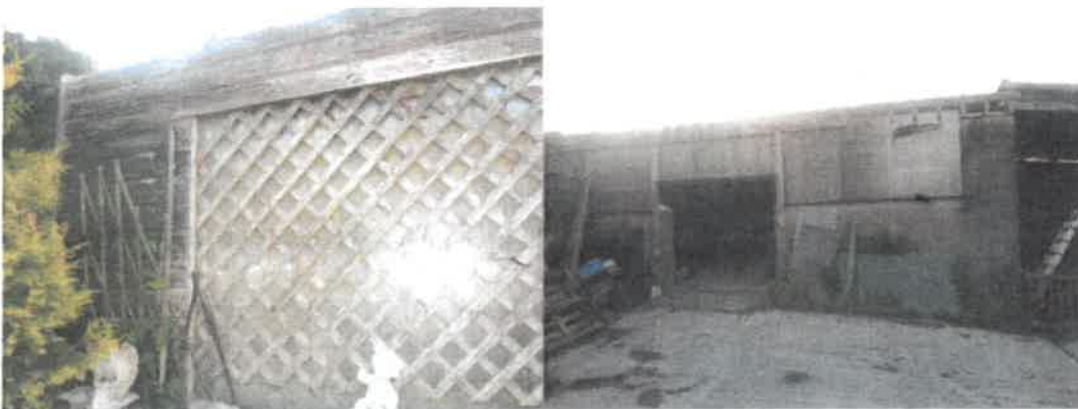
The stables were of breeze block with a sloping roof of corrugated sheeting roof. The roof was mostly unlined, but there were areas over the stalls with board lining (photo 4) There was some plank cladding at the west end of the building (photo 1).

P1 West end of south aspect, plank cladding P2 South aspect showing open doorway

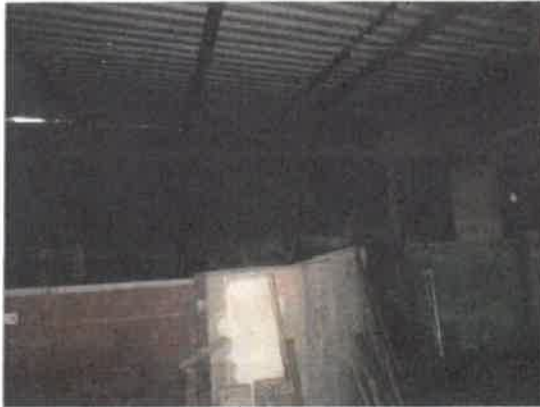
**P3 Inside main section, unlined roof**

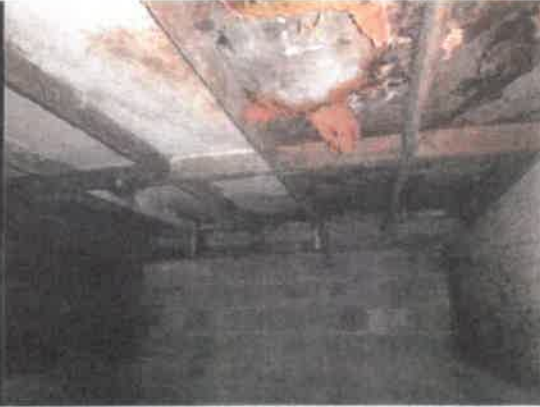
**P4 Board lining over stalls**

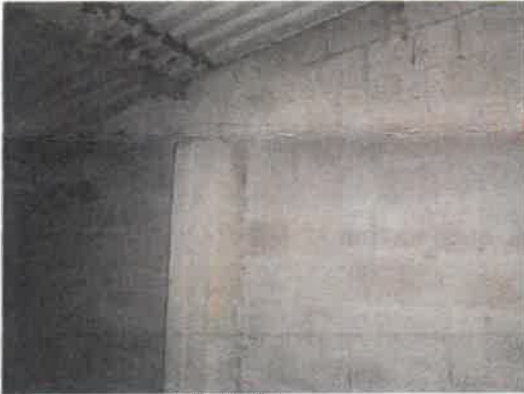
**P5 Interior breeze block**

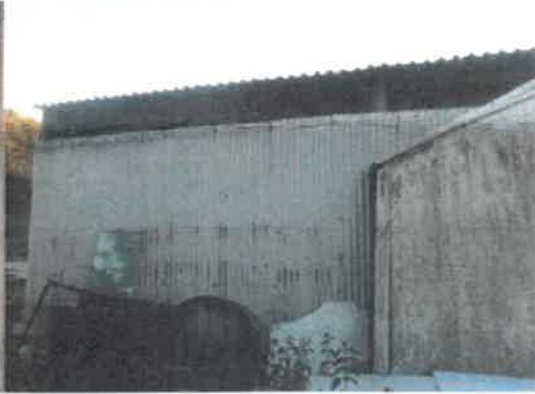
There was a corrugated sheeting section at the east end of the stables considered to have negligible bat roosting potential.

**P6 Corrugated rear open section**

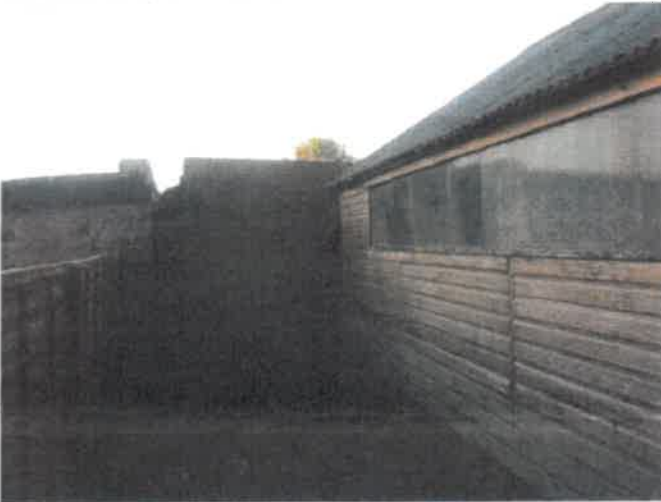
There were many gaps at the eaves, and open doorways making the building very draughty. The ground floor was easily searchable. No signs of roosting bats were found. Any bat access to the rear of the building was effectively blocked by neighbouring buildings.

**P7 Next door building obstructing rear of affected stables**
