# Bat

# Presence-Absence Survey

Dry Gap Farm

Ramsbottom

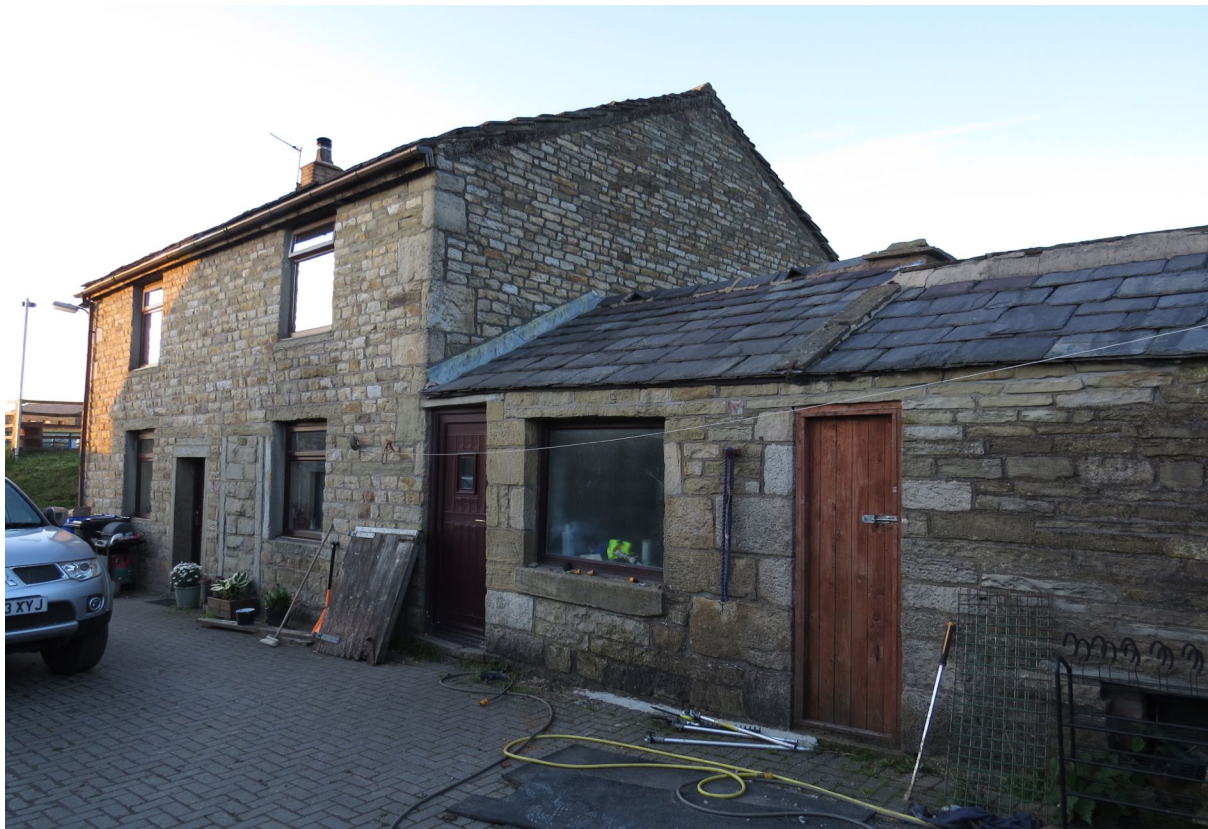
3.1a – The west side of the farmhouse, south gable end, and attached outbuildings.

Dry Gap Farm is a detached pre-1900's stone farmhouse which is currently occupied. The roof is pitched and covered with rough-cut stone roof & ridge tiles; roof pitches face east & west, gable ends face north & south. Single storey outbuildings at the south gable end have pitched roofs covered with slate roof tiles and vented ceramic ridge tiles.

Wooden fascia boards are fitted at the eaves of the farmhouse, lead flashing is fitted where roof tiles abut stonework. Walls are solid local stone, and have been re-pointed within the last 10 years. Lintels and sills are stone, window and door frames are UPVC, all glass is intact.

Fascia boards at the eaves are in good condition, however, they are fixed to the end of rafters with a >50mm gap between stonework and timbers. Stone tiles are in good condition, and end tiles at the verges are sealed with cement.

There are features externally which could be used by roosting bats including:

- gaps beneath stone roof & ridge tiles
- gaps behind fascia boards
- gaps between roof and ridge tiles on outbuildings

The gaps present could be used by crevice dwelling species of bats, or could give access to the inside of the building.

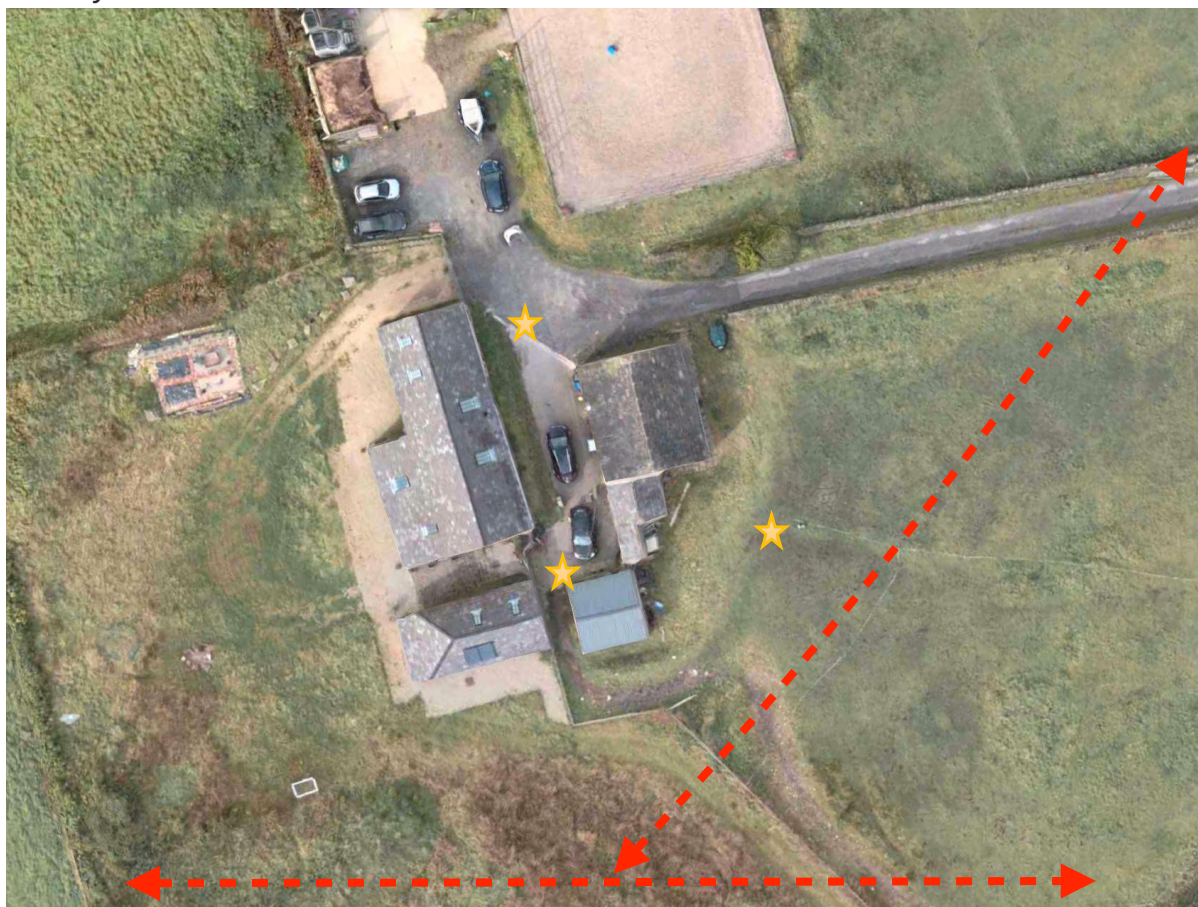
4.1a – Surveyor locations and bat activity.

The first bat recorded during the survey was a single common pipistrelle at 21:58, 38 minutes after sunset. The bat came from the northeast, and was seen flying southwest.

The level of bat activity during the survey was low, with occasional foraging passes recorded along the tree-line to the south of the site. Between 21:58 and 22:23 five passes by single common pipistrelle bats were recorded. No bats were recorded after 22:23.

No bats were recorded emerging from the building during the survey.

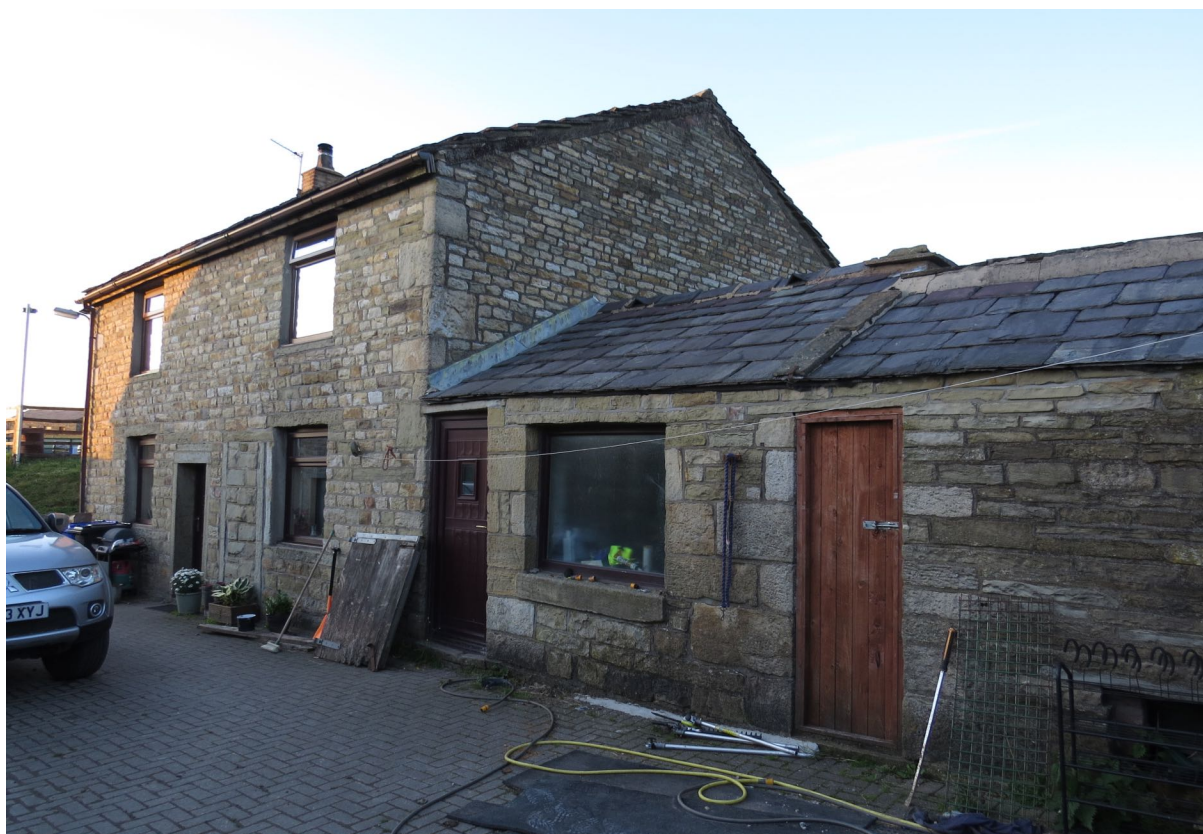
1 – The south gable end and west side of the farmhouse and outbuildings.

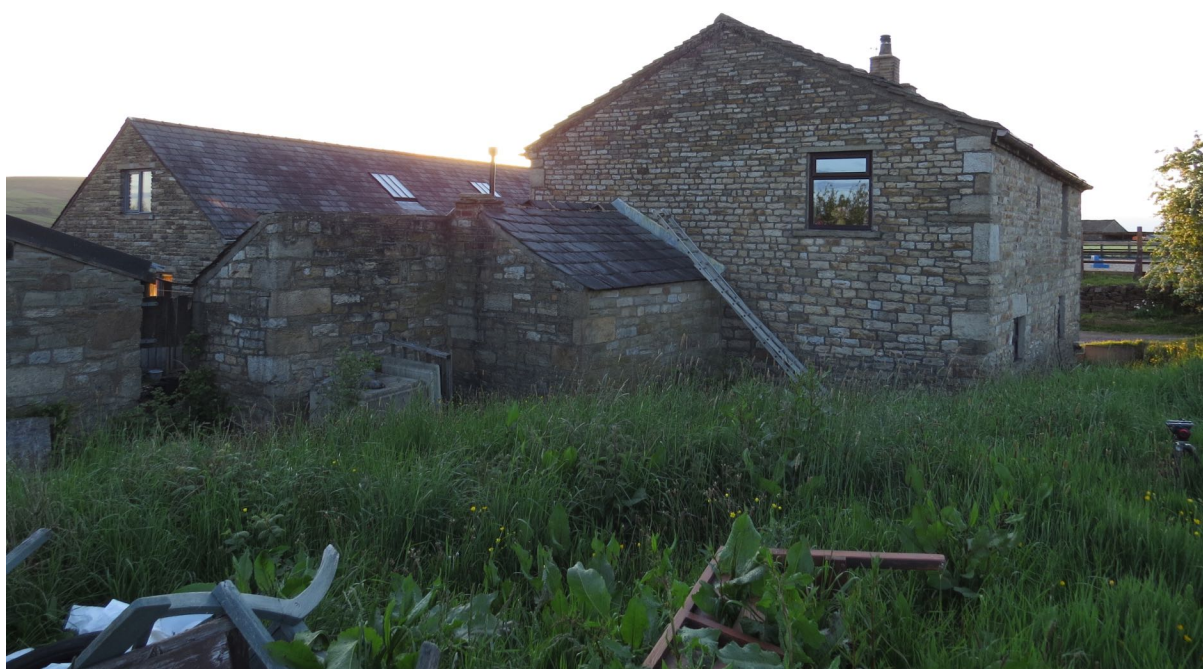
2 – The south gable end, and east side of the farmhouse and outbuildings.

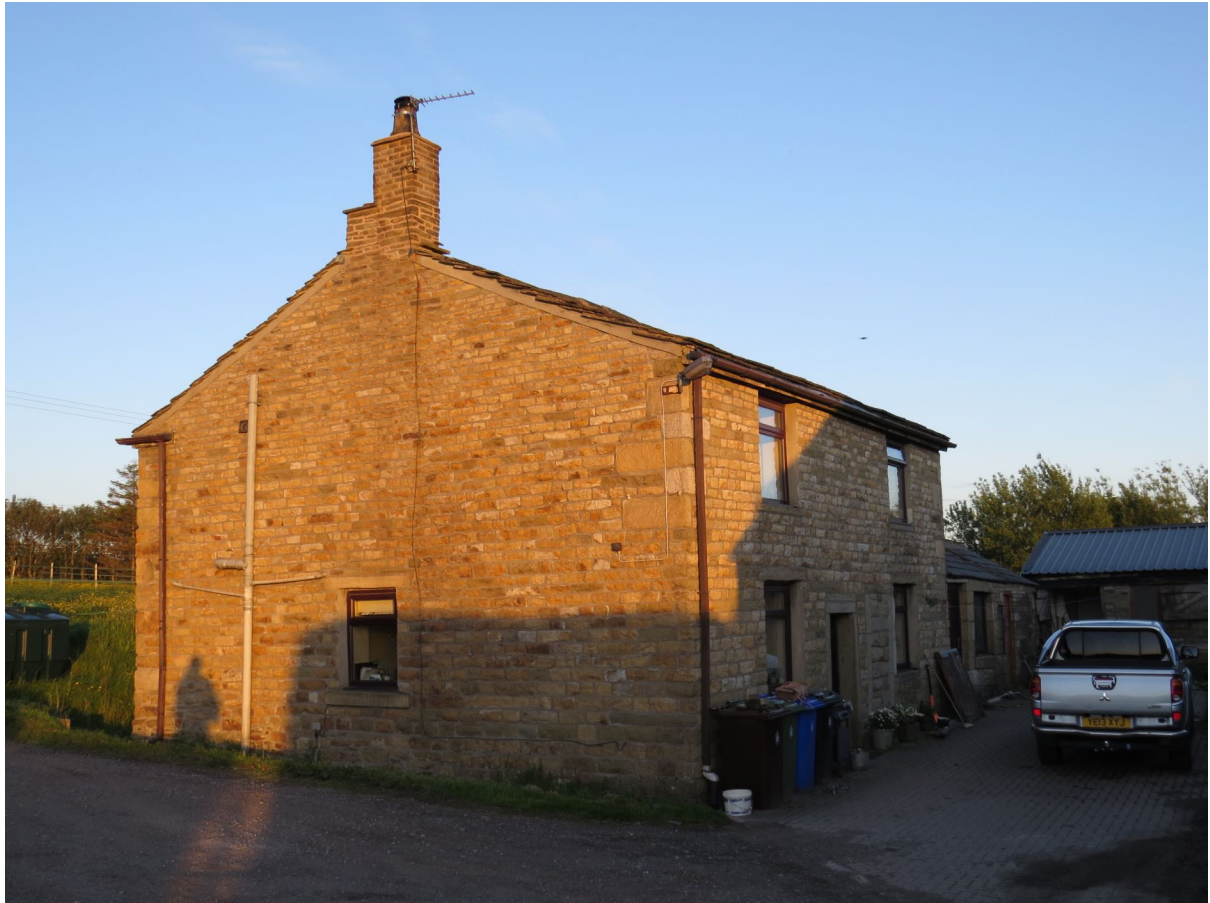
3 - The north gable end of the farmhouse.

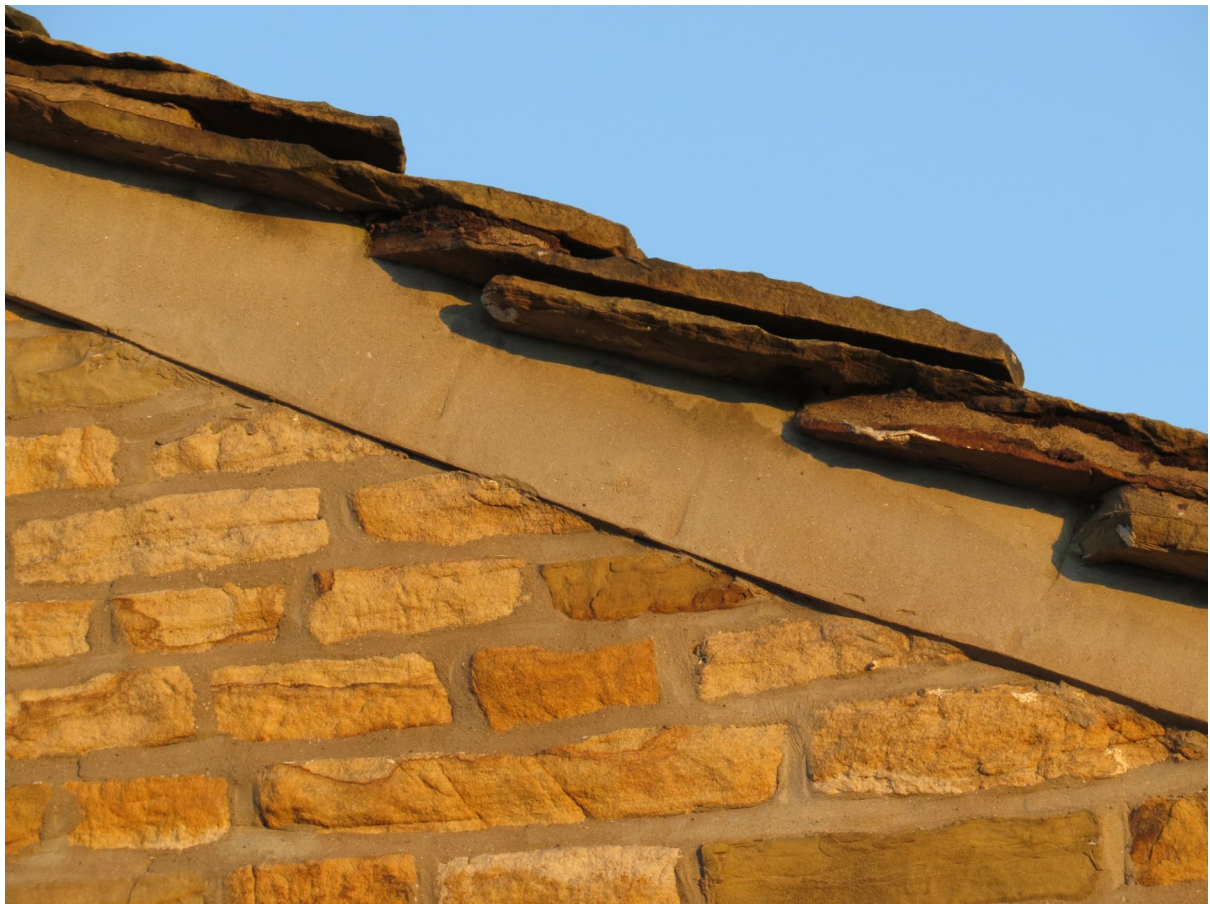
4 - Pointing between stonework and at the verges is in good condition with no gaps.

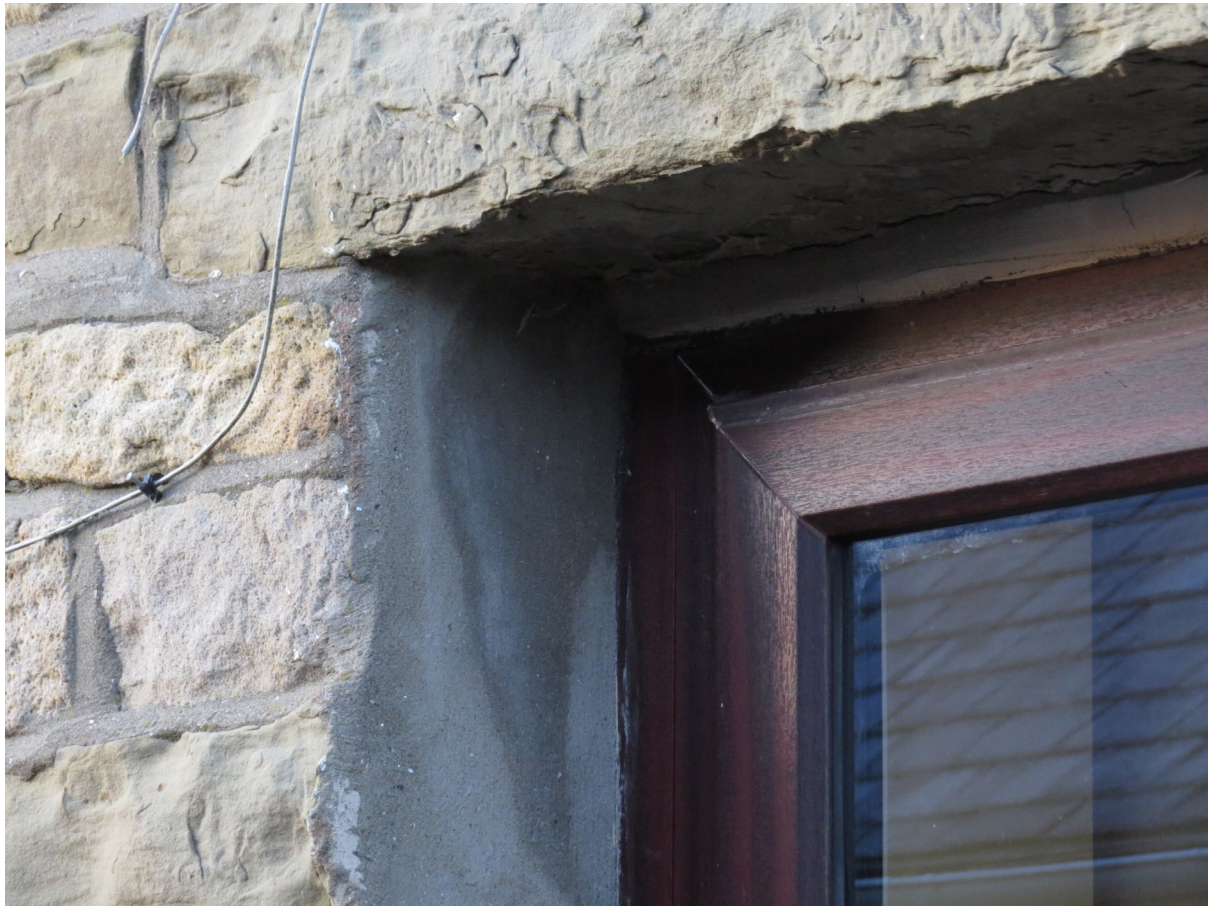
5 - There are no gaps around windows or lintels.

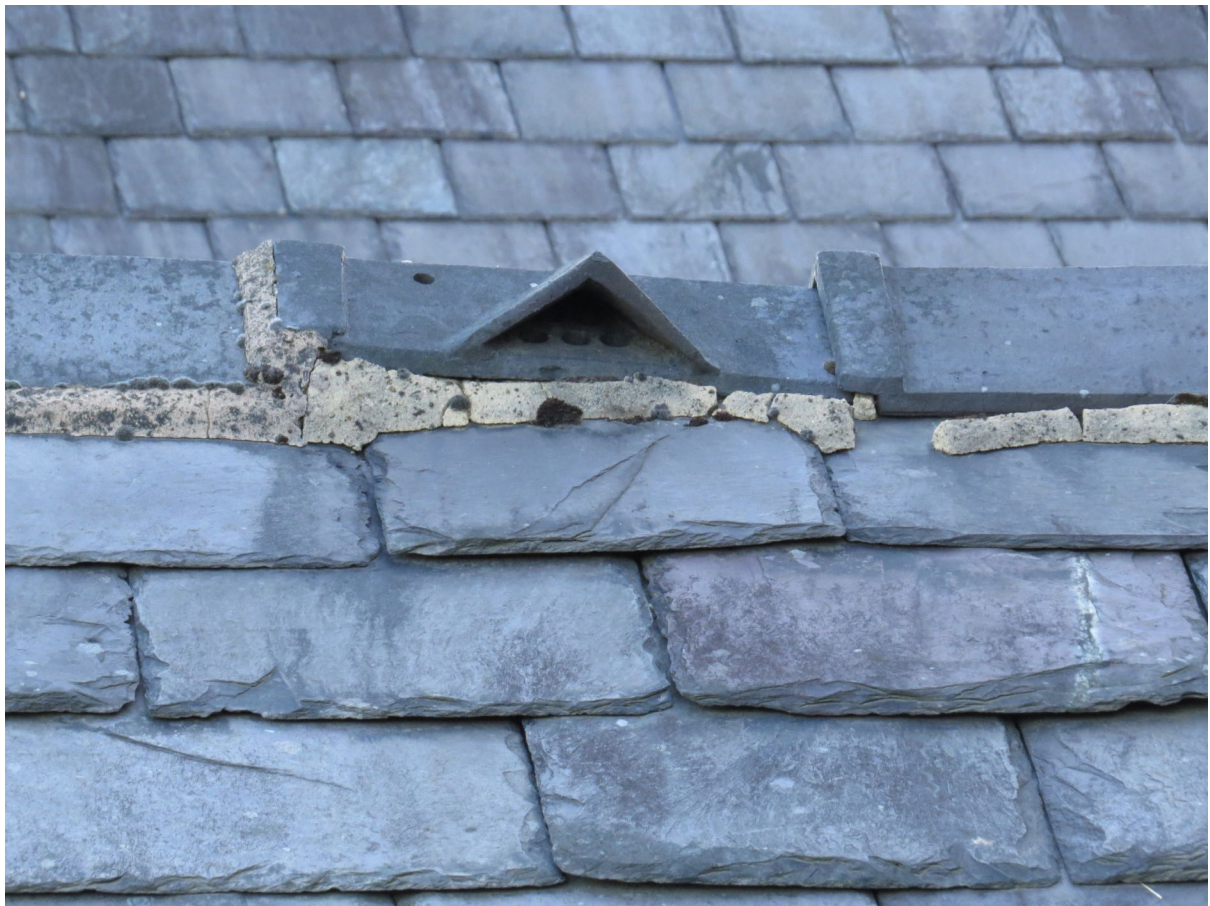
The thick stone walls of the building, rough-cut stone roof tiles, and gaps beneath roof slates on outbuildings, could provide suitable summer roosts for bats.

6 - There are gaps beneath roof and ridge tiles on the outbuildings.

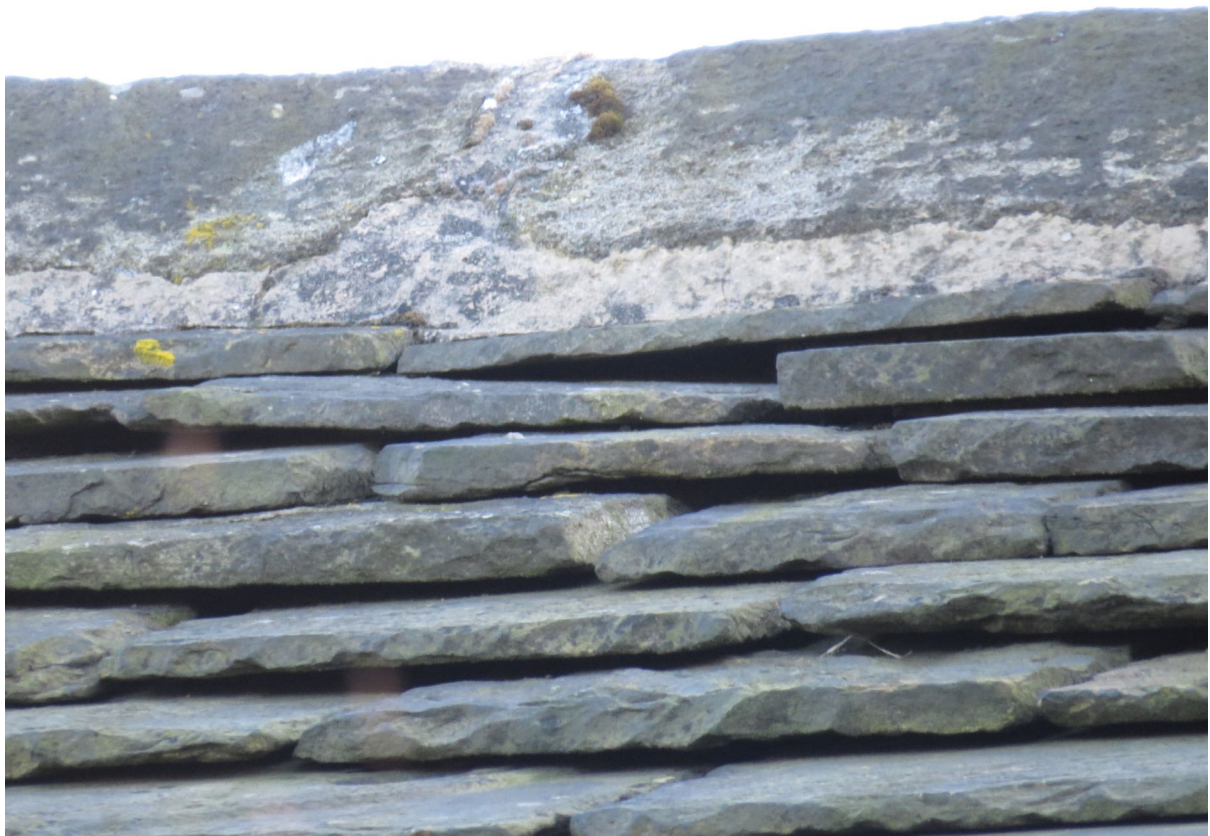
The building has external features which could be used by crevice dwelling bats, such as gaps & beneath roof and ridge tiles, and gaps at the eaves.

7 - There are gaps between stone roof tiles.

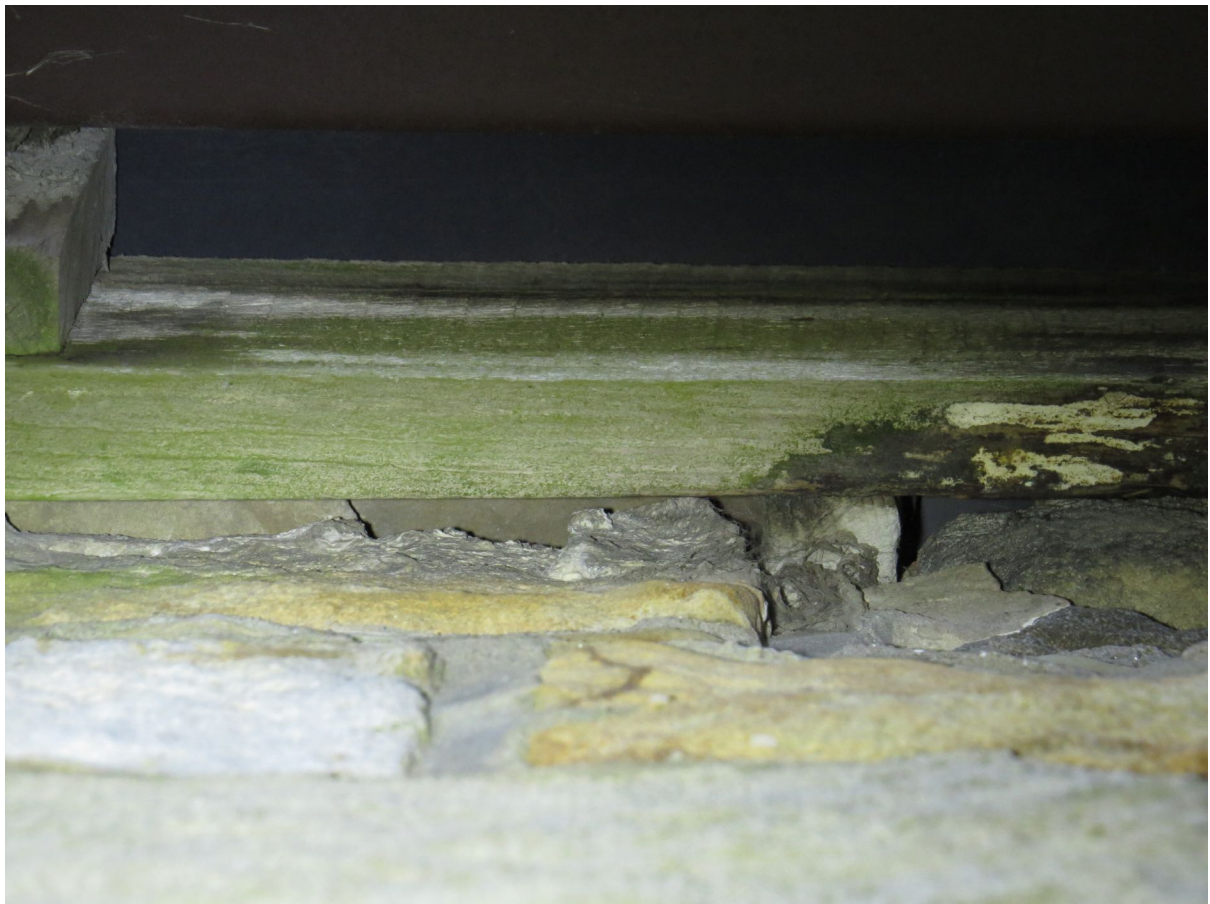
Gaps at the eaves of the farmhouse could allow access to the roof void, or to small gaps and crevices within the stone walls.

8 - There gaps between timbers and stonework at the eaves.
