# KNOWSLEY HOUSE, AINSWORTH NURSING HOME, RADCLIFFE

## PHASE 2 GEO- ENVIRONMENTAL INVESTIGATION, RISK ASSESSMENT AND REMEDIATION STRATEGY

**Job Number:** LKC 20 1567-B3

**Date:** October 2020

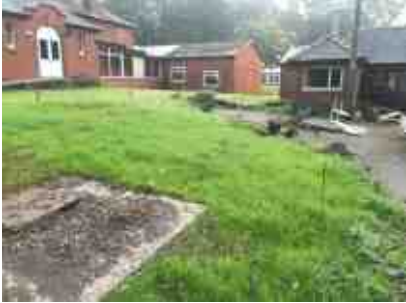
| <b>Photograph 1</b> – General picture of the back of Knowsley house, including possible well on site. | <b>Photograph 2</b> – General picture of the front of the house |

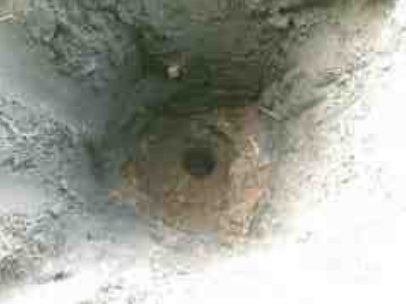
| <b>Photograph 3</b> – HD101 - made ground of slightly gravelly slightly sandy silt to 0.50m with brick fragments and coal, natural yellowish brown slightly gravelly slightly sandy silt to 1.20m. | <b>Photograph 4</b> – Contents of HD101. |

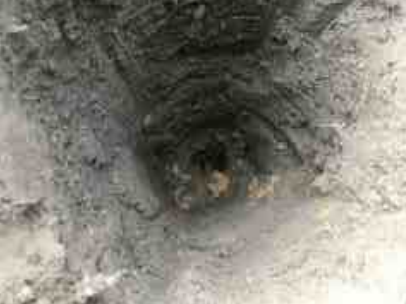
| <b>Photograph 5</b> – HD102 - made ground of slightly gravelly slightly sandy silt to 0.60m with brick fragments, pottery fragments and coal, overlying natural yellowish brown slightly gravelly slightly sandy silt to 1.20m. | <b>Photograph 6</b> – Contents of HD102. |

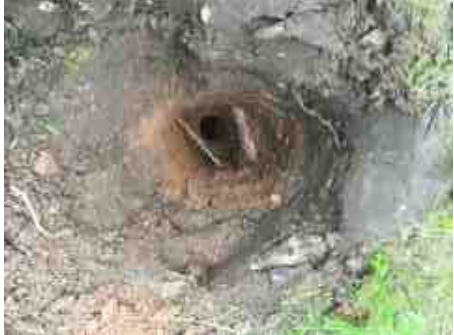
| <p><b>Photograph 7</b> – HD103 - made ground of slightly gravelly slightly sandy silt to 0.20m with brick fragments and coal, overlying natural yellowish brown slightly gravelly slightly sandy silt to 0.60m, underlain by a possibly reworked natural yellowish brown slightly sandy silt.</p> | <p><b>Photograph 8</b> – Contents of HD103.</p> |

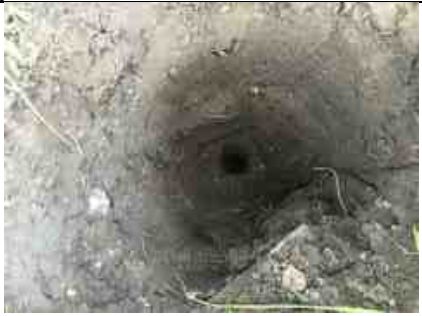
| <p><b>Photograph 8</b> - HD104 - made ground of slightly gravelly slightly sandy silt to 0.40m with brick fragments and coal, overlying a second made ground yellowish brown slightly gravelly slightly sandy silt to 0.90m, overlying an ash layer to 1.20m.</p> | <p><b>Photograph 9</b> – Contents of HD104.</p> |

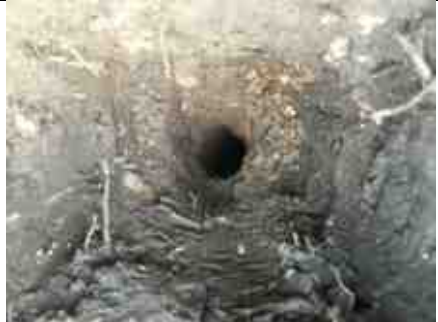
| <p><b>Photograph 10</b> - HD105 - made ground of slightly gravelly slightly sandy silt to 0.50m with brick fragments and glass fragments, overlying a second made ground yellowish brown slightly gravelly slightly sandy silt to 1.20m.</p> | <p><b>Photograph 11</b>- Contents of HD105.</p> |

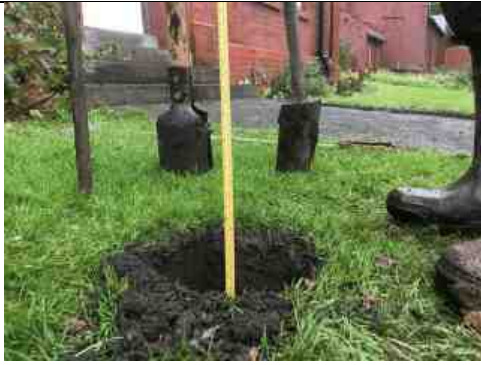
| <p><b>Photograph 12 – HD201</b> - made ground of slightly gravelly slightly sandy silt to 0.50m with brick fragments and coal, overlying natural yellowish brown slightly gravelly slightly sandy silt to 1.20m.</p> | <p><b>Photograph 13</b> – Location of HD201.</p> |

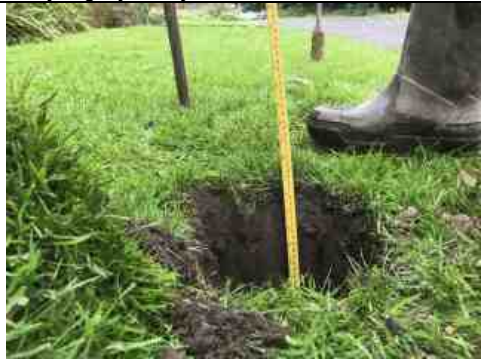
| <p><b>Photograph 14 – HD202</b> - made ground of slightly gravelly slightly sandy silt to 0.60m with brick fragments, pottery fragments and coal, overlying a natural yellowish brown slightly gravelly slightly sandy silt to 1.20m.</p> | <p><b>Photograph 15</b> – Location of HD102.</p> |

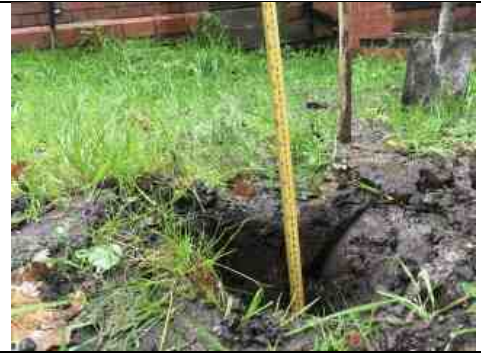
| <p><b>Photograph 16 – HD203</b> - made ground of slightly gravelly slightly sandy silt with brick fragments and coal to 0.60m, natural yellowish brown slightly sandy silt to 0.90m.</p> | <p><b>Photograph 17</b> – Location of HD203.</p> |

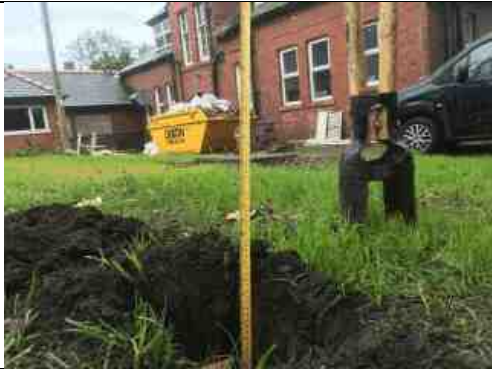
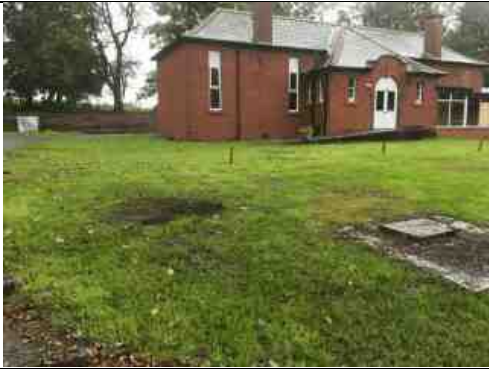
| <p><b>Photograph 18 – HD204</b> - made ground of slightly gravelly slightly sandy silt to 0.40m with brick fragments and coal, overlying a second made ground light brown slightly gravelly slightly sandy silt to 1.20m with concrete fragments, overlying another made ground of predominately brick, that is probably reworked natural to 2.20m where the hand auger refused.</p> | <p><b>Photograph 19 –</b> Location of HD204 in relation to the nearby well.</p> |

Made ground is likely lying directly above the bedrock at HD204 / HD104 and HD205 / HD105, related to the installation of the nearby well, and noted to be reworked natural ground below 1.2mbgl at HD204. Although elevated PAHs and heavy metals were identified on site, this is likely associated with the coal and pottery within the upper layers of made ground. The made ground / reworked natural from HD205 below 1.2mbgl was tested and no elevated contaminants were identified, and should offer the Secondary A Aquifer some protection. As no groundwater was encountered during the site investigation, and the made ground constituents are predominately crystalline, these are unlikely to leach and affect the underling aquifer onsite or the nearby drainage feature.

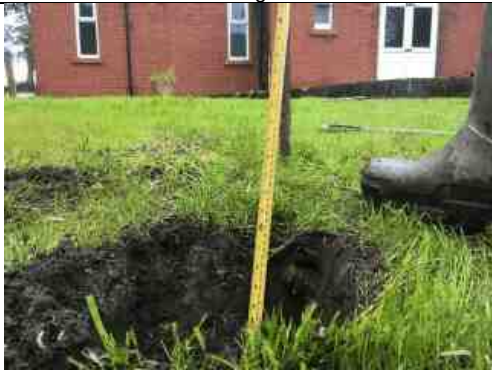
| <p><b>Photograph 20 – HD205</b> - made ground of slightly gravelly slightly sandy silt to 0.40m with brick fragments and coal, overlying a second made ground orangish brown slightly gravelly slightly sandy silt to 1.20m, finally a third made ground of grey and reddish brown slightly gravelly silty sand with brick, concrete and coal to 1.85m where the hand auger refused on possible sandstone.</p> | <p><b>Photograph 21-</b> Location of HD205.</p> |

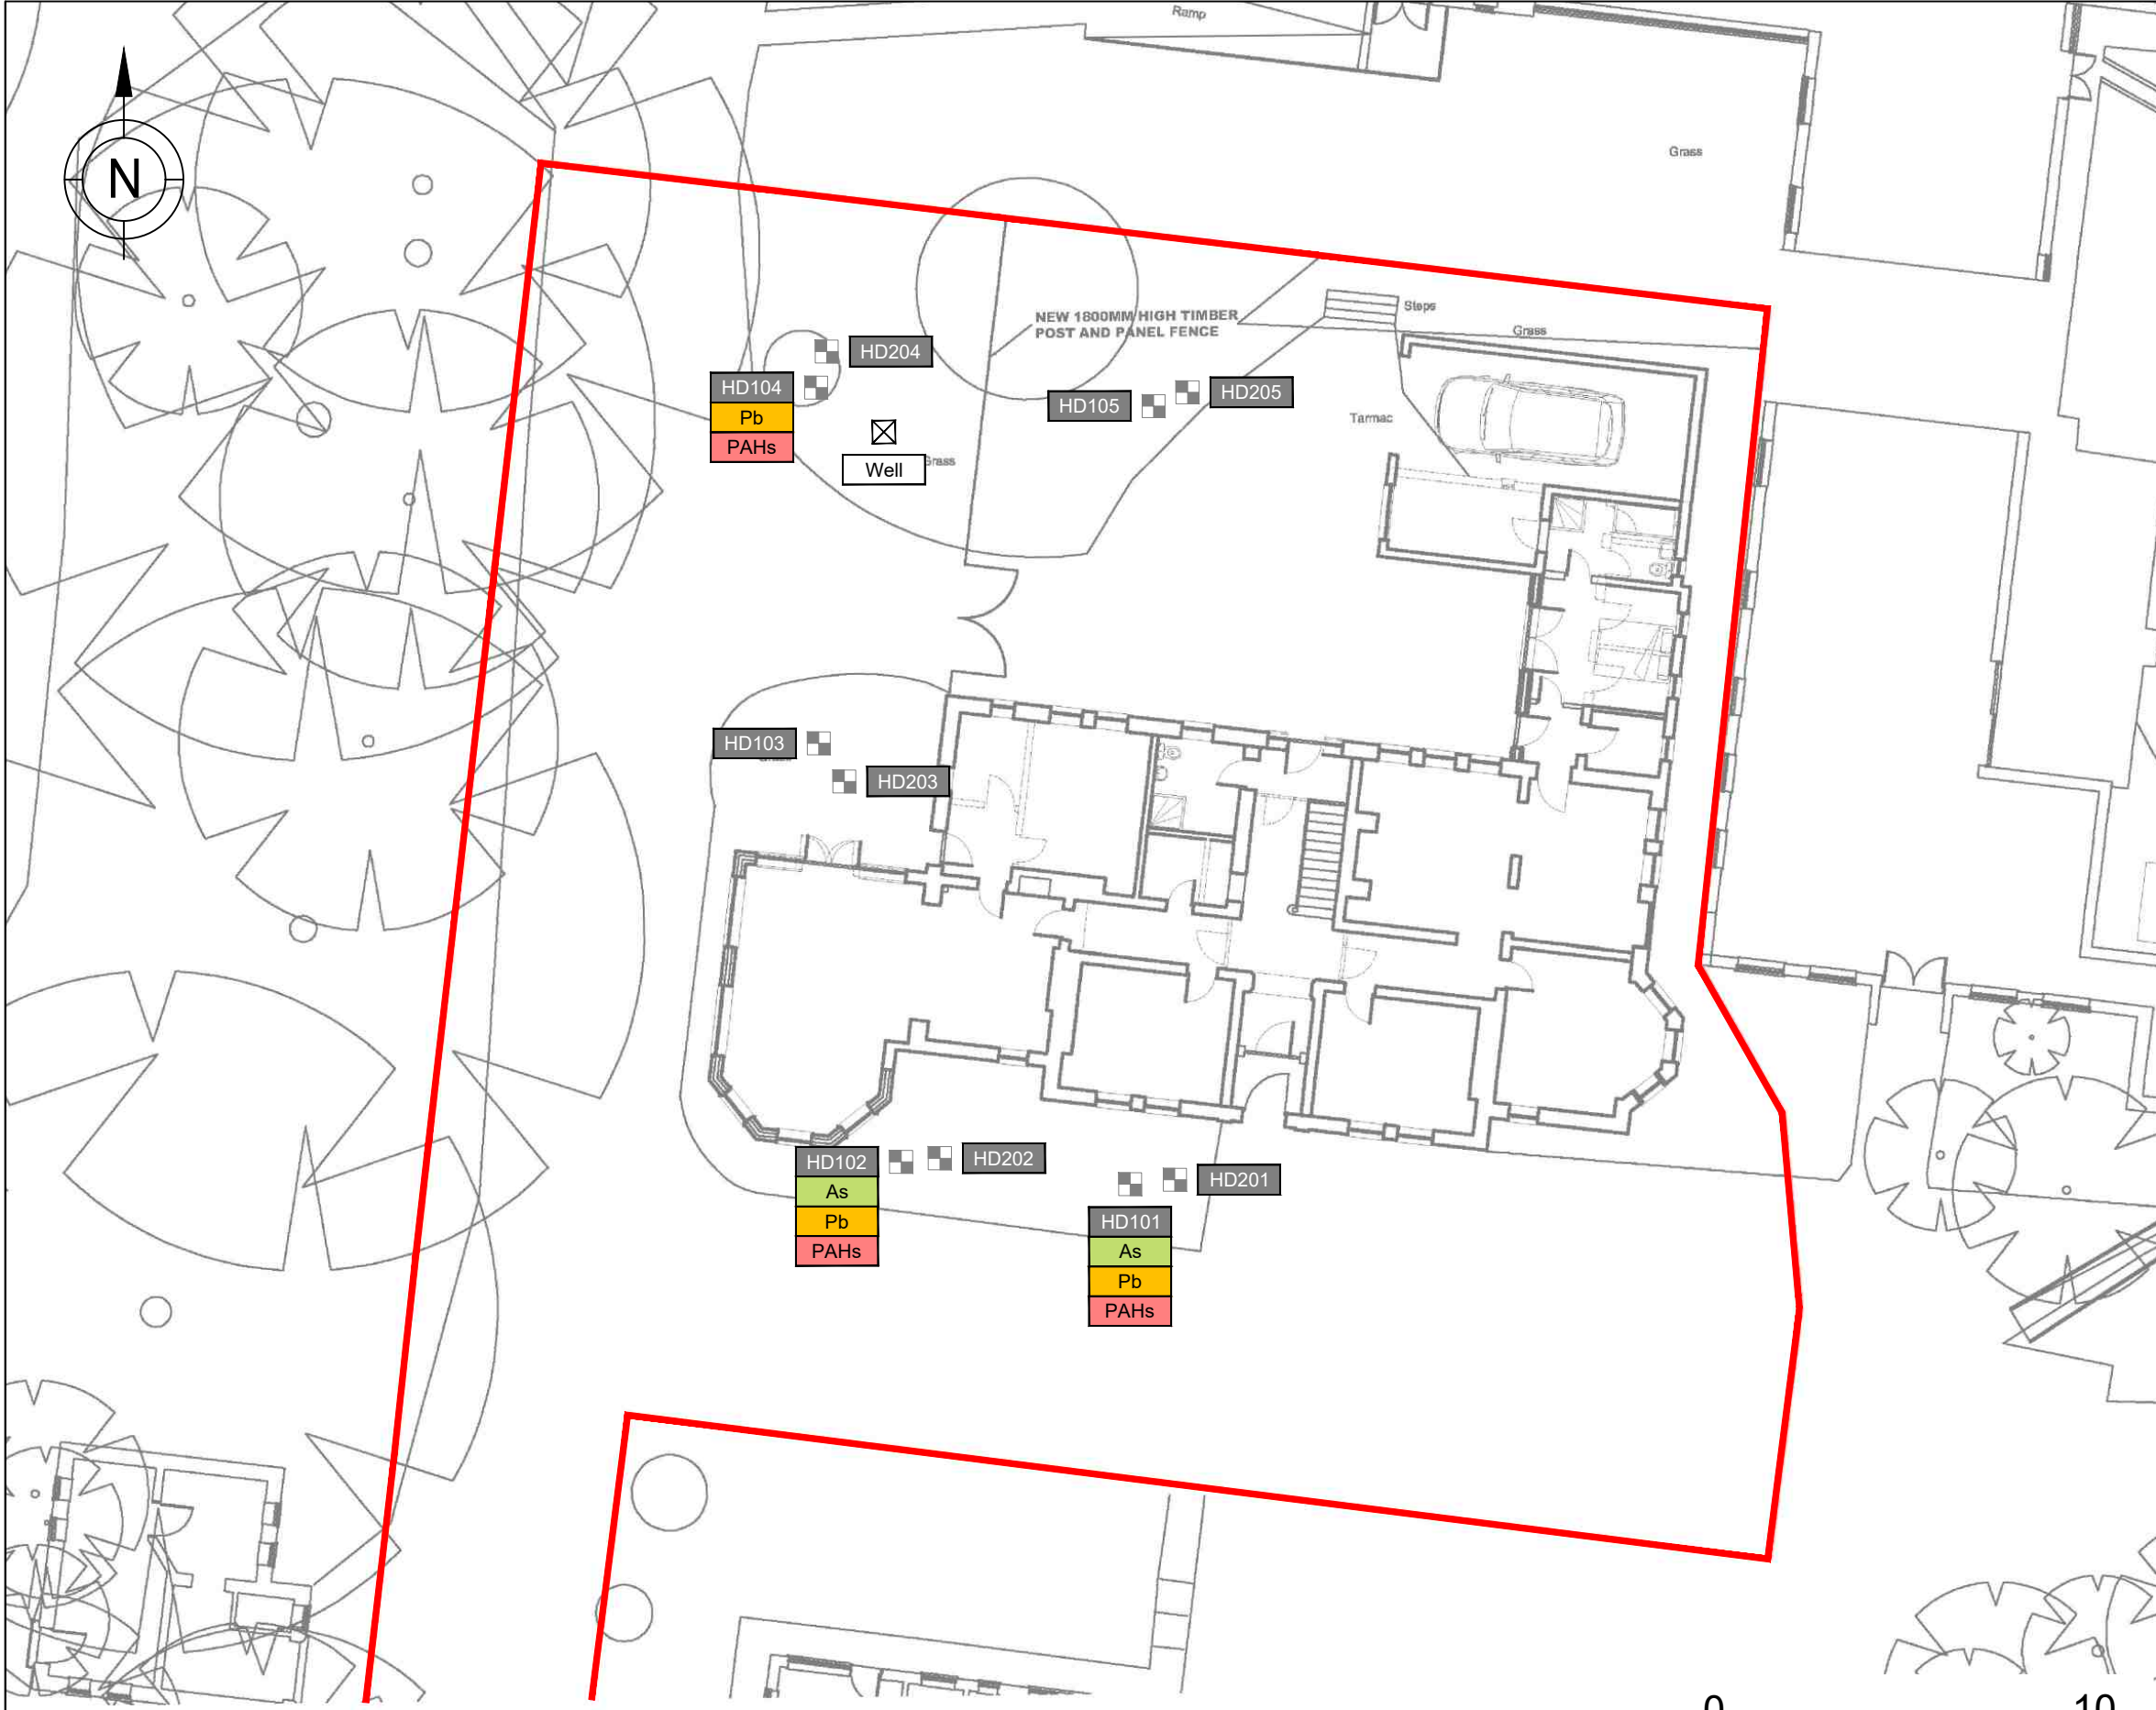
**KEY**

- Site Boundary
- Hand Dug Trial Pit (HD)
- Well Location

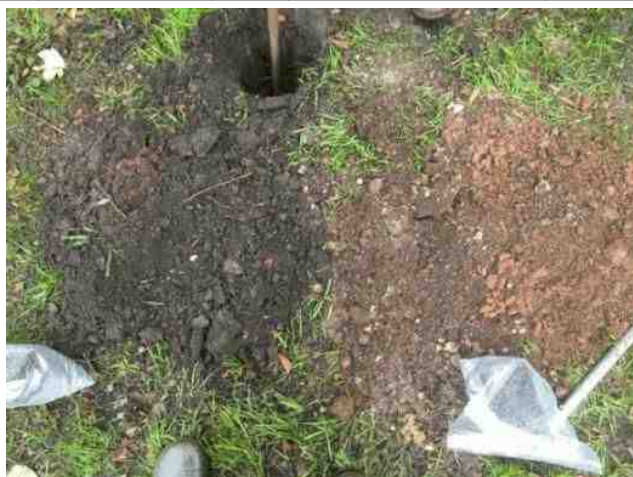
| Depth (m) | Sample / Tests | Water Depth (m) | Field Records | Level (mOD) | Depth (m) (Thickness) | Description | Legend | Water |
|---|---|---|---|---|---|---|---|---|
| | | | | 160.85 | 2.15 | Whole brick encountered at 2.20mbgl. | | |

Location estimated from <https://gridreferencefinder.com/> accurate to 3.0-5.0m.  
Hand auger refusal at 2.15mbgl on possible whole brick.  
Hand dug pit dry and unstable.  
Elevation estimated from <https://www.freemaptools.com/elevation-finder.htm>.  
HD204 is approximately 1.00meter from a possible well.

Made ground was bottomed out at all locations except HD204 / HD104, where the hand auger refused on whole brick at 2.20mbgl. As bedrock was encountered at 1.85mbgl in HD205 / HD105 and reworked natural ground was encountered in HD204 from 1.2mbgl, the depth of the made ground at HD204 location is likely related to the installation of the nearby well (see Plate 3-2, photograph 19).

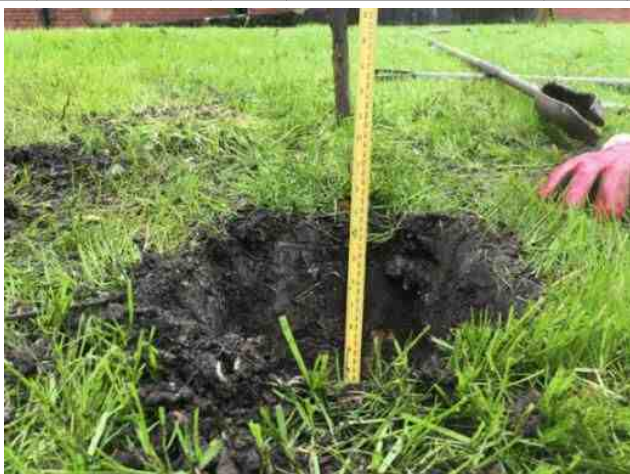
Hand dug pit dry and unstable.  
Hand auger refusal at 1.85mbgl on possible sandstone bedrock.  
Elevation estimated from <https://www.freemaptools.com/elevation-finder.htm>.  
Location estimated from <https://gridreferencefinder.com/> accurate to 3.0-5.0m.
