# Contaminated Land Phase Two Intrusive Investigation for Proposed Residential Development at, Land adjacent 6 Bentley Lane, Bury, BL9 6RZ.

October 2021

This report consists of a phase two intrusive investigation and proposed remediation plan for a proposed residential development on land adjacent 6 Bentley Lane, Bury, BL9 6RZ.

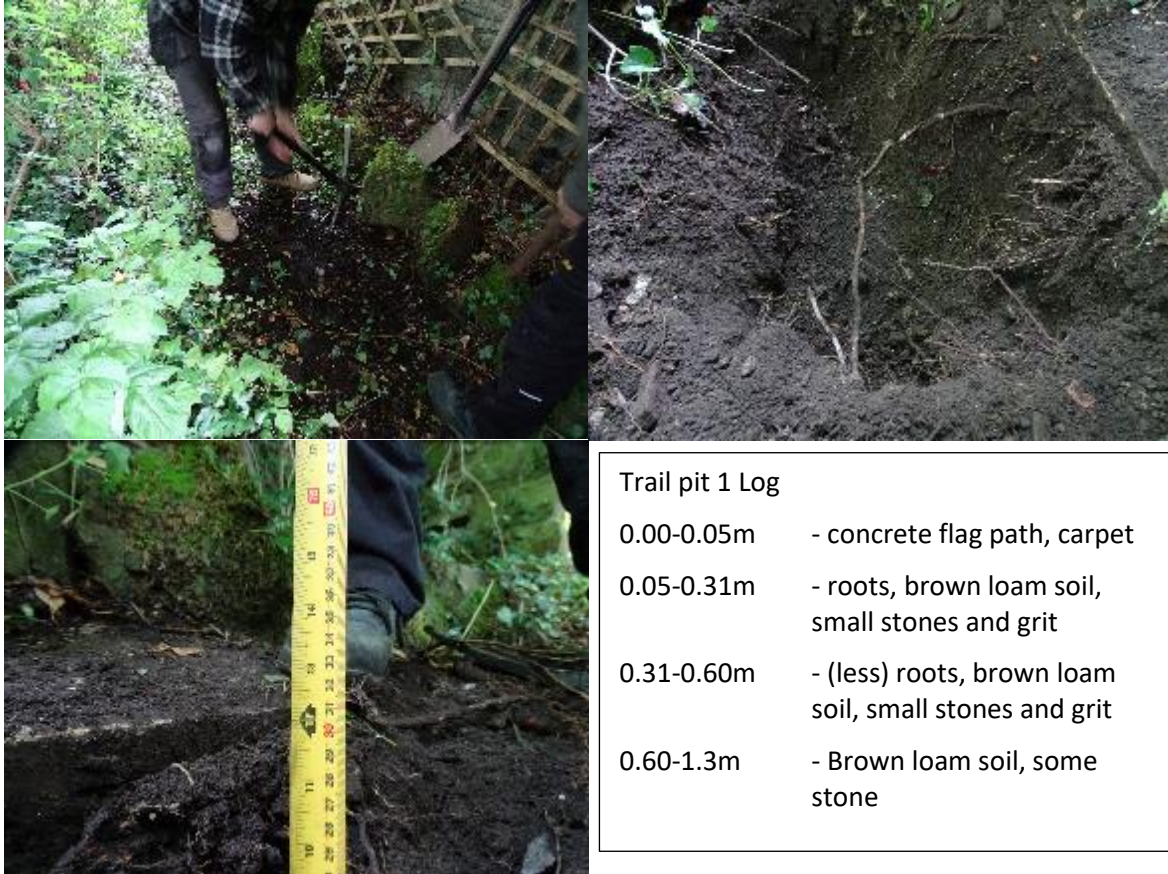
The surface of the site consists of a mixture of flower beds and concrete/stone pathways, below which a thick root system was encountered. The soil was a brown loamy soil with some grit. A few larger pebbles were found in the soil.

Trail Pit 1a – South East 330mm bgl

Due to the presence of high lead levels within the soil it is recommended that a clean cover system consisting of a total depth of 600mm be placed within any garden landscaped area. The impacted soils should be excavated to a depth of 600mm below garden formation level and replaced with 450mm of inert, clean (non-waste), granular subsoil and an upper layer of 150mm topsoil to act as a growing medium.

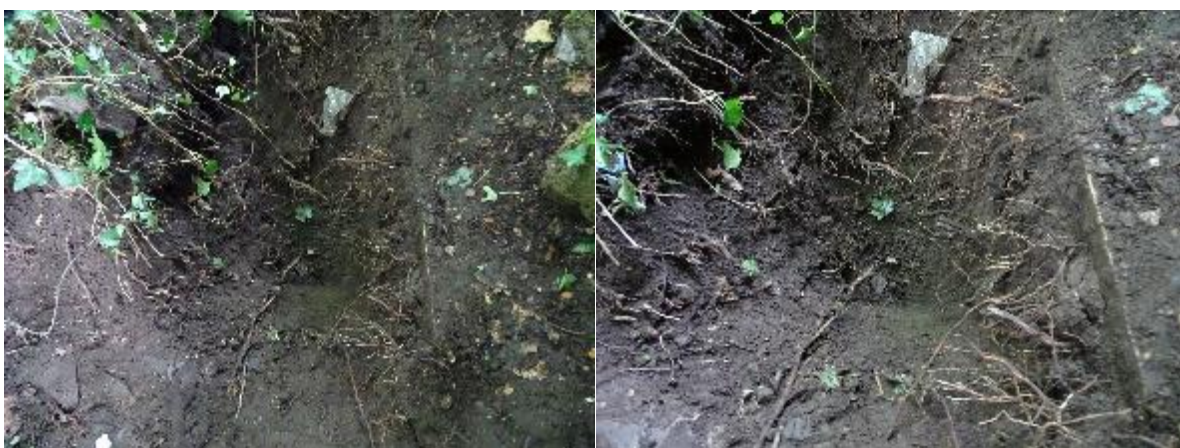
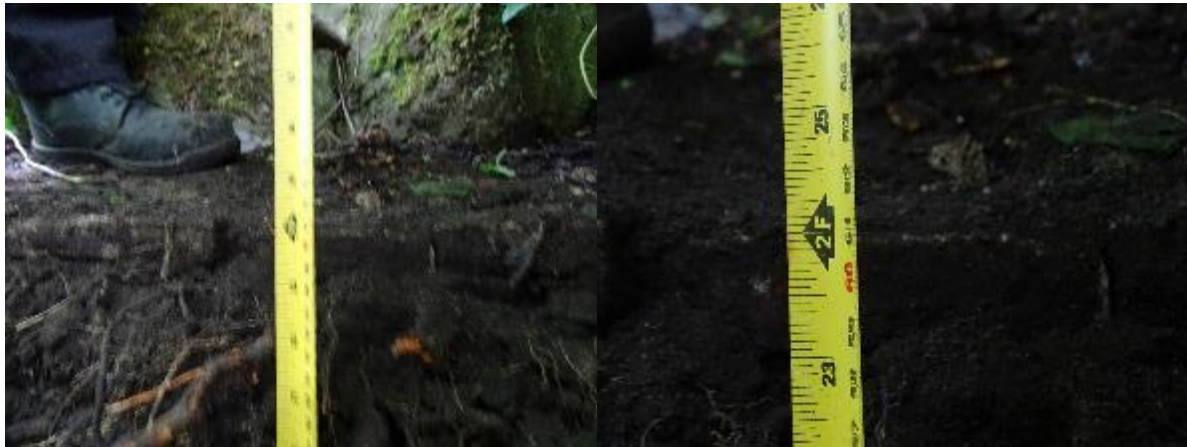
Trail pit 1B – 600mm bgl

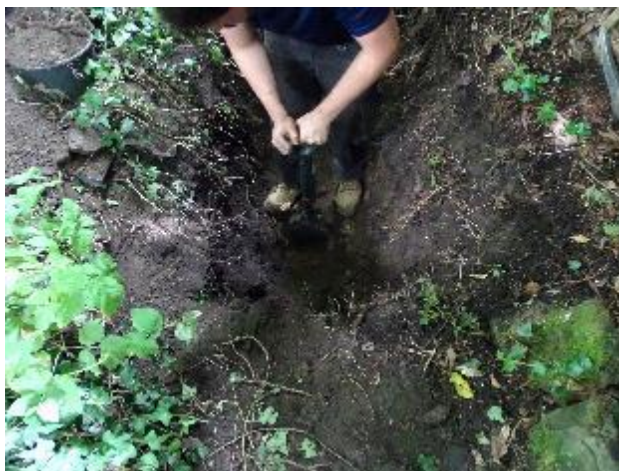
Samples were taken at an approx. depth of 300mm and 600mm below ground level (bgl). Trail hole 1 was extended to a depth of approx. 1300mm to undertake a surface water percolation test at the time, no ground water was identified.

The site slopes south away from the road to the north and trial holes were located towards the southern boundary. Excavations went down to 1300mm bgl as part of the surface water percolation tests and no ground water was identified.

Trail pit 1 – excavation to 1.3m

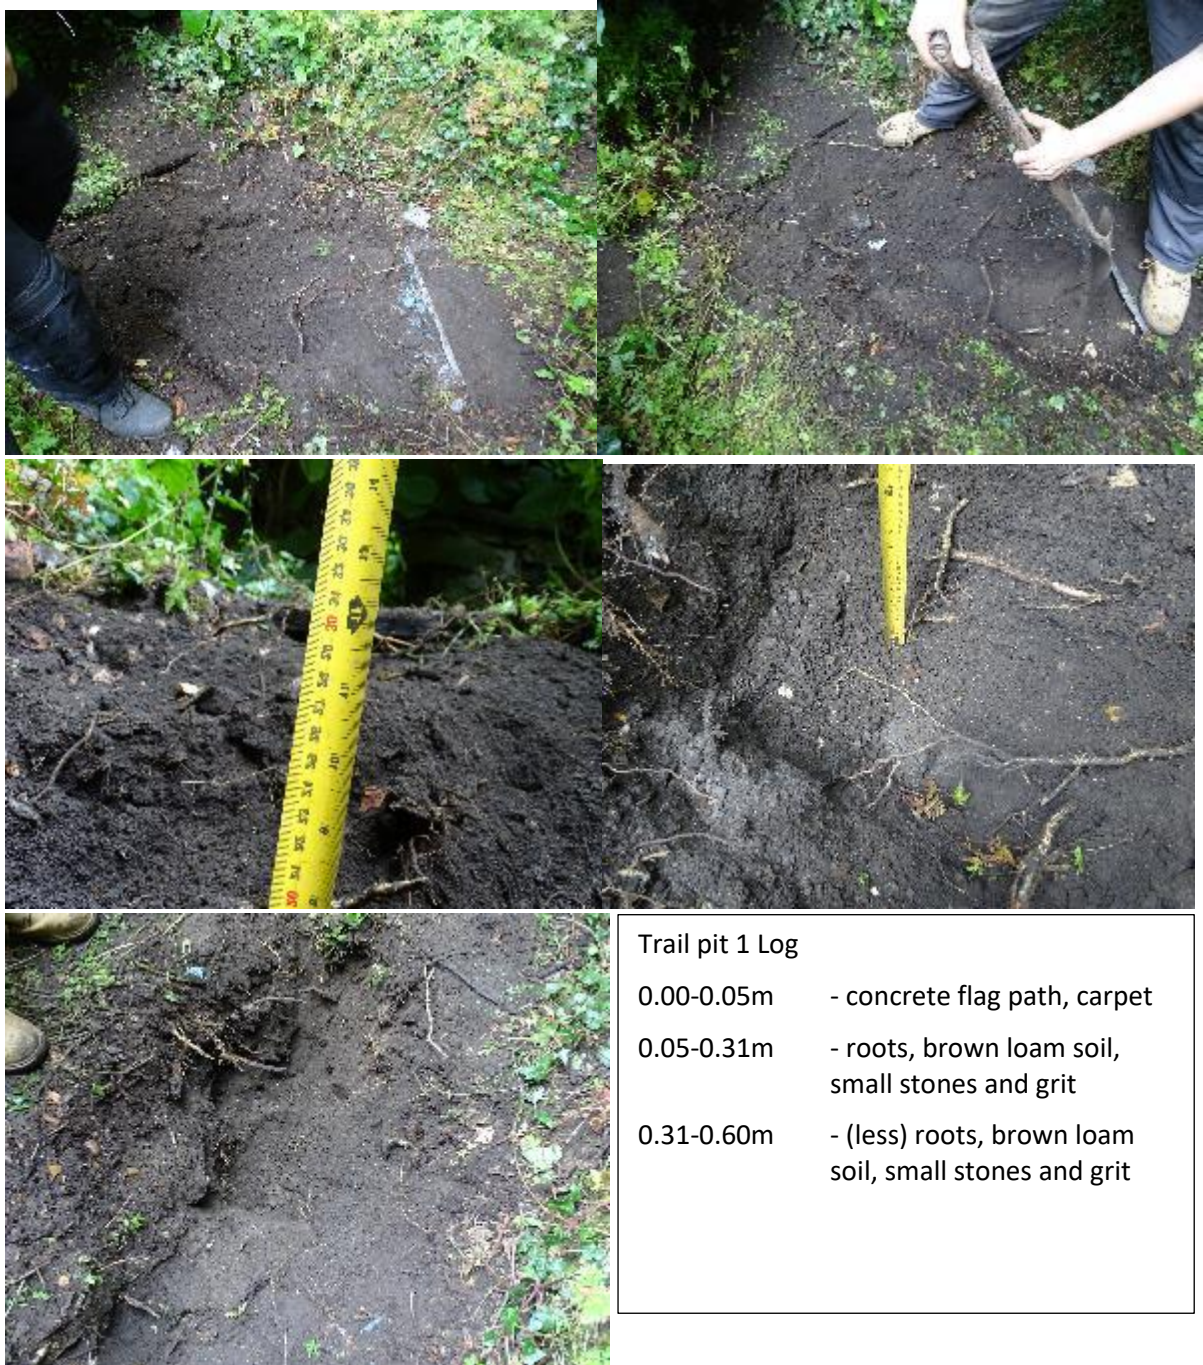
Trail Hole 2 southwest – 2a 300mm bgl

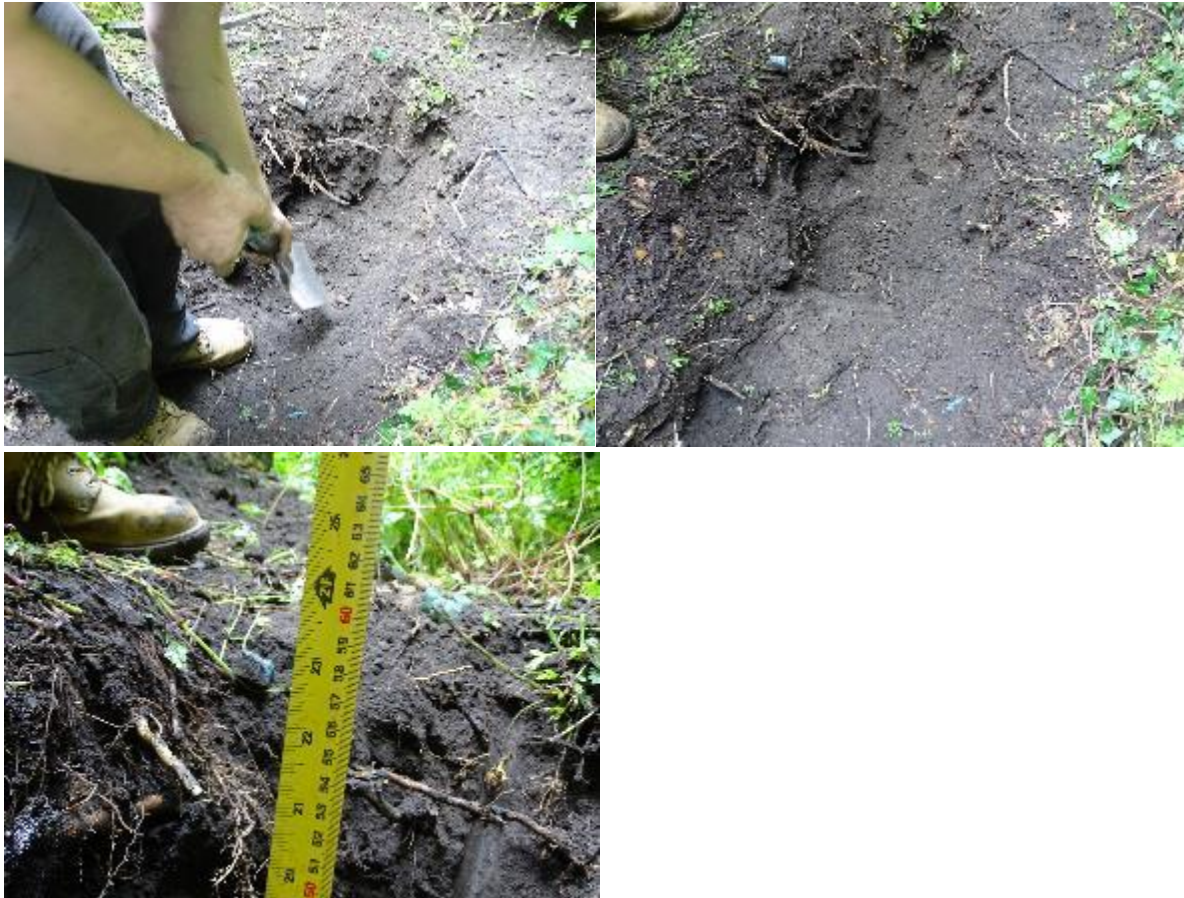
Trail hole 2b – 600mm
