**Desk Study  
&  
Ground Investigation Report**

**Mondi Site, Ramsbottom**

**REPORT NO: 19ECH016/DSGI**

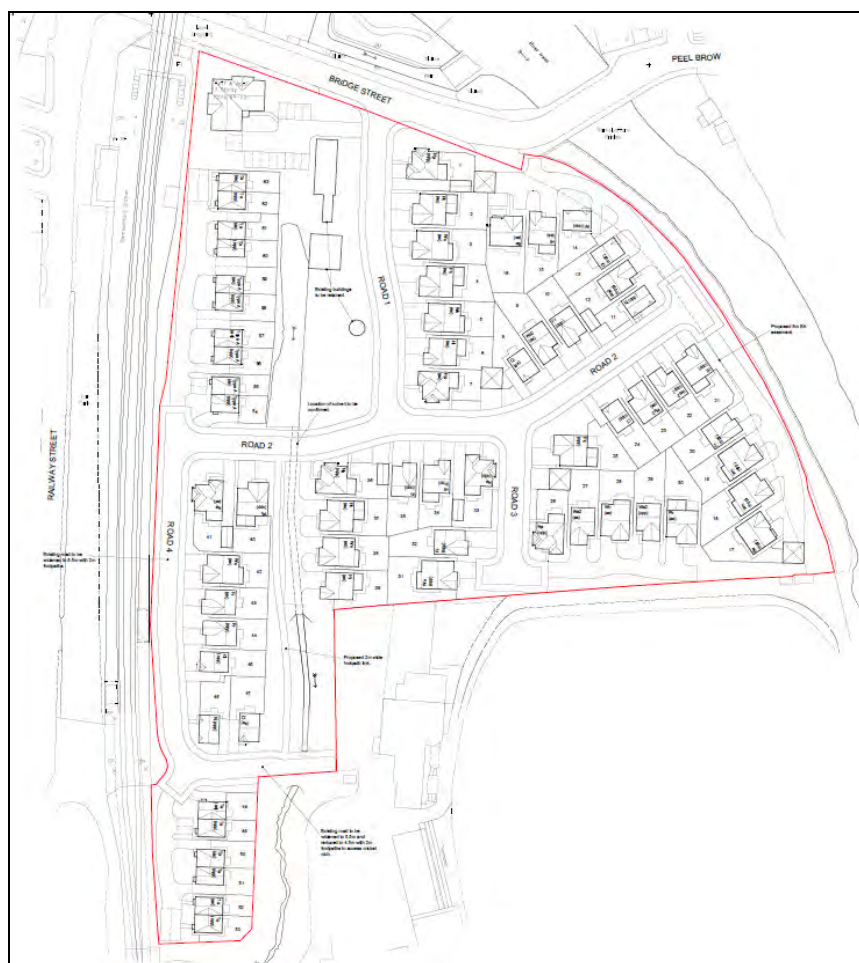
At the time of writing this report, a draft only layout was available. The layout is plan can be seen below;

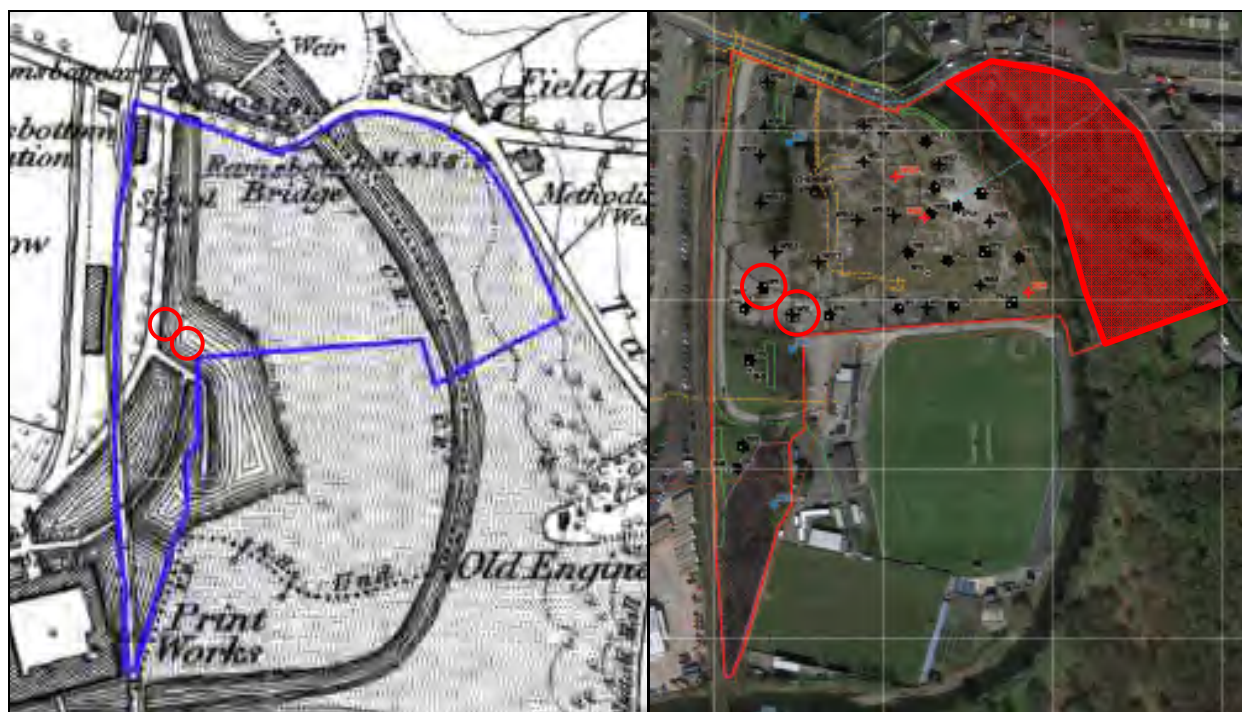
Based on the locations of TP5 and WS1, in relation to the formerly existing reservoirs, it is now considered likely that these are Made Ground samples from backfill / basal reservoir materials. As shown in the sketch below;
