## Bat Roost Assessment

Former Mondi Site  
(Site 1)

Holcombe Mill  
Bridge Street  
Ramsbottom  
BL0 0BS

Ref: P.1202.19

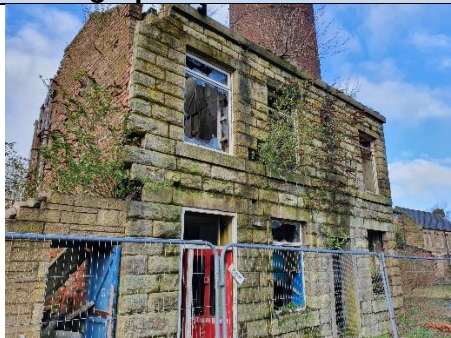
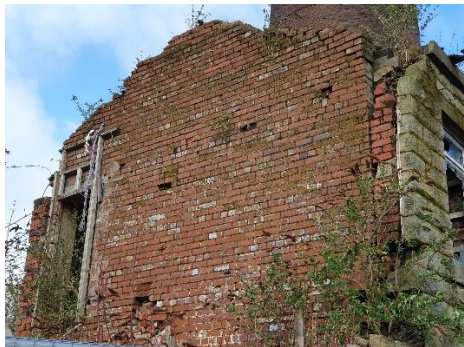
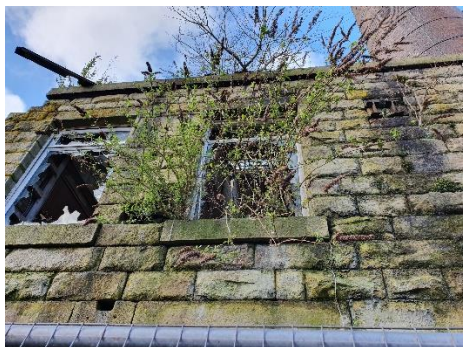
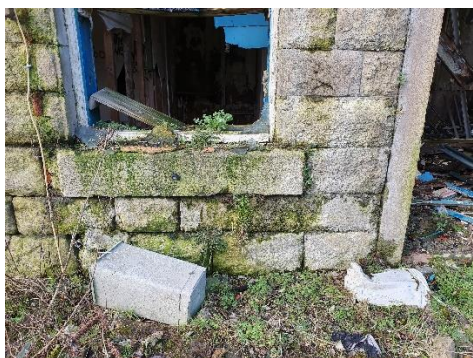
| Building | Photograph |
|---|---|
| <p>Building B3 is a detached two-story building constructed of brickwork walls and a pitched slate roof. The building has been unoccupied for several years and in a poor state of repair.</p> <p>The eastern elevation of the building, which was formerly the main entrance area has been faced with stone block and cavity wall brick work visible to the southern elevation. Small gaps were visible under the ledges above and below the windows. The windows on the eastern aspect are timber frame and all have broken glass. The doors are also timber, not secure and have broken glass. Gaps were noted within the wooden window frames that may provide potential roost features for bats.</p> <p>To the southern elevation there is a part demolished extension to the buildings, the remains indicate that the section of the building was constructed from solid brick work walls. Visible gaps and areas of missing mortar were visible within the remaining wall of the building and within the areas of demolished walls. The roof was in a very poor state of repair with large areas of the slate roof tiles missing, exposing the pitched roof beams and supports. In the areas where the roof is intact visible gaps were noted along the ridge line and small gaps were visible with the aid of binoculars under the roof tiles. To the northern and southern aspects of the roof gaps were identified under the flashing. Vegetation including buddleia has colonised in sections of the building, including around door and window frames, short ephemeral vegetation has colonised on the ground floor</p> | <p><b>B3 Eastern elevation</b></p> <p><b>B3 Southern elevation</b></p> <p><b>B3 Buddleia around a first-floor window</b></p> <p><b>B3 Visible gaps within stonework</b></p> |

window frames and moss was noted within the brickwork.

No signs of bats were noted during the external inspection, including no evidence of dropping, staining or scratching. Although the building is relatively exposed due to the missing roof, a number of features including the gaps within mortar, gaps surrounding the flashing and gaps within the cavity brick work walling could provide potential roost access points for bats. The building will be lost within the current planning application. The building has been assessed to provide **moderate** bat roost potential for cavity and void dwelling species and will require a minimum of two nocturnal surveys for bats between May and August in suitable weather conditions.

If bats are found to using the building as a roost, then a licence application to Natural England will be required for the destruction of a bat roost.

1. A minimum of two nocturnal surveys to be carried out at building B3 between May and August (in suitable weather conditions) to assess for the presence of roosting bats;

2. The roof and ridge tiles should be removed using Reasonable Avoidance Measures to ensure no harm to bats that may roost within the property opportunistically over the summer;

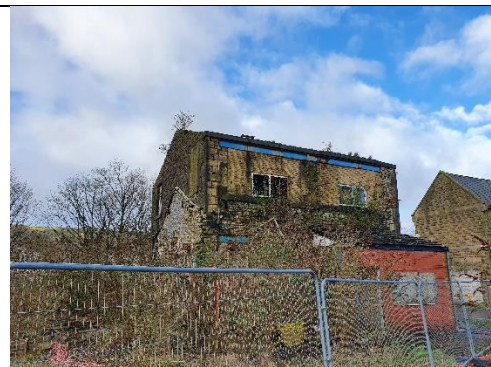
**B2 eastern elevation with single storey extension**

Building B2 is a two-storey building constructed from a mixture of cavity and solid brickwork and stone walls with a pitched roof. To the eastern elevation of the building there is a single storey brick extension with a sloped roof. Evidence of a single storey extension that has been demolished to the south elevation of the building was noted. The windows throughout the building were all upvc frames with missing glass, the windows to the ground floor were all boarded over. The main entrance door is a wooden frame with missing glass panels.

Buddleia was noted growing from the brickwork throughout the building.

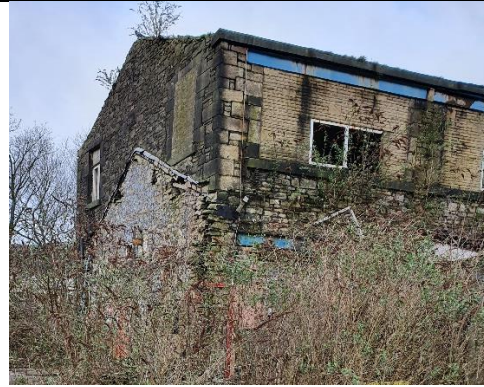
**B2, demolished section to the southern elevation**

During the external inspection gaps and cracks were noted throughout the stonework, with small missing areas of mortar between the brickwork. A metal supporting beam was visible on the eastern elevation with gaps noted between the frame and brickwork within the walls. Woodpigeons and crows were noted within the building during the external inspection. A great tit was also noted sheltering under the metal support beam to the eastern elevation. The building was secured by heras fencing and no internal access to the building was available due to health and safety precautions. No signs of bats were noted during the external inspection, including no evidence of dropping, staining or scratching. Although the building is relatively exposed due to the missing roof, a number of features including the gaps within mortar, gaps surrounding the metal support beam and within the stone walling could all provide potential roost access points for bats. The building has been assessed to provide **moderate** bat roost potential for cavity and void dwelling bats. The building will be retained within the proposals and will not require nocturnal surveys for bats within the current planning application.

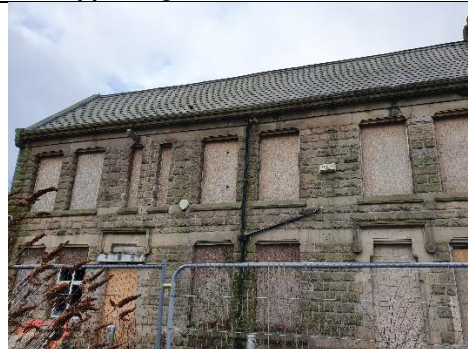
**B1 Eastern elevation**

Building B1 is the most northern structure within the site and is a detached two storey building. The walls of the building are of stonework construction with a pitched slate roof. To the southern elevation of the building there is a demolished extension that leaves an exposed cavity wall with visible gaps within the mortar and sections of missing mortar. The brickwork is in good condition within the main building and all the visible roof tiles were in place, with no noticeable slipped or missing tiles.

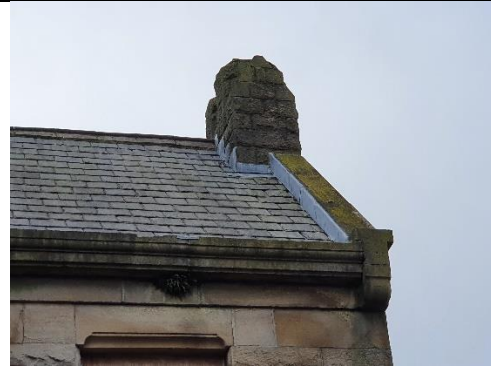
**B1 Visible gaps within the ridge line and surrounding flashing**

Small gaps were visible under the ridge line and under roof tiles. Gaps were also present within the flashing to the northern and southern elevations. To the eastern elevation gaps were noted under the overhanging areas of the stonework. All the windows and doors were boarded over with wooden panels, gaps were noted surrounding boarding at the windows on the eastern elevation.

No signs of bats were noted during the external inspection, including no evidence of dropping, staining or scratching. The building has been assessed to provide **low** bat roost potential for cavity and void dwelling bats. The building will be retained within the proposals and will not require nocturnal surveys for bats within the current planning application.

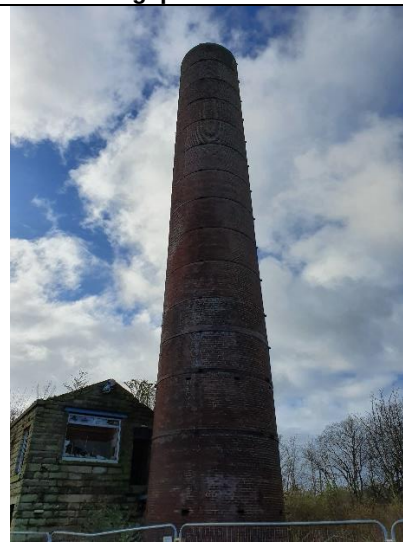
A chimney is present to the north of building B3 and is a solid brickwork constructed building. No windows or doors are present. The brick work is in a good condition, with acceptance to a few visible gaps and cracks with the aid of close focusing binoculars. Ventilation bricks were noted within the lower sections of the chimney. The building has been assessed to provide **low** bat roost potential for cavity and void dwelling bats. The building will be retained within the proposals and will not require nocturnal surveys for bats within the current planning application.

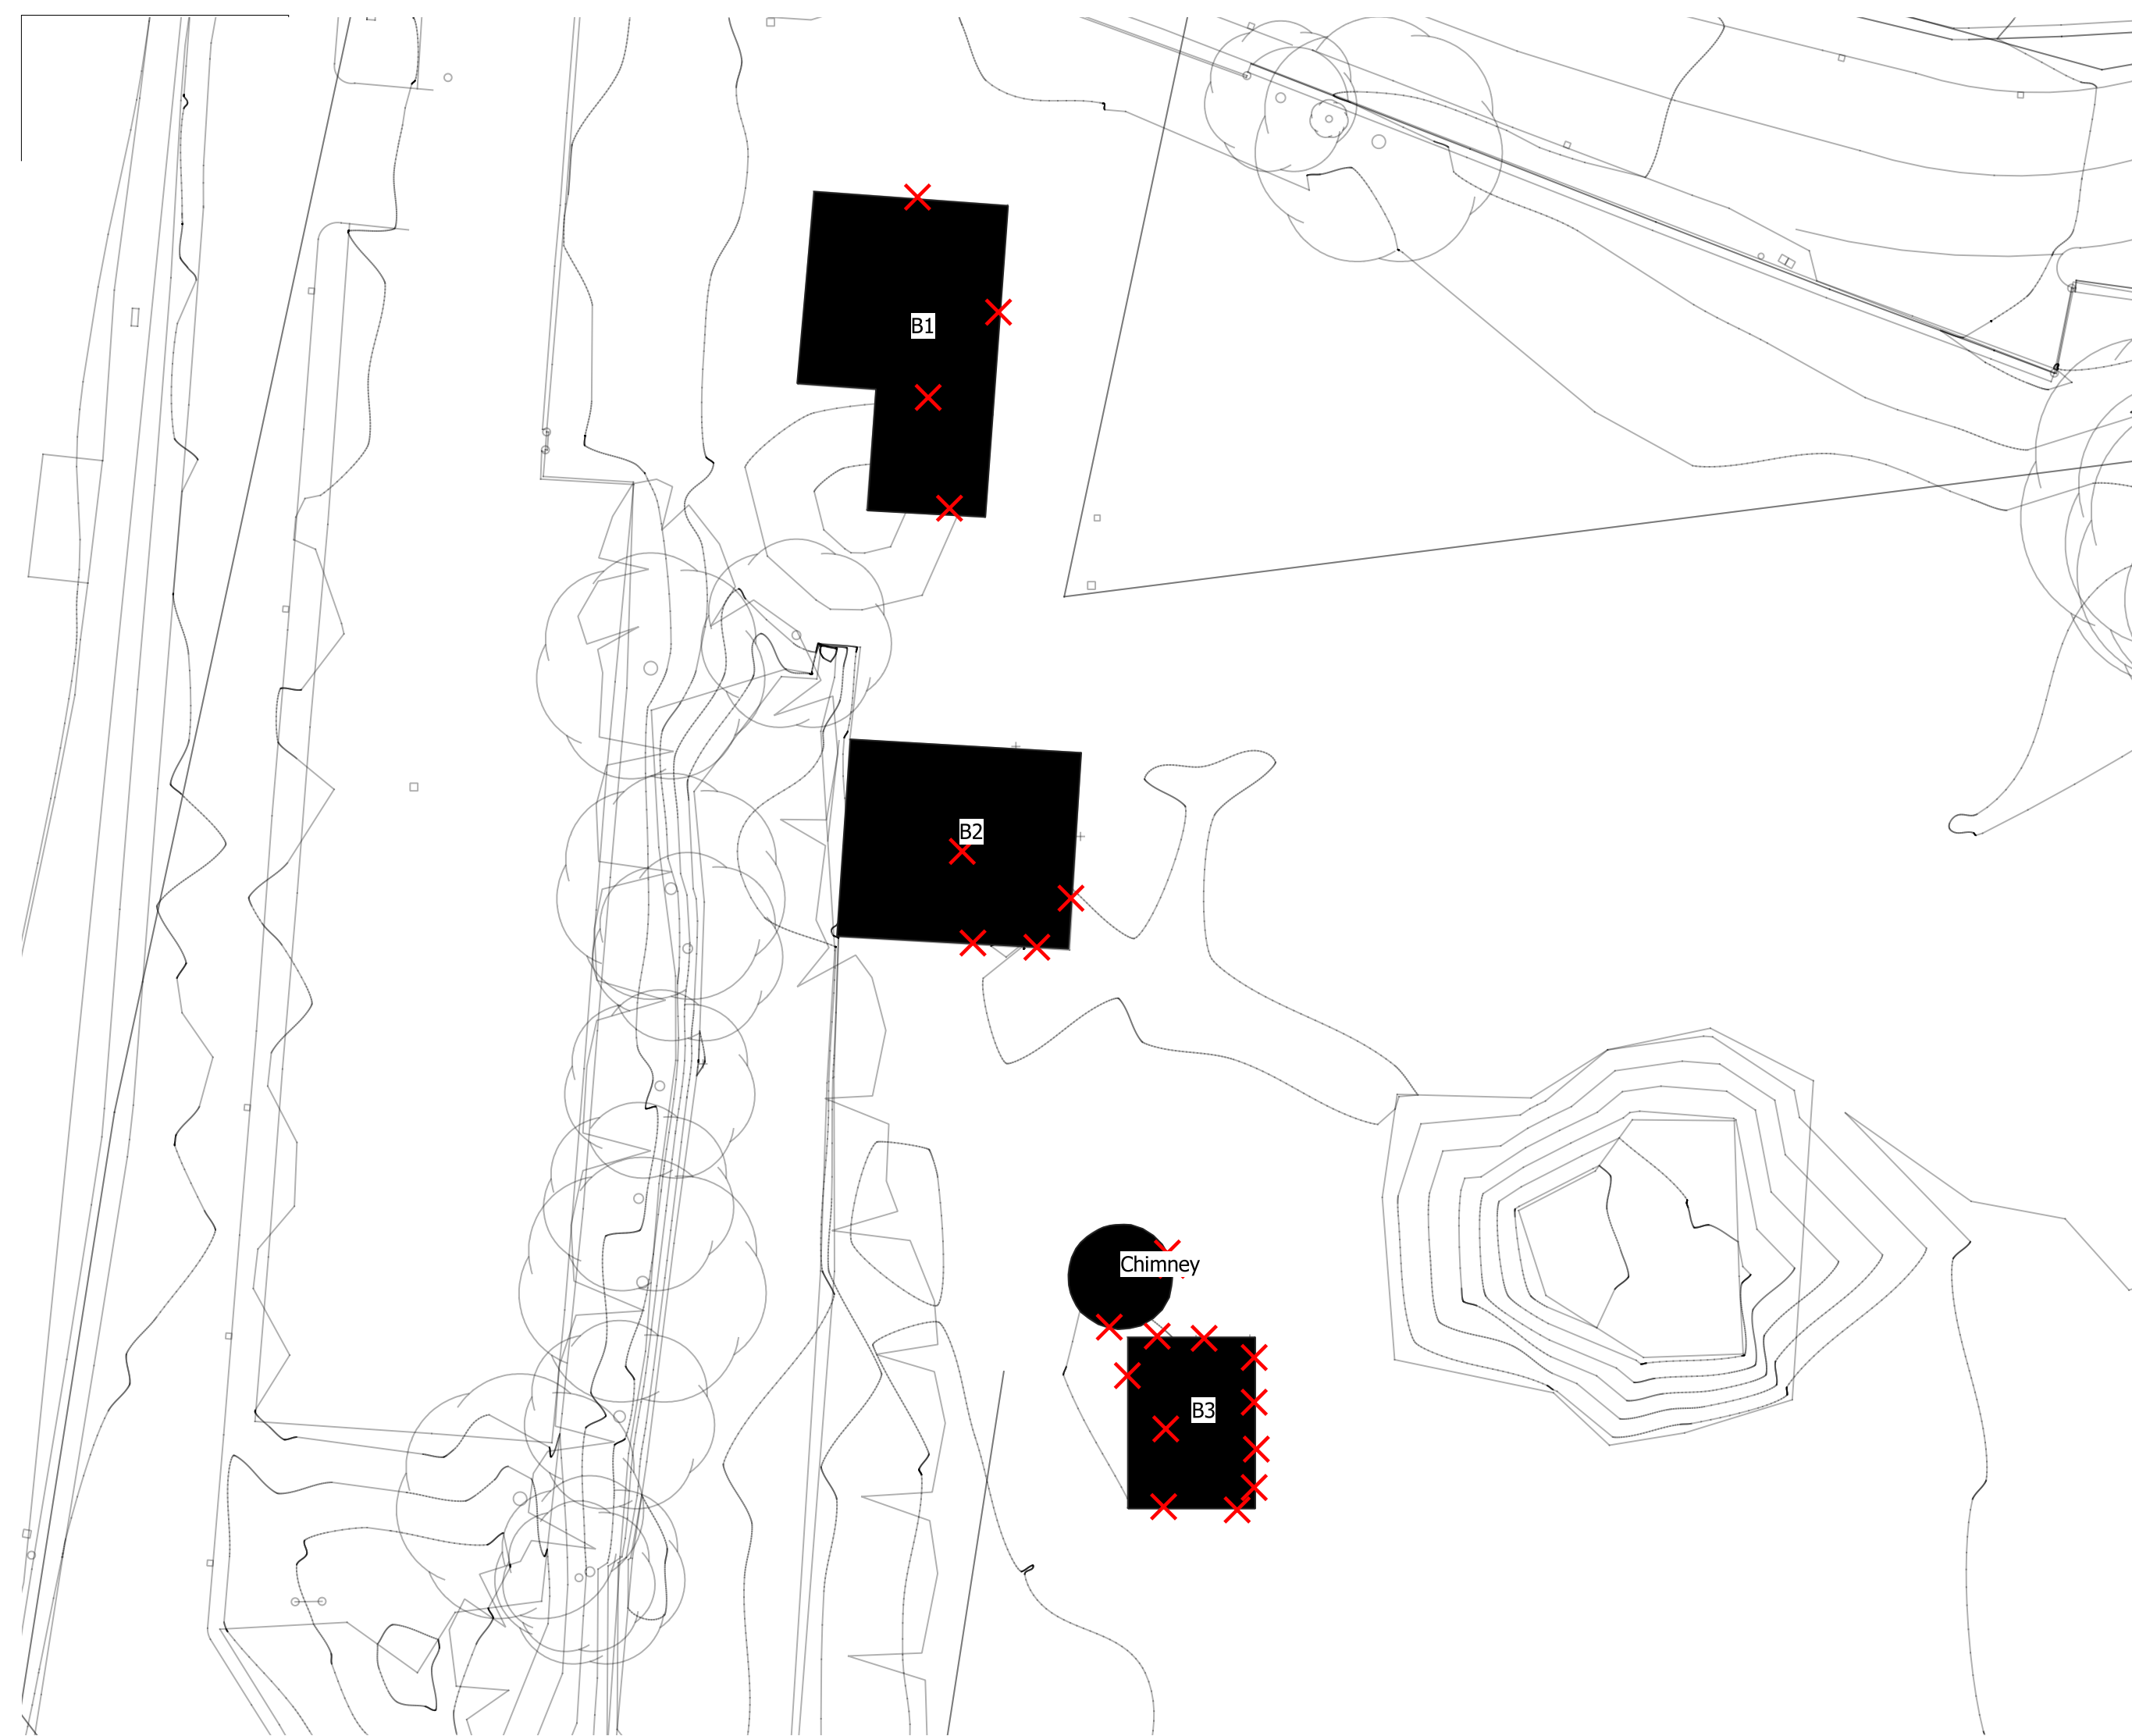
DRAWING TITLE:  
Preliminary Bat Roost Assessment

Potential access points
