## **PHASE I AND PHASE II GEO-ENVIRONMENTAL SITE INVESTIGATION**

**Bevis Green Works (Tetrosyl)  
Mill Road  
Walmersley  
Bury  
Lancashire  
UK  
BL9 6RE**

**E3P Report: 10-110-r1  
Issued: May 2014**

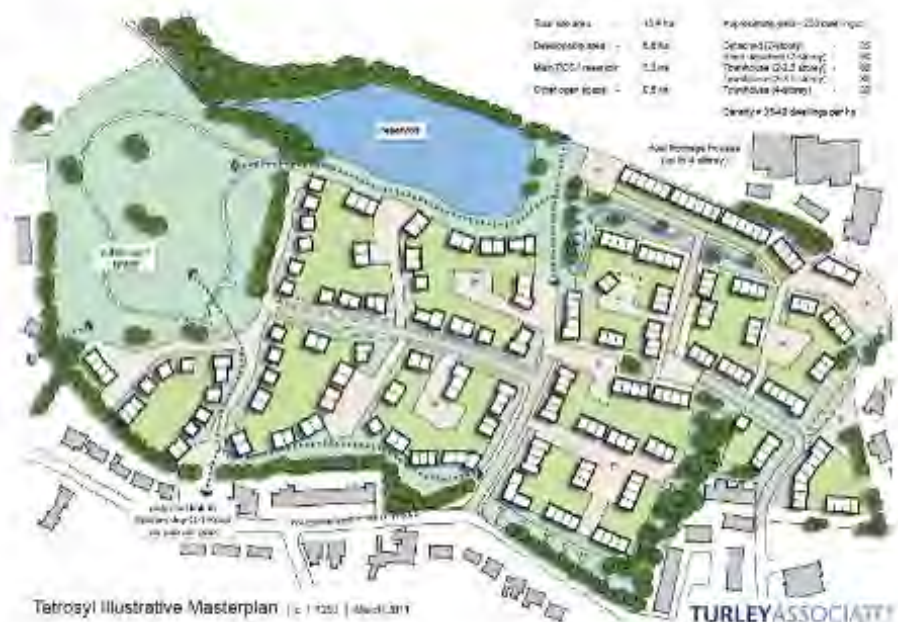
**Figure 1.1 – Indicative Development Layout**

Tetrosyl have been granted outline Planning Permission (ref: 53762) dated 30/03/2011 for the construction of 275 dwellings with associated private gardens and driveways, estate roads and adopted infrastructure. At this time the final development layout has not been defined, however the indicative 'master plan' has been presented within Drawing 10-110-003 and indicated in Figure 1.1 (below)

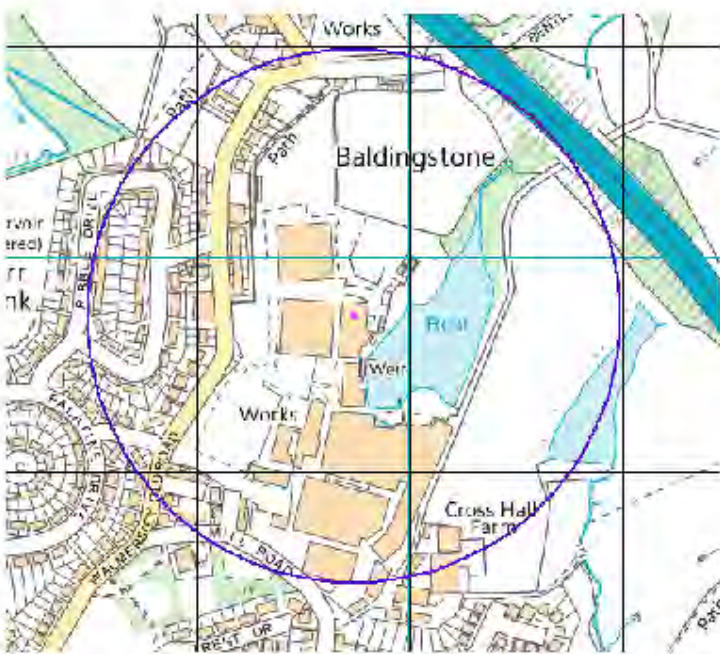
**Figure 2.1 Current Site Location & Layout**

The current site layout and synopsis of land uses is detailed within E3P Drawing 10-110-002 included within Appendix III of this report and indicated in Figure 2.1 below.

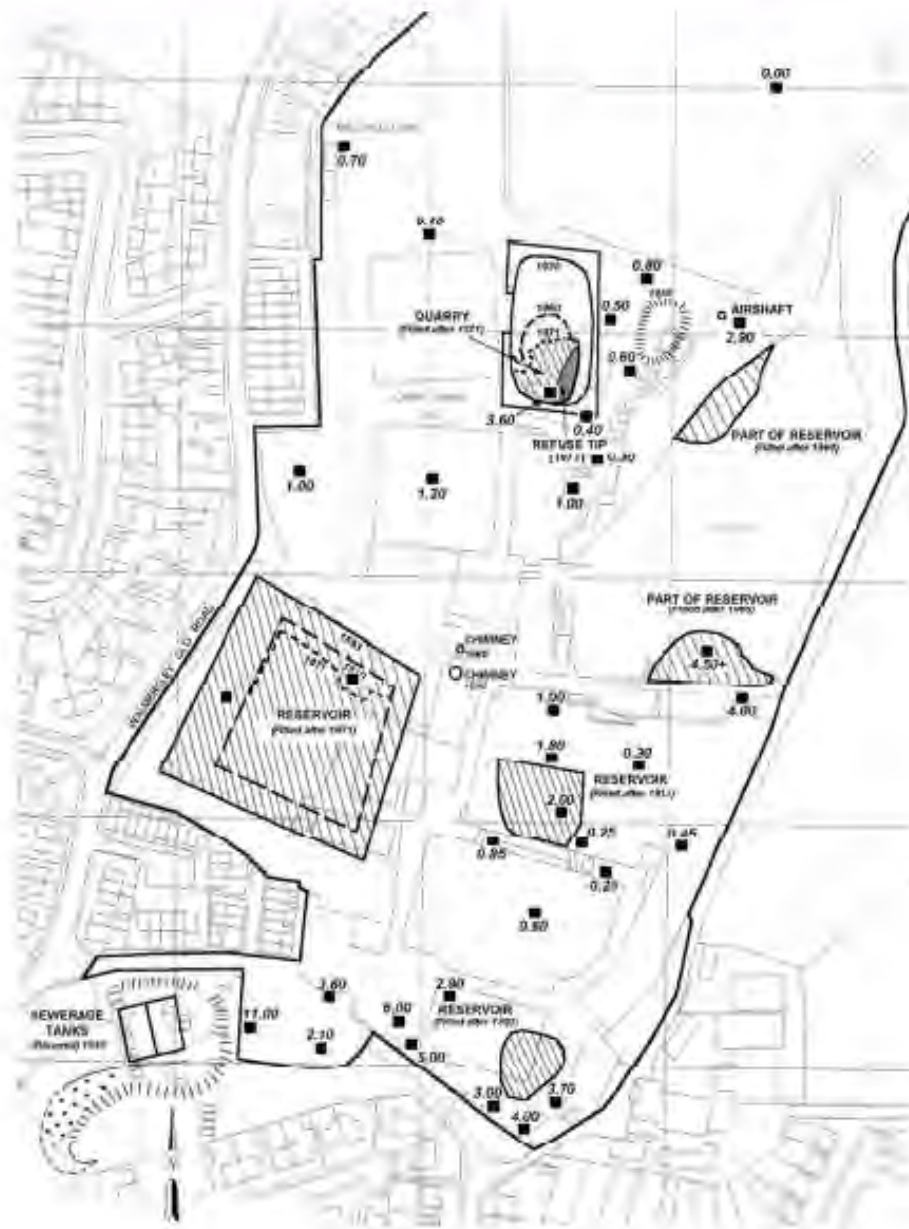
Figure 2.1 – Extract of RSK Intrusive Investigations & Historic Land Use

An extract of the RSK Historical Synopsis is included as Figure 2.1 (overleaf).

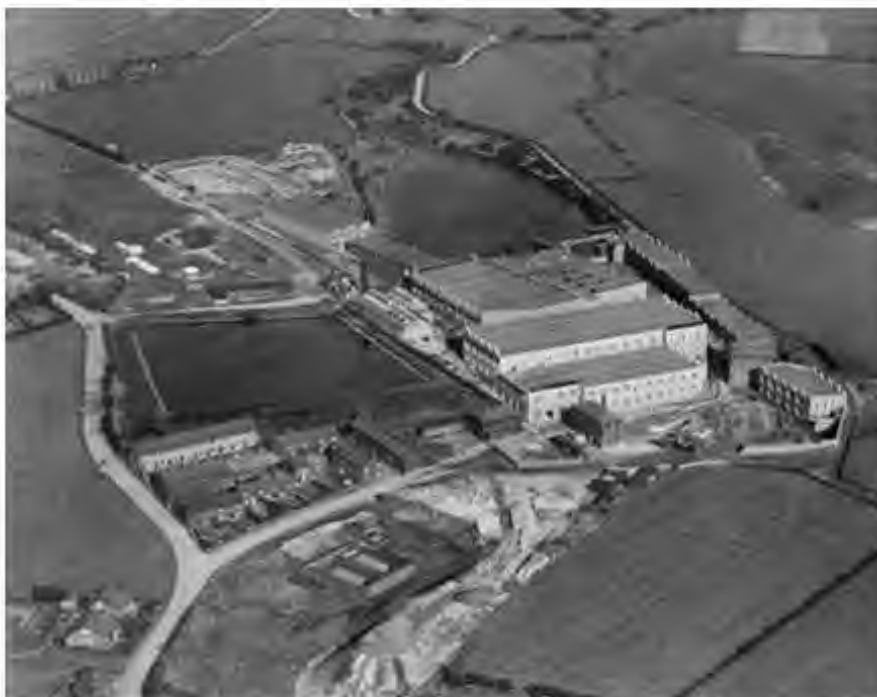
An extract of aerial photography from English heritage 1927 archive is presented as **Figure 3.1 below:**

Figure 3.1 gives an overview of the site with two large reservoirs to the north and west and main mil complex to the central and southeast. The landform has been dammed to allow the collection of water with mill buildings having been built into the hillside to create a split level site.

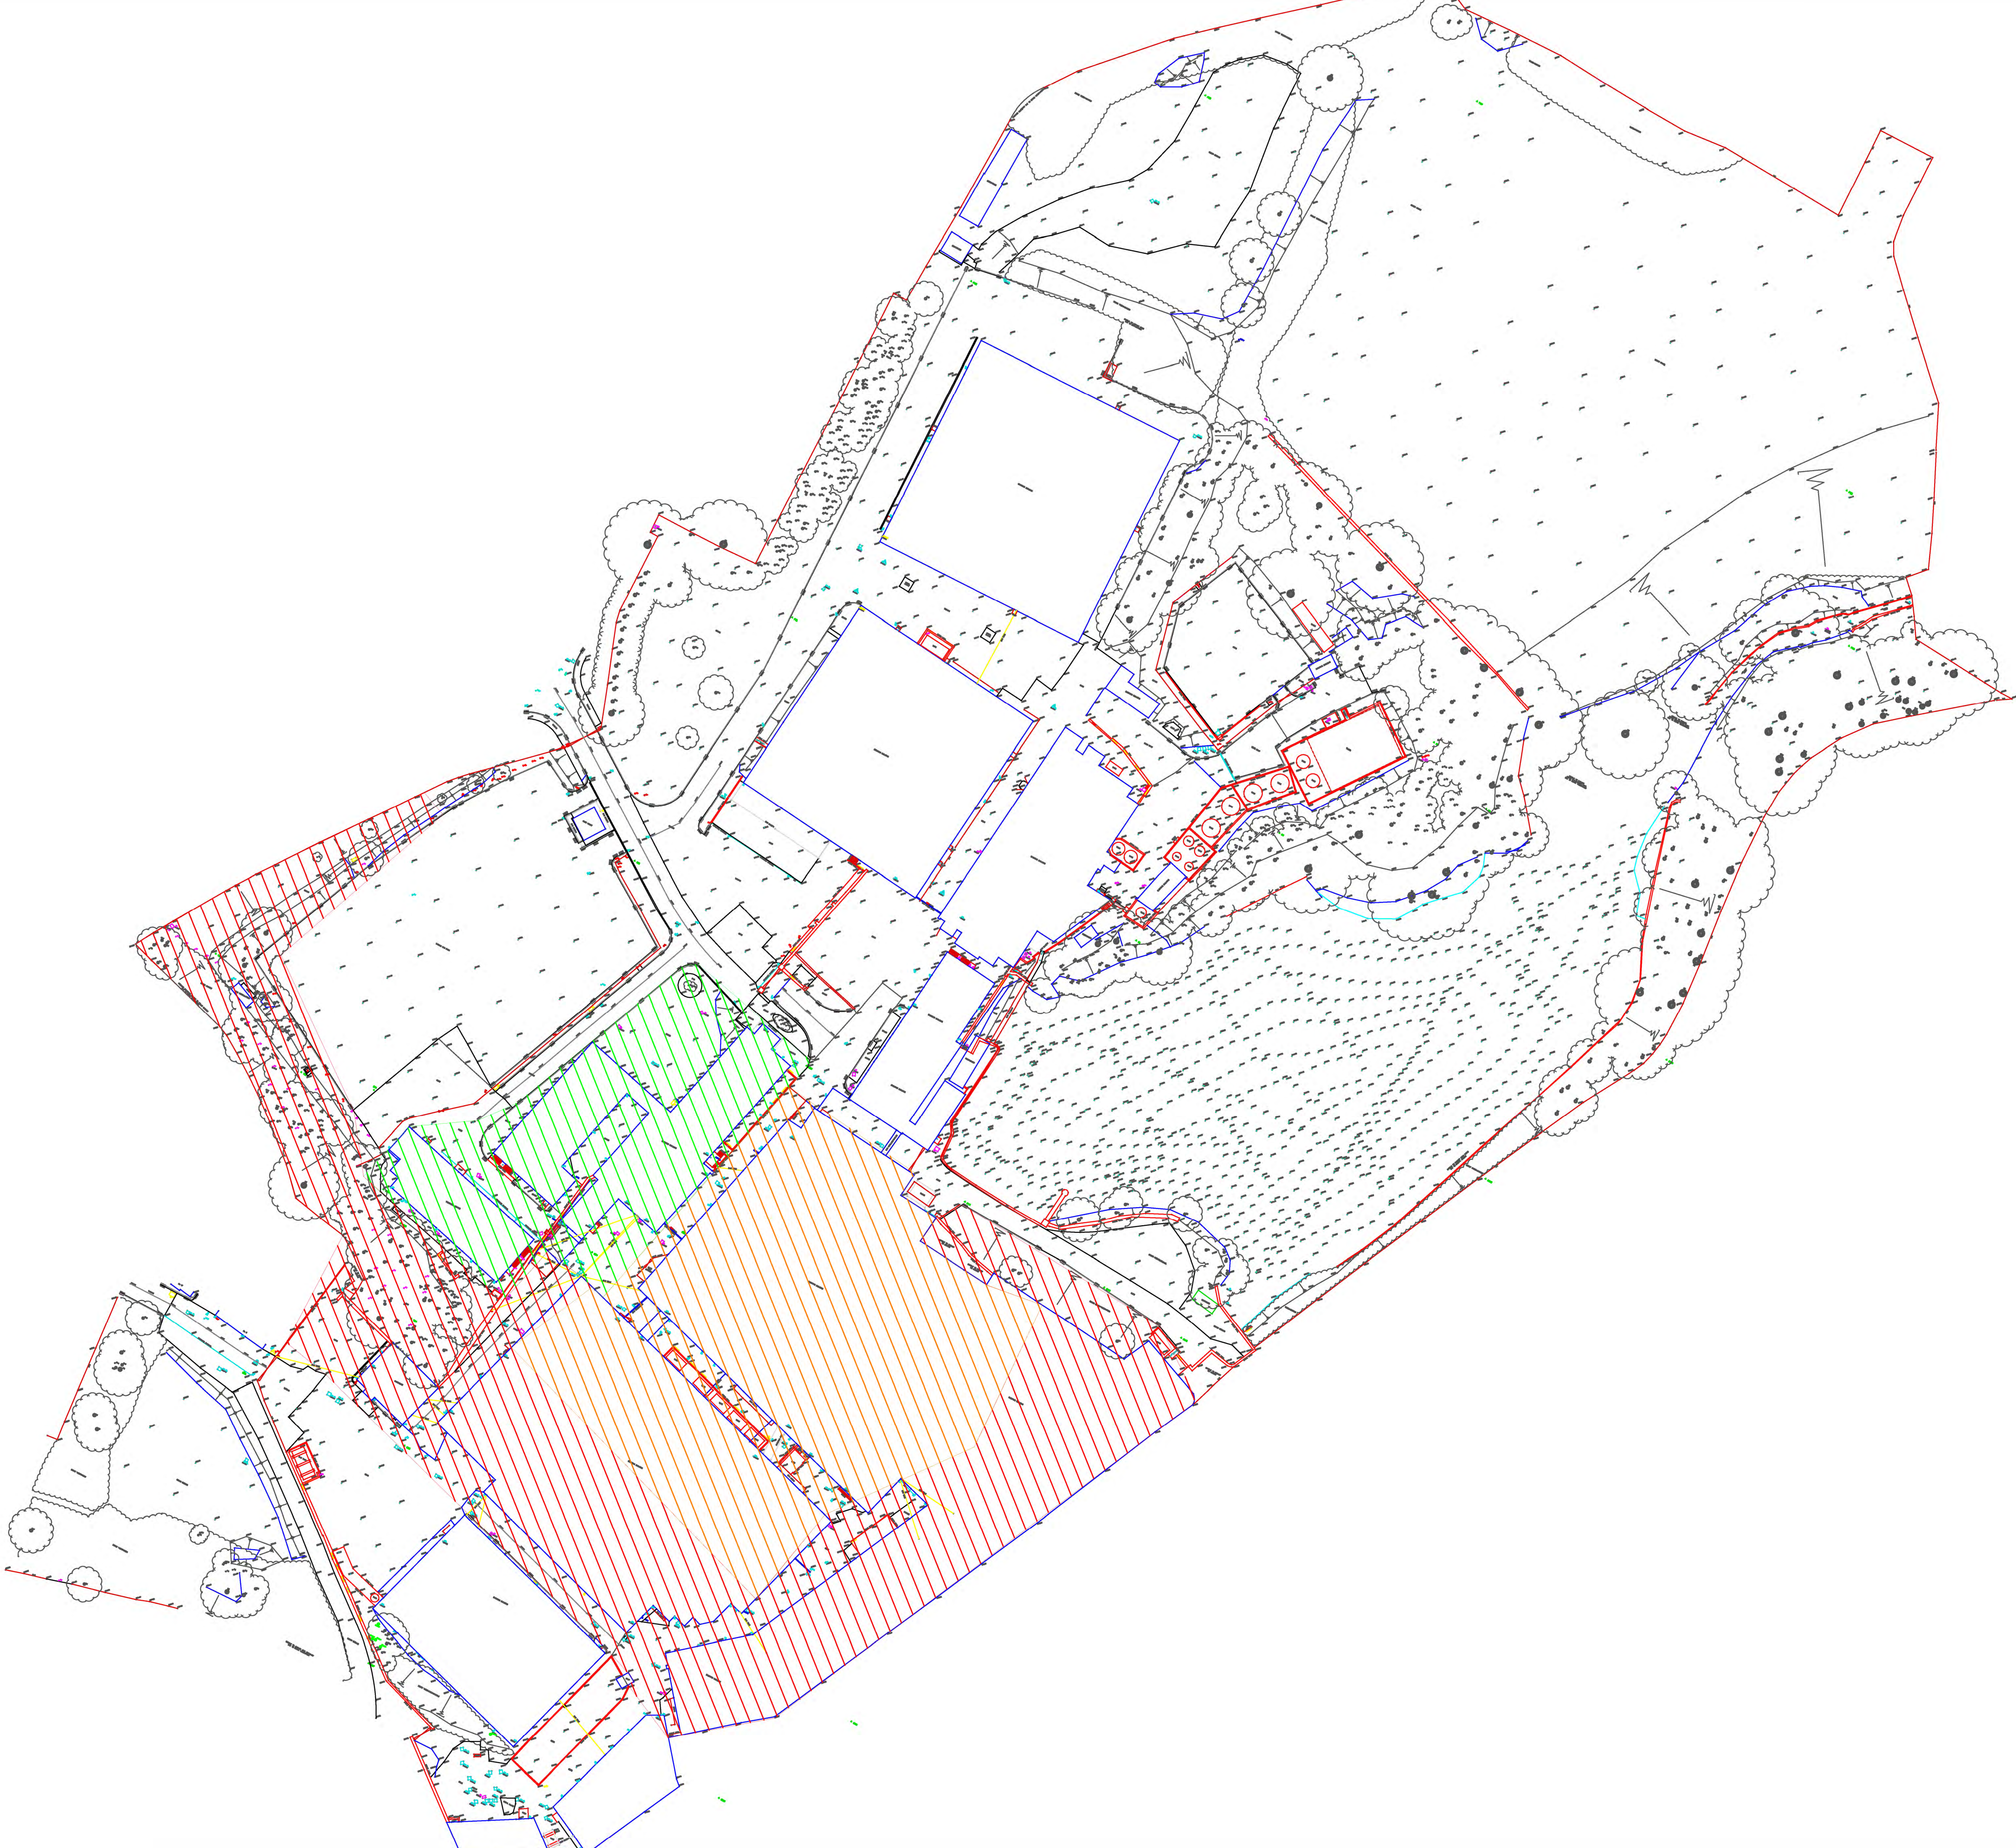
Red area denotes sectors of the site where significant topographic variations have been observed

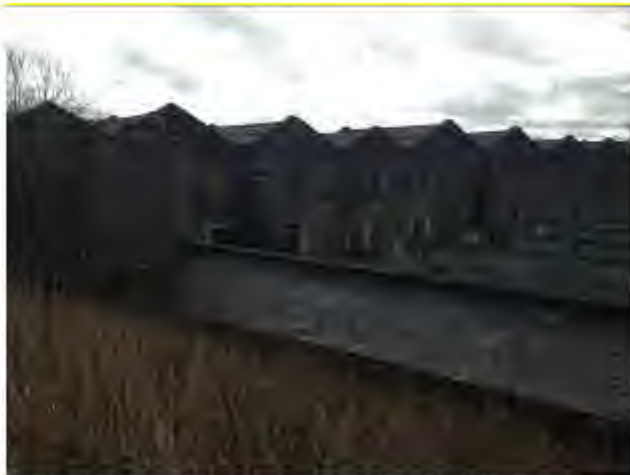
**Plate 7 – Dam Looking Southeast Showing Split Level Site**

Current site elevations must be considered in the appraisal of the proposed residential development and it must be noted that the current 19<sup>th</sup> Century Structures form a large ten meter retaining structure at the eastern boundary and also form the split levels across the development site.

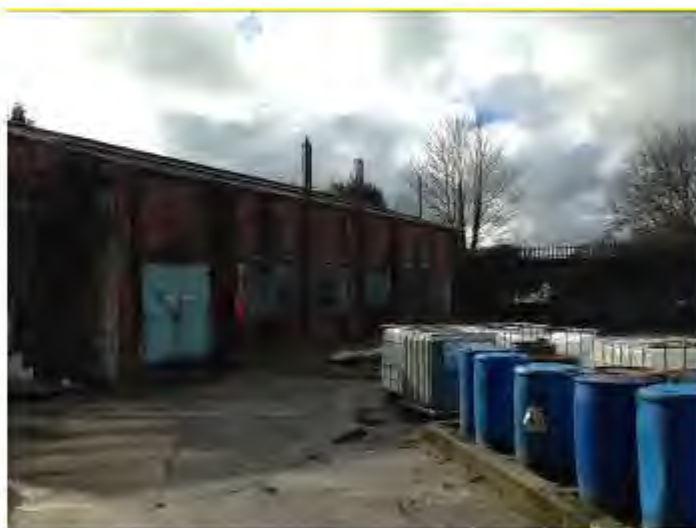
**Plate 12 - Far Southern sector showing Underground Tank Farm and Ventilation Pipes**

An underground Tank Farm was observed within the far southern corener of the site (at the lower elevation) with evidence of filler points, air ventilation pipework and general manhole covers representing UST's. The site manager had no detailed records of the number, type and current condition of the UST's.

A series of Underground Storage Tanks (UST's) have been identified at the far southern boundary, used for the storage of petrol, diesel and White Spirit. Given the age, condition and historic use of these UST's, it is considered that general decay of filler pipes and tank infrastructure, will have resulted in impact to underlying soil from this infrastructure.

Historical, tank leakage, spillage and seepages will have occurred from these storage tanks on site and there is considered to be short term risk to construction workers who may come into contact with any. It is also considered that there is a risk to future residential site occupants through the migration of vapours to indoor air, direct contact and consumption of home-grown vegetables.
