**Westchurch Homes**

**REMEDIATION STRATEGY**

**Land at Radcliffe Moor Road, Bolton**

**REPORT No: 20WCH011/RS**

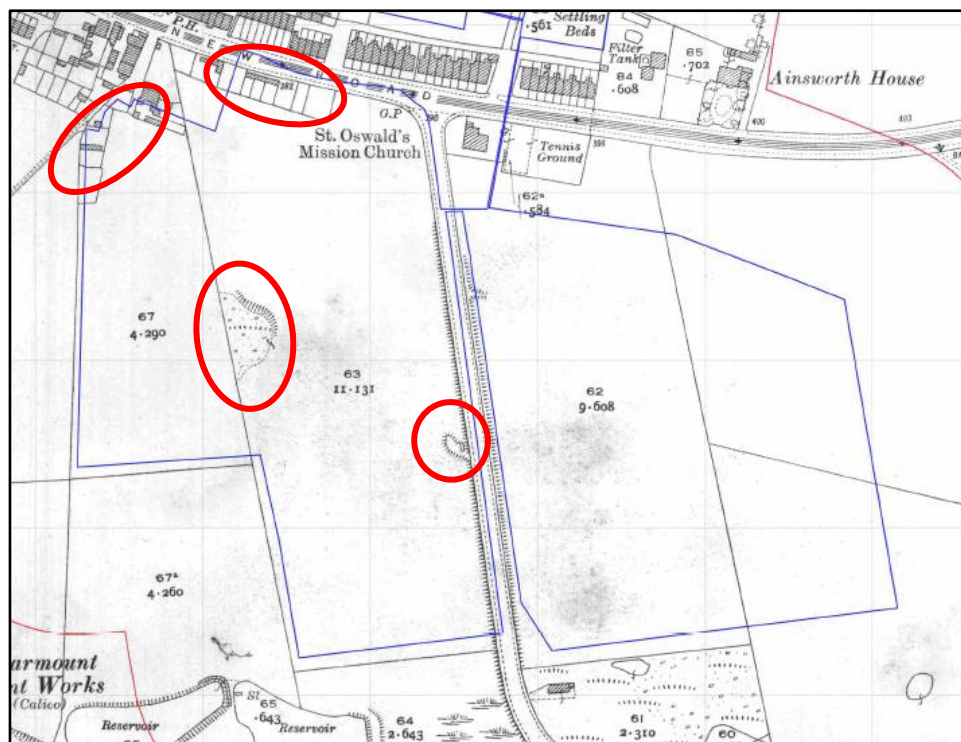
## 1930 1:1,250 Map

No further major changes are shown to occur onsite until the 1930 1:2,500 map where the pumping station is no longer shown and instead is just a hollow and a possible mound of made ground is shown in the centre of the western parcel. A number of buildings are also shown along the very northern boundary of the western parcel. An extract of this map is shown below:

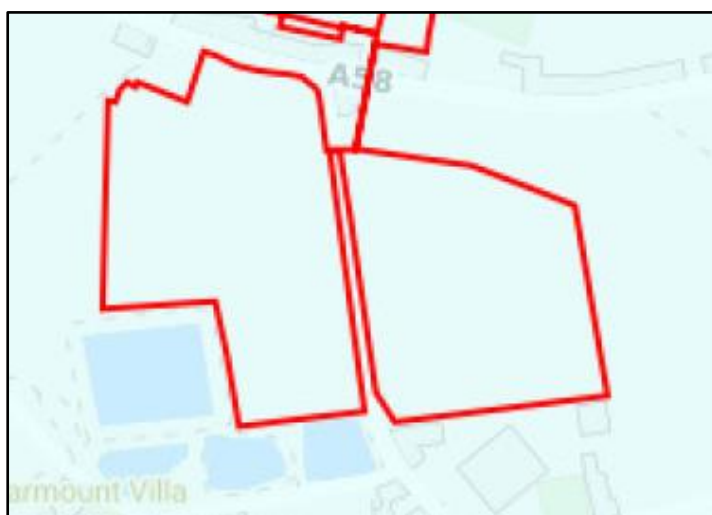
### Superficial Geology

| ID | Location | LEX Code | Description | Rock description |
|---|---|---|---|---|
| 1 | On site | TILLD-DMTN | Till, Devensian - Diamicton | Diamicton |

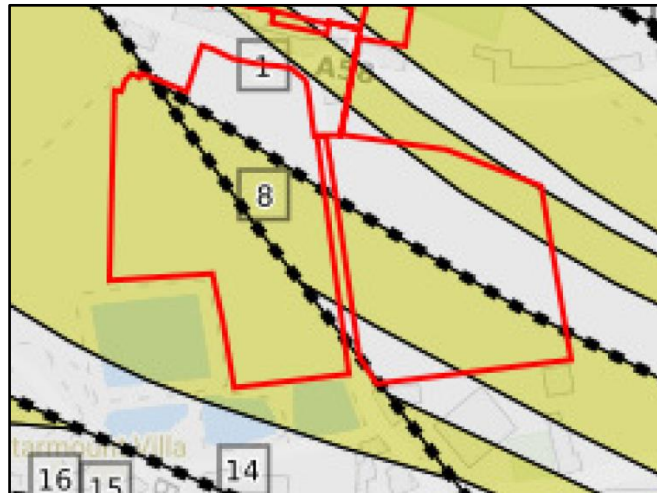
### Bedrock Geology

| ID | Location | LEX Code | Description | Rock age |
|---|---|---|---|---|
| 1 | On site | PLCM-MDSS | Pennine Lower Coal Measures Formation - Mudstone, Siltstone And Sandstone | Langsettian Sub-age |
| 3 | On site | CAR-SDST | Cannel Rock (south Lancashire) - Sandstone | Langsettian Sub-age |
| 4 | On site | TRBR-SDST | Trencherbone Rock - Sandstone | Langsettian Sub-age |
