# HOLLINS LANE, BURY

## PHASE 1: PRELIMINARY RISK ASSESSMENT

**Job Number:** LKC 22 1603  
**Date:** 10<sup>th</sup> November 2022  
**Client:** Gary Ridings

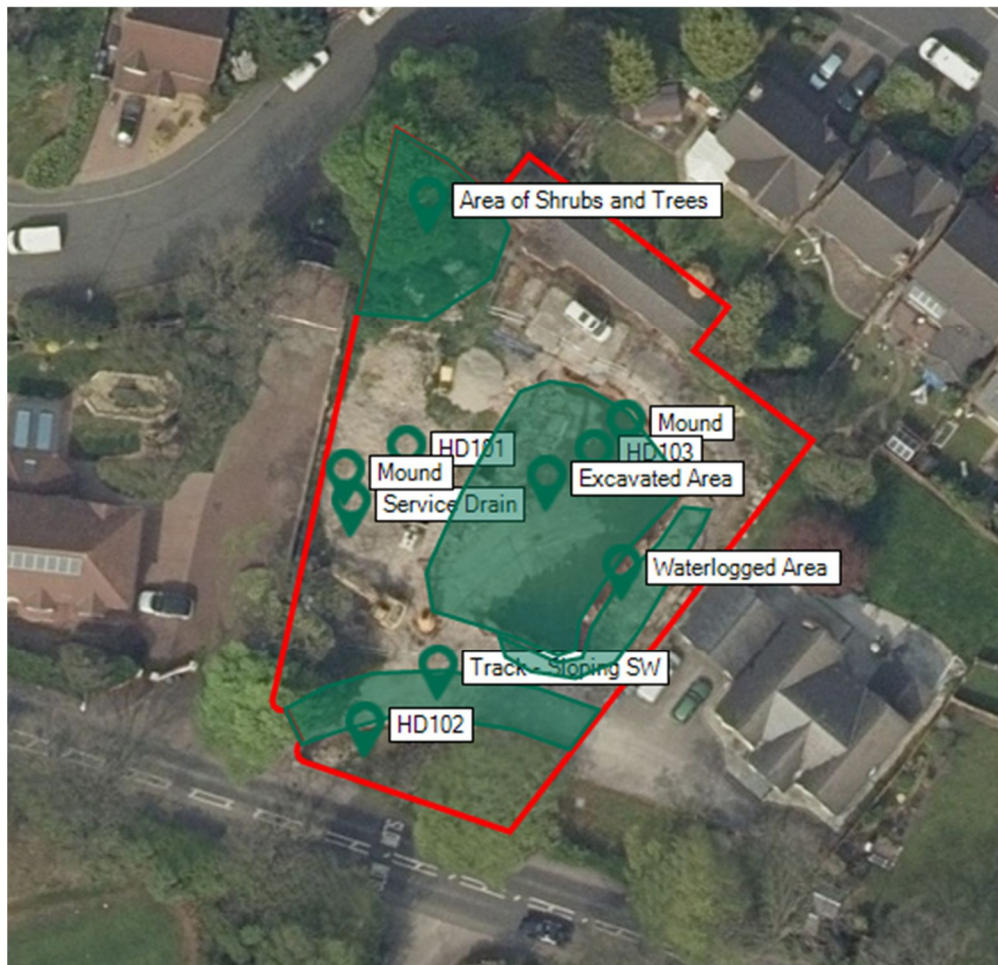
Plate 4-3: Plan showing relevant site walkover features.

- » Southern area of the site comprises a driveway area. A hardstood track of gravel, concrete and stone is present, along with a soft verge with shrubs and trees to the south of the track raised ~0.7m above the track. The track slopes down gently to the site entrance in the southwest.

- » A derelict one storey brick building is present in the northern tip of the site. This was inaccessible at the time of the site walkover.
- » The central area of the site comprises a groundcover of clayey made ground. A flat excavated area with sheet piling surrounding it is present in the centre, which is ~1.10m below the adjacent areas of the site. The area to the west of this (at ground level) contains several in ground structures visible from the surface and the excavated area.

- » The excavated area between the east of the sheet piling and ground level was pooled with water. A collapse of the concrete to the south of the building was also present. These factors make the areas to the north and east of the sheet piling likely inaccessible for site investigation with drilling. There are no access restrictions in the rest of the site.

- » No evidence of contamination identified. Several heaps of made ground present across the site.
- » One service drain was noted in the southwest of the site.

Relevant features are also shown on Plate 4-3.
