**PHASE 2 GROUND INVESTIGATION:  
PINFOLD LANE, PRESTWICH**

**GSL3003R01**

**27 NOVEMBER 2023**

GroundSolve Ltd

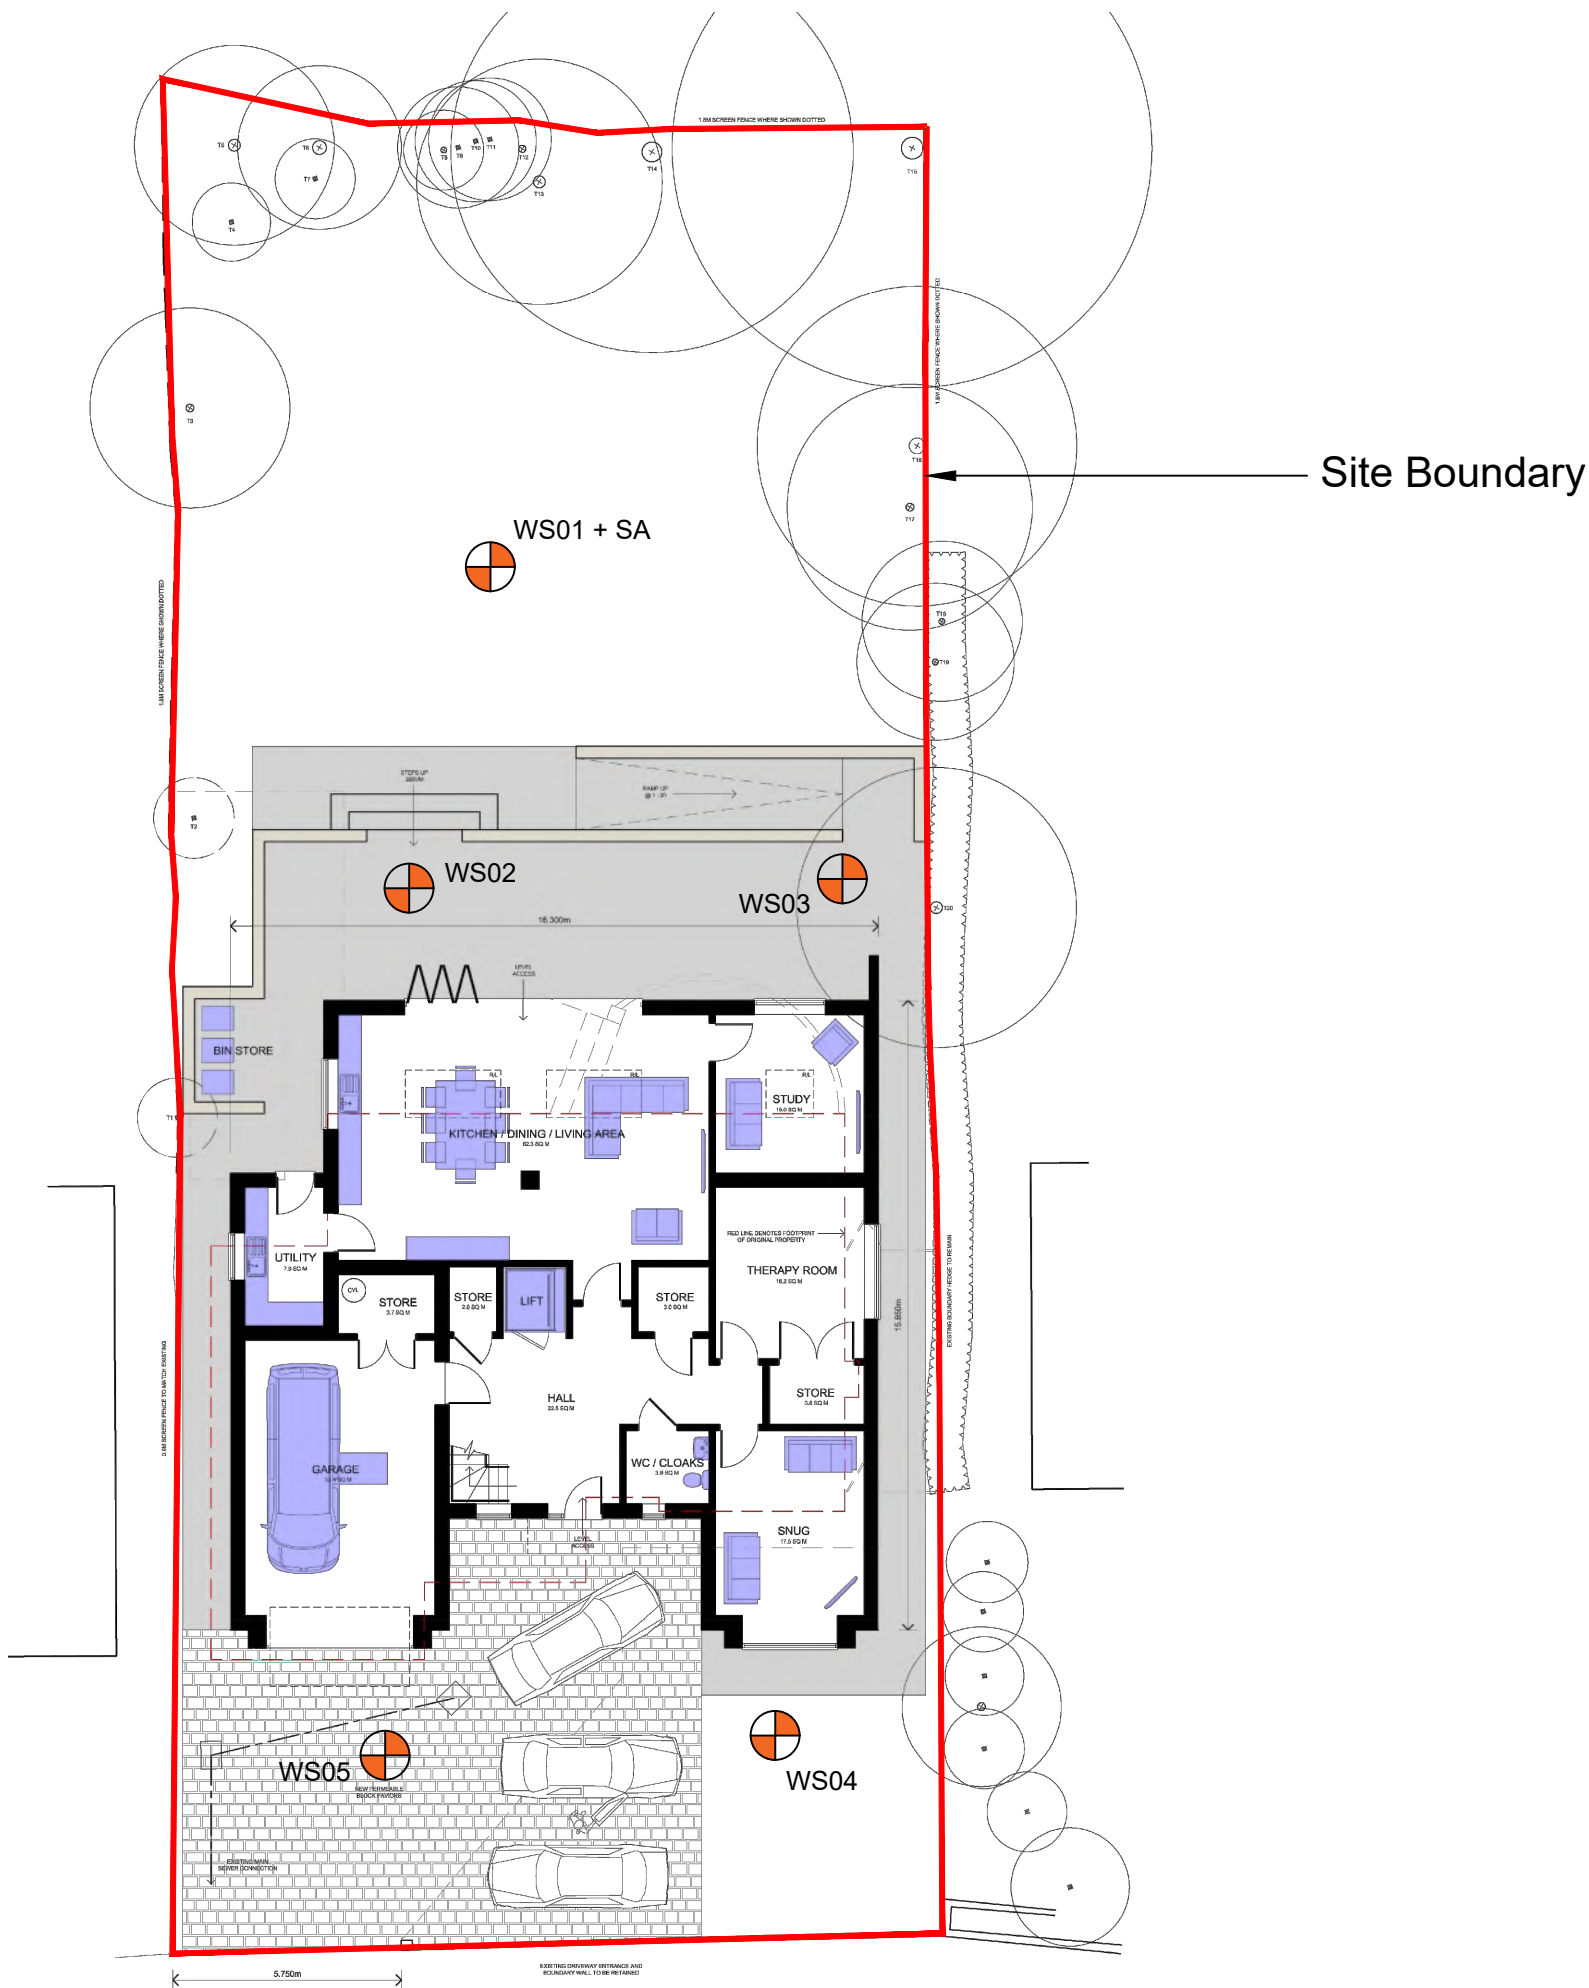
| <b>3003-DR-001</b> | <b>A</b> | |

Exploratory Hole Location
