# **Bat Survey Report and Method Statement European Protected Species (Bats)**

**Outbuilding at Barrack Fold Farm,  
Knowsley Road,  
Ainsworth,  
BL2 5PU**

**31.08.2023**

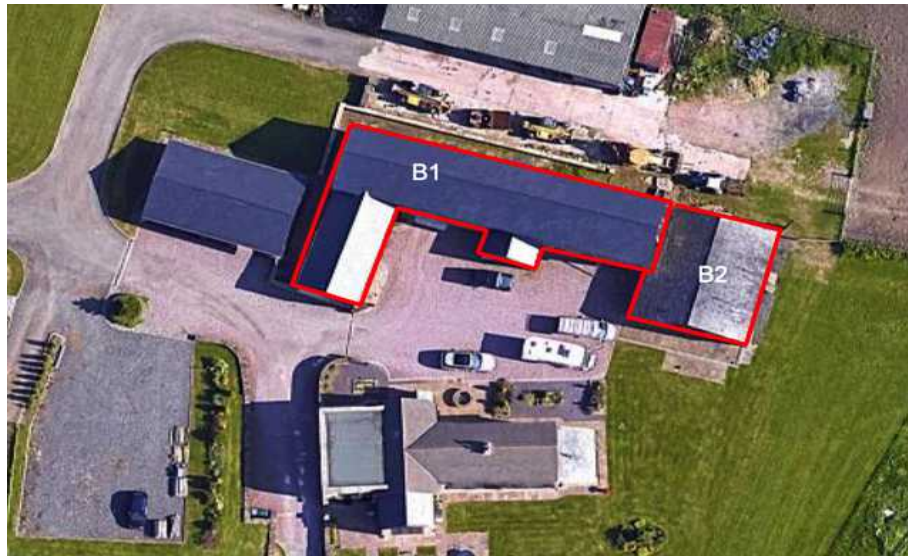
The property consists of a two adjoining buildings.

Is a recently converted stone and brick built L-shaped detached barn with a double pitched slate roof. A single storey porch is present on the frontage.

Walls are generally well pointed and sealed with no cracks, gaps or crevices suitable for roosting bats. Soffits and fascia boarding are close fitting. The gable ends are pointed and sealed.

Roof slates are generally close fitting with no lifted, missing or slipped slates present. The ridge is well sealed. Slates are lined with a modern breathable membrane.

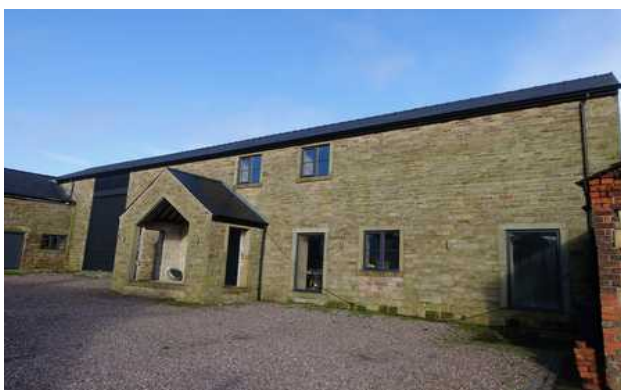
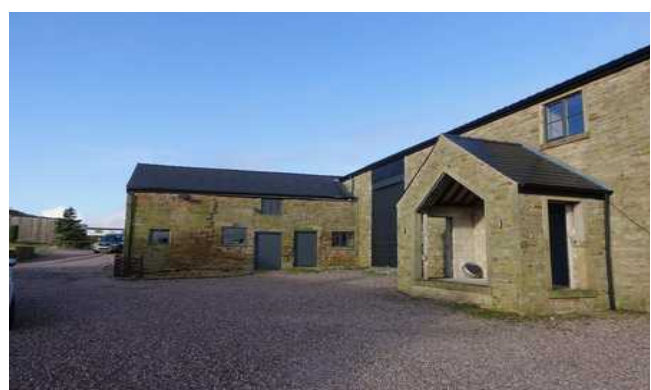
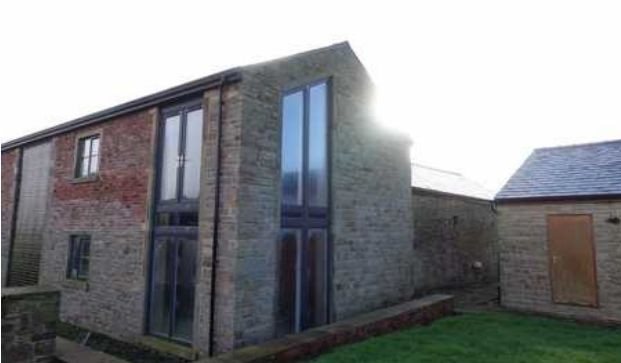
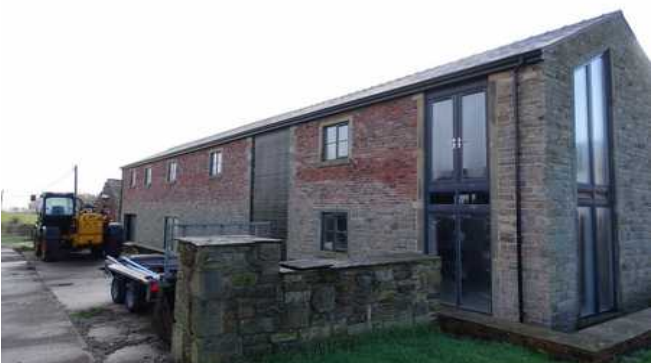
### Building B1

Overall when considered in combination with surrounding habitat the building was assessed as offering negligible bat roost potential.

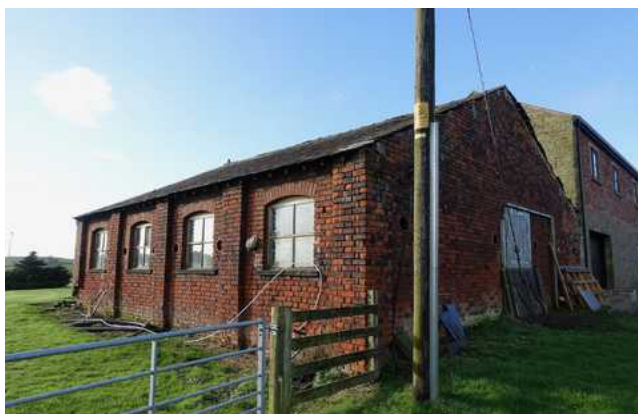
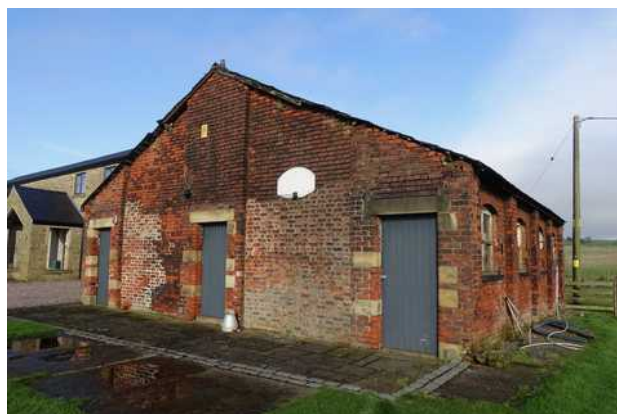
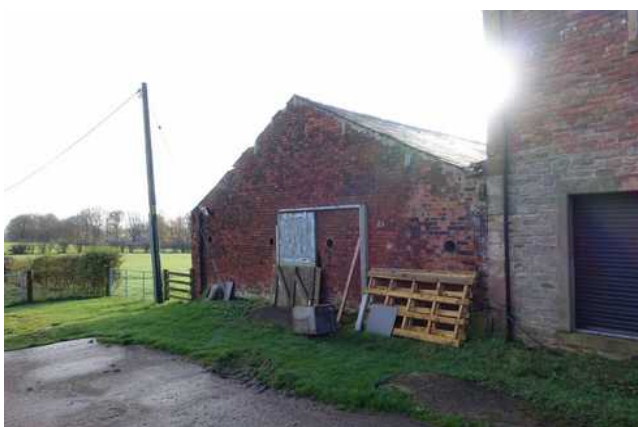
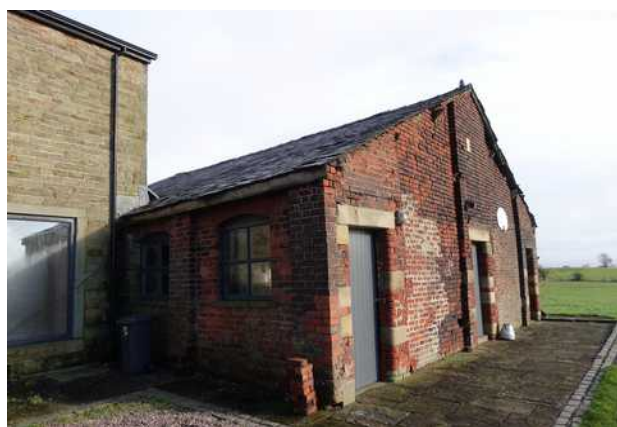
## Building B2

Building B2 is a single storey brick built outbuilding with double double pitched slate roof adjoining the eastern gable end of Building 1.

Walls are generally well pointed and sealed with no cracks, gaps or crevices however large open gaps were recorded at wall top level. Blocked openings were present on gable ends and the eastern facade.

Roof slates are generally close fitting with a sealed ridge, however some lifted, missing or slipped slates are present and gaps were present on gable ends.

Overall when considered in combination with surrounding habitat the building was assessed as offering low bat roost potential.

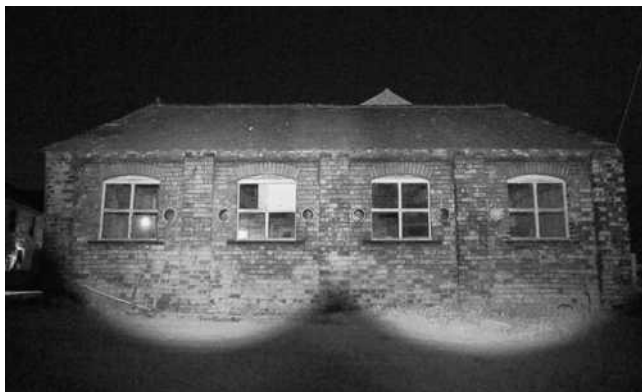
*Eastern facade*

Illumination levels at end of survey.
