# Contaminated Land Phase Two Intrusive Investigation for Proposed Residential Development at, Land adjacent 6 Bentley Lane, Bury, BL9 6RZ.

October 2021

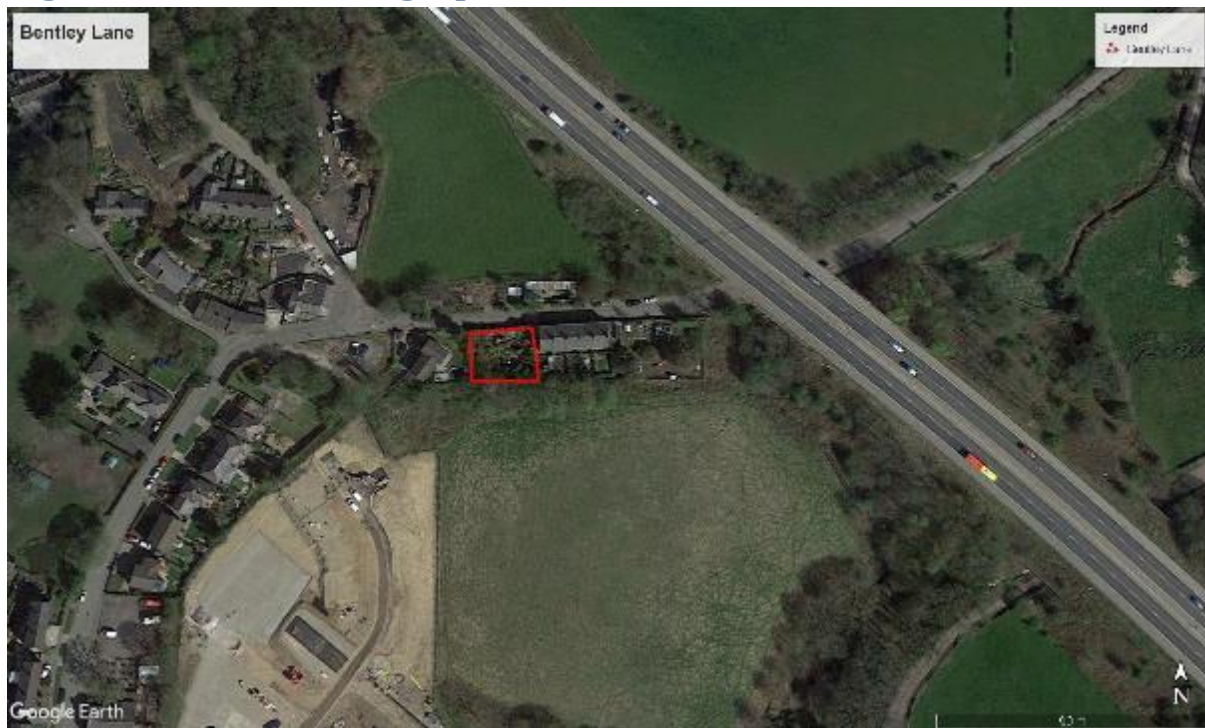
**Figure 1 – Aerial Photograph**

An aerial photograph of the site is included in Figure 1.

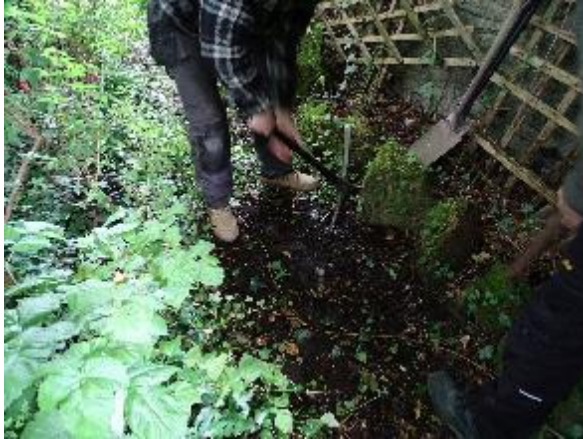
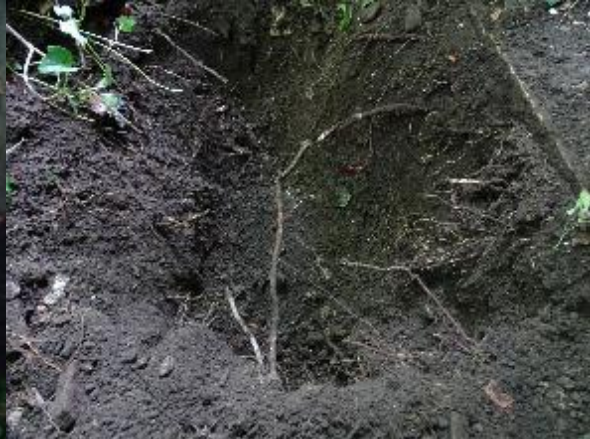
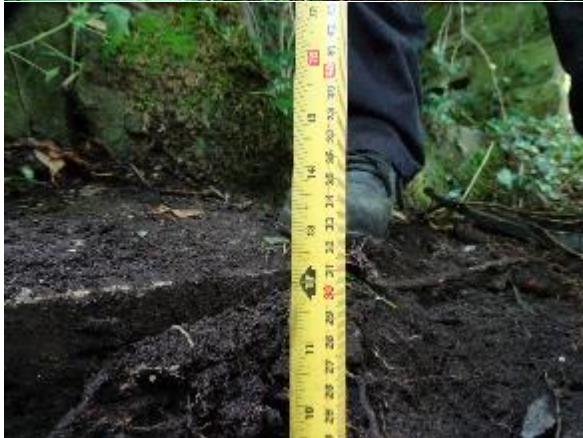
Trail Pit 1a – South East 330mm bgl

| 0.00-0.05m | - concrete flag path, carpet |
| 0.05-0.31m | - roots, brown loam soil, small stones and grit |

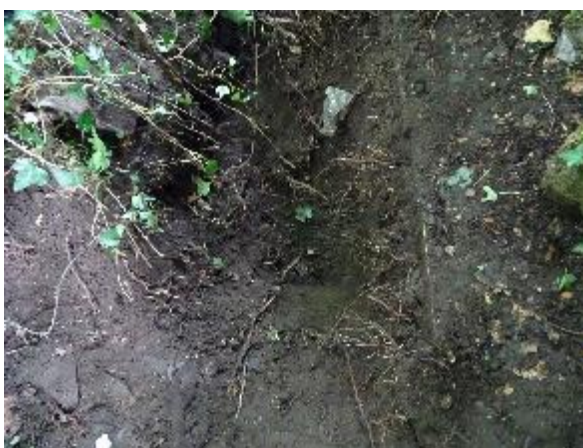
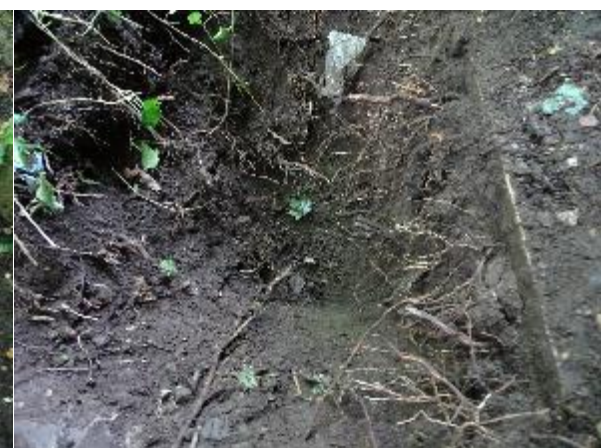
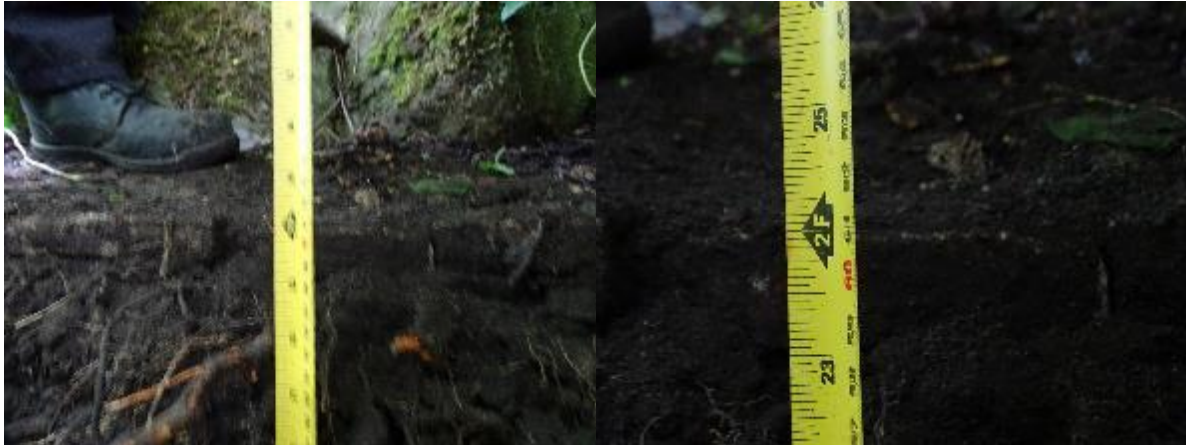
Trail pit 1B – 600mm bgl

| 0.31-0.60m | - (less) roots, brown loam soil, small stones and grit |

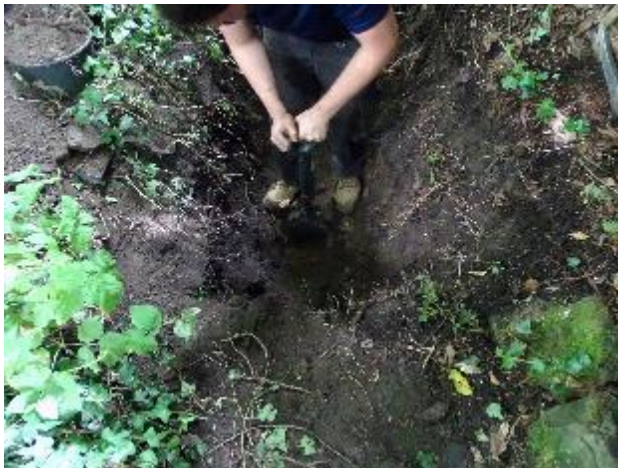
Trail pit 1 – excavation to 1.3m

Samples were taken at an approx. depth of 300mm and 600mm below ground level (bgl). Trail hole 1 was extended to a depth of approx. 1300mm to undertake a surface water percolation test at the time, no ground water was identified.

| 0.60-1.3m | - Brown loam soil, some stone |
