**The Waterside Village – Opulwood  
River Wall Report  
Date: 01.06.2022**

Elluc Projects have been commissioned by Opulwood Developments to provide a report on the condition of the River Irwell retaining wall in order to close out planning condition 16.

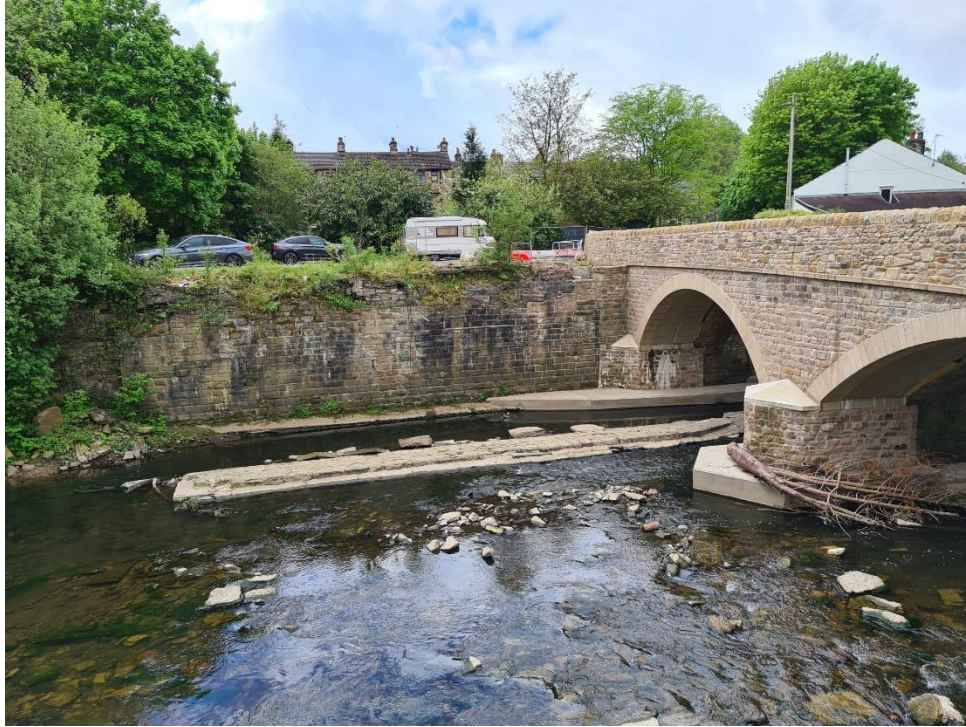
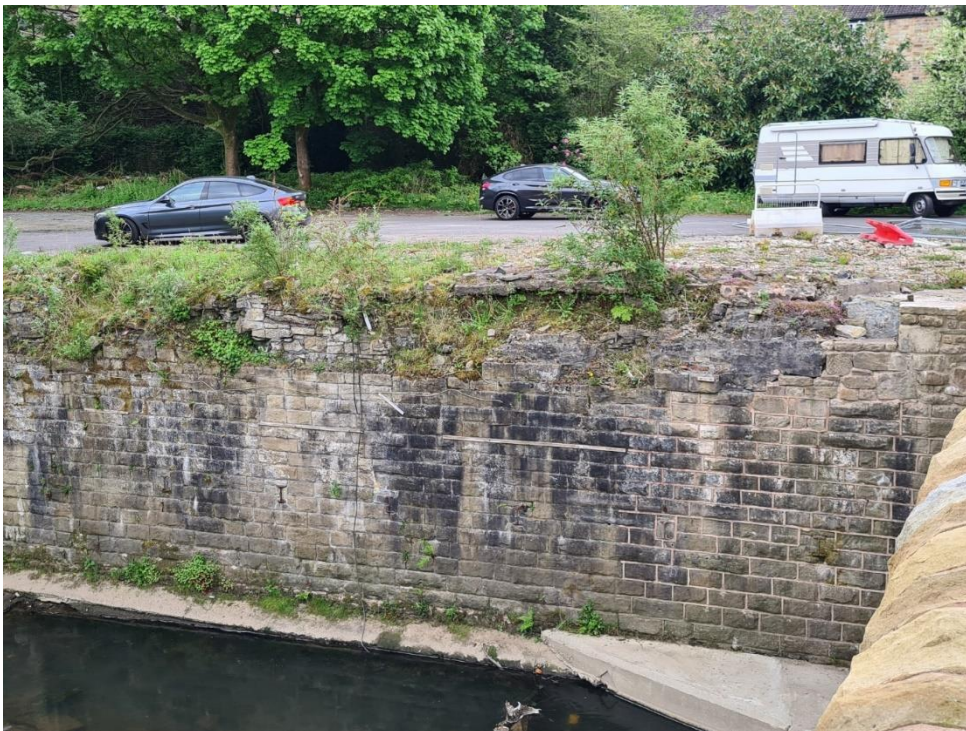
The wall on the northern boundary is approximately 5.5m high retaining wall. The wall is constructed out of stone and ties into the masonry bridge spanning over the River Irwell. There is no evidence of any cracking, bowing or failure of the existing wall at low levels.

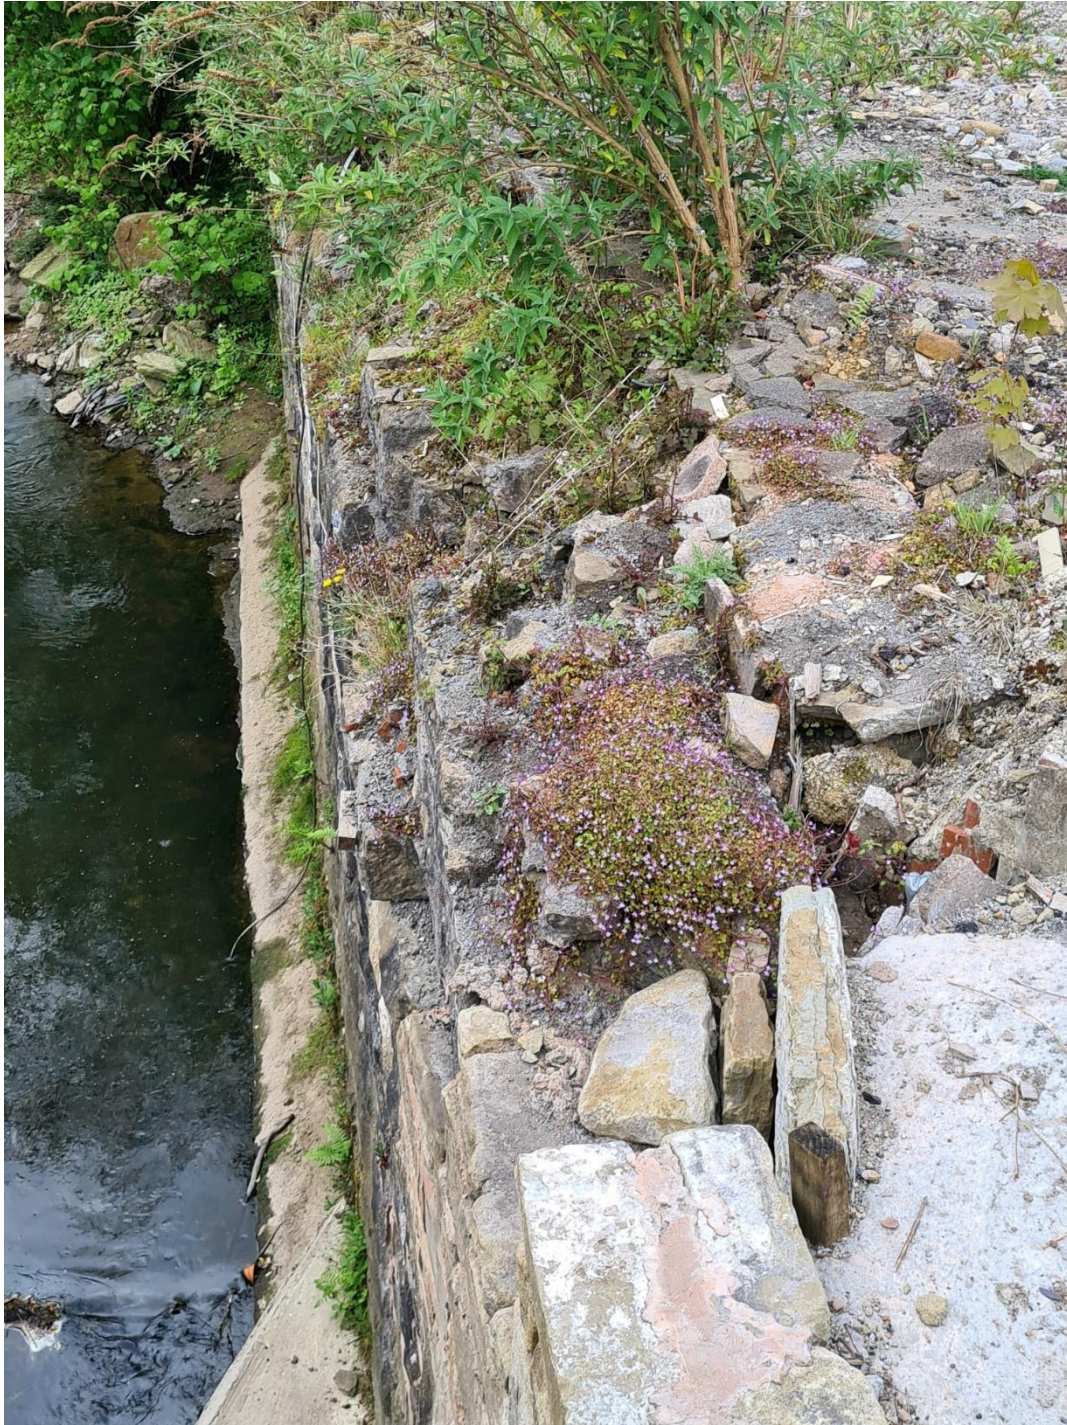
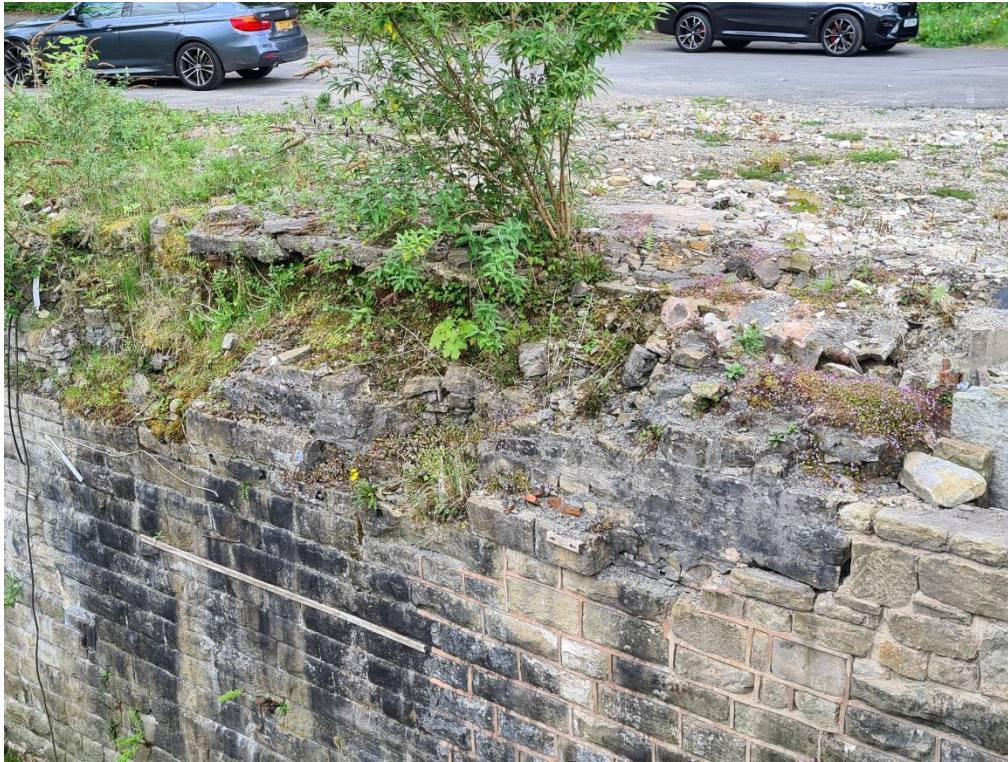
The top section of the wall however is not present and has either failed or been demolished.

The missing section of the wall confirms the construction of the wall as solid masonry construction, this is as expected for the age and location of the retaining wall.

We propose that the missing top section of the wall is rebuilt with a solid masonry construction to match the construction on the opposite bank and on the bridge. The wall thickness should be approximately 400 thick which would be adequate to retain 500mm of earth with the footpath, and this construction should continue above ground up to a height of 1.1m to provide fall protection.

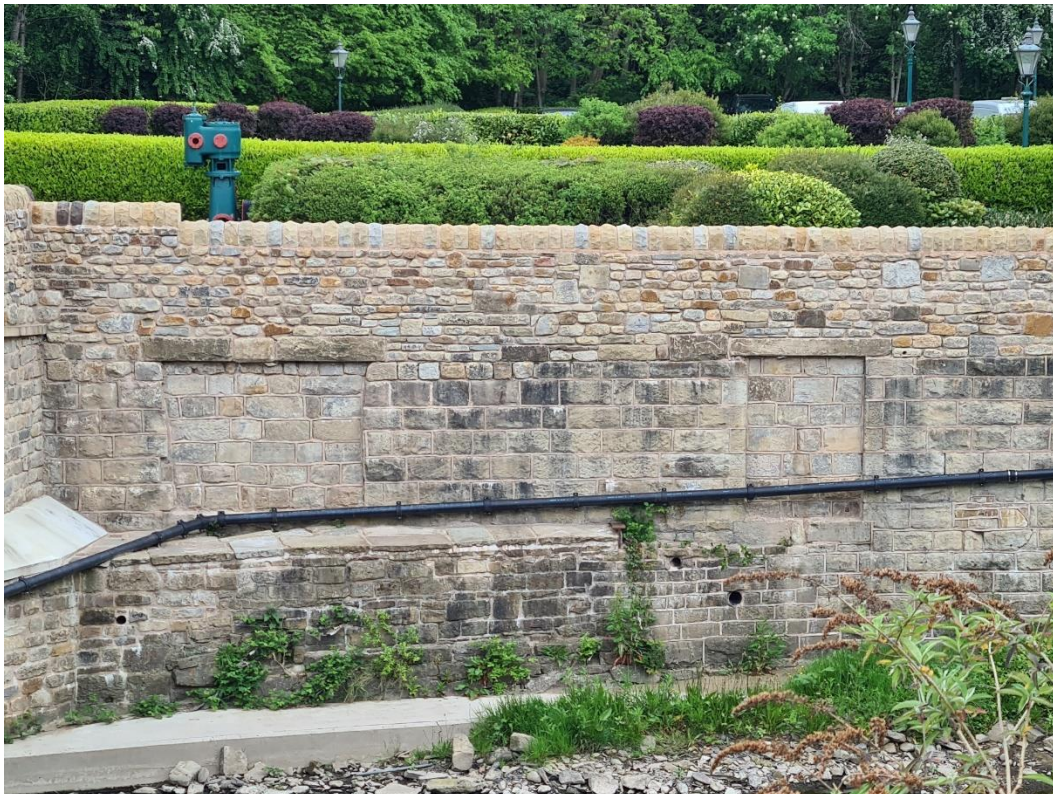
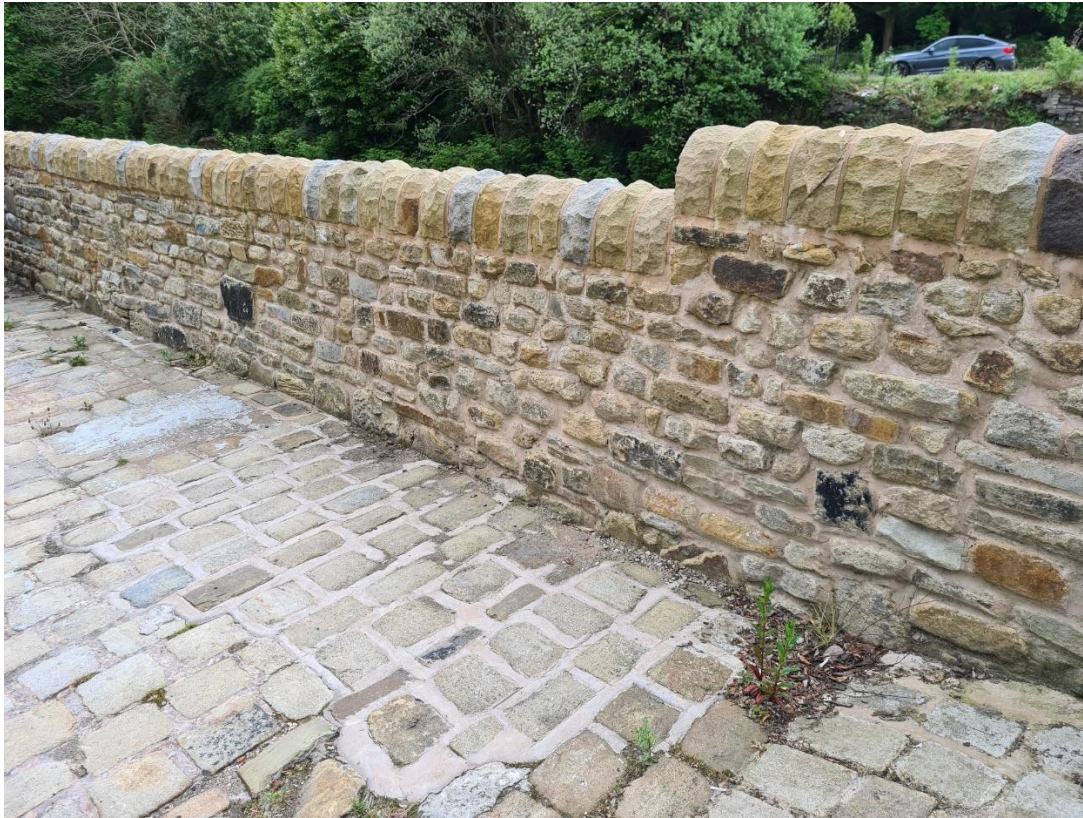
On the opposite side of the river there is evidence of the existing retaining wall with a new build stone wall being constructed above.
