# **ARBORICULTURAL COMPLIANCE SUBMISSION**

## **Planning Conditions 13 & 15**

**Former Ambulance Station  
Cemetery Road, Ramsbottom, Bury, BL0 9PU**

Planning Application: 73410  
Arboricultural Method Statement: 2524\_AMS.03  
Prepared for: HOME Group NW Ltd  
Submission date: 24 September 2026

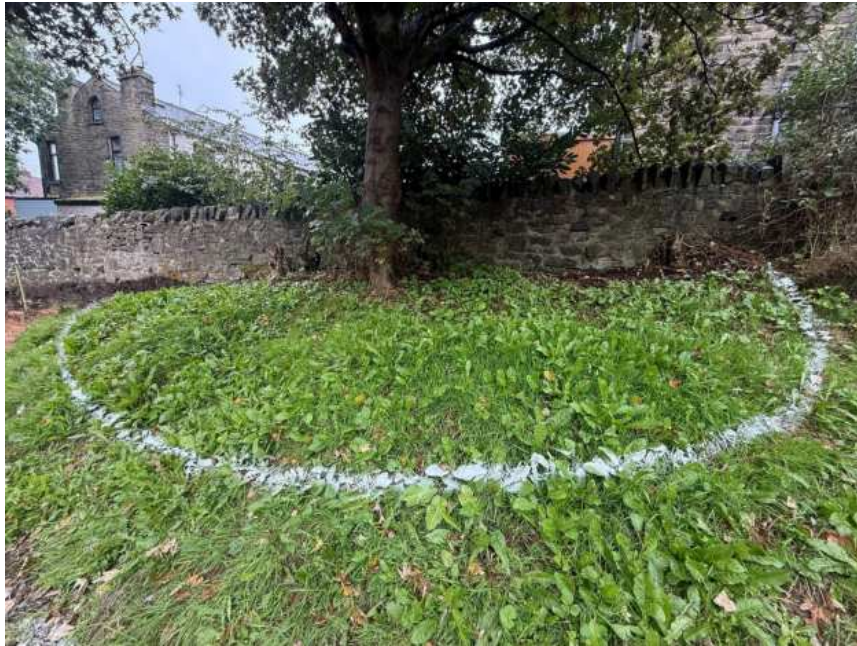
**Photo 1:** Initial view of the retained Sycamore and the marked protection / working boundary prior to the later excavation sequence.

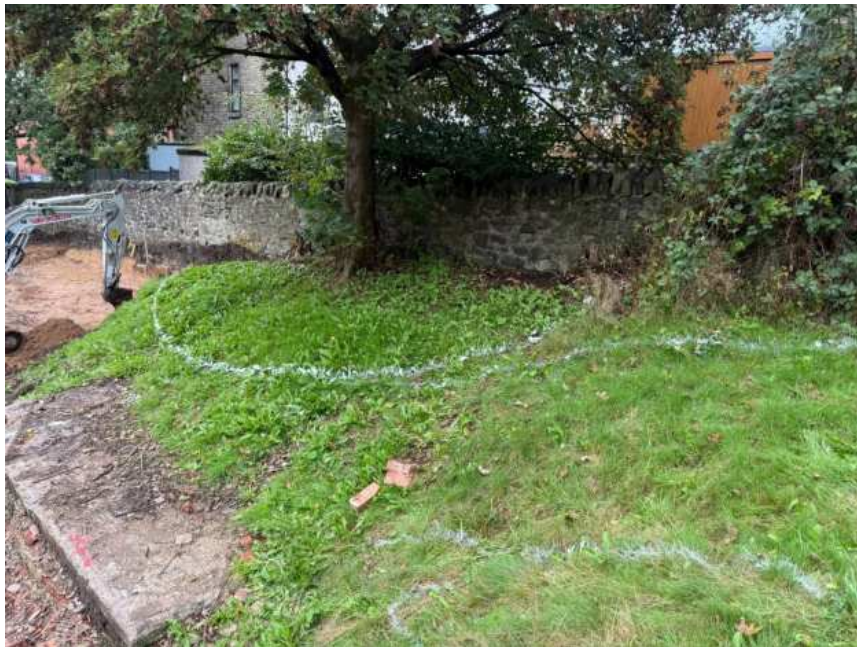
**Photo 2:** Alternative view of the retained Sycamore and marked protected area before excavation works in the adjoining construction zone.

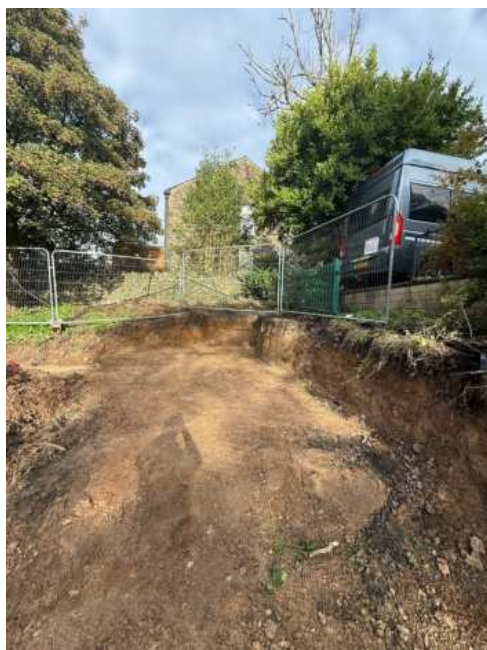
**Photo 3:** Excavated construction area adjacent to retained tree protection zone; temporary fencing separates the tree area from the excavation.

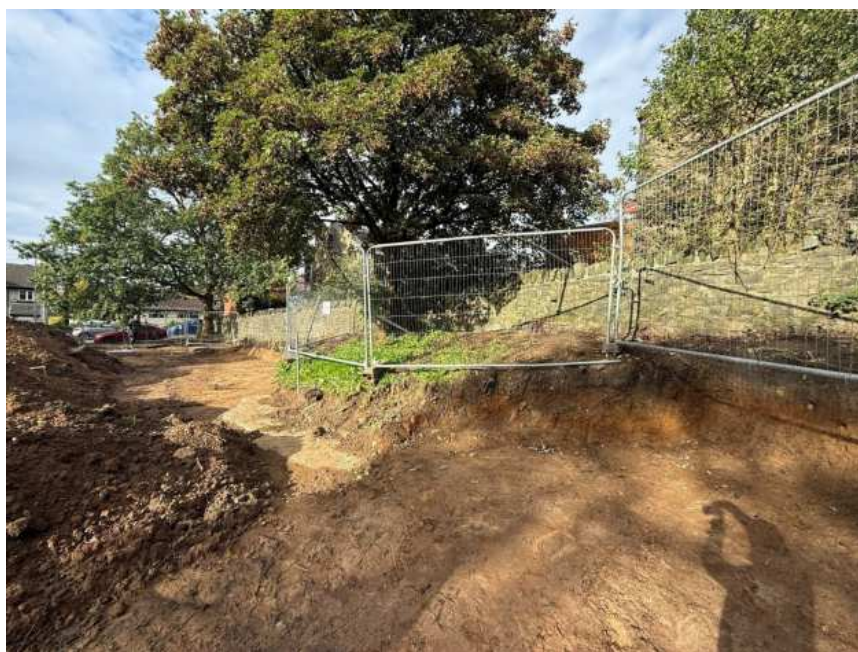
**Photo 4:** Wide view showing the retained Sycamore behind the protected area and the excavation face outside the fenced zone.

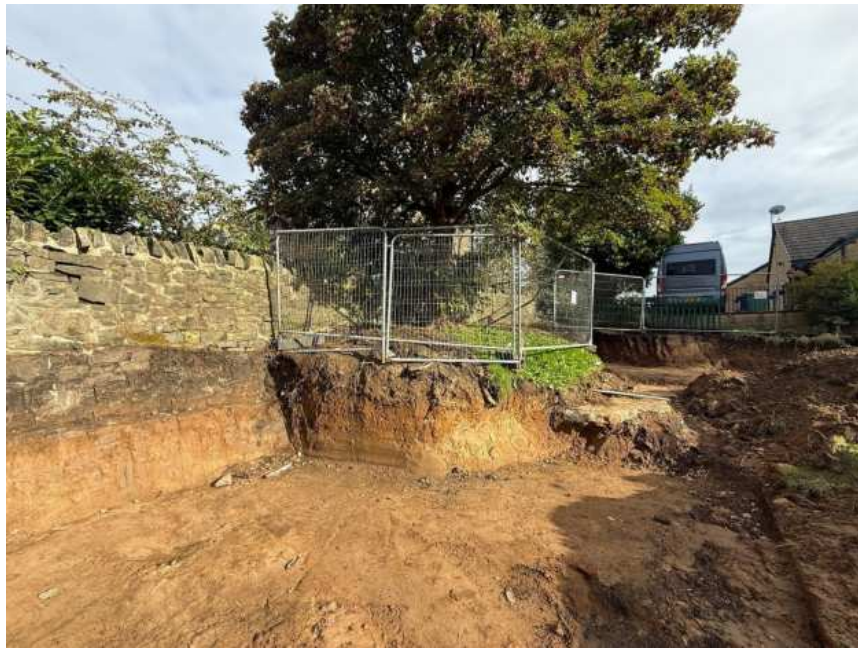
**Photo 5:** Excavation geometry around the retained tree area, with temporary fencing positioned along the upper edge of the protected zone.

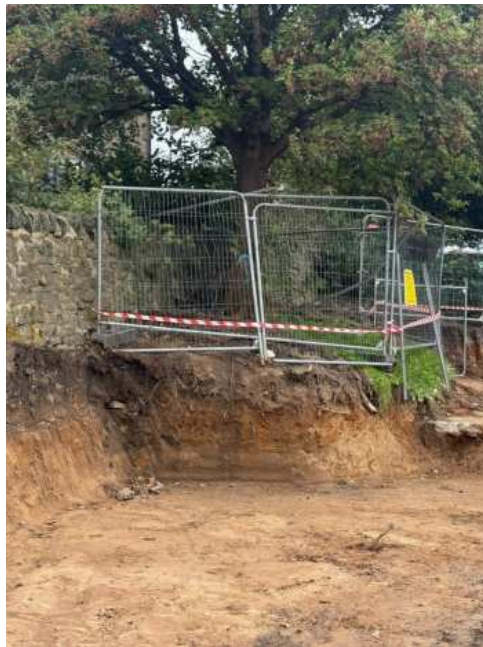
**Photo 6:** Closer view of the Sycamore and temporary protective fencing above the excavation face.

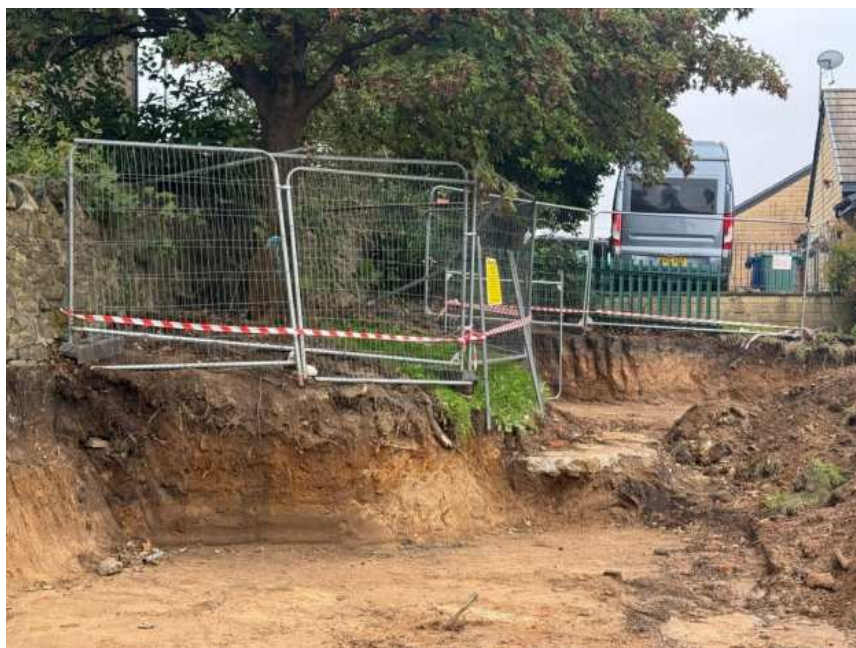
**Photo 7:** Retained Sycamore with protective fencing, warning tape and controlled access around the tree-protection area.

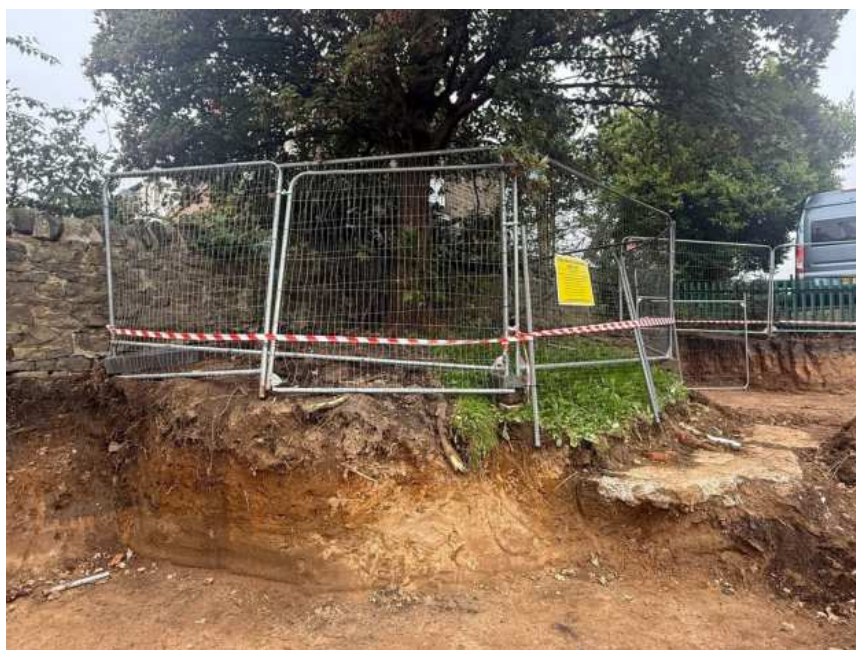
**Photo 8:** Retained Sycamore enclosed by temporary fencing with tree-protection warning signage visible.

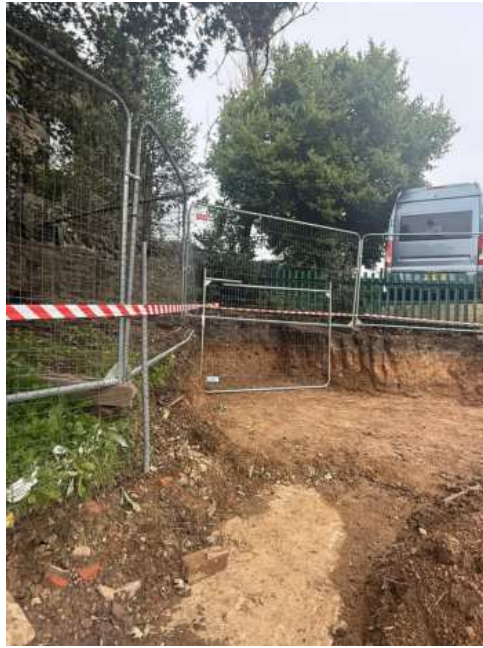
**Photo 9:** Controlled route / working area adjacent to the retained tree zone with temporary fencing maintained.

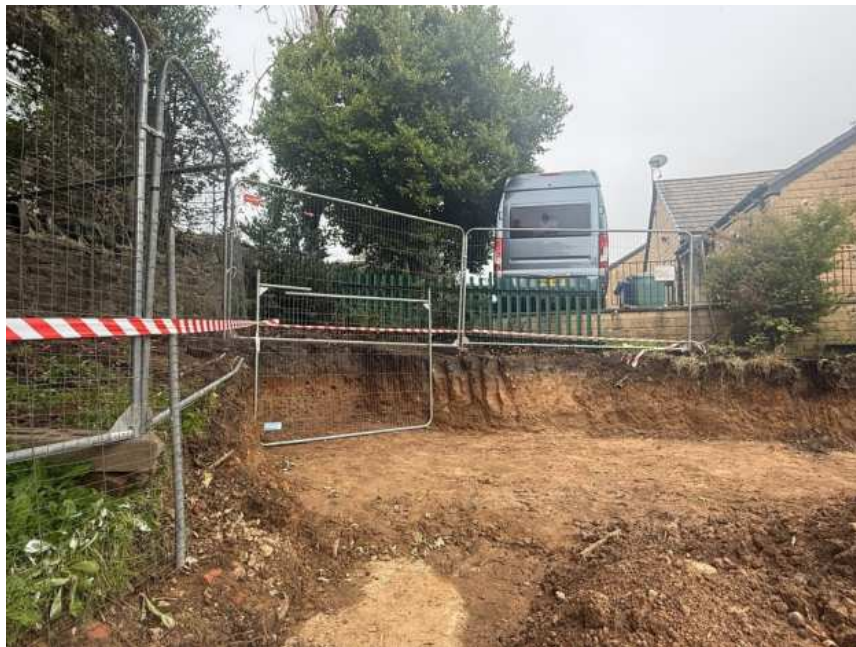
**Photo 10:** Further view of the excavated construction zone and retained tree-protection boundary.

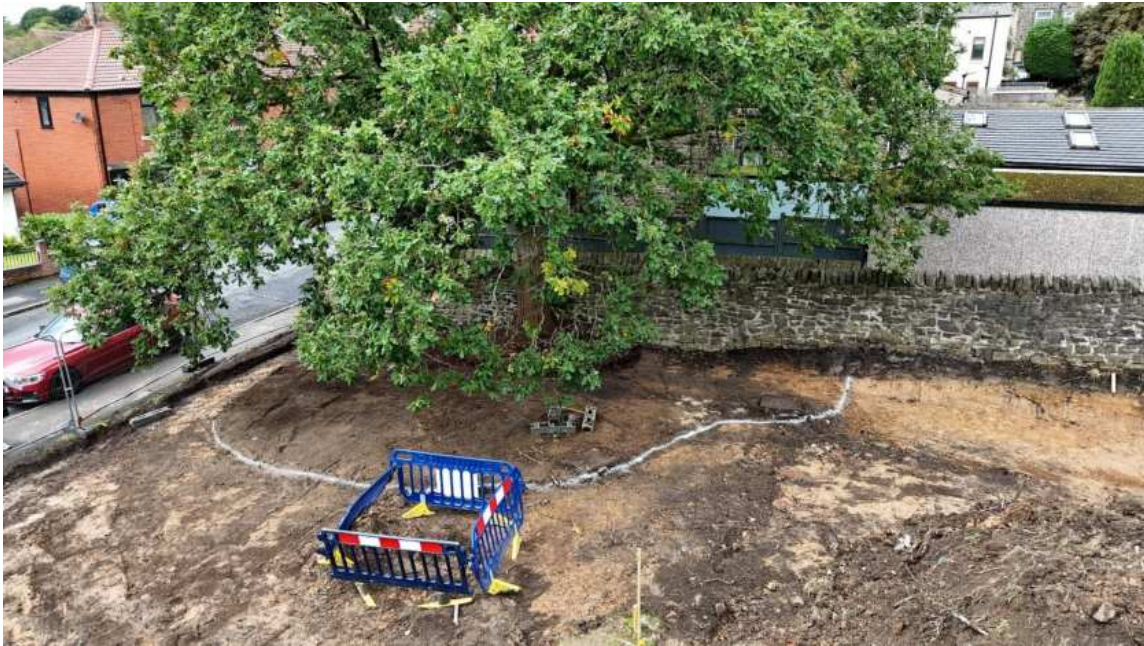
**Photo 11:** High-level view of T8 Pedunculate Oak with the RPA / working boundary marked on the prepared ground.

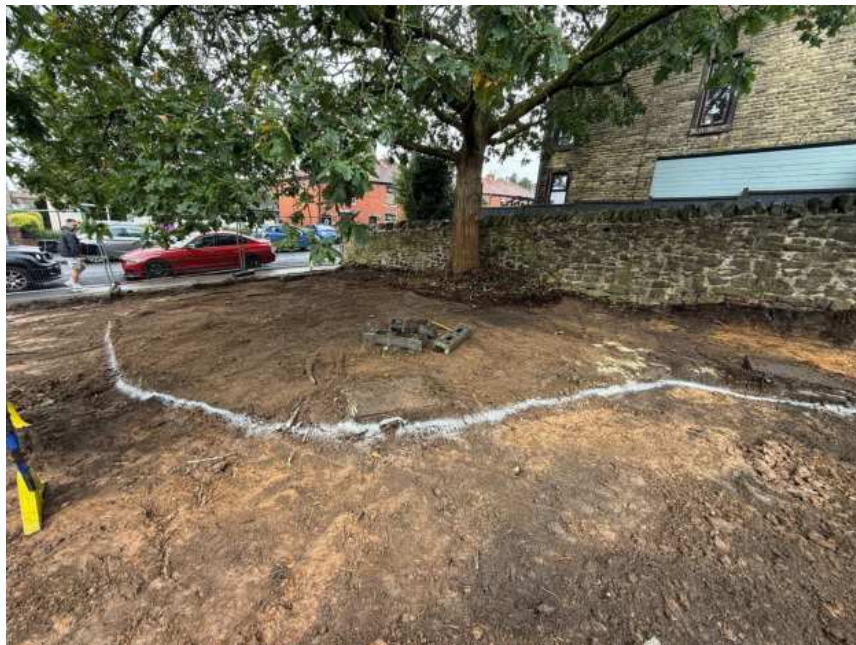
**Photo 12:** Ground-level view of the marked RPA / construction interface around T8 Oak.

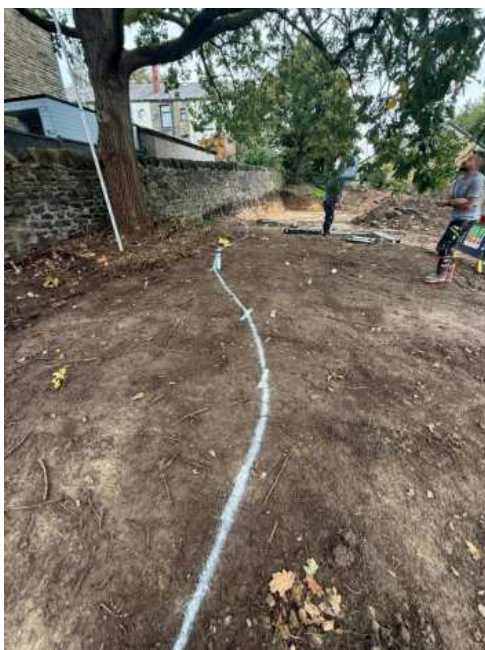
**Photo 13:** RPA / protection line marked in relation to the T8 Oak stem and adjacent construction area.

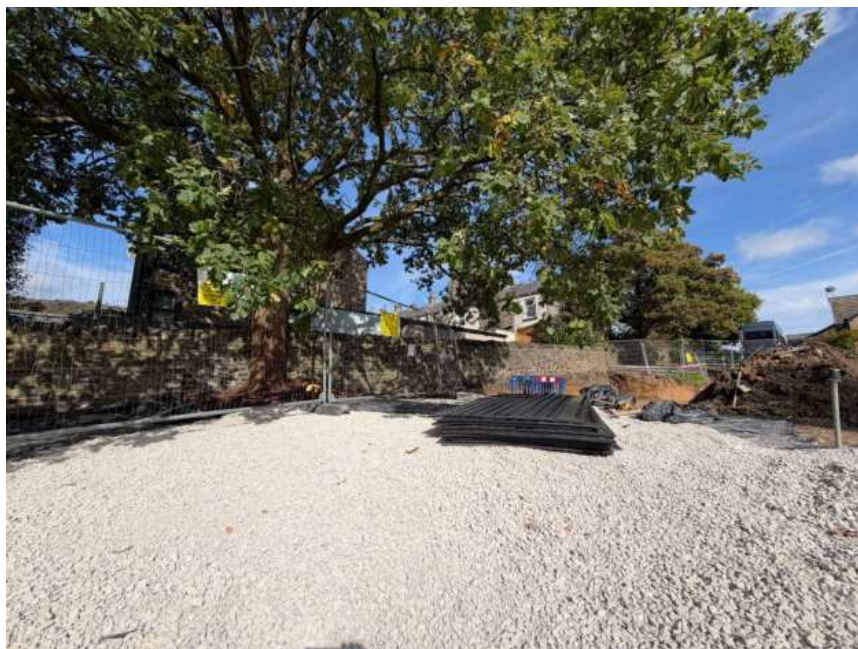
**Photo 14:** Open-graded aggregate working layer installed adjacent to T8, with protective fencing and warning signage maintained.

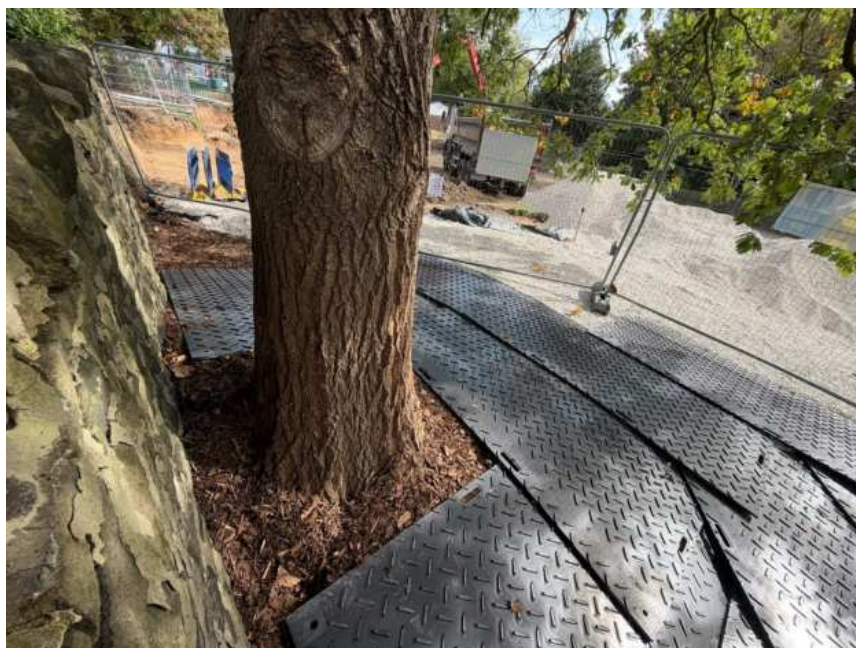
**Photo 15:** Interlinked ground-protection boards positioned around the Oak stem with aggregate working layer beyond.

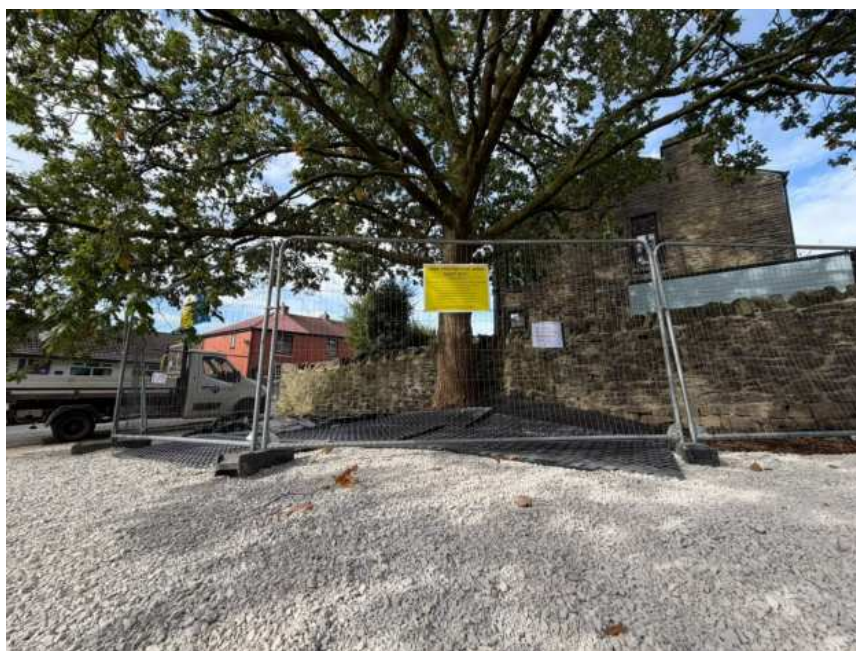
**Photo 16:** Completed protected area around T8 showing fencing / warning signage, ground-protection boards and permeable aggregate working surface.

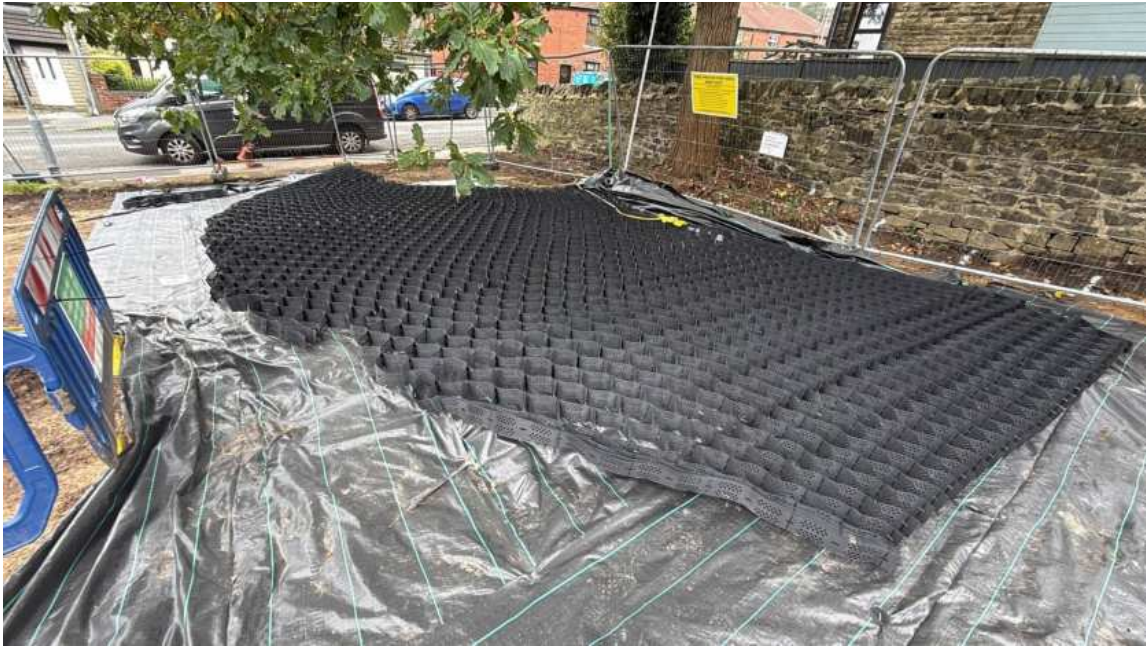
**Photo 17:** Base geotextile laid over the prepared formation with cellular confinement expanded across the defined area; tree-protection fencing remains in place.

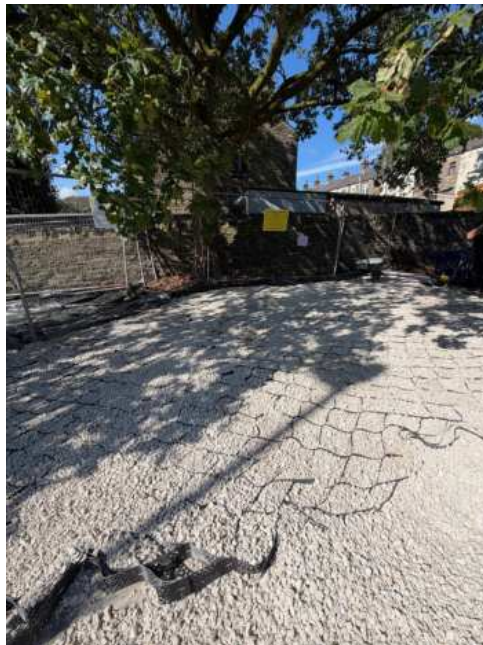
**Photo 18:** Cellular confinement system substantially filled with open-graded aggregate, with confinement matrix visible at the surface.

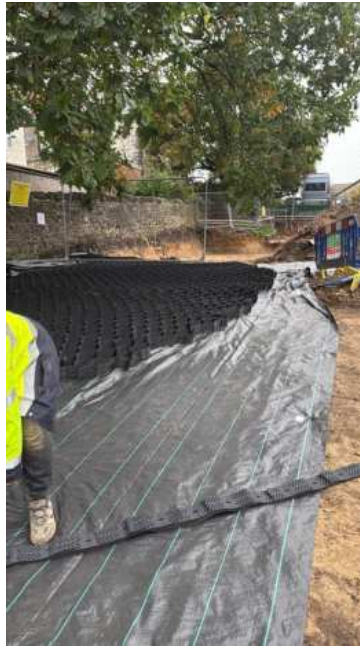
**Photo 19:** Installation-stage view showing geotextile beneath the expanded confinement cells before aggregate infill.

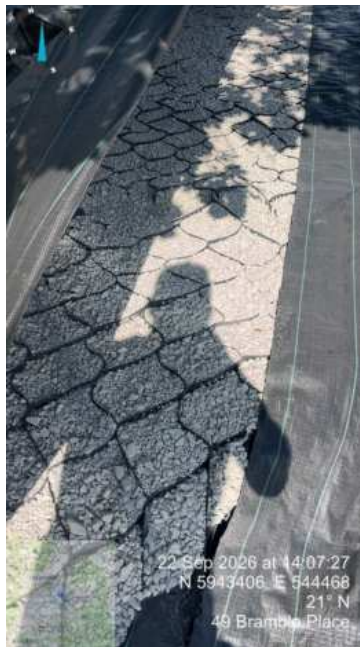
**Photo 20:** Timestamped close view showing the cellular confinement matrix filled with open-graded aggregate.

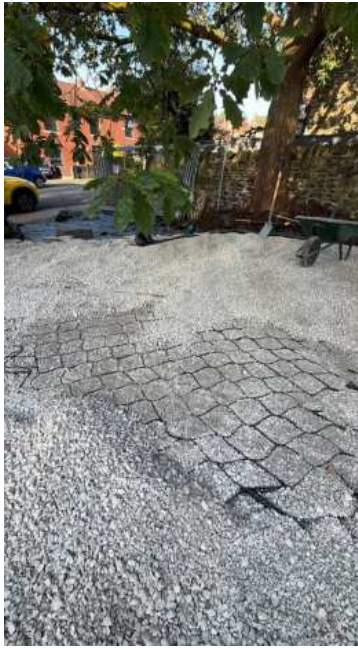
**Photo 21:** Filled cellular confinement adjacent to T8 Oak, with open-graded aggregate placed through and over the cell matrix.

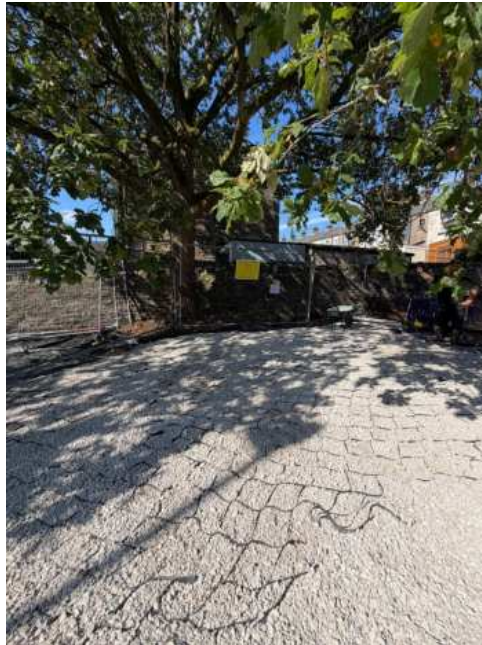
**Photo 22:** General completed installation view showing the cellular matrix visible within the aggregate surface beneath the Oak canopy.
