**Westchurch Homes**

**Ground Investigation Report**

**Land at Radcliffe Moor Road**

**REPORT NO: 20WCH011/GI**

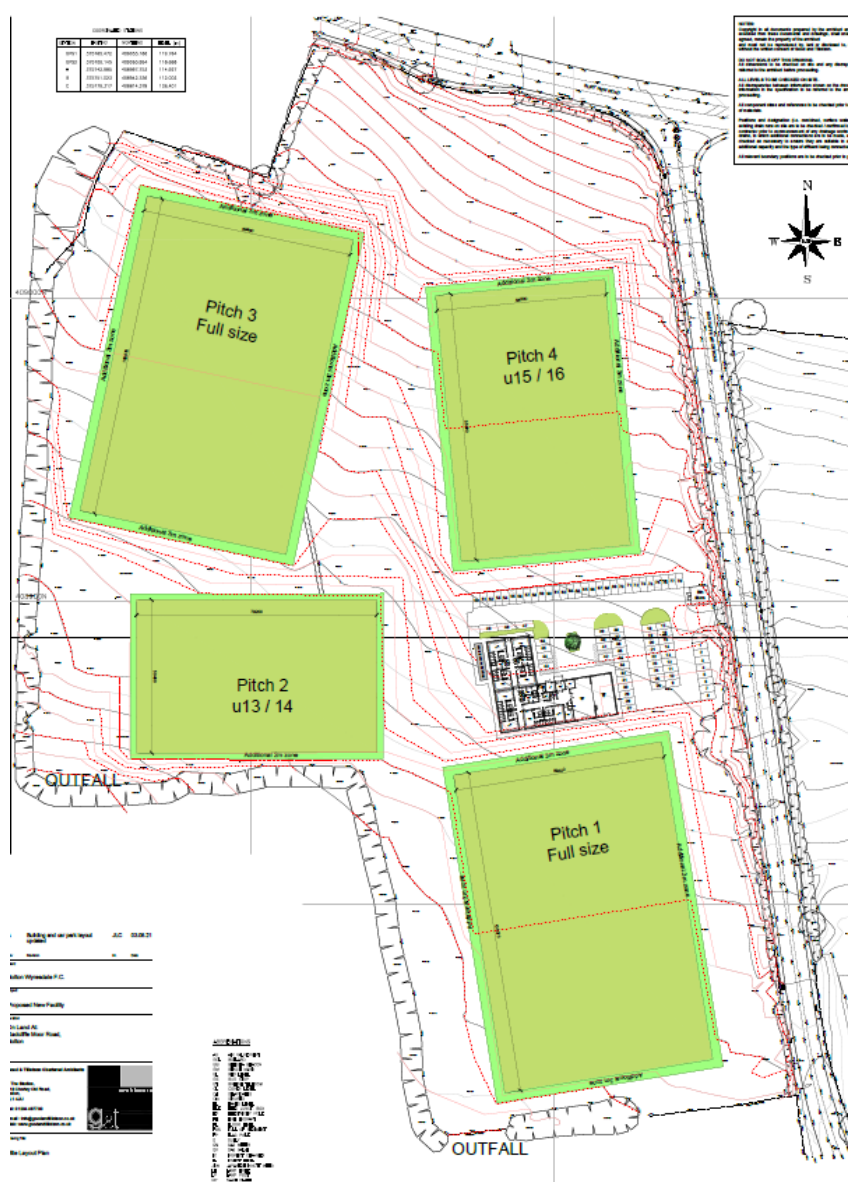
This investigation was carried out on the instruction of Westchurch Homes. The purpose of the work was to undertake ground investigation works based on the desk study findings to provide geotechnical and contamination risk information for the proposed construction of Sports Pitches, Club House and associated parking, new access road and associated infrastructure. The proposed site layout (sketch) can be seen below;

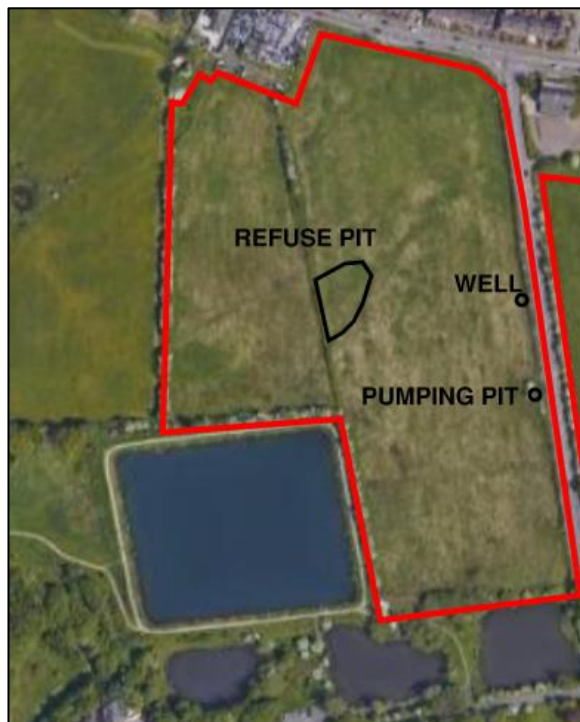
The site has a number of historic uses including a former well, a pumping pit (for drainage of coal mines), possible mound of made / reworked ground (central west) and former houses along the boundary edge. The

suspected approximate locations are shown below;

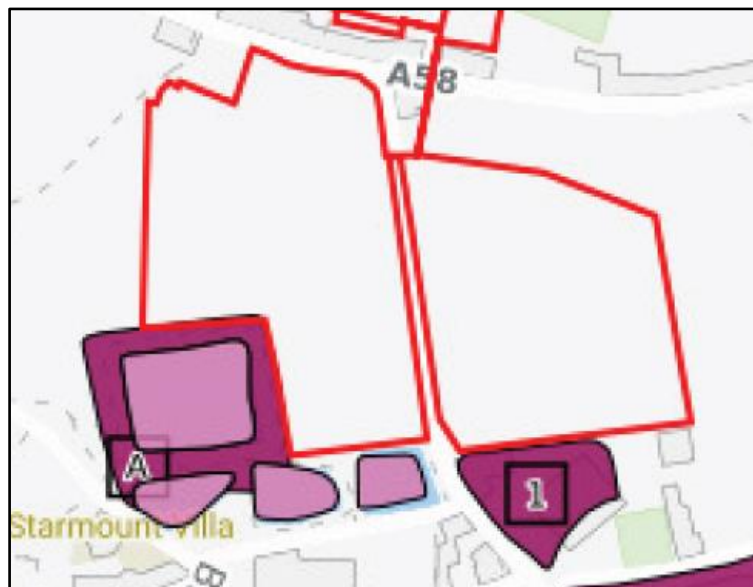
| ID | Location | LEX Code | Description | Rock description |
| A | On site | MGR-ARTDP | Made Ground (Undivided) | Artificial Deposit |

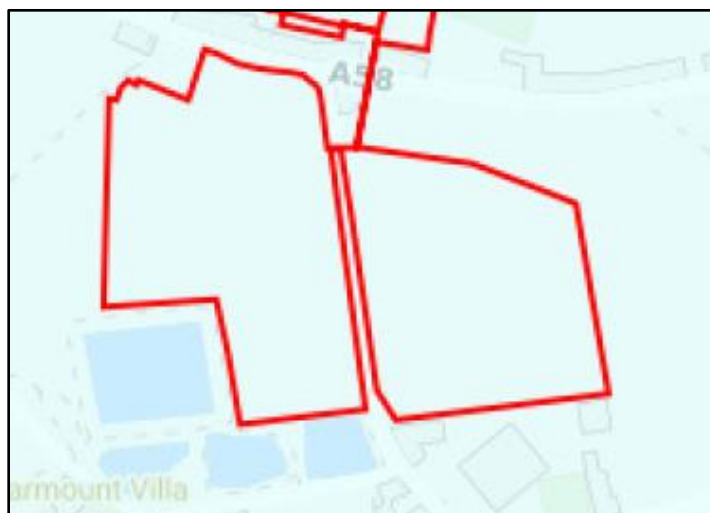
## Superficial Geology

| ID | Location | LEX Code | Description | Rock description |
| 1 | On site | TILLD-DMTN | Till, Devensian - Diamicton | Diamicton |
