## Highways Photographic Dilapidation Survey

Address: 131 Radcliffe New Road,  
Whitefield, M45 7RP

| Reference | RNRDS |
| Project | 131 Radcliffe New Road<br>Whitefield M45 7RP |

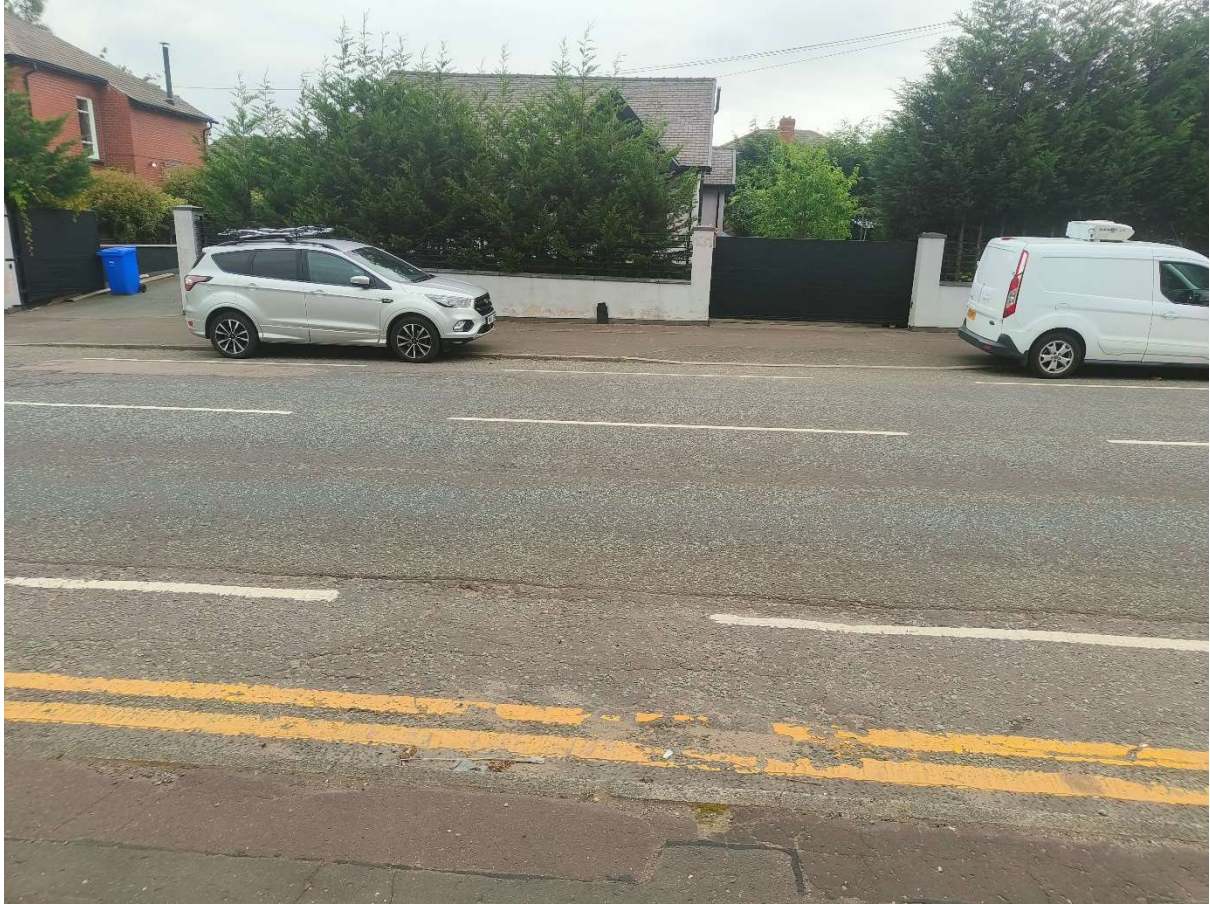
Photograph 1

The road has a tarmac finish with thermoplastic white lining to separate the carriageways and cycle lane as identified in photographs 1-11, and yellow thermoplastic double lines at the junction between Radcliffe New Road and Leicester Road.

There is cracking in the tarmac in multiple locations, as identified in photographs 1,2,3,6,7,8,9,10 and 11.

The yellow thermoplastic double lines at the junction of Radcliffe New Road and Leicester Road are degraded and in some areas are no longer visible, as identified in photographs 1,2,10,12, 14 and 15.

The yellow thermoplastic double lines at the junction between Leicester Road and Radcliffe New Road are degraded and in some areas are no longer apparent, as identified in photographs 1,2,10,12,14 and 15.

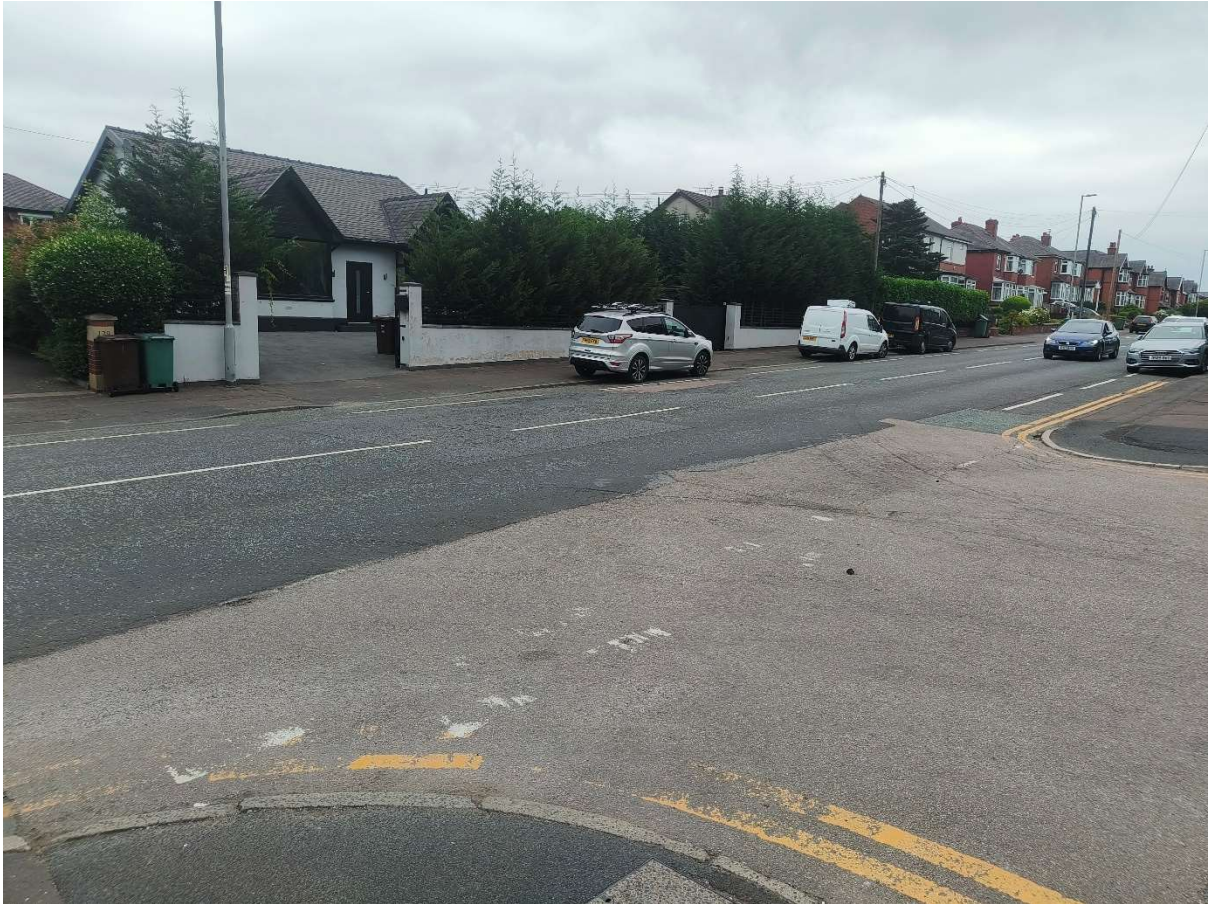
Photograph 2

Radcliffe New Road has various finishes to the tarmac, laid at different times. There is visible wear and tear to the junction between the different tarmac finishes, as identified in photographs 2,3,6,7,8,10 and 11.

Thermoplastic road markings are degraded and in some locations are no longer visible due to resurfacing and / or wear and tear, as identified in photographs 2.

Leicester Road has a tarmac finish with no visible road markings to separate the carriageways but does benefit from yellow thermoplastic double lines and white thermoplastic road end markings at the junction between Leicester Road and Radcliffe New Road. Leicester Road has various finishes to the tarmac, laid at different times for road surface and pothole repairs. There is significant wear and tear at the junction of Leicester Road and Radcliffe New Road between the different tarmac finishes as identified in photographs 2, 14 and 15.

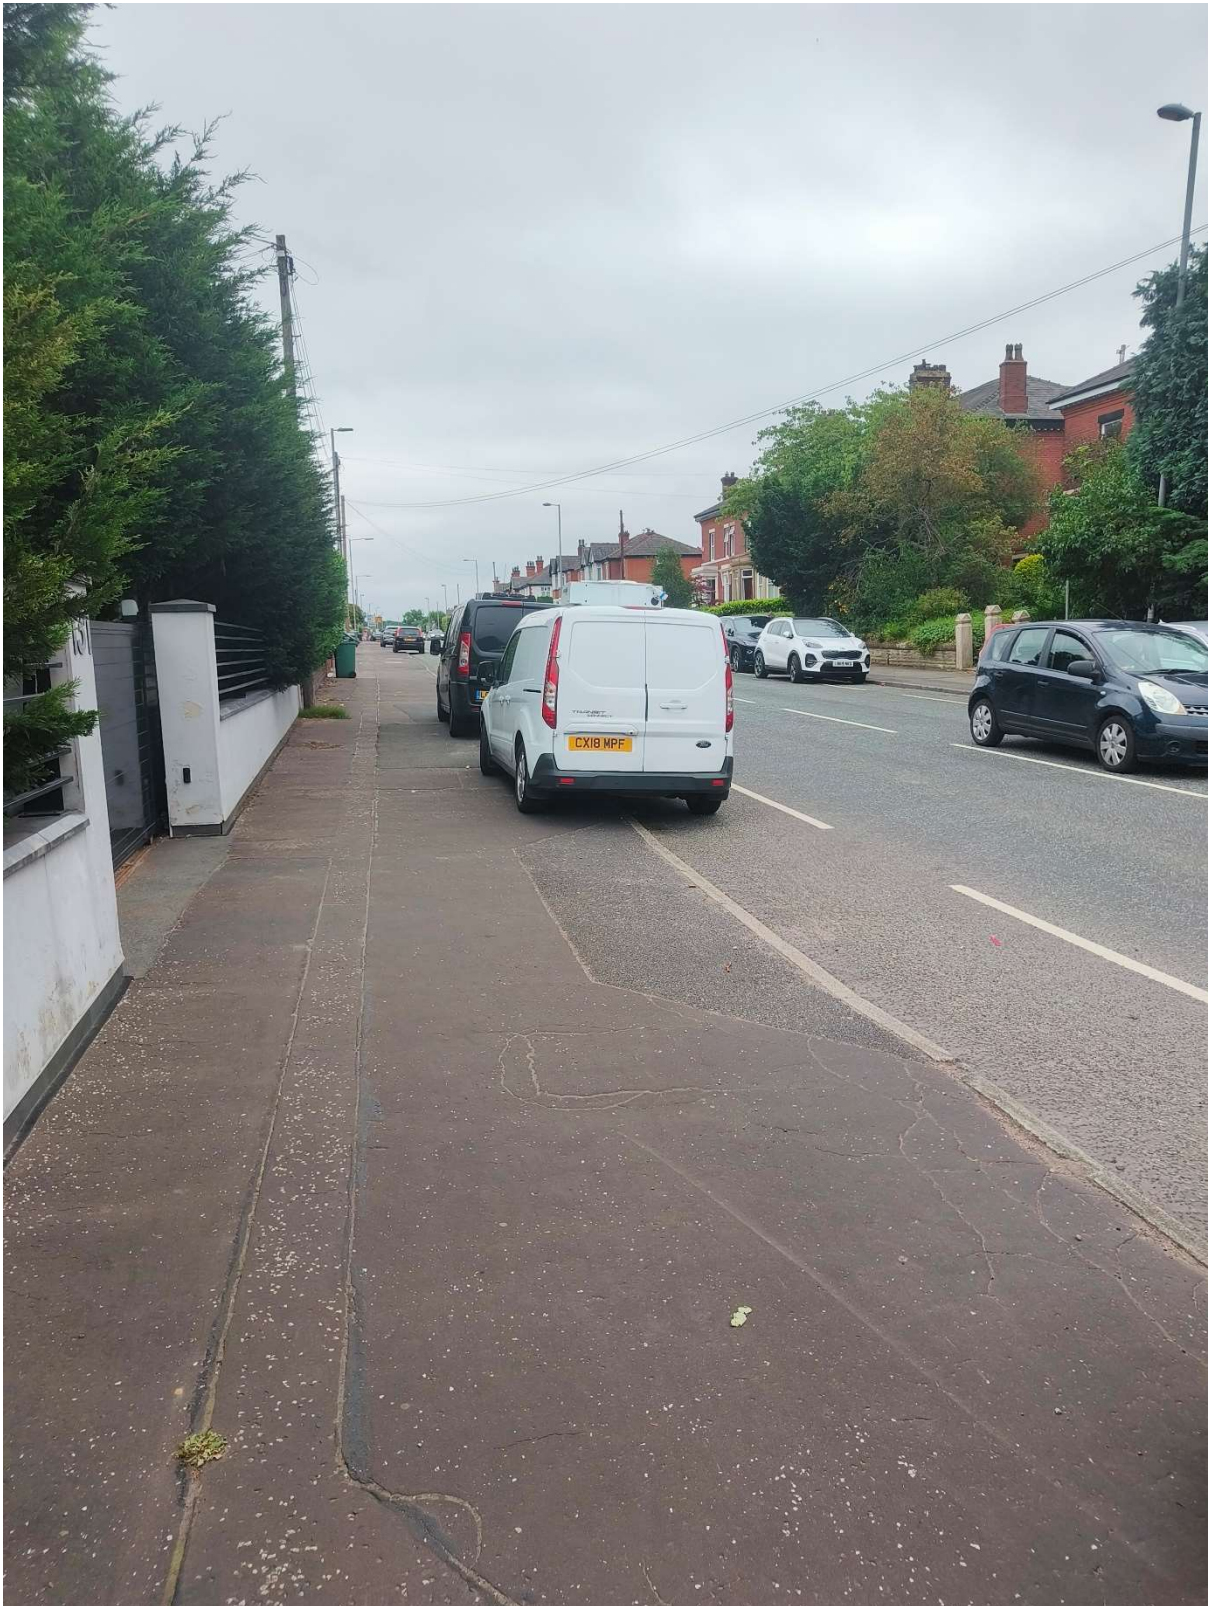
Photograph 5

There is extensive wear and tear to the kerb lines on both sides of the road, as identified in photographs 5,10,11 and 12.

The footway on both sides of the carriageway has a mixture various finishes including flagstone and tarmac repairs as identified in photographs 5,7,10,12 and 14.

There are cacks and damage visible in multiple areas of the footway as identified in photographs 5 & 13.

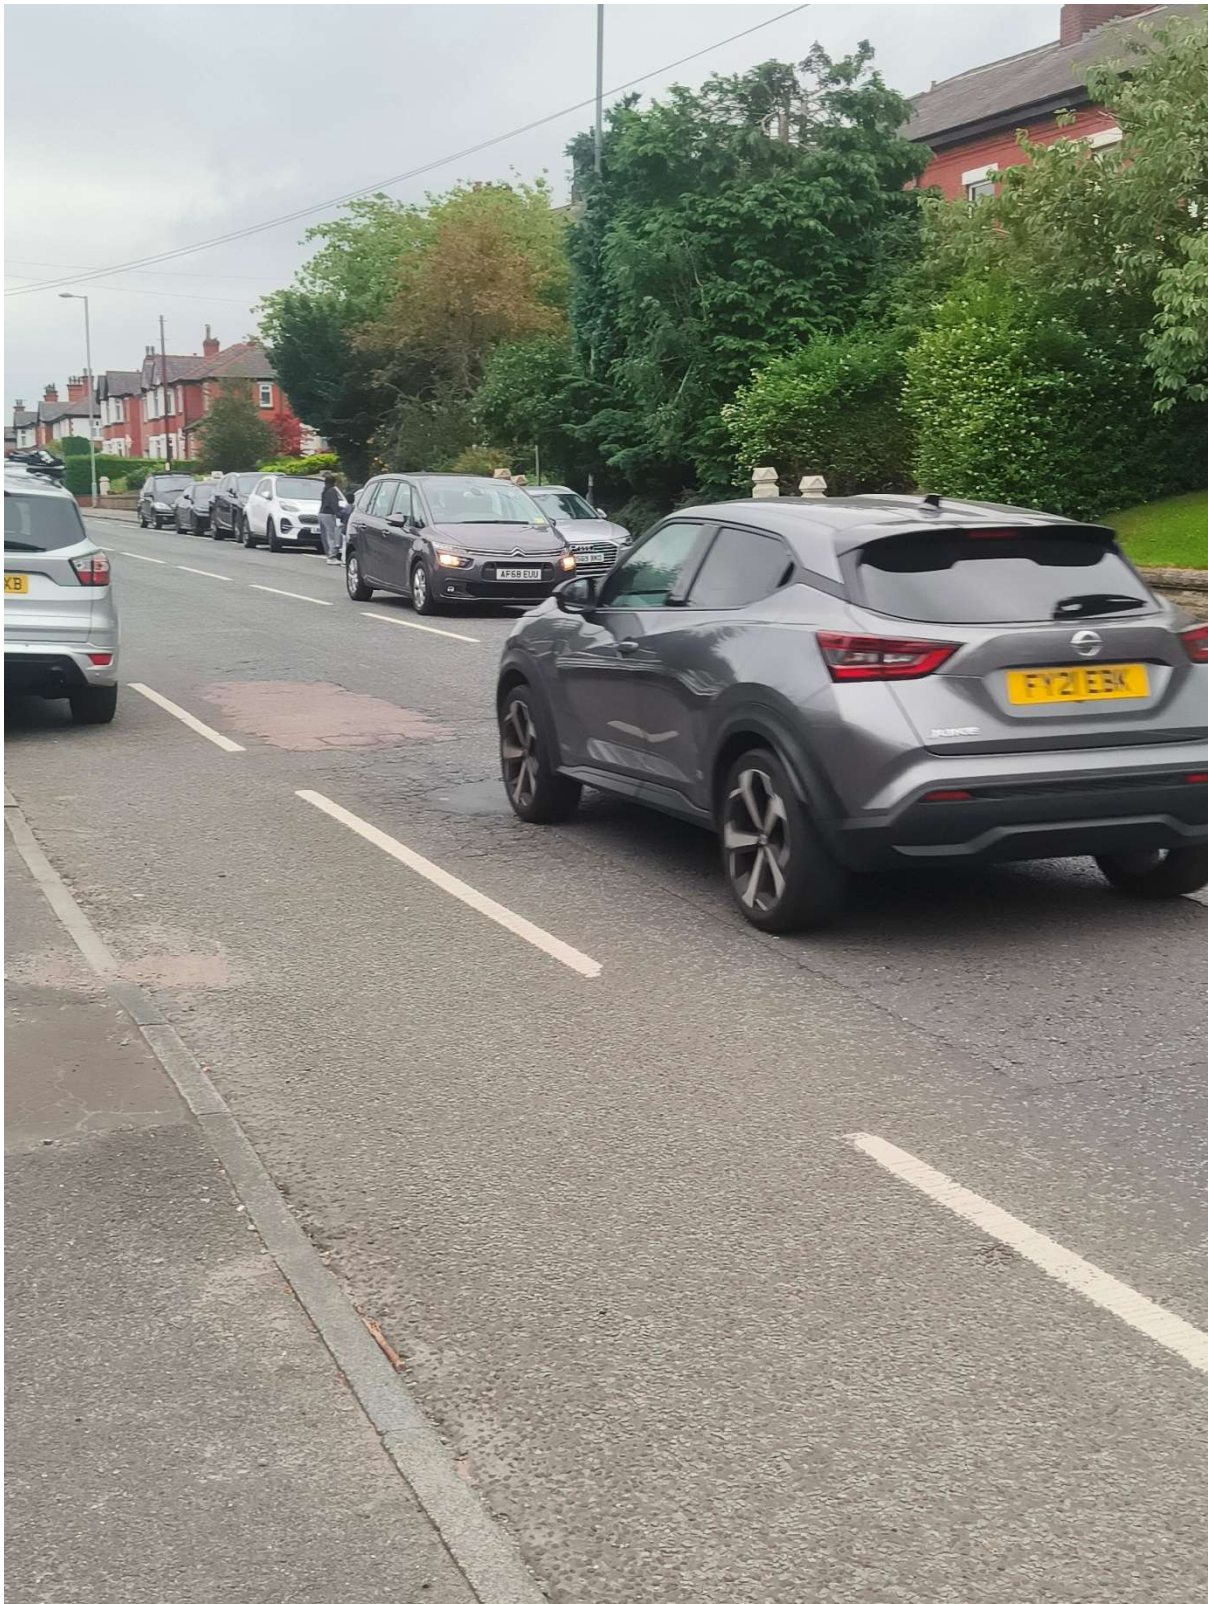
Photograph 6

Potholes along the road have been filled in at different times with different road surfaces, as identified in photographs 6,9 and 11.

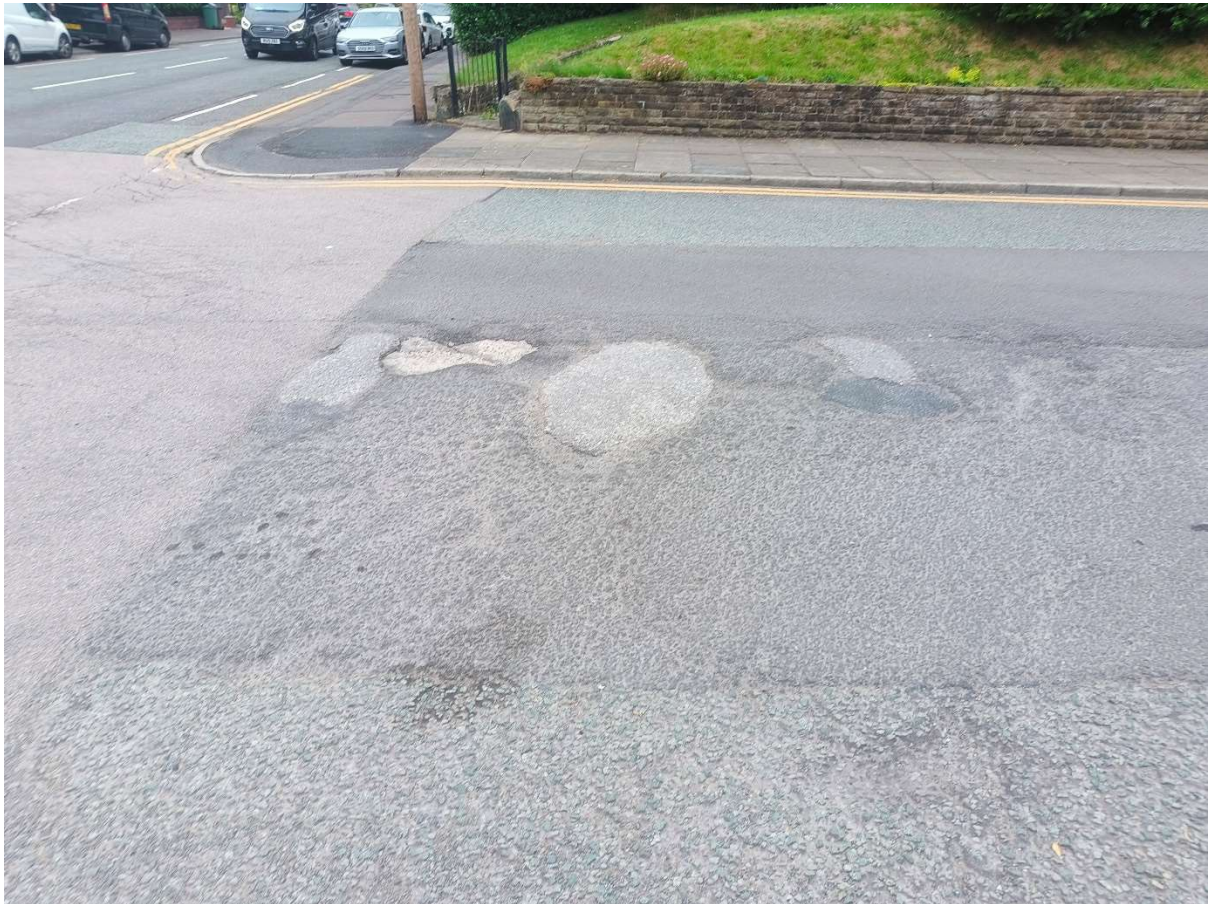
Photograph 14

There are multiple potholes along the road as identified in photographs 14, 15 and 16.

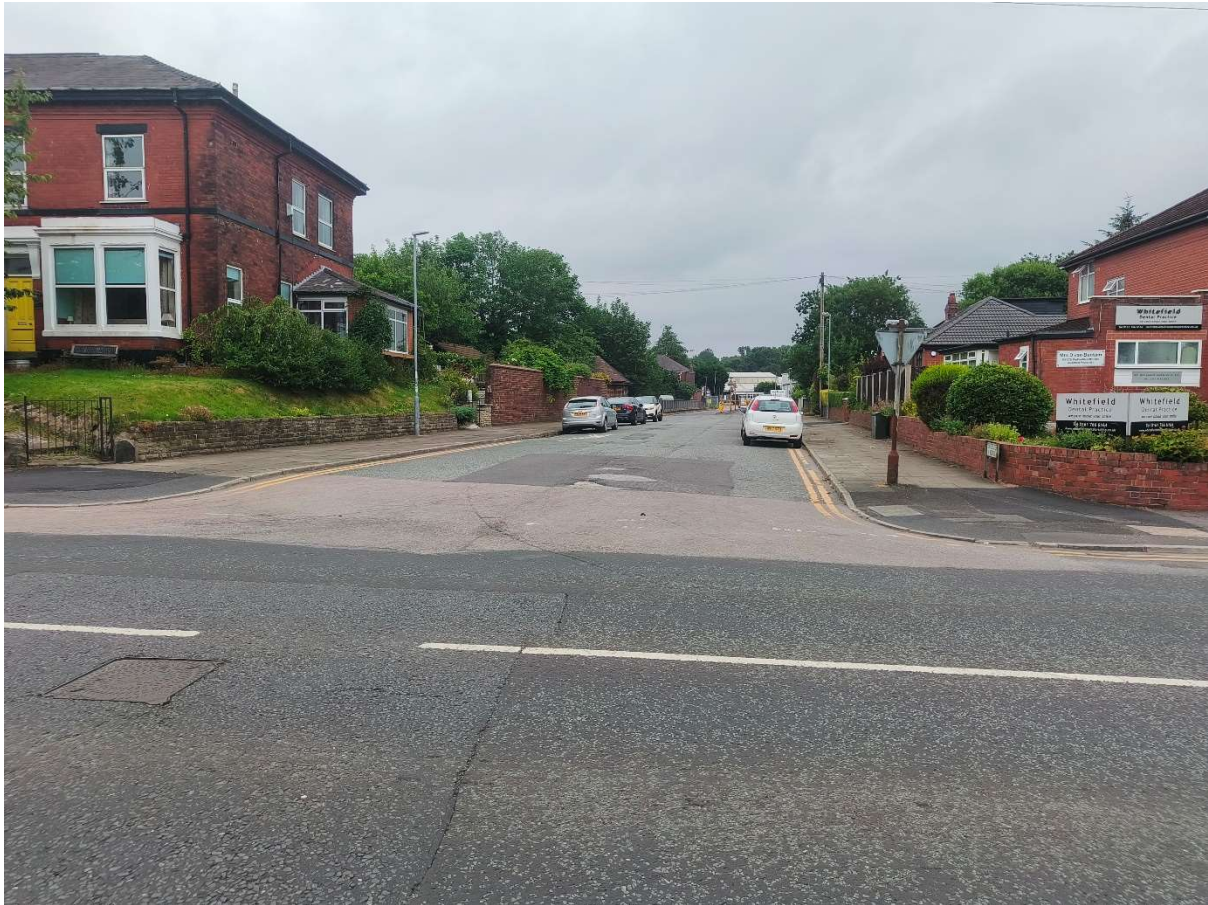
Photograph 15

There is a manhole on the eastbound carriageway that appears to have been installed or repaired in isolation of the rest of the carriageway, with Isolated tarmac resurfacing to this are as identified in photographs 15. The tarmac around the manhole is showing light cracking and weathering.
