**FLOOD RISK ASSESSMENT  
FOR  
PROPOSED RESIDENTIAL DEVELOPMENT, FORMER TETROSYL SITE  
WALMERSLEY OLD ROAD, BURY, GREATER MANCHESTER  
ON BEHALF OF  
BARRATT HOMES MANCHESTER**

**DECEMBER 2018**

**Project:** Proposed Residential Development, Former Tetrosyl Site, Walmersley Old Road, Bury, Greater Manchester

**Document Title:** Flood Risk Assessment

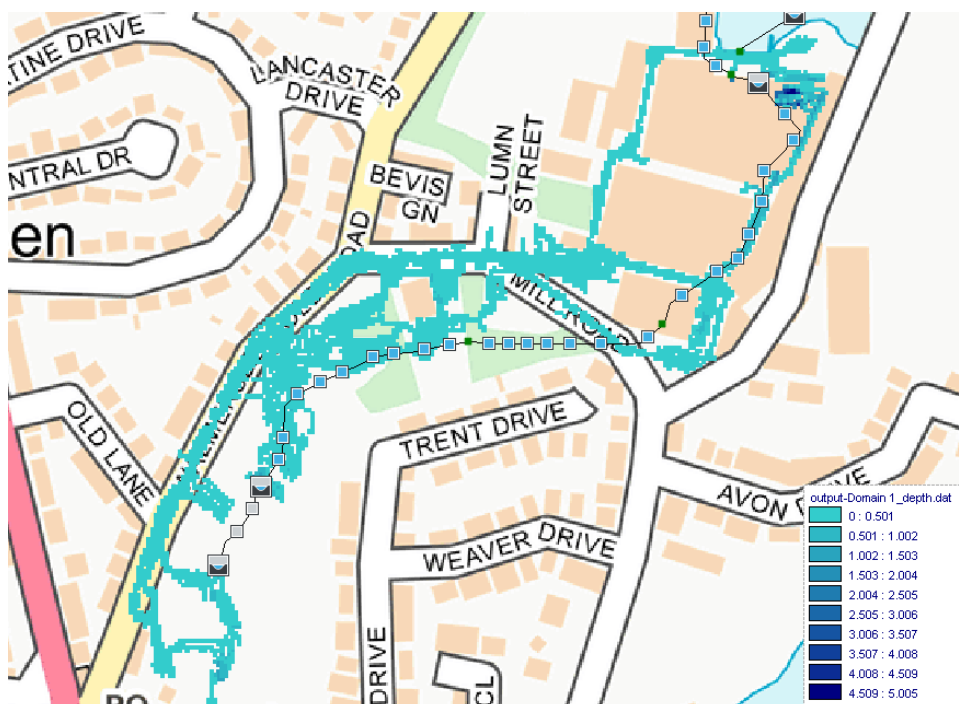
Figure 3.1: Maximum fluvial flood extent for the 1:100 year + 30% climate change event

- 3.9 Hydraulic modelling found that for the existing site:
- during the 1:20 year event all flows remain in-bank through the site, with no flooding occurring from Mill Reservoir.
  - during the 1:100 year and 1:100 year+ 30% climate change event, flooding occurred within the existing site occurring from the southern bank of Mill Reservoir. 2D flood mapping undertaken as part of the *Hydraulic Modelling Study* indicates that floodwaters issuing from Mill Reservoir travel southwards through the site and along Walmersley Old Road before re-entering the open channel section of PLB tributary some 120m downstream of the development site. Refer to Figure 3.1 below.
  - Mill Reservoir provides some attenuation to flood flows downstream of the development site.

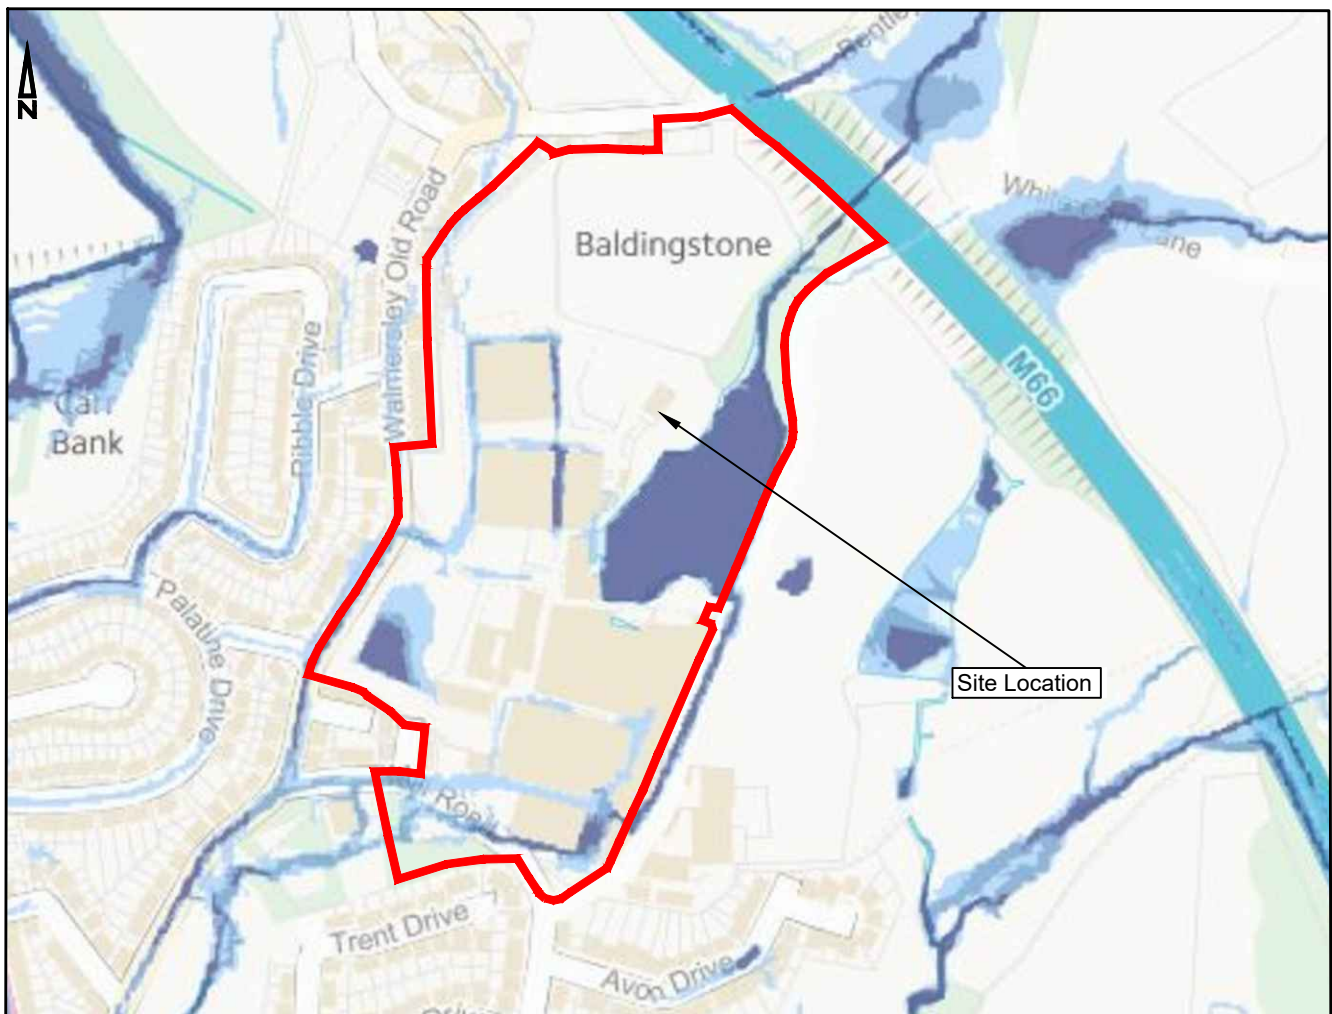
Surface Water  
Flooding - Low  
Risk

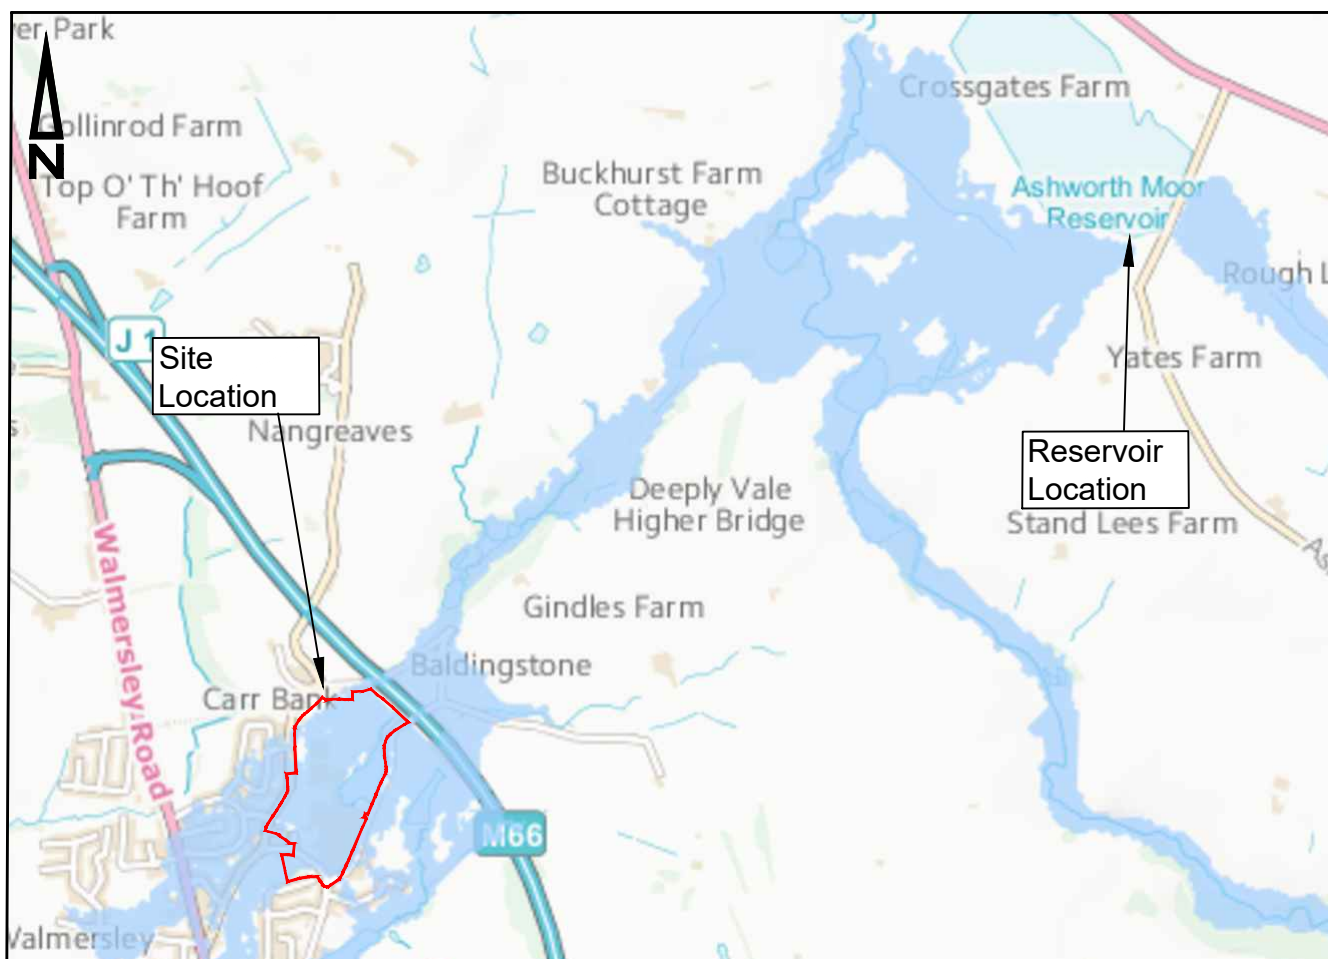
Maximum extent of flooding

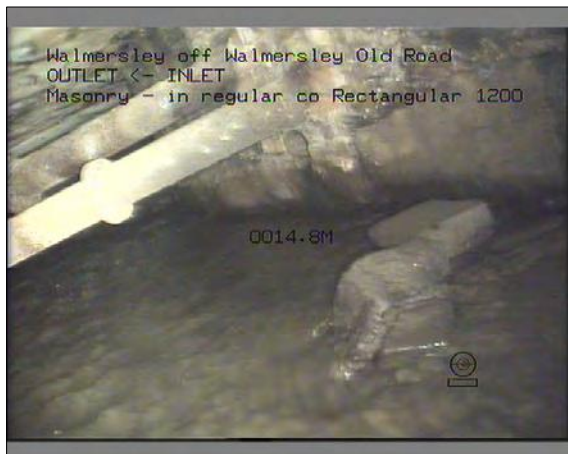
Photo: 011.JPG  
14.8m, Settled deposits, other, 20% cross-sectional area loss

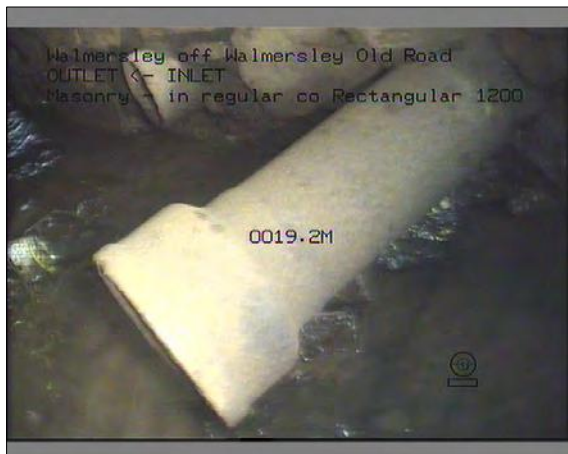
Photo: 015.JPG  
19.2m, Connection intruding, at 5 o'clock, diameter 150mm, intrusion 20%

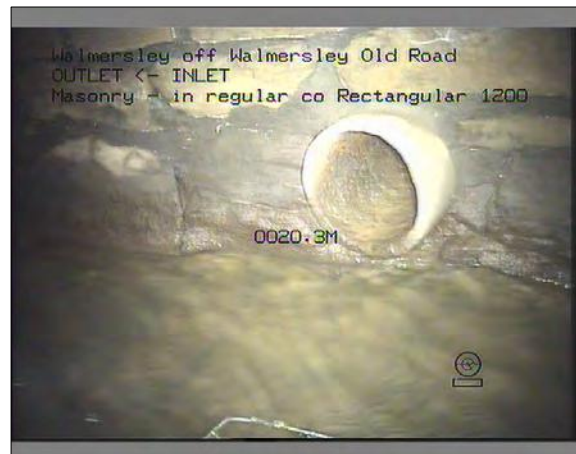
Photo: 016.JPG  
20.3m, Connection intruding, at 5 o'clock, diameter 150mm, intrusion 05%

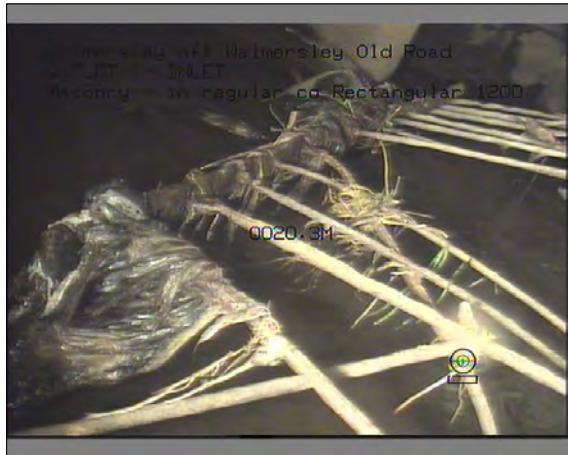
Photo: 017.JPG  
20.3m, Settled deposits, other, 20% cross-sectional area loss

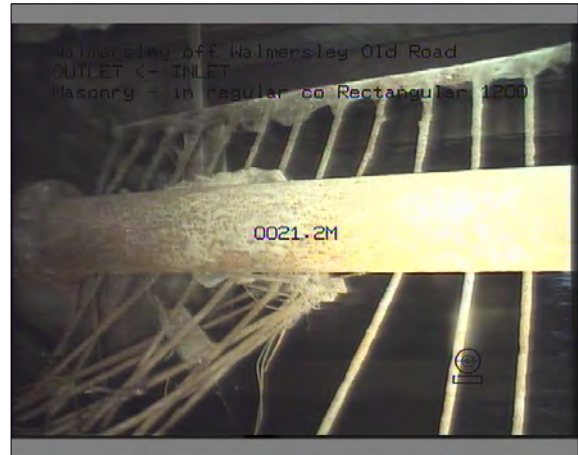
Photo: 018.JPG  
21.2m, Other obstacles, other object in invert, from 1 to 6 o'clock, 85% cross-sectional area loss

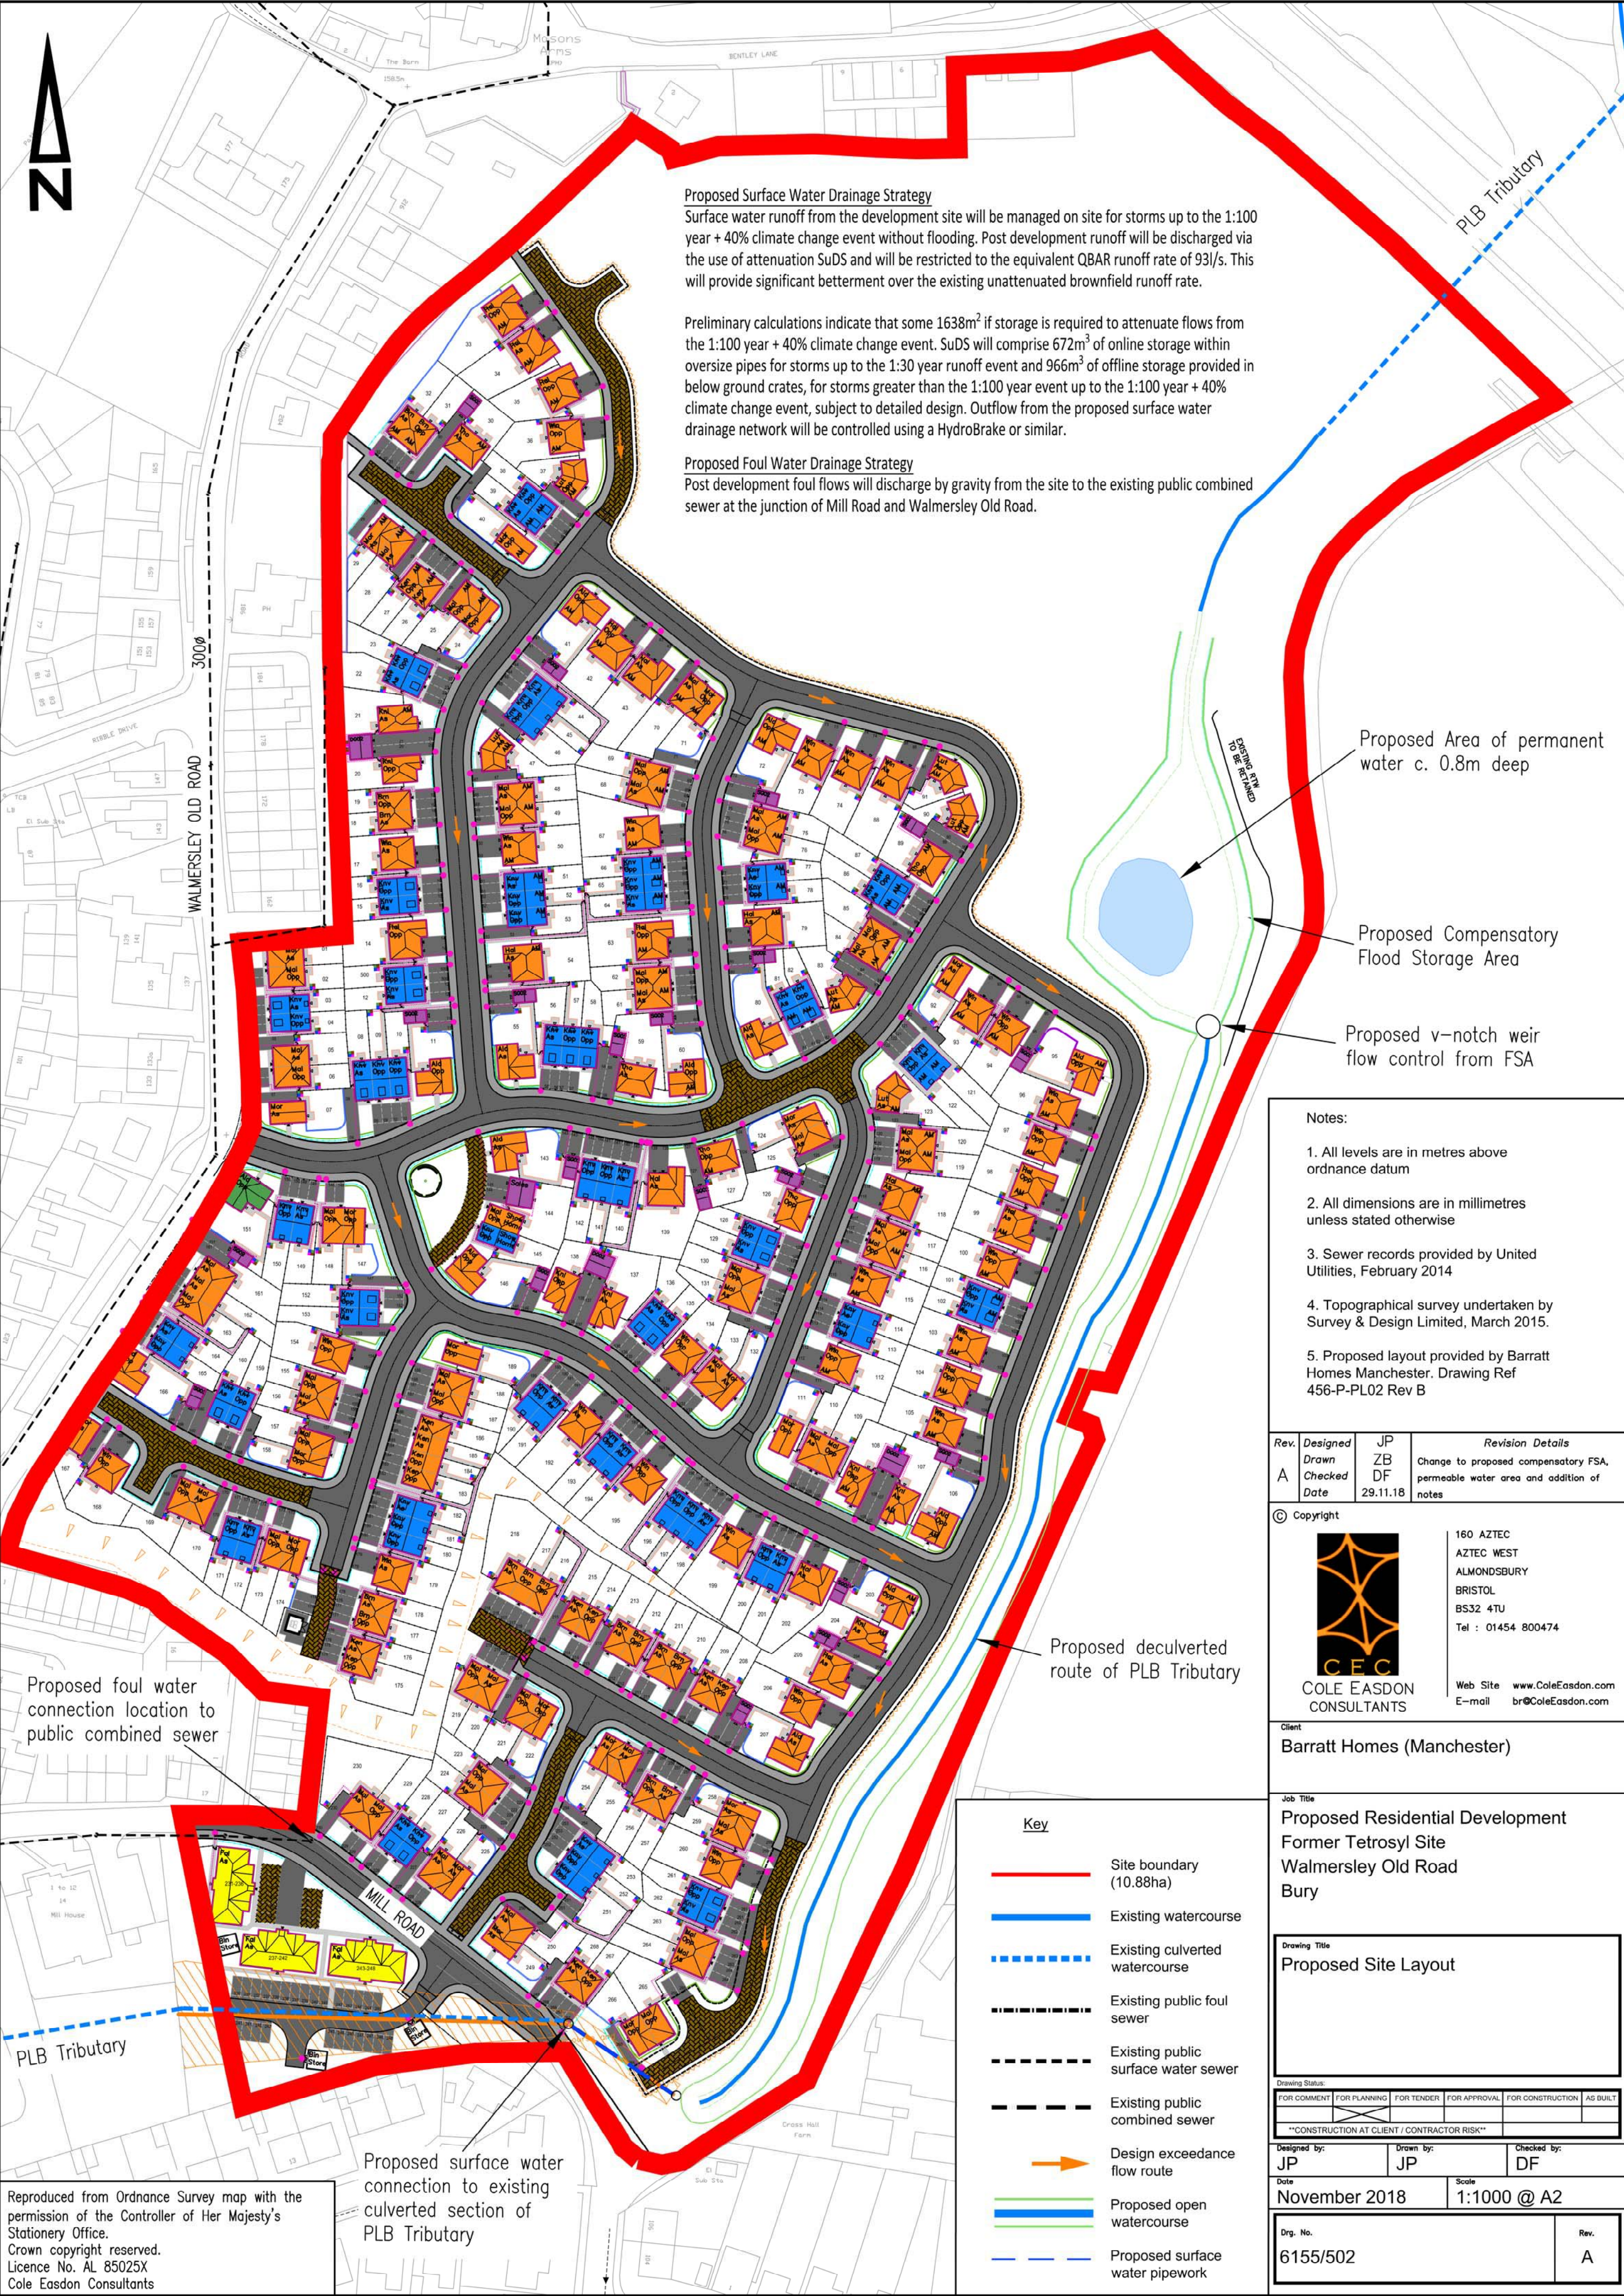
**Proposed Surface Water Drainage Strategy**  
Surface water runoff from the development site will be managed on site for storms up to the 1:100 year + 40% climate change event without flooding. Post development runoff will be discharged via the use of attenuation SuDS and will be restricted to the equivalent QBAR runoff rate of 93l/s. This will provide significant betterment over the existing unattenuated brownfield runoff rate.

Preliminary calculations indicate that some 1638m<sup>3</sup> of storage is required to attenuate flows from the 1:100 year + 40% climate change event. SuDS will comprise 672m<sup>3</sup> of online storage within oversized pipes for storms up to the 1:30 year runoff event and 966m<sup>3</sup> of offline storage provided in below ground crates, for storms greater than the 1:100 year event up to the 1:100 year + 40% climate change event, subject to detailed design. Outflow from the proposed surface water drainage network will be controlled using a HydroBrake or similar.
