**WATER FRAMEWORK DIRECTIVE RISK ASSESSMENT  
FOR  
PROPOSED RESIDENTIAL DEVELOPMENT, FORMER TETROSYL SITE  
WALMERSLEY OLD ROAD, BURY, GREATER MANCHESTER  
ON BEHALF OF  
BARRATT HOMES MANCHESTER**

**FEBRUARY 2021**

**Project:** Proposed Residential Development, Former Tetrosyl Site, Walmersley Old Road, Bury, Greater Manchester

**Document Title:** Water Framework Directive Risk Assessment

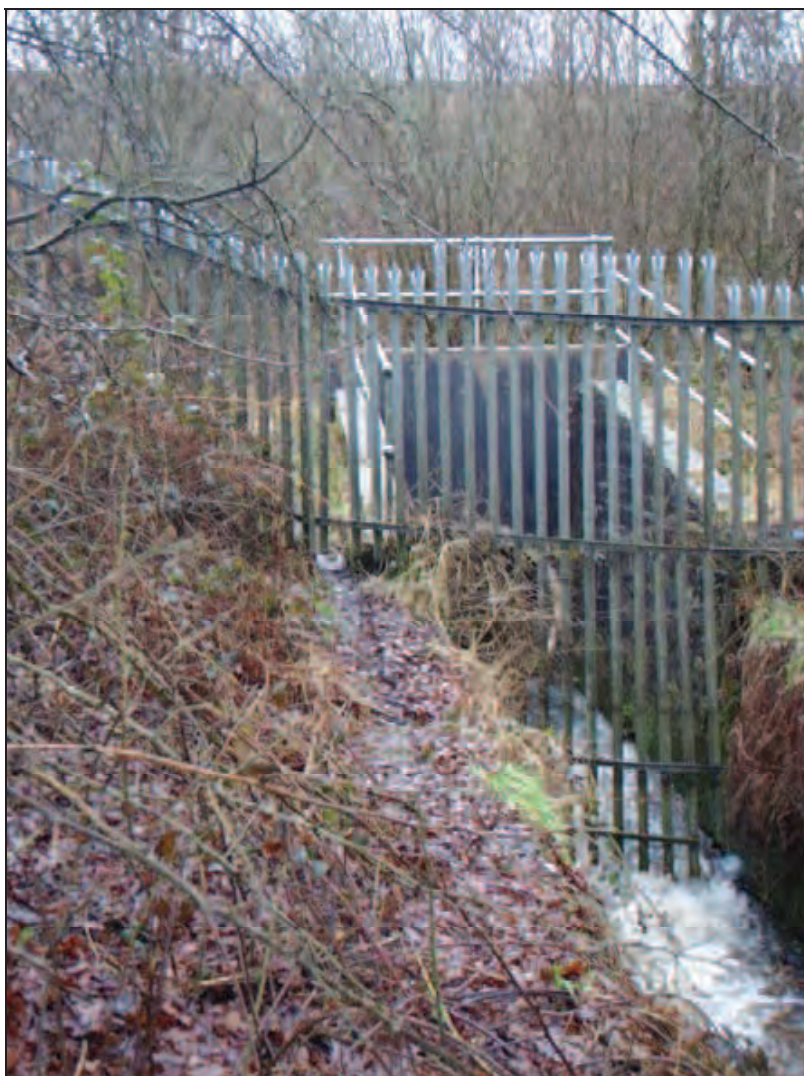
**Photograph 5: Watercourse entering north east corner of the site**

A fast-flowing watercourse enters the wooded valley from the north-east (Target Note 5, see Photograph 5). As the watercourse enters the site it is canalised within a stone channel. As the channel widens into the reservoir within the site, the banks are formed by wooded banks.

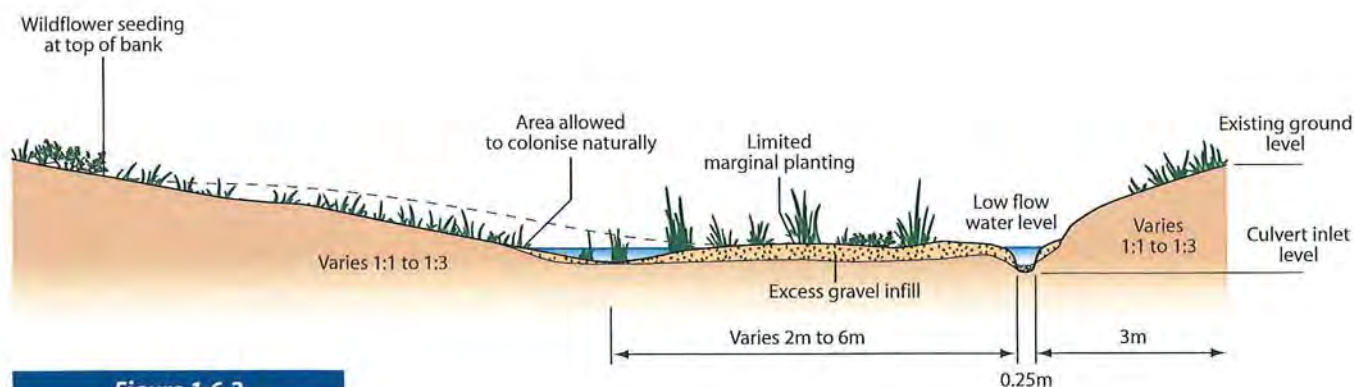
Figure 1.6.2

The new channel varied in bank slope and bed width, but followed a smooth longitudinal bed profile. By then infilling with an excess of gravel, the stream was allowed to shape its new bed, rather than 'constructing' pools and riffles.

SECTION A THROUGH RAISED BED  
AND MARGINAL SHOAL

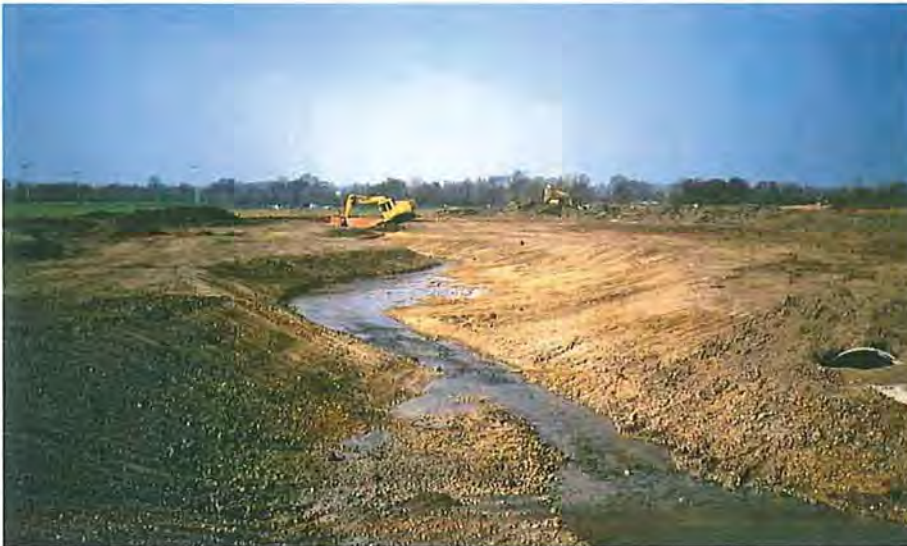
Looking downstream at the shallow bank slopes. The severed culvert still visible

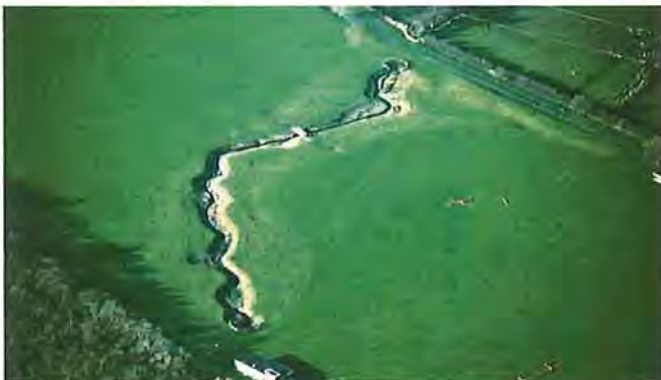
The new sinuous course and extent of wildflower seeding

The new course is 12.5% longer than the culvert, sinuous, with varying bed and top-of-bank widths. A shallow (1:8 batter) 'beach' area, as a result of an exposed gravel lens, and new meanders (1:5 inside batters) form the focal points for access to the stream.

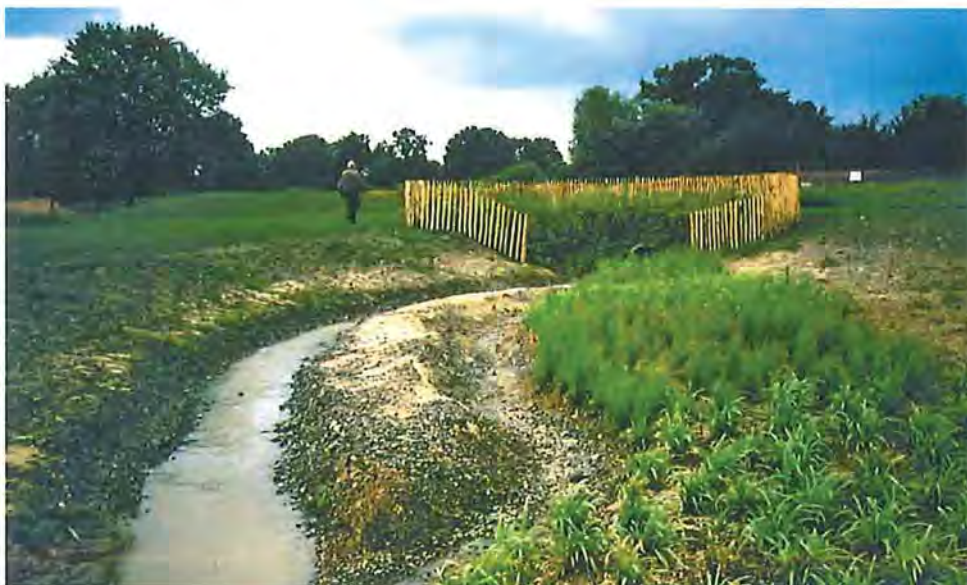
Planting up the 'wet berm' area  
and shielding the culvert  
entrance with shrub planting

Topsoil was not replaced on the riverbanks in order to attain a low fertility substrate suitable for the natural colonisation of wildflowers and plants from upstream. A 'buffer zone' between the amenity grassland and the top of the bank was seeded with a low-density wildflower mix from an approved source. This creates a visually pleasing edge to the playing fields and provides a suitable seed source for the banks. On the river's edge native provenance marginal plants were carefully sourced from a local nursery. School children were involved in some of the marginal planting. Wildflower plugs were also planted. The culvert entry and exit were both screened using a variety of native shrub species.

The marginal planting is suffering disturbance from early use and may take longer than expected to establish a good cover, though this should eventually produce a good diversity of edge habitats. The wildflower plugs have been decimated by crows in search of worms. About a third were removed from the ground and died.

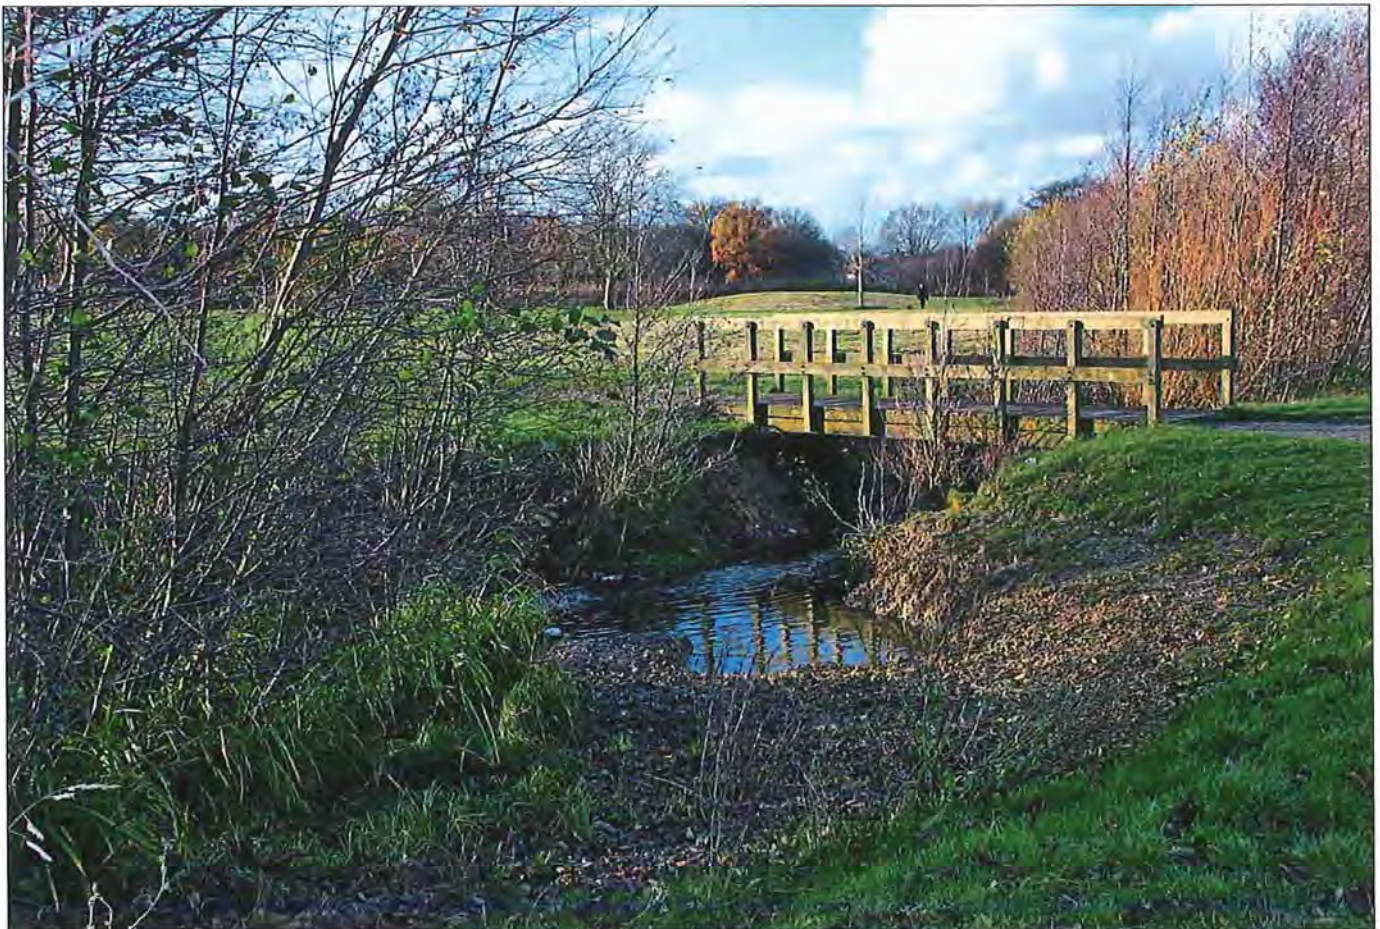
Effective narrowing of the channel, and asymmetric shallowing of the bed has occurred following restoration – 2012

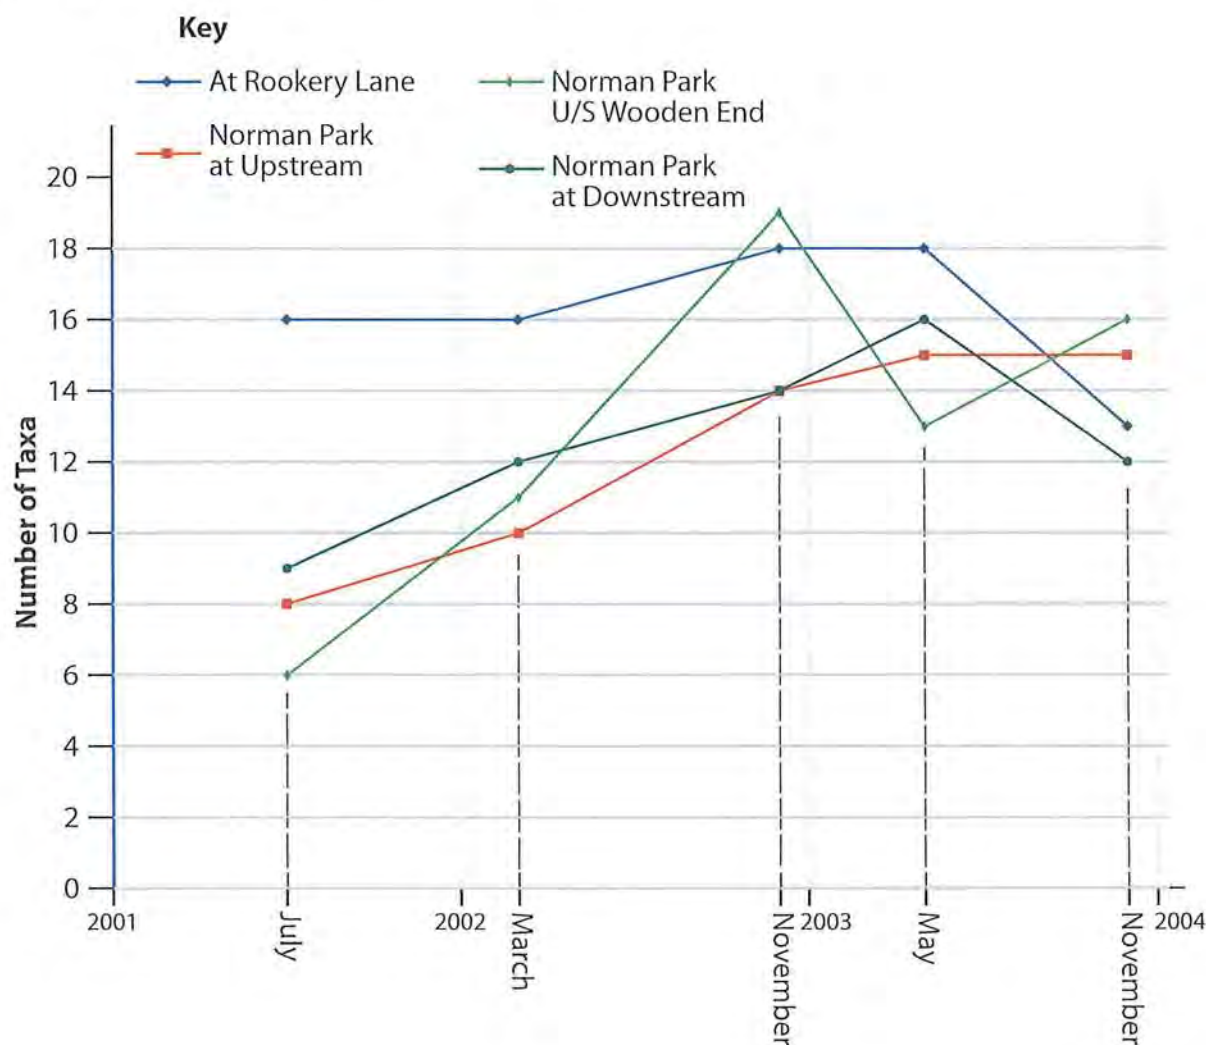
Macroinvertebrate sampling was undertaken between 2001 and 2003 and this showed an increase in the number of taxa recorded following the works. Further sampling is planned for 2013 in order to compile a more complete dataset.

### Changes in the number of invertebrates between 2001 and 2003.

By 2003 numbers for the control site (Rookery Lane) and the restored sites were similar demonstrating ecological improvement in the de-culverted stretch of the river.  
(River Ravensbourne, EA data)

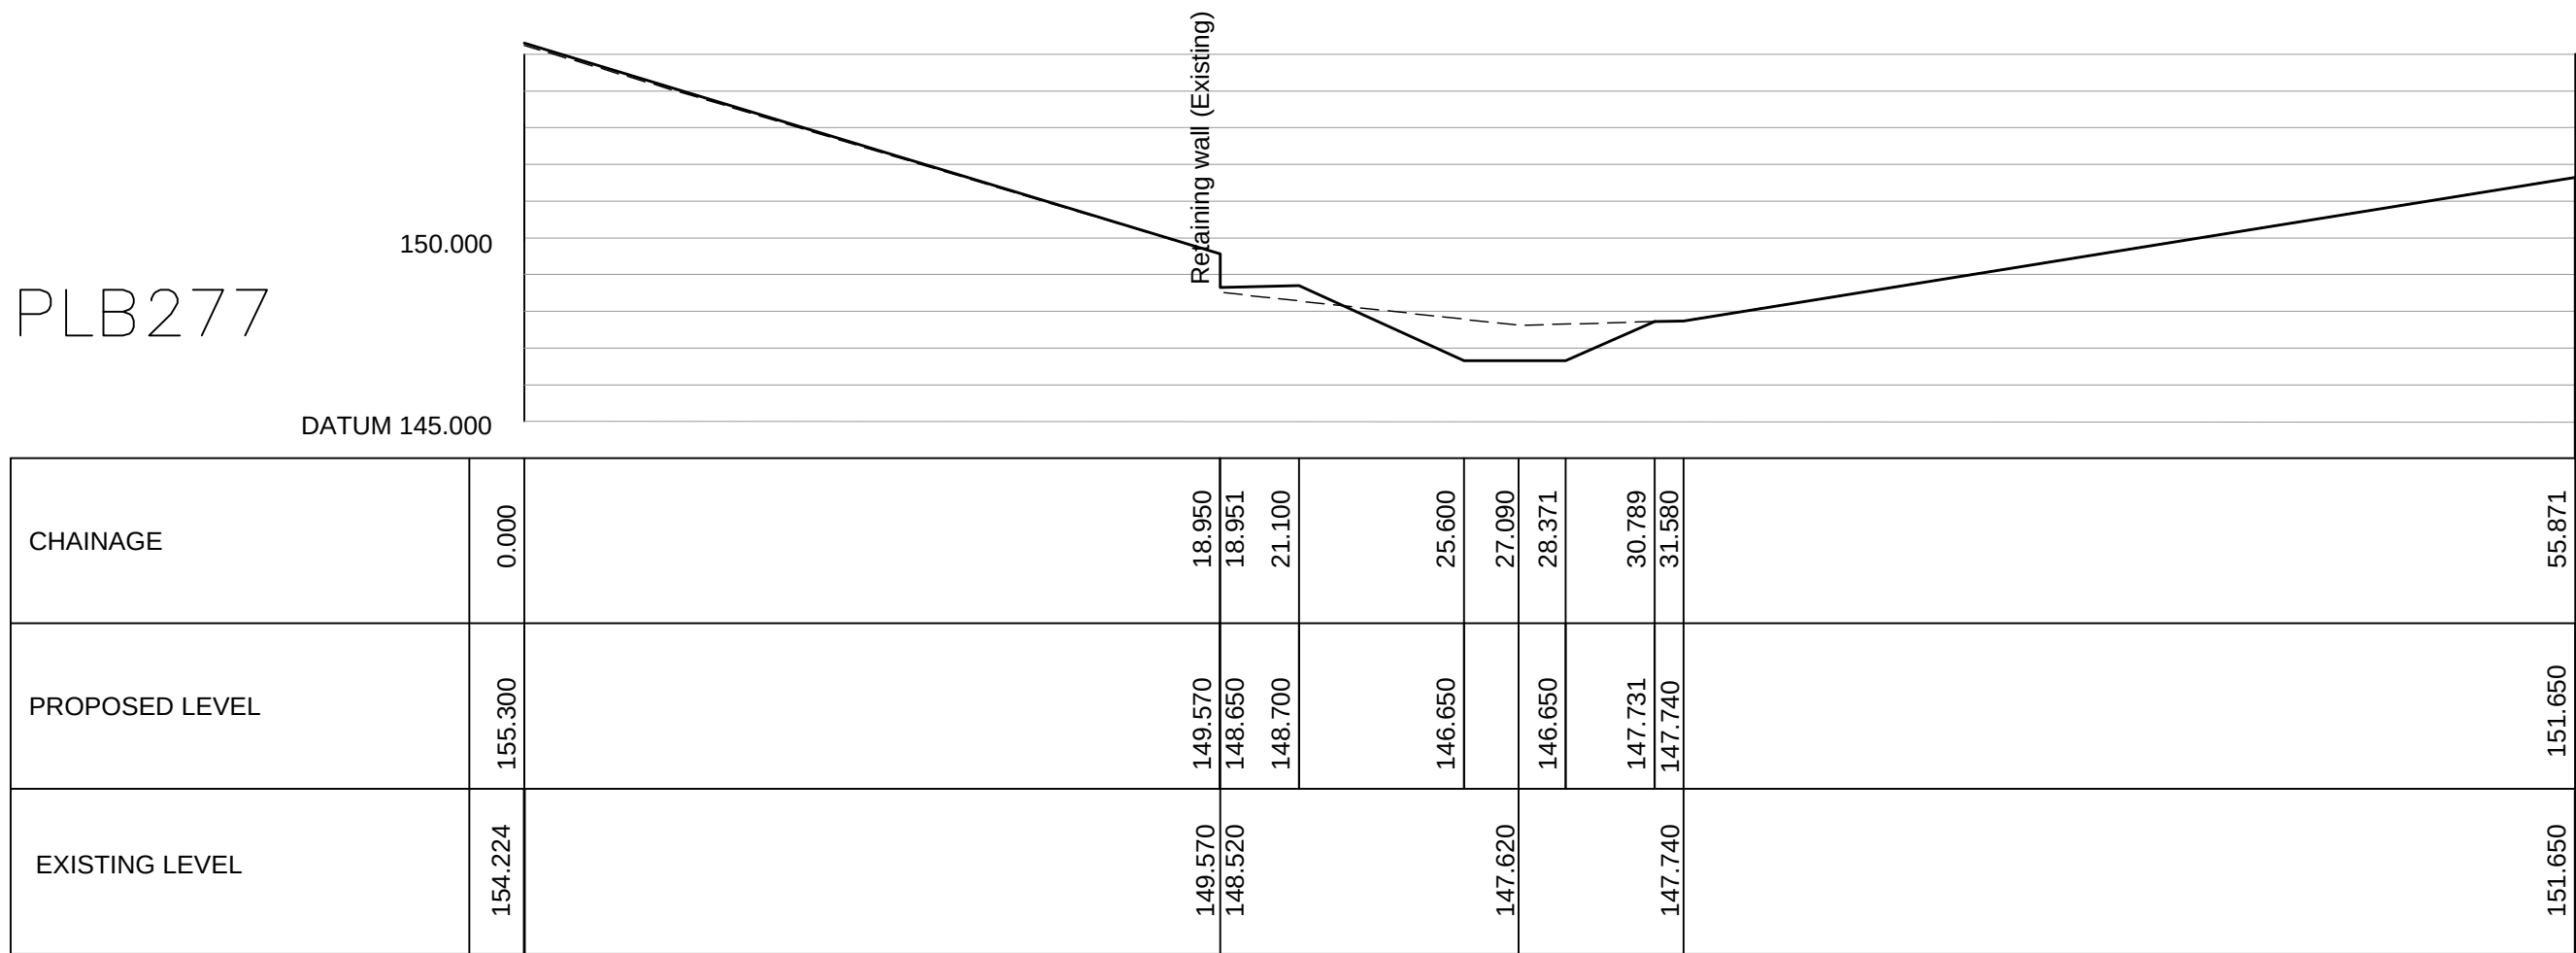
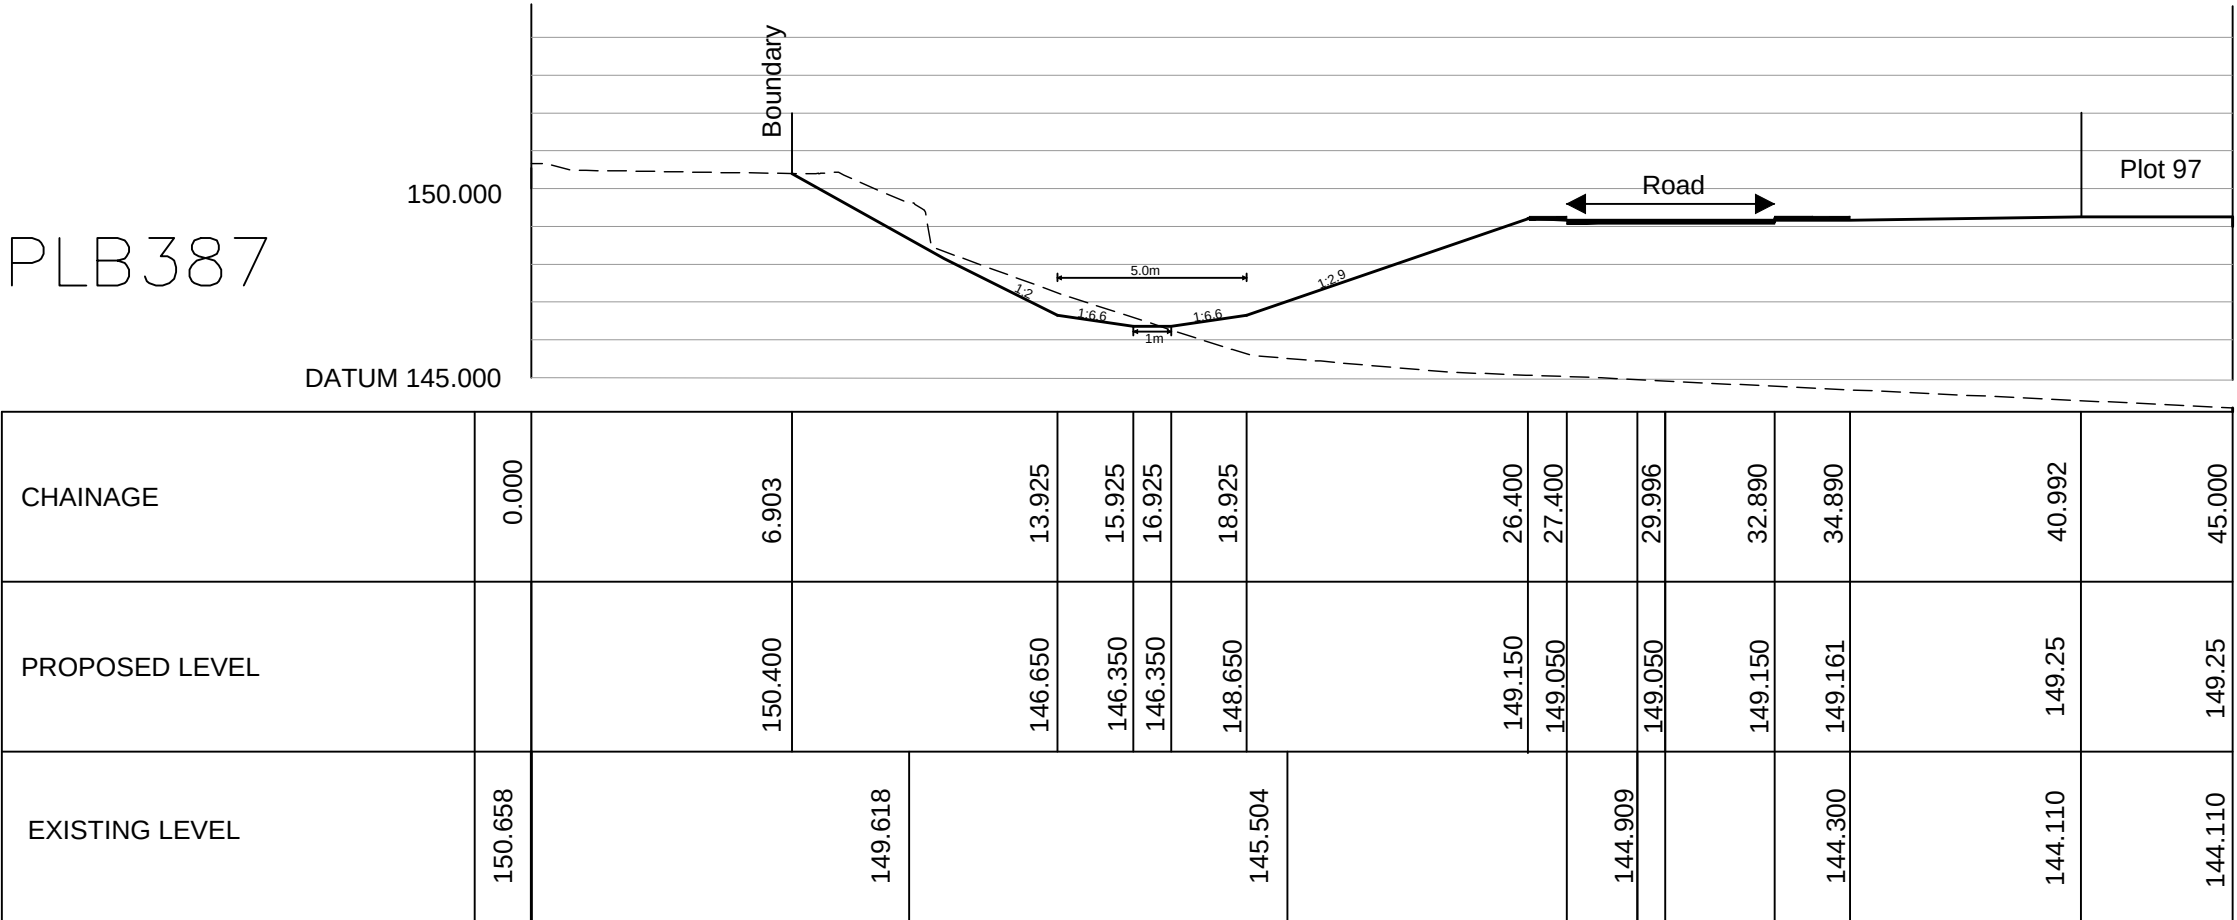
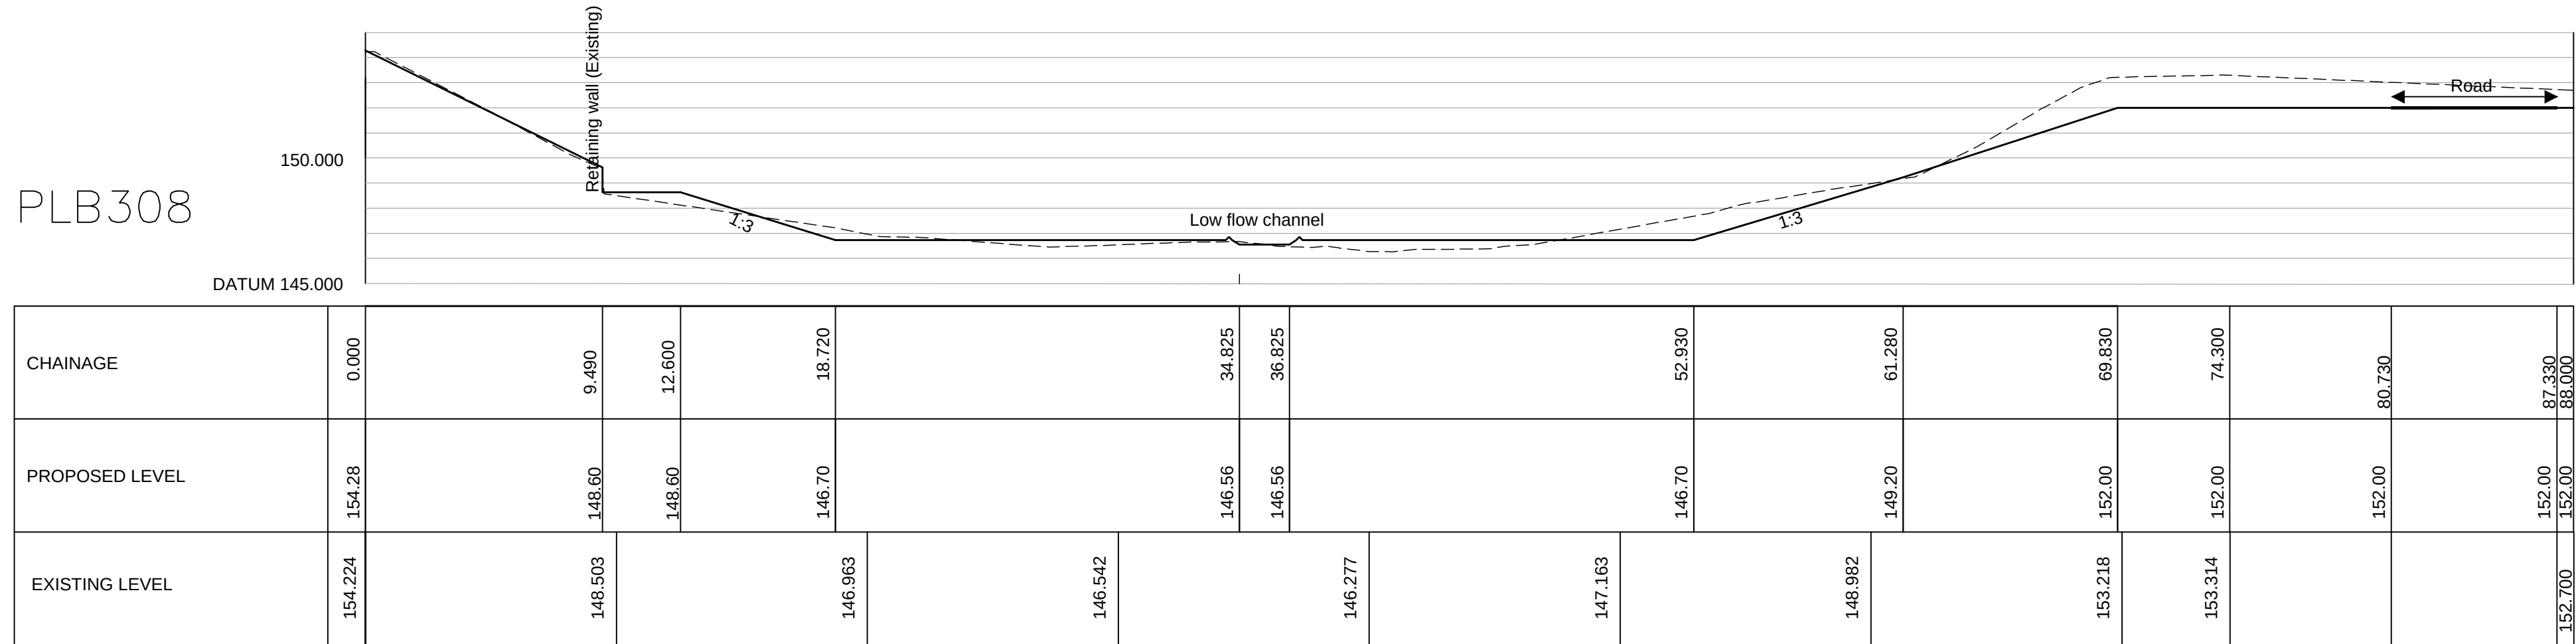
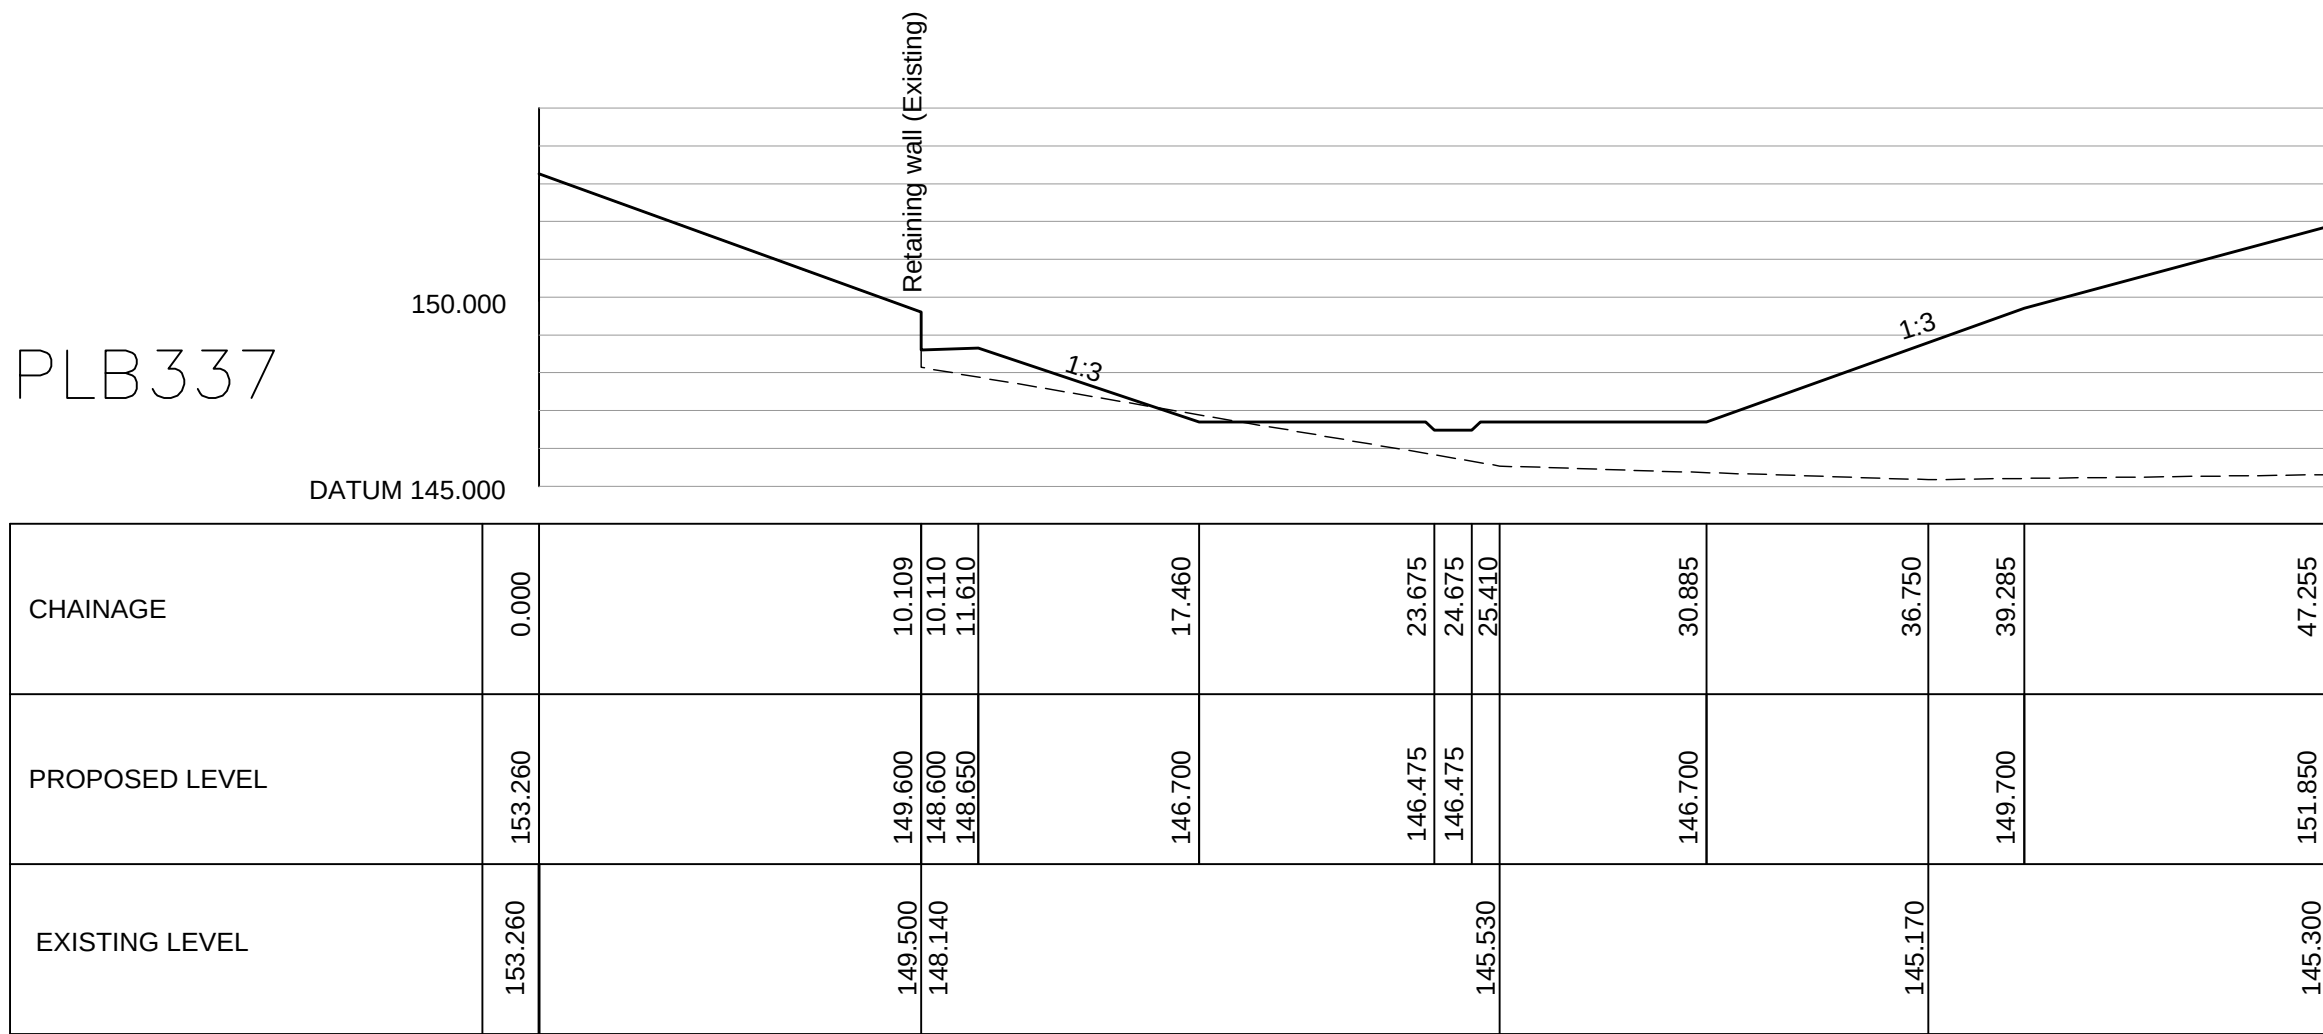
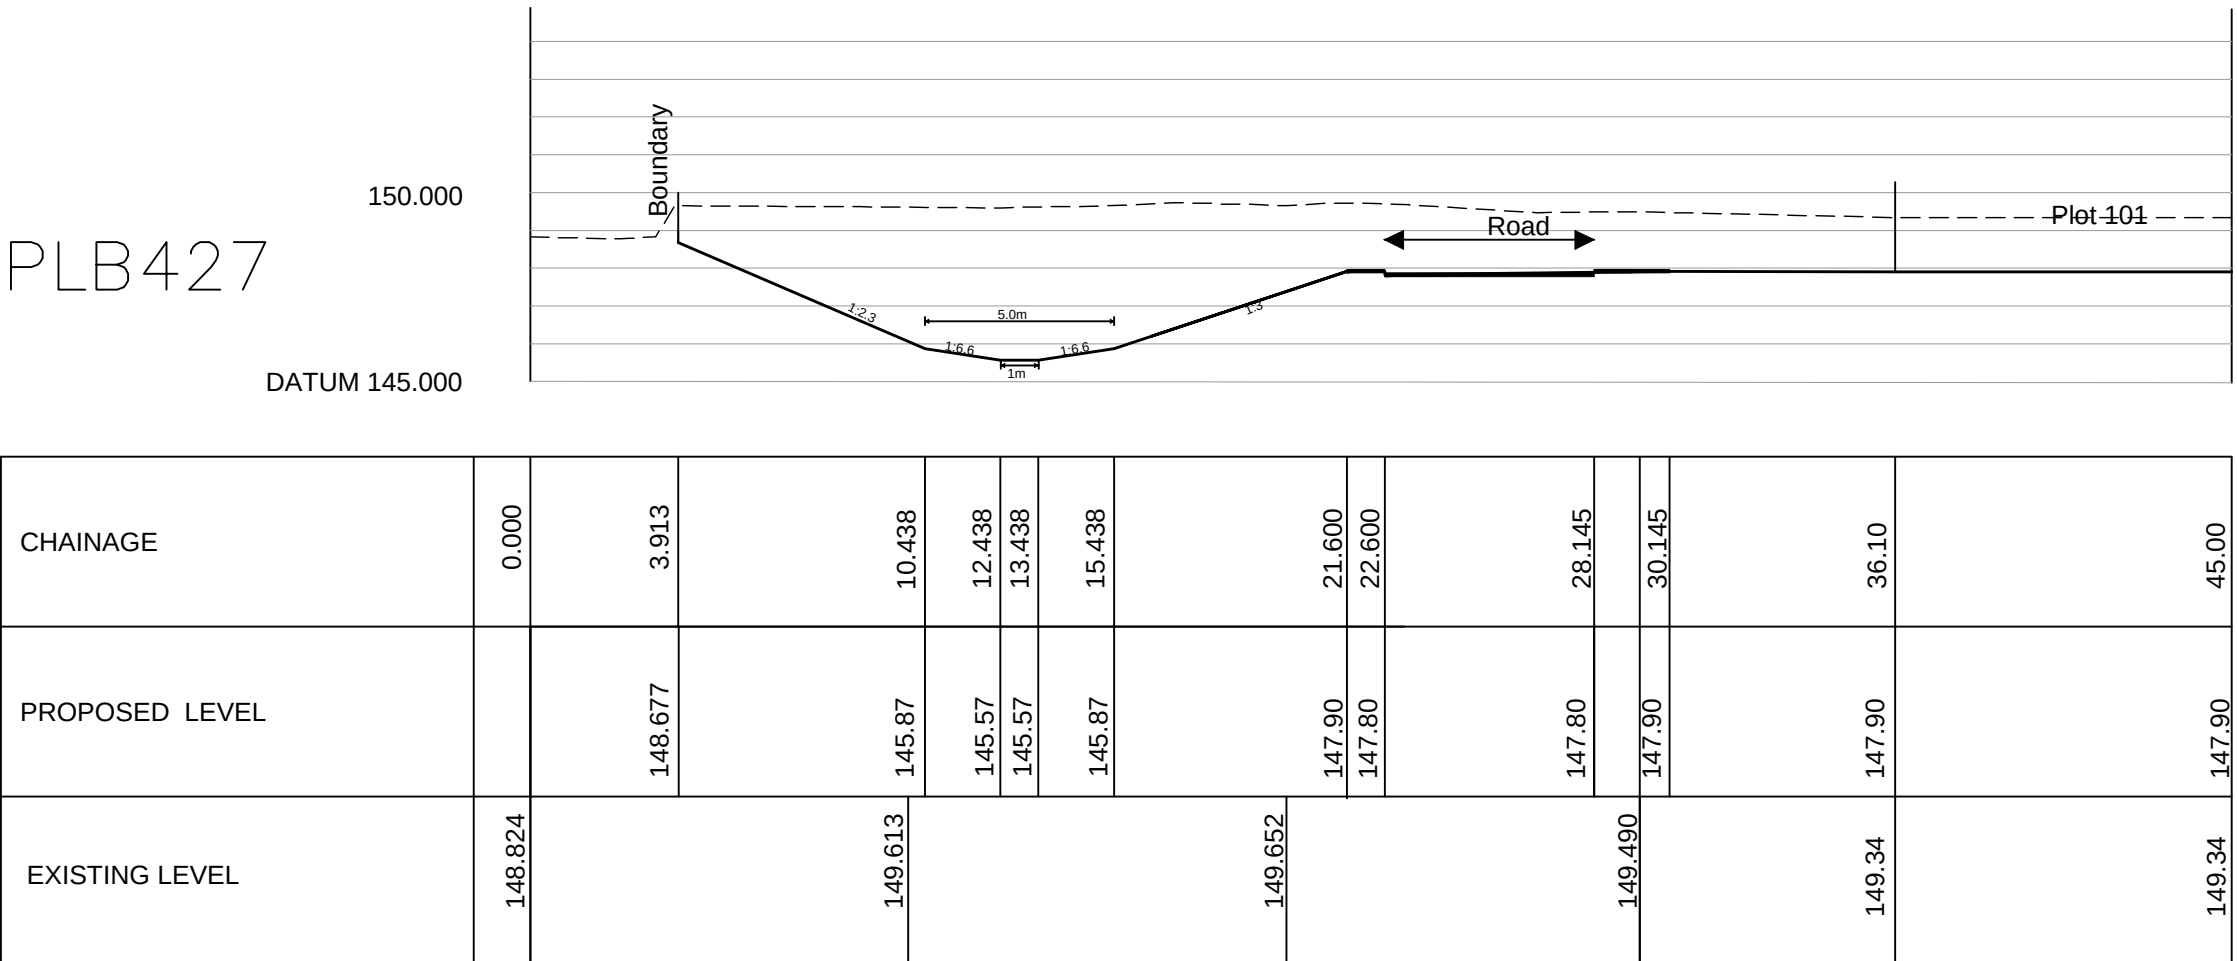
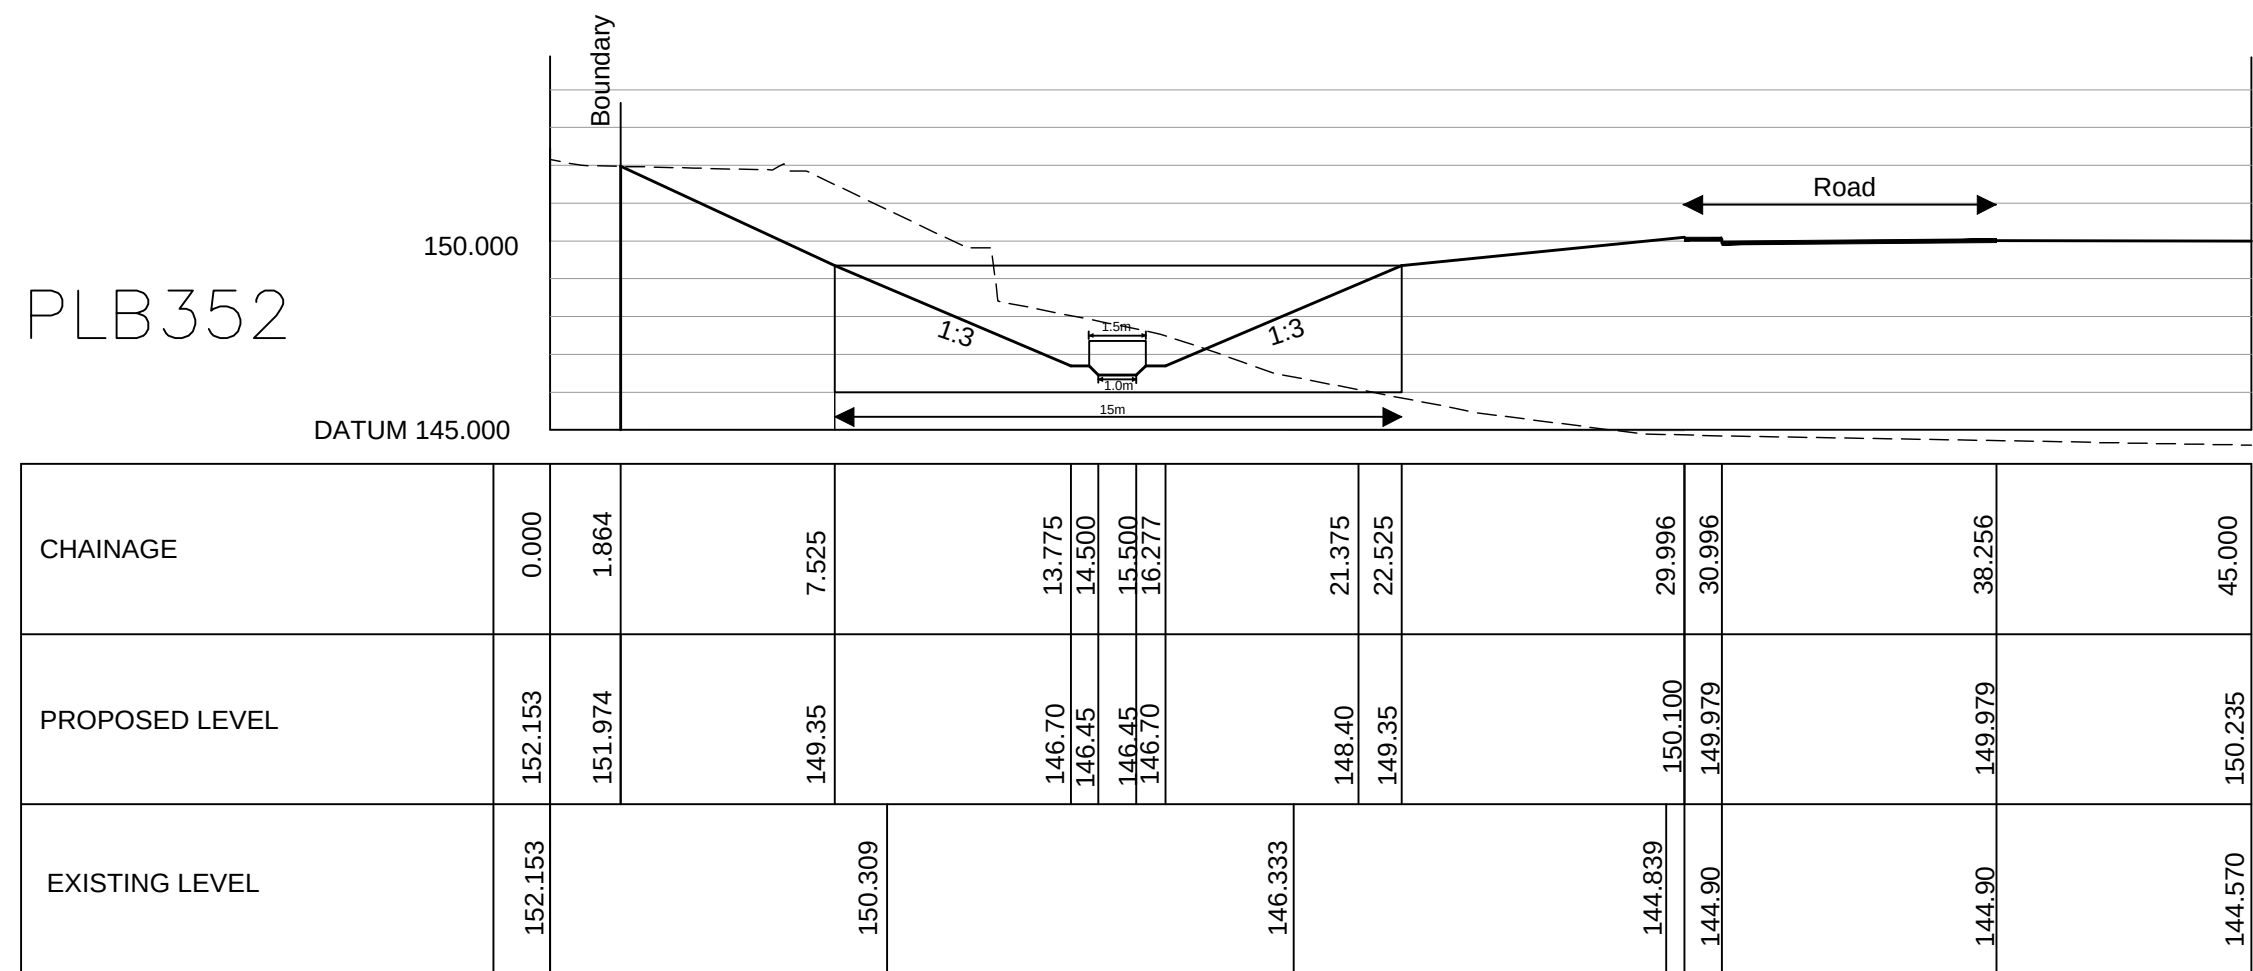
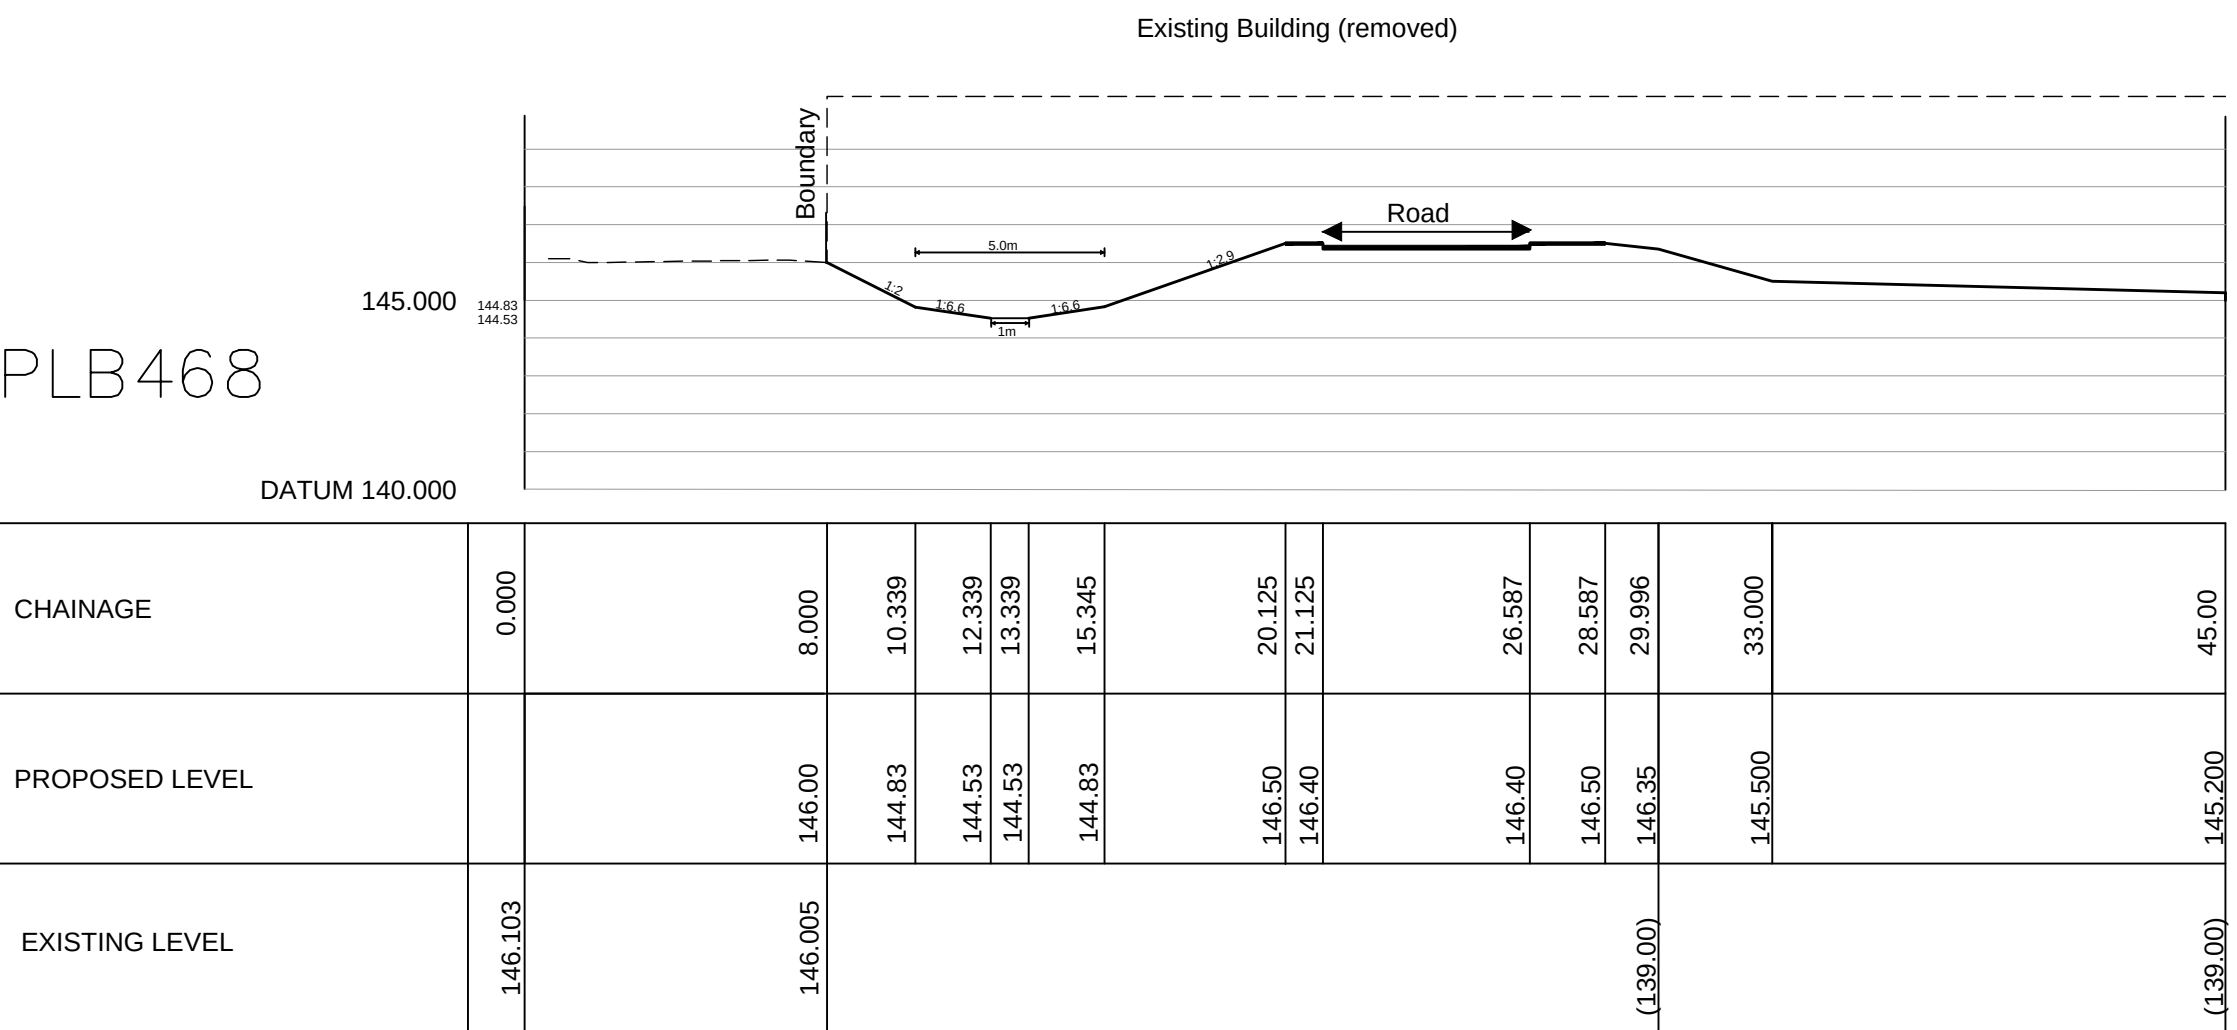
1. All levels in meters above ordnance datum.
2. All sections are viewed downstream.
3. Refer to Drawing 6155/502 for section locations
