**WATER FRAMEWORK DIRECTIVE RISK ASSESSMENT  
FOR  
PROPOSED RESIDENTIAL DEVELOPMENT, FORMER TETROSYL SITE  
WALMERSLEY OLD ROAD, BURY, GREATER MANCHESTER  
ON BEHALF OF  
BARRATT HOMES MANCHESTER**

**FEBRUARY 2021**

**Project:** Proposed Residential Development, Former Tetrosyl Site, Walmersley Old Road, Bury, Greater Manchester

**Document Title:** Water Framework Directive Risk Assessment

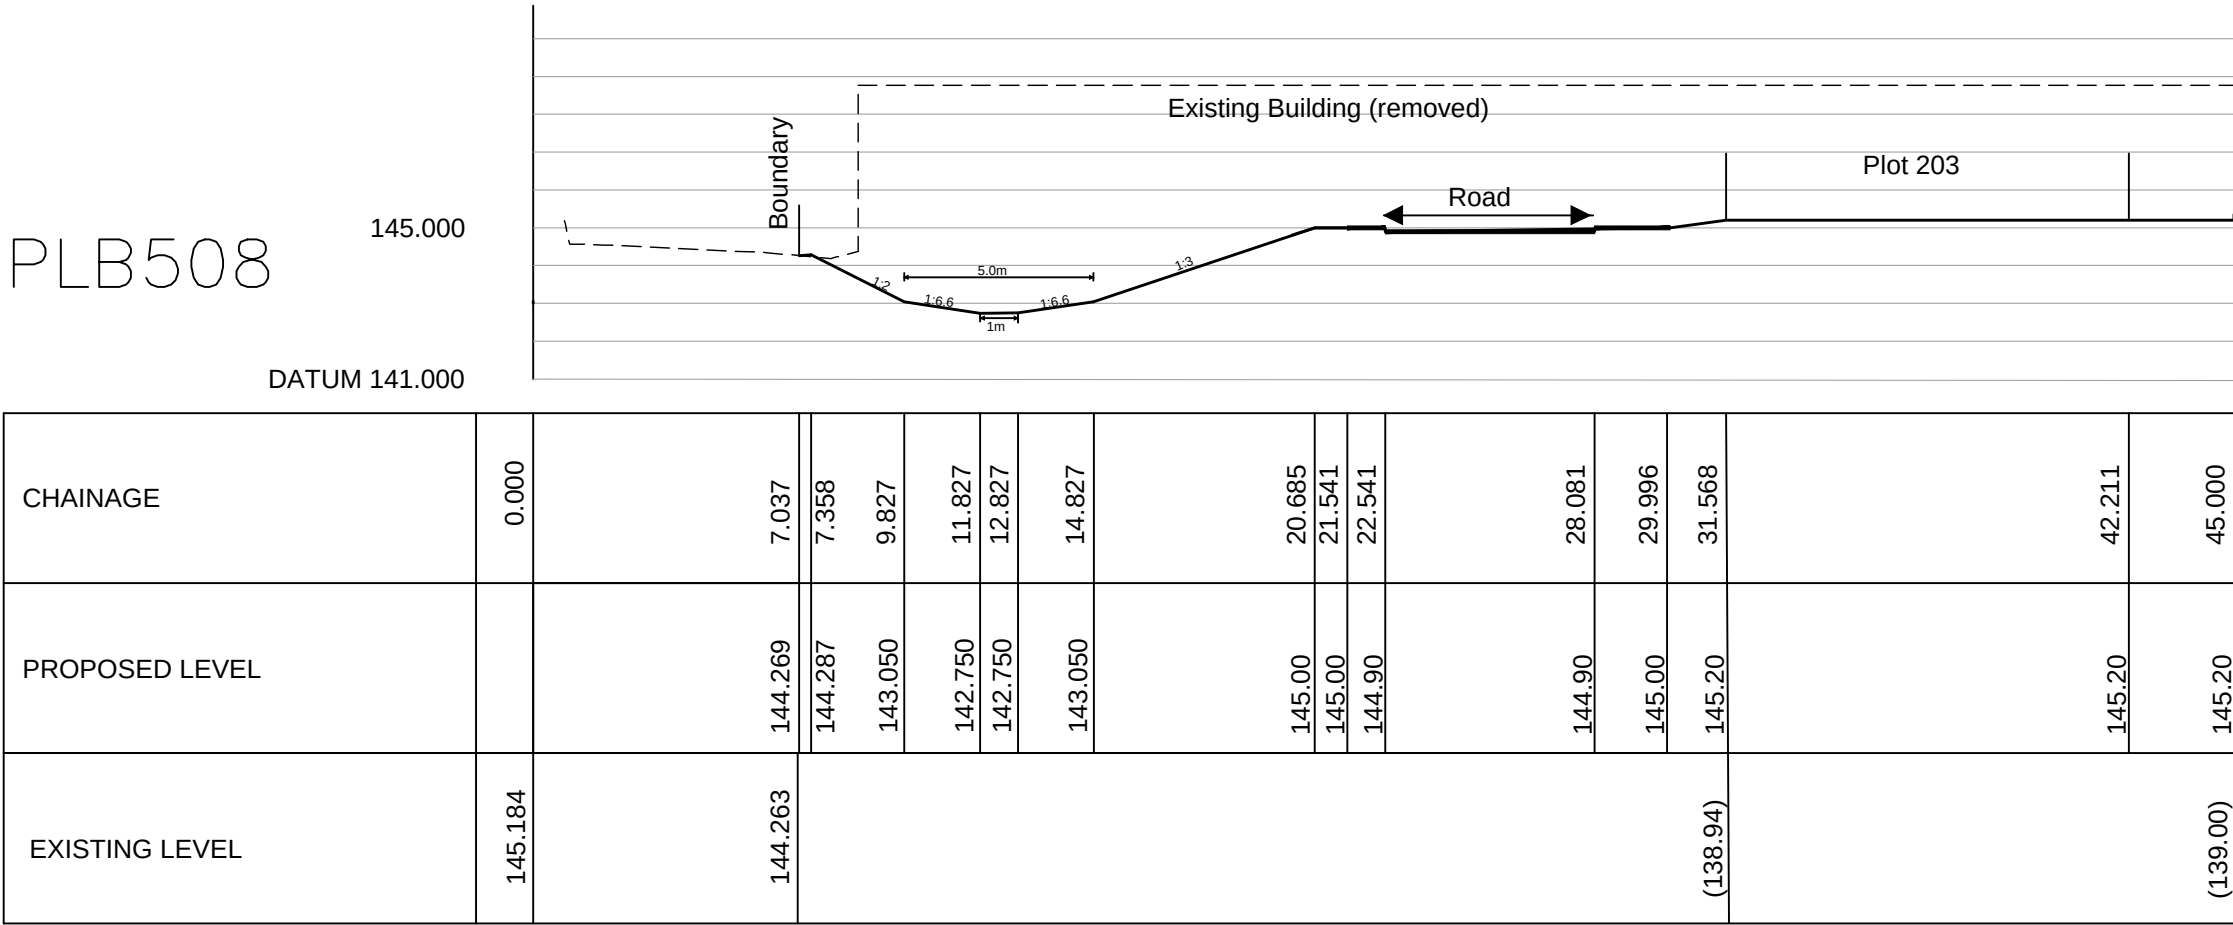
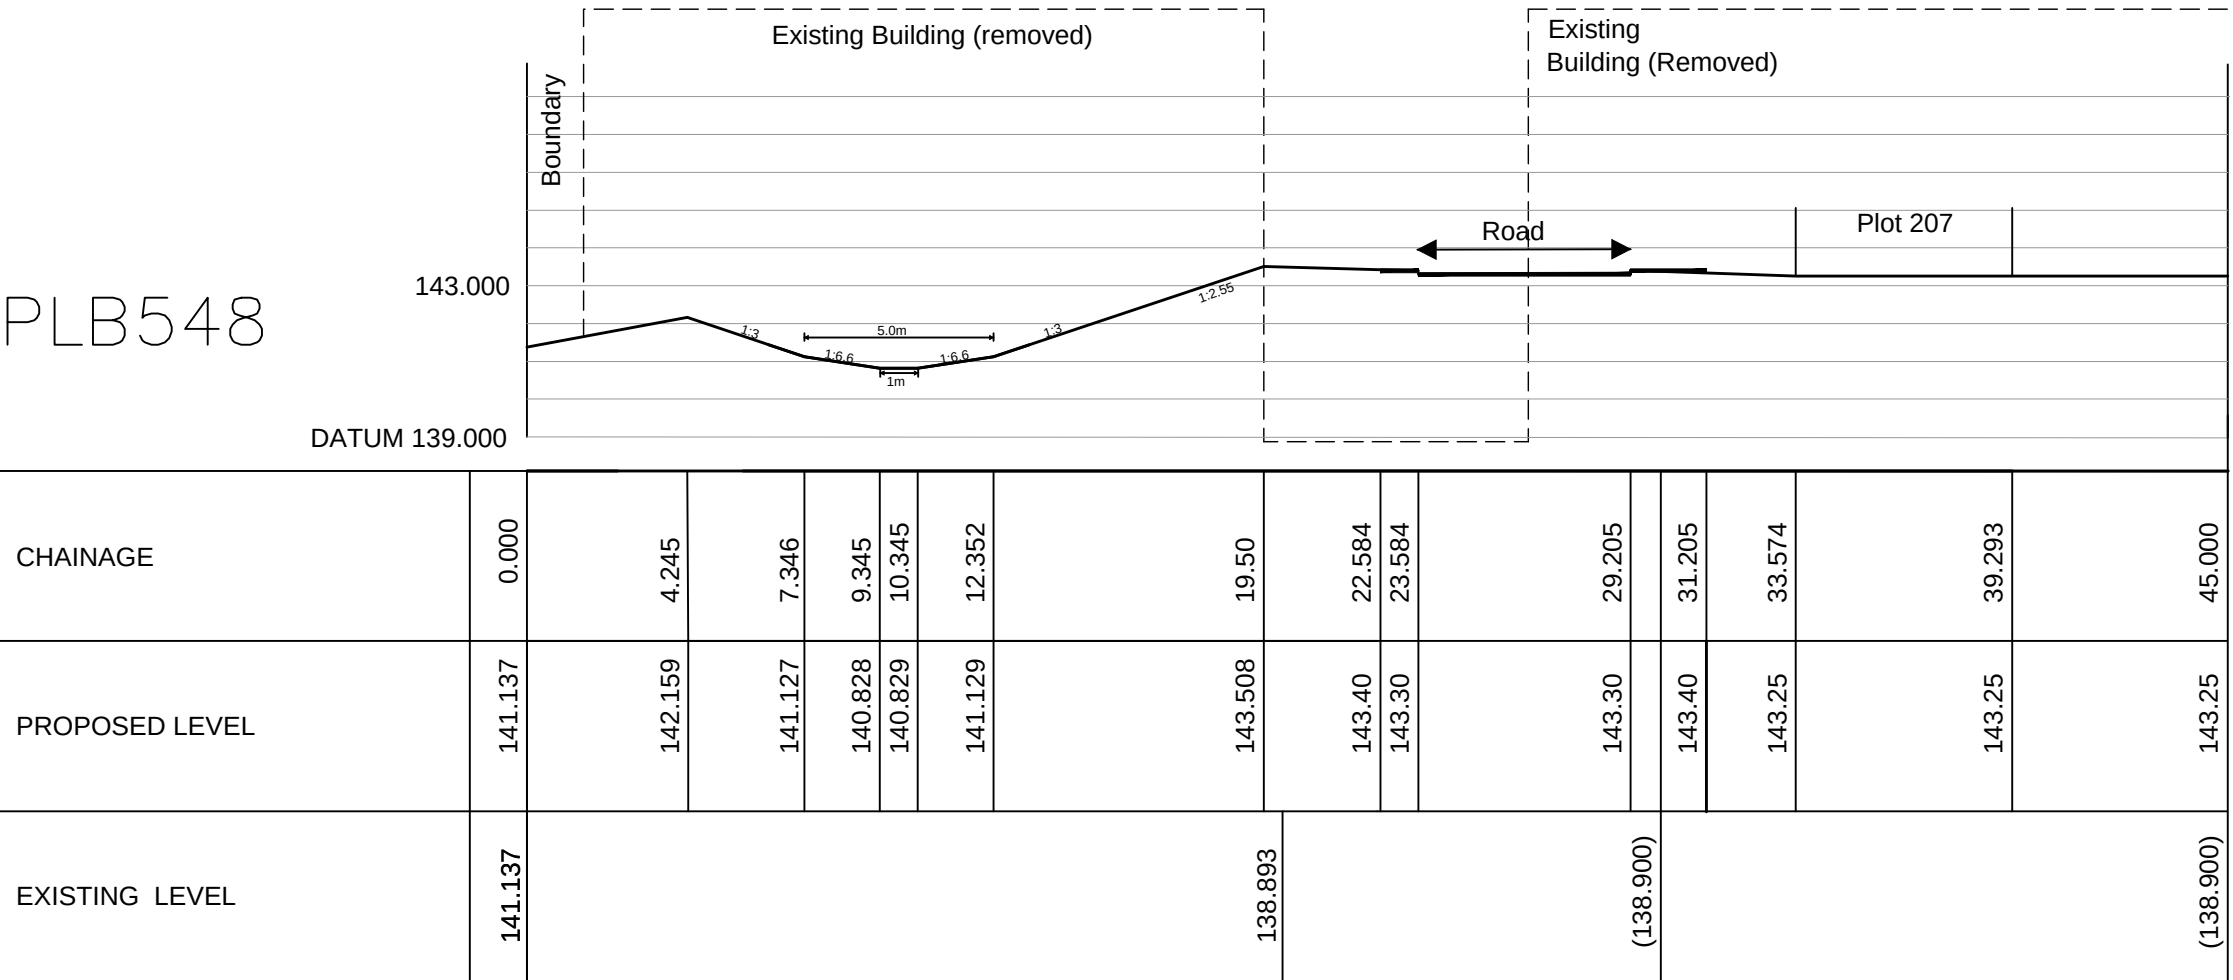
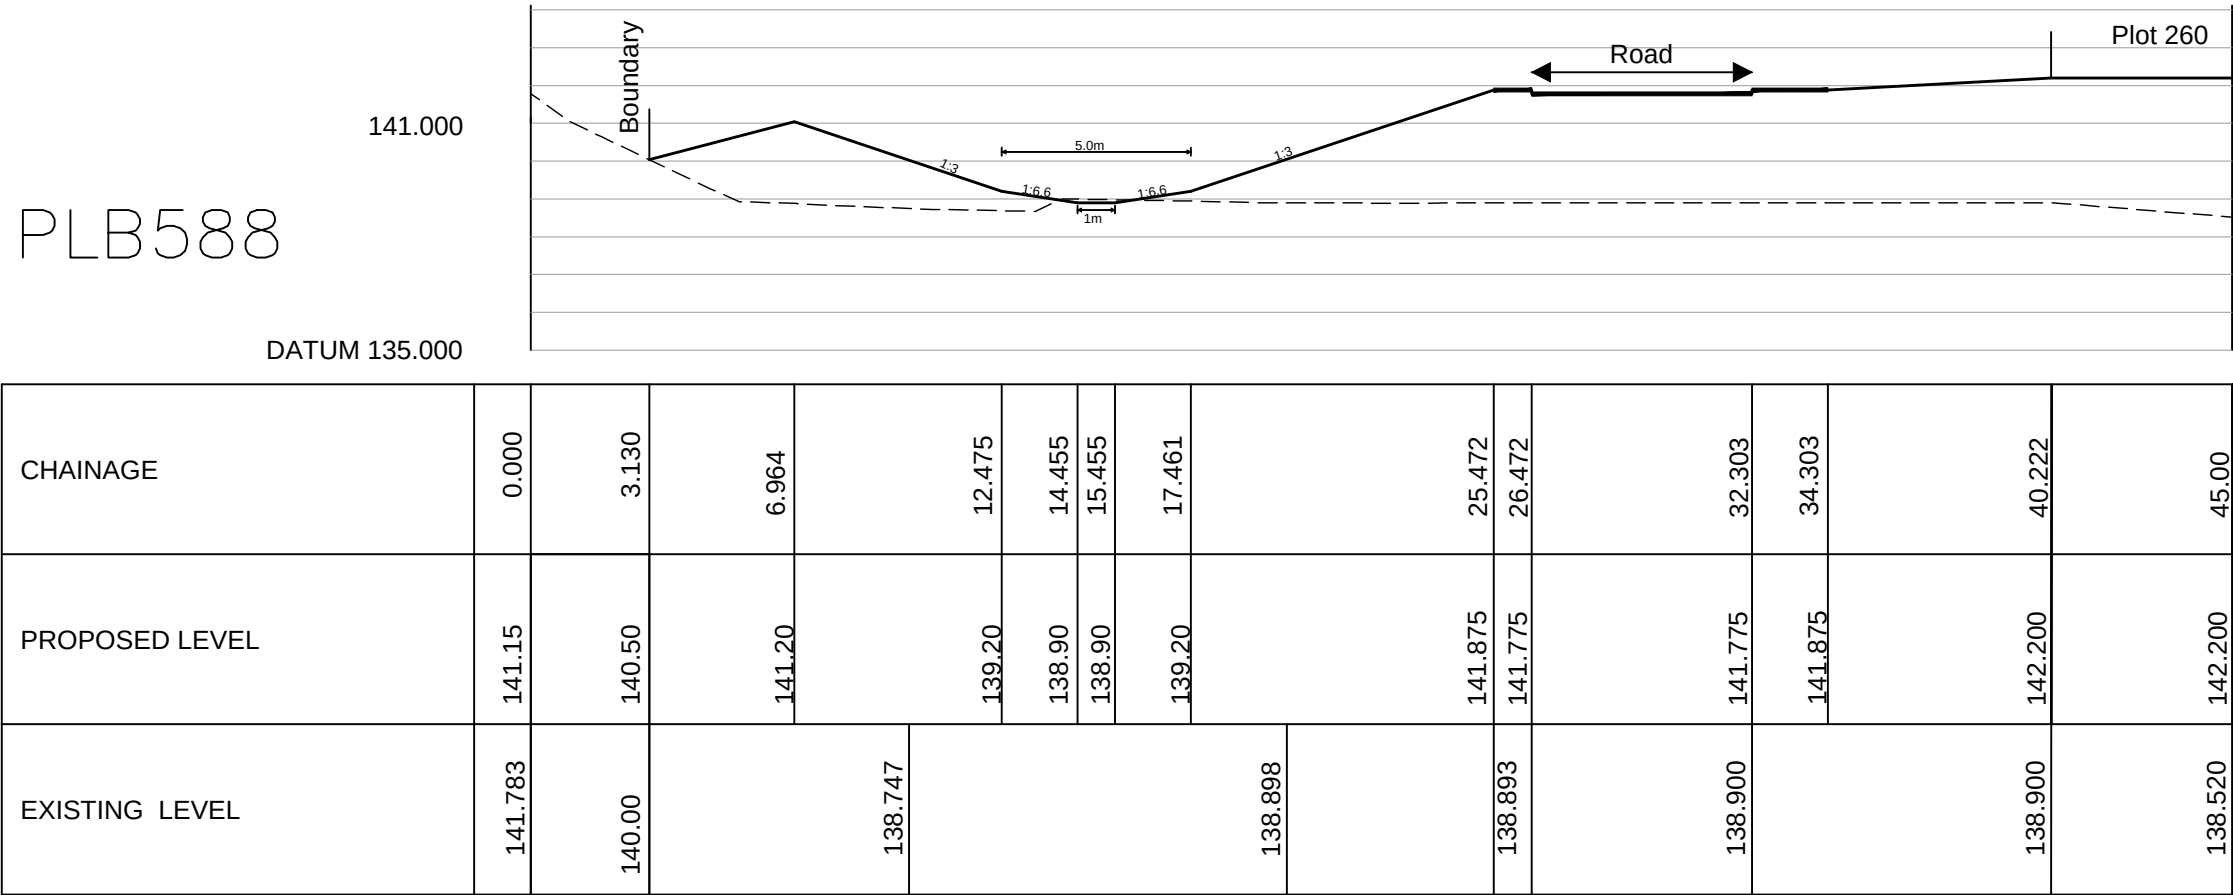
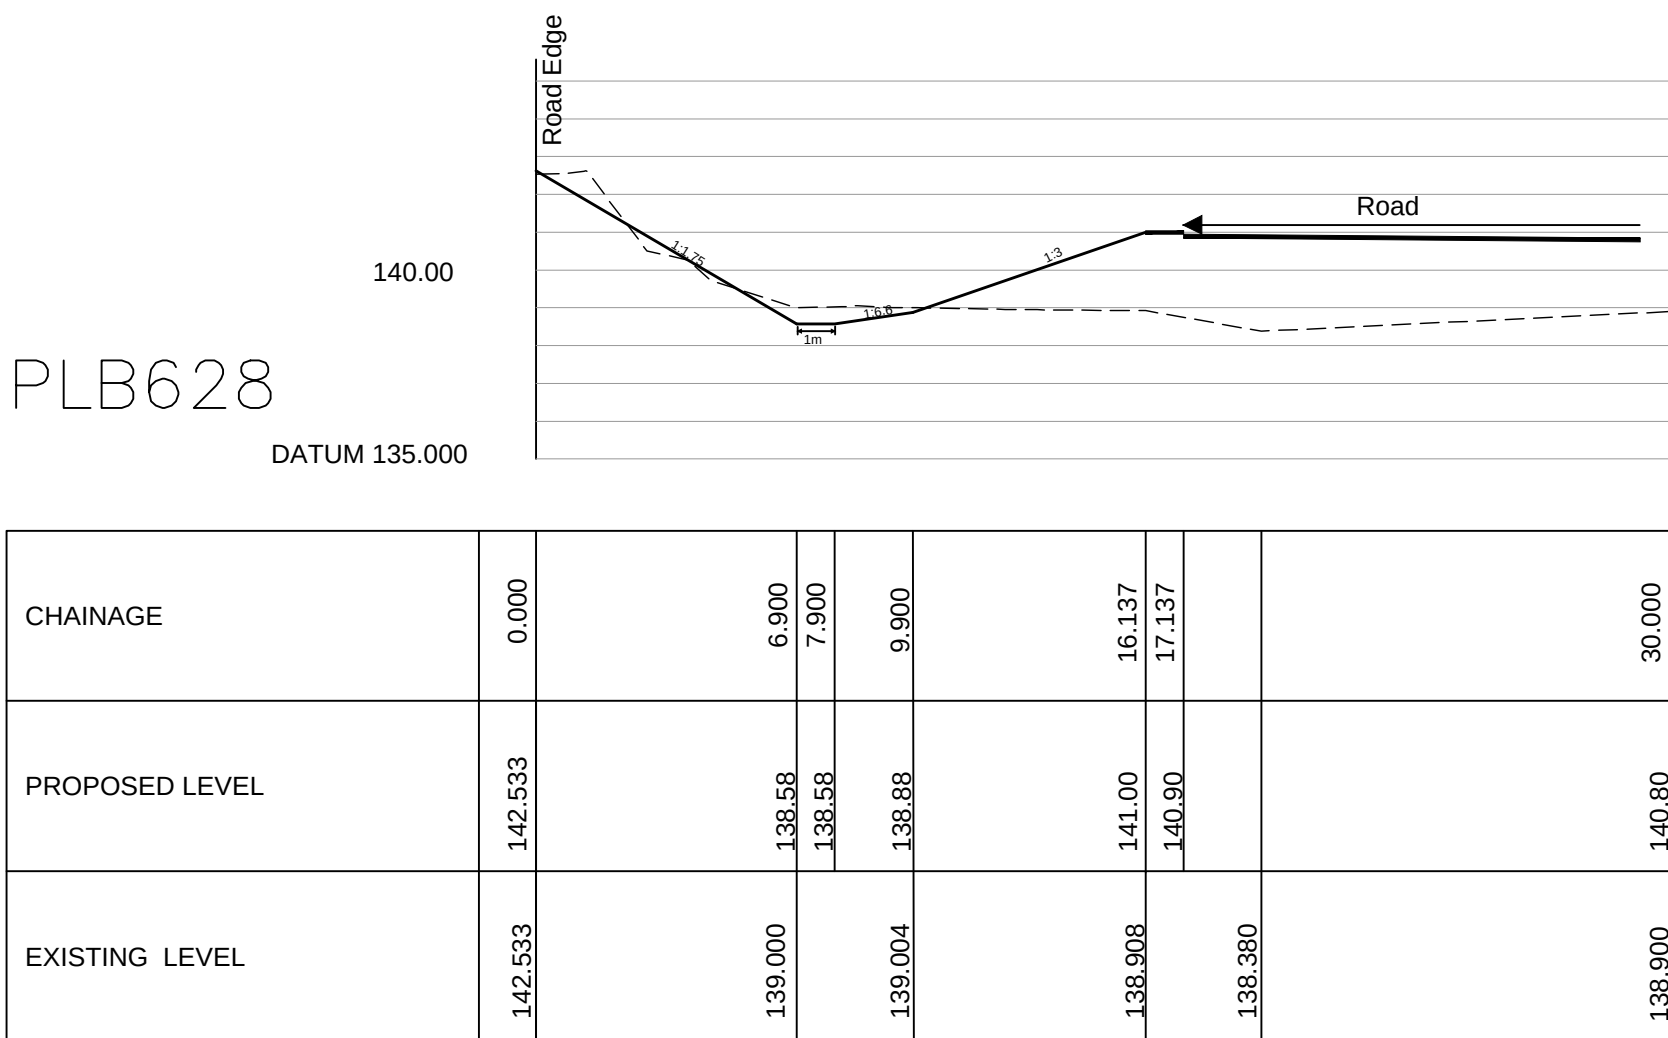
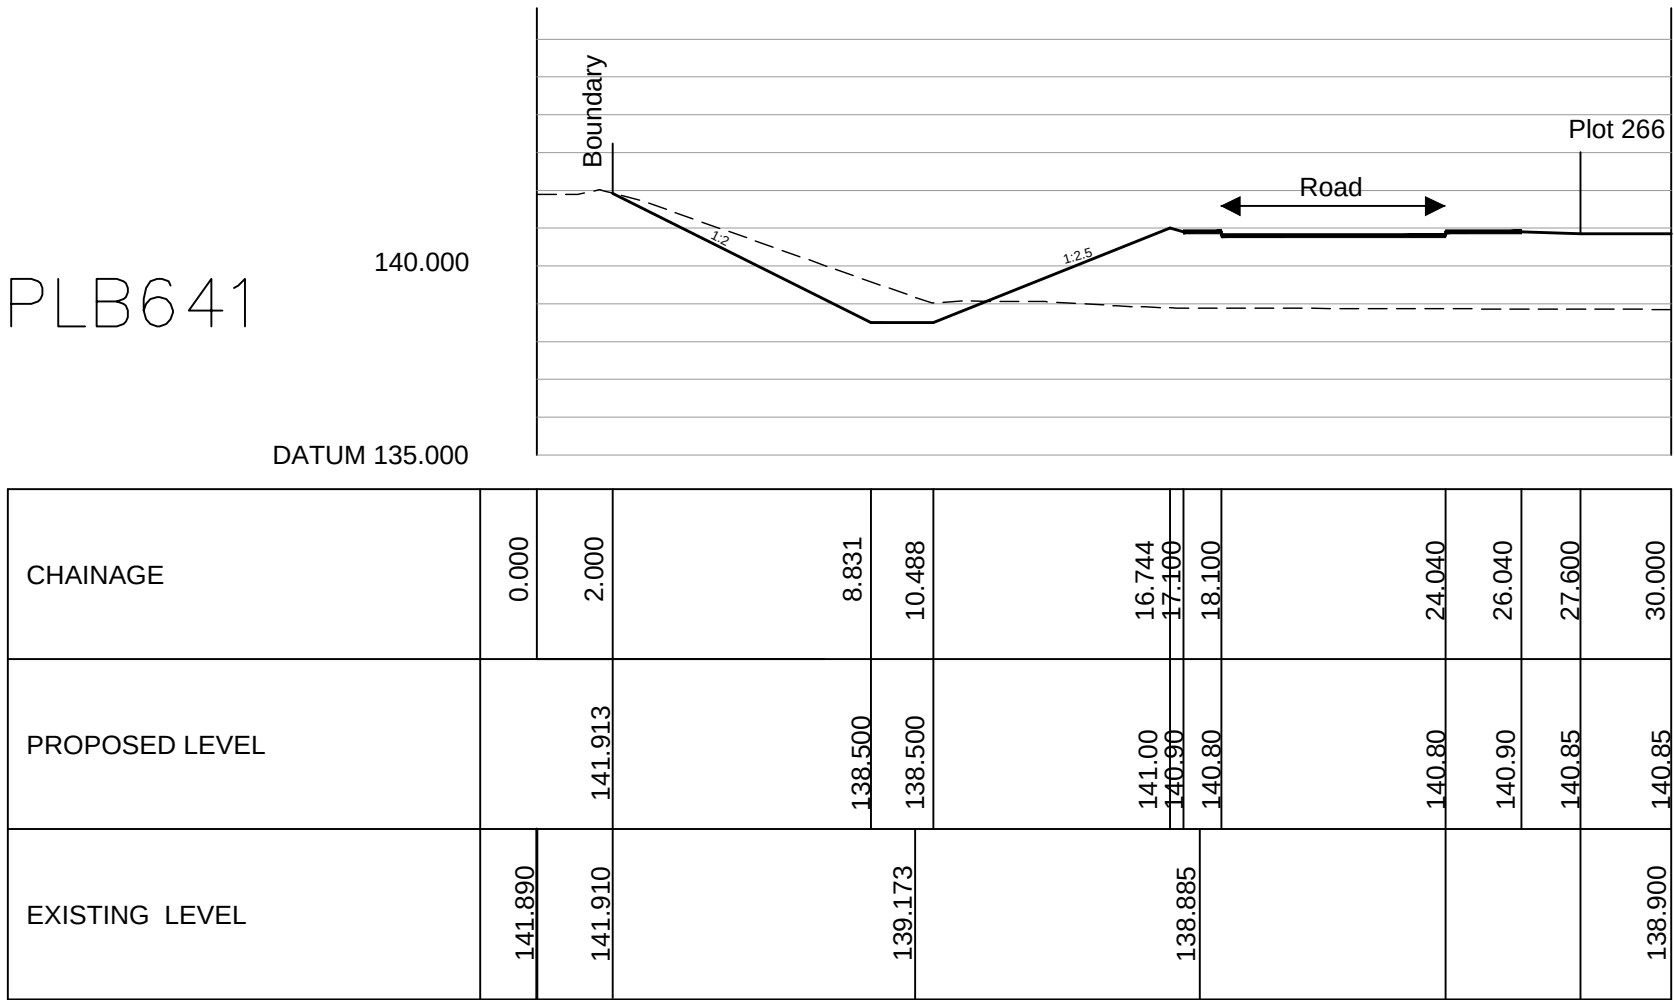
1. All levels in meters above ordnance datum.
2. All sections are viewed downstream.
3. Refer to Drawing 6155/502 for section locations

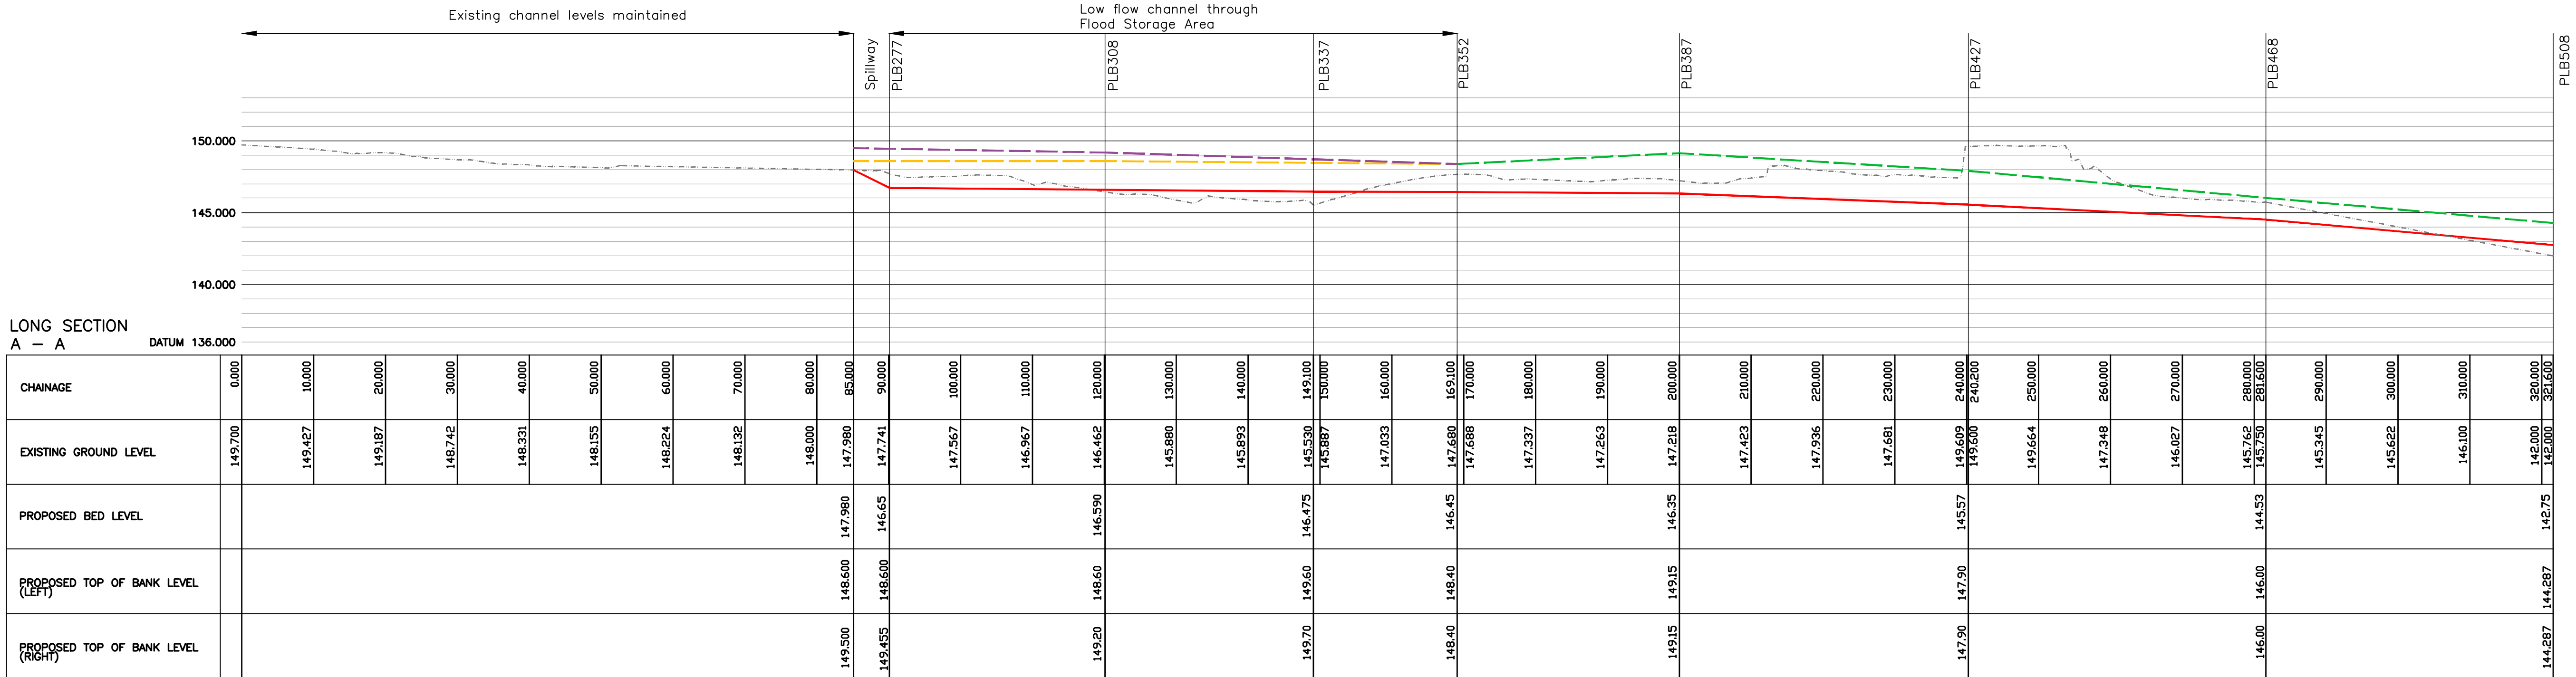
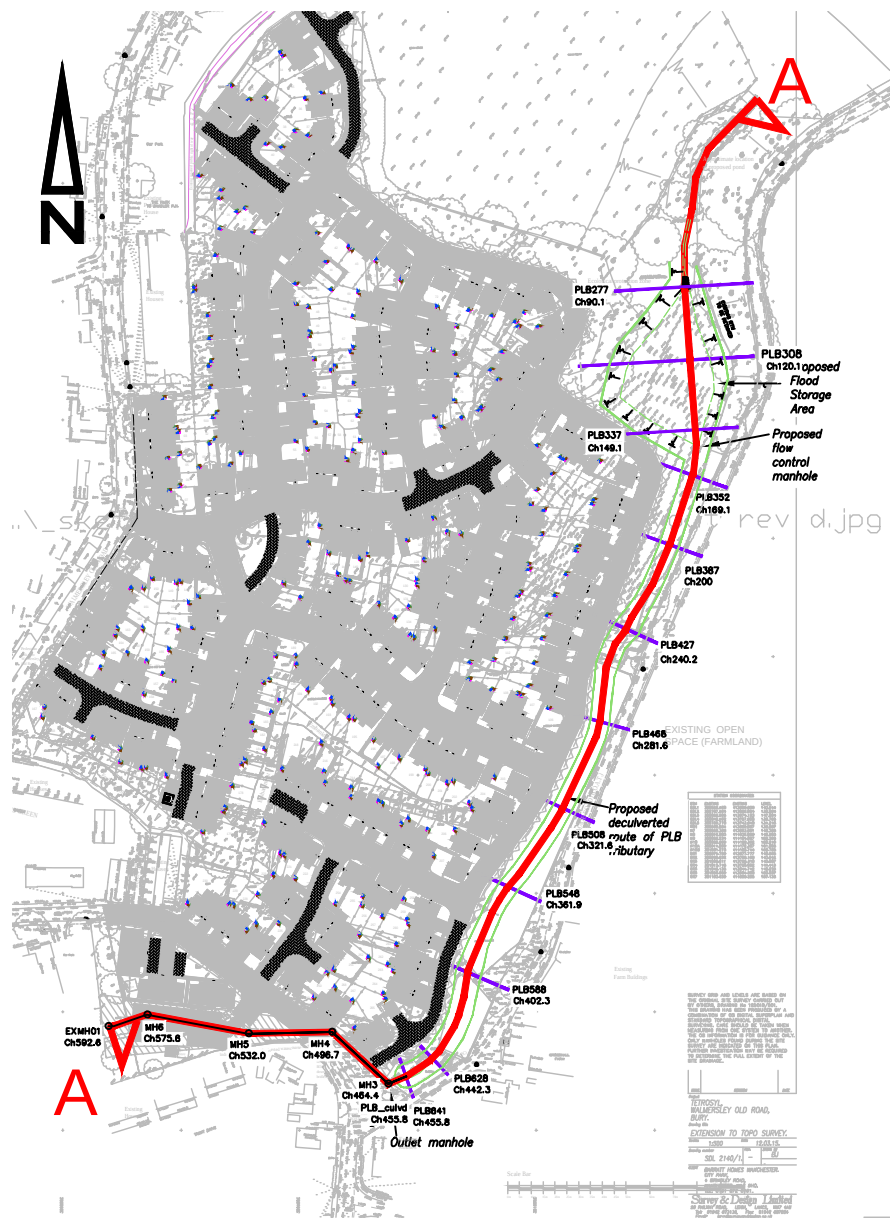
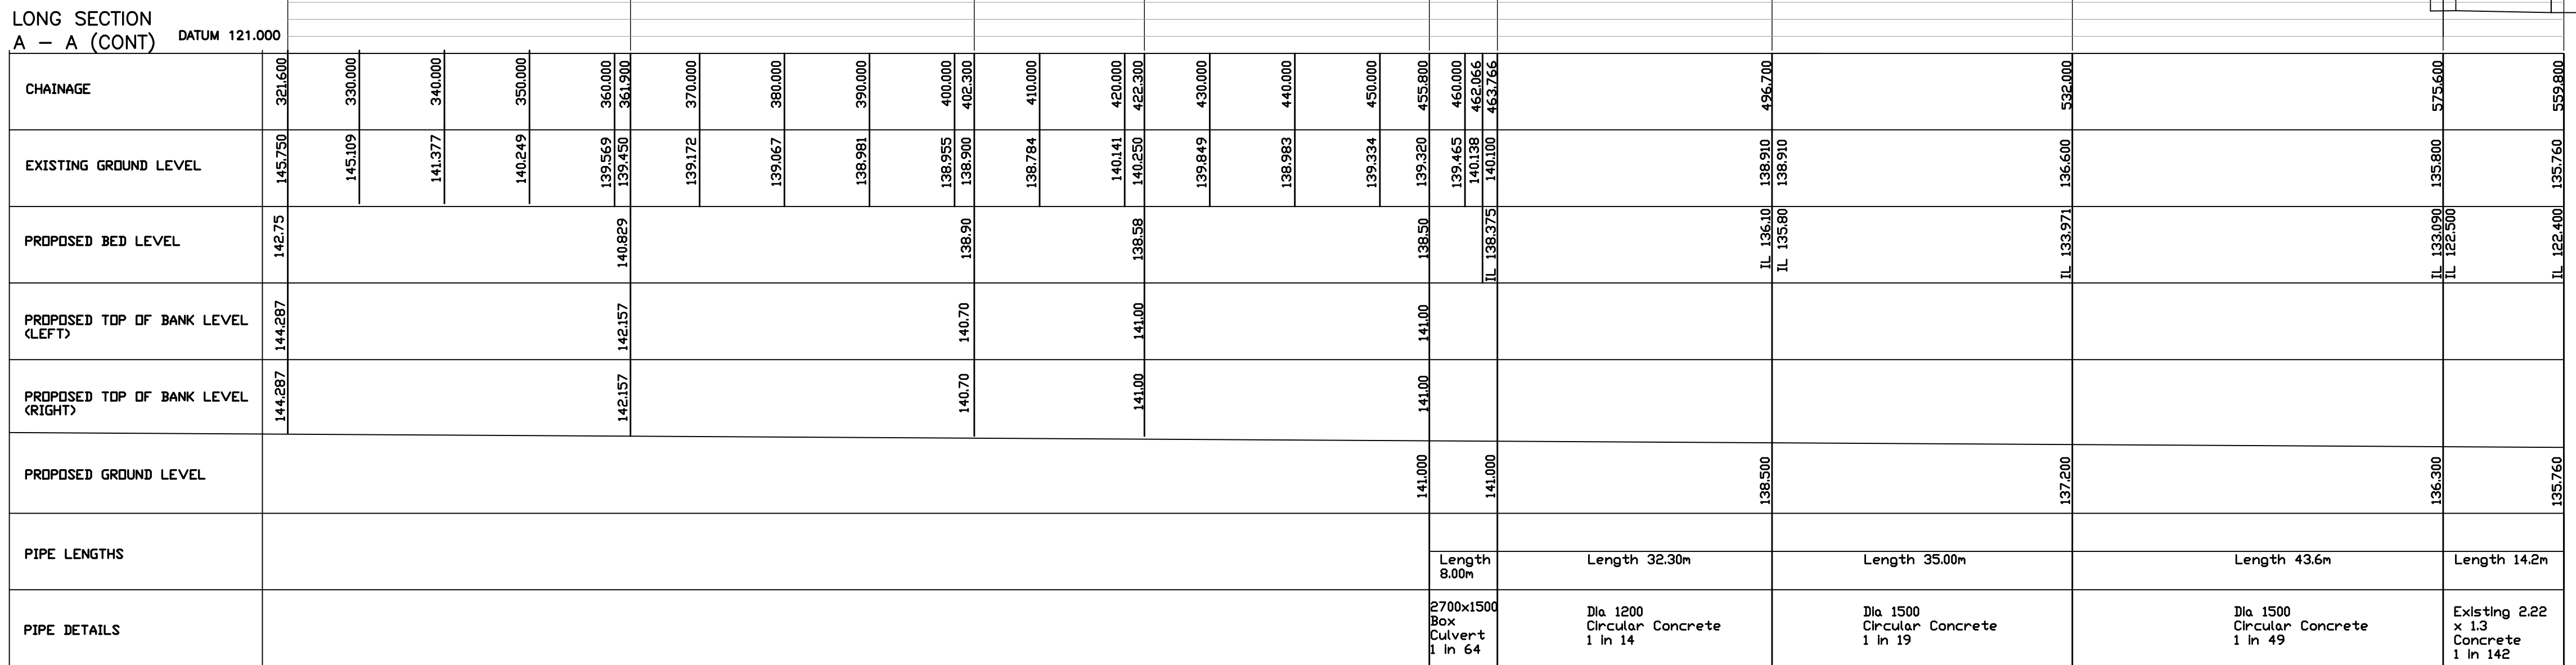
Dwg. No.: 6155/507/02 Rev.: D

SECTION A - A LOCATION PLAN NTS

- KEY
- Existing ground profile
  - Proposed bed level
  - Proposed top of bank (left)
  - Proposed top of bank (right)
  - Proposed top of bank (left & right)
  - Proposed Ground Level
- NOTES
- All levels are in metres above Ordnance datum

B NJ 05.01.21 Long Section Updated

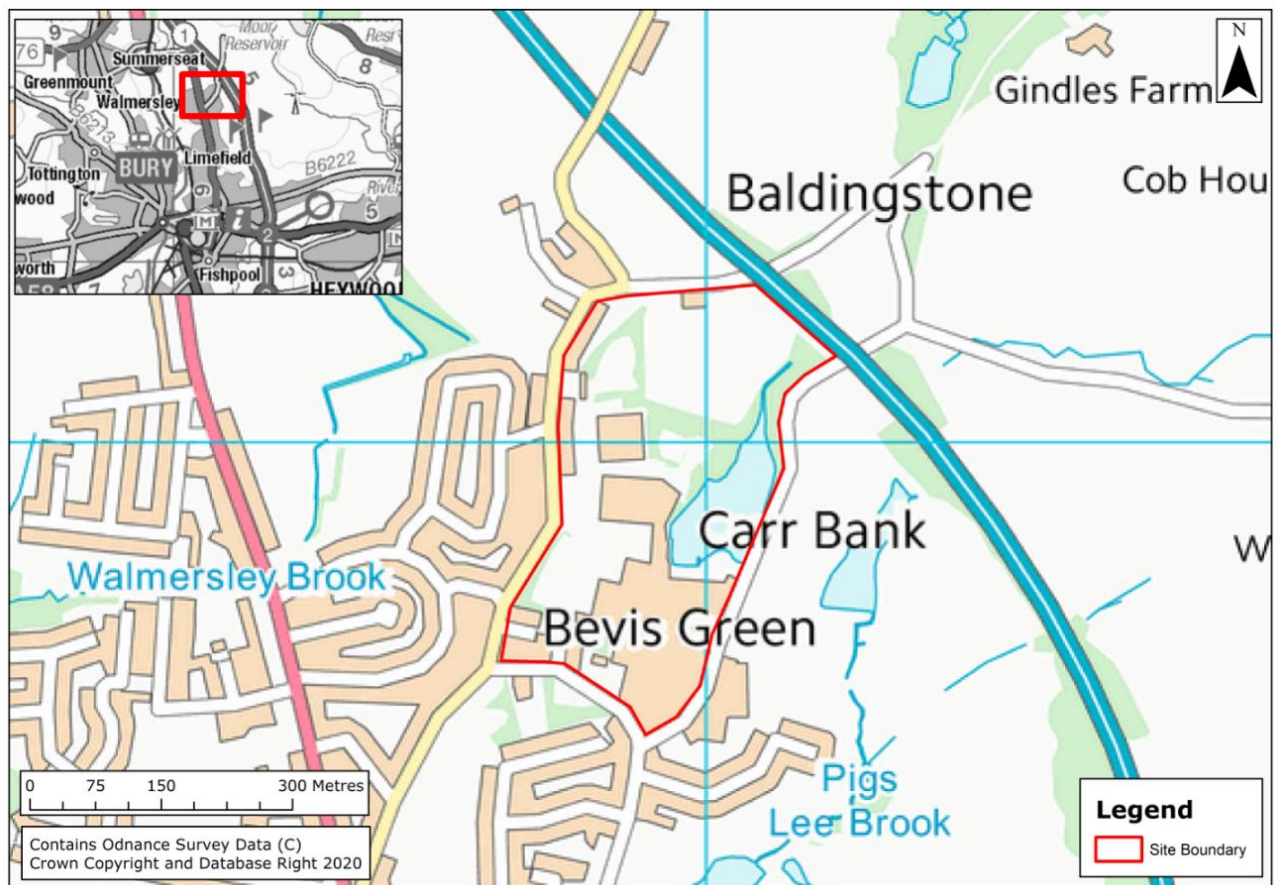
Figure 1-1: Site Location

Figure 1-1 displays the site location and the catchment area of the watercourse, which is unnamed and is a tributary of Pigs Lee Brook. The watercourse rises on the southern edge of Harden Moor near Nangreaves and flows primarily south towards the site. The outflow from the reservoir is controlled by a weir in which the channel is culverted and then flows into open channel before discharging into Pigs Lee Brook.

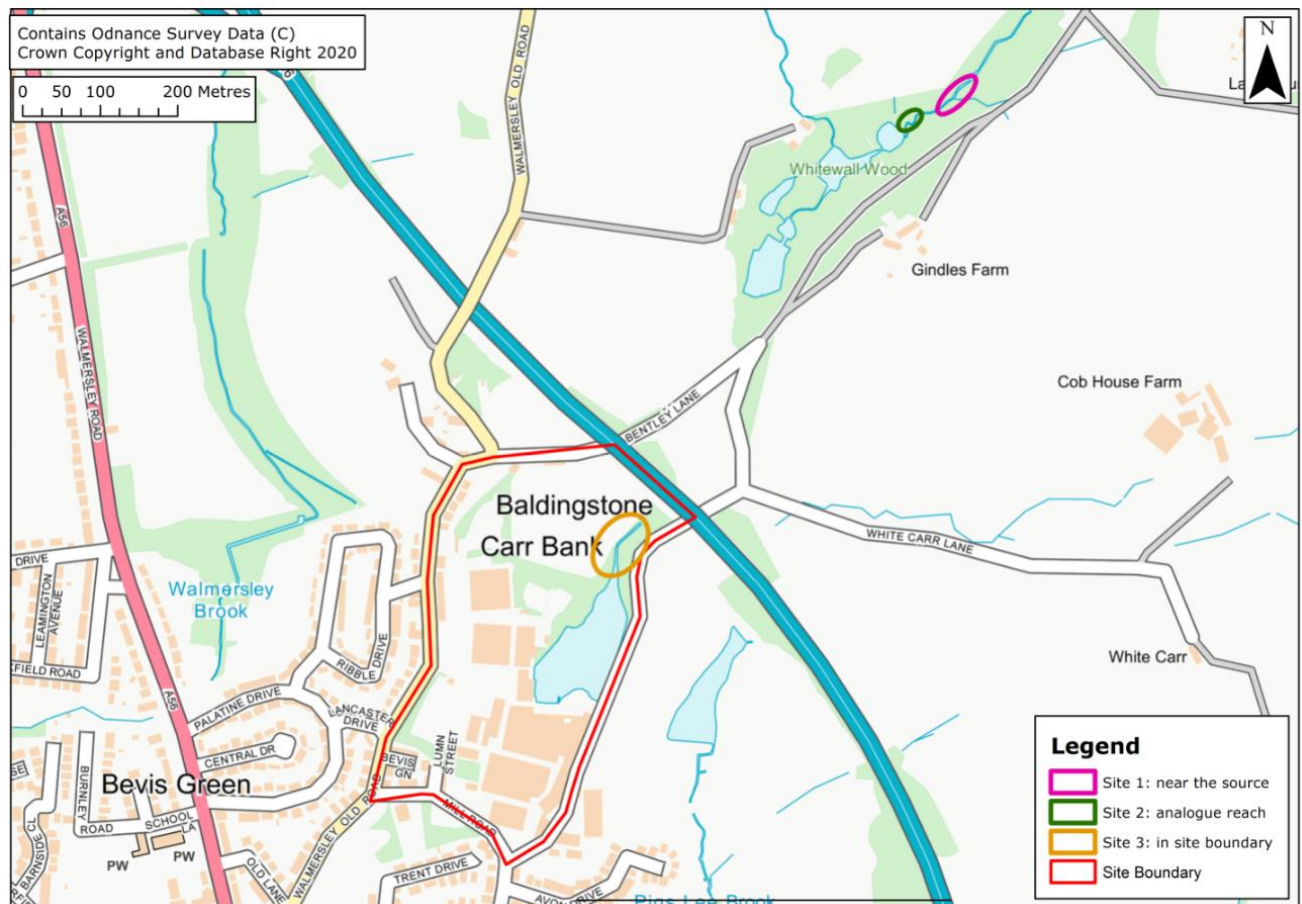
Figure 3-1: Survey Locations

A walkover assessment was completed on the 15th July 2020 by Rebecca Thrower (geomorphologist) and Emma Wright (geomorphologist) of the watercourse through the site and upstream of the site boundary. The purpose of surveying the watercourse upstream of the site was to identify analogue reaches to gain an understanding of the geomorphic conditions of the river when not confined to culverts.

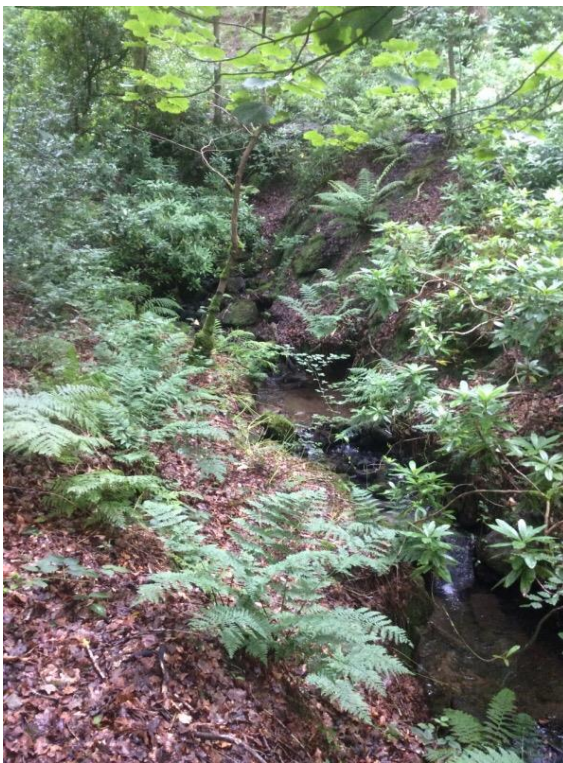
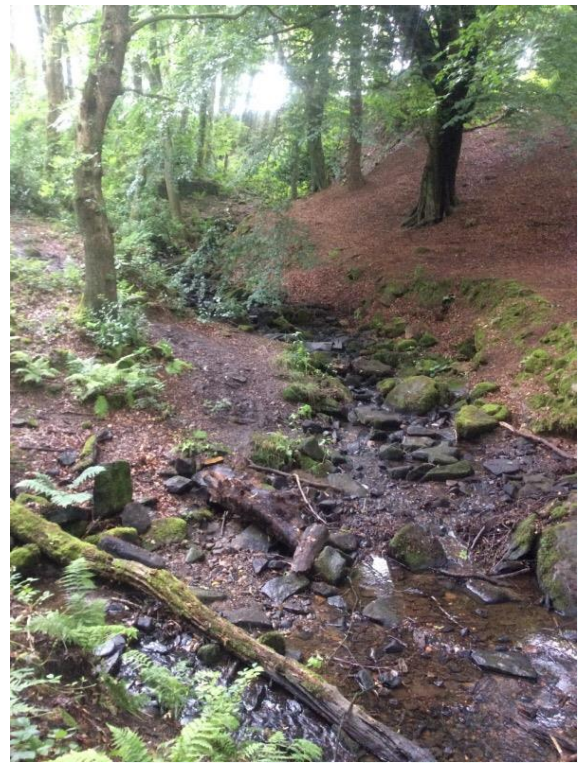
Figure 3-2: Upstream steep morphology

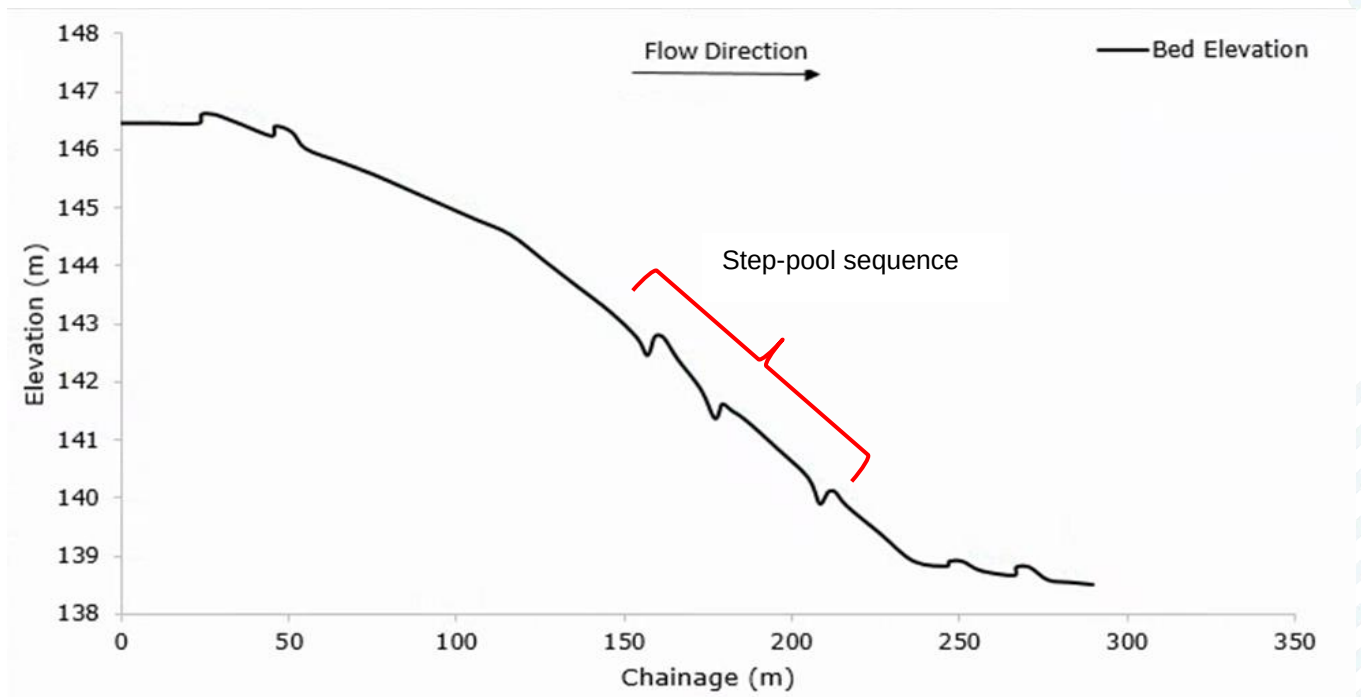
This reach could be used to define characteristics of the new channel if the gradient is to be of similar steepness. Figure 3-3 depicts the long section throughout the site but specifically the step-pool sequences that occur within the steeper gradient. This can be used as an analogue to determine the in-channel features within an area of steeper gradient.

Figure 3-3: Long section to demonstrate the step-pool (step-pool) sequence

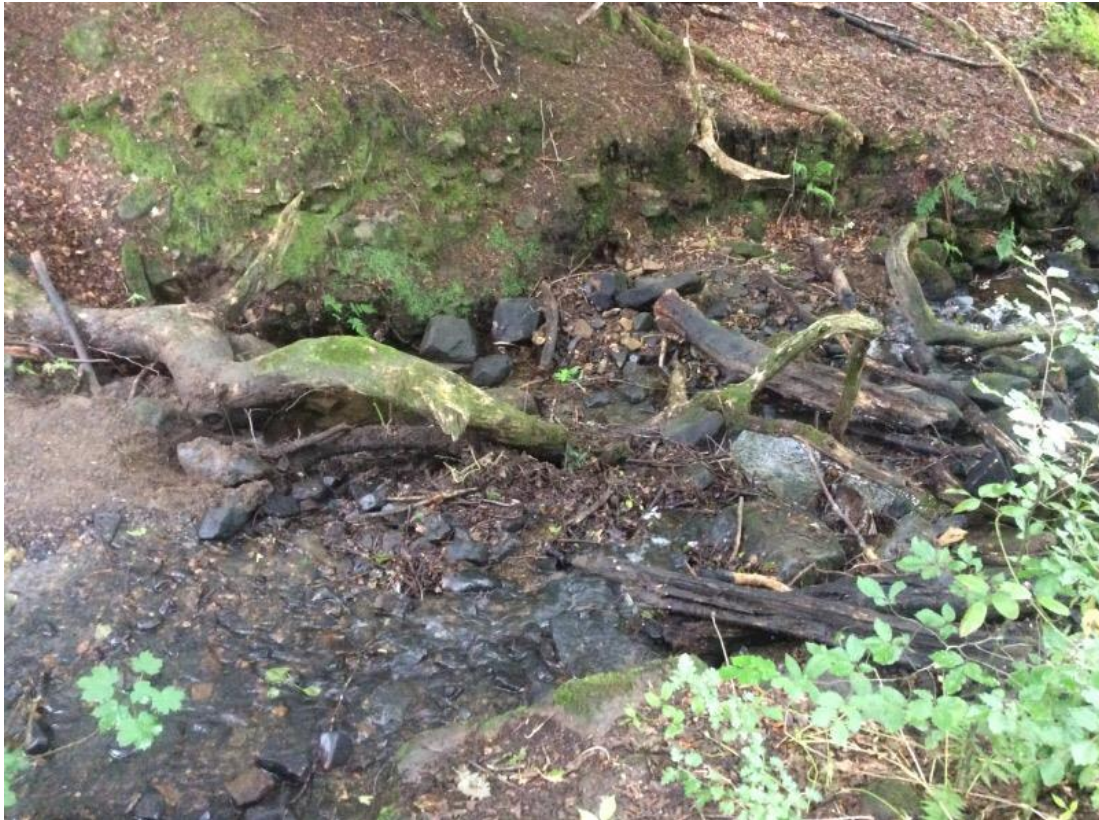
The riparian zone consists of a broadleaf woodland providing a large supply woody debris and leaf litter into the channel (Figure 3-4).

Figure 3-4: Large woody debris supplied into the channel with bank erosion

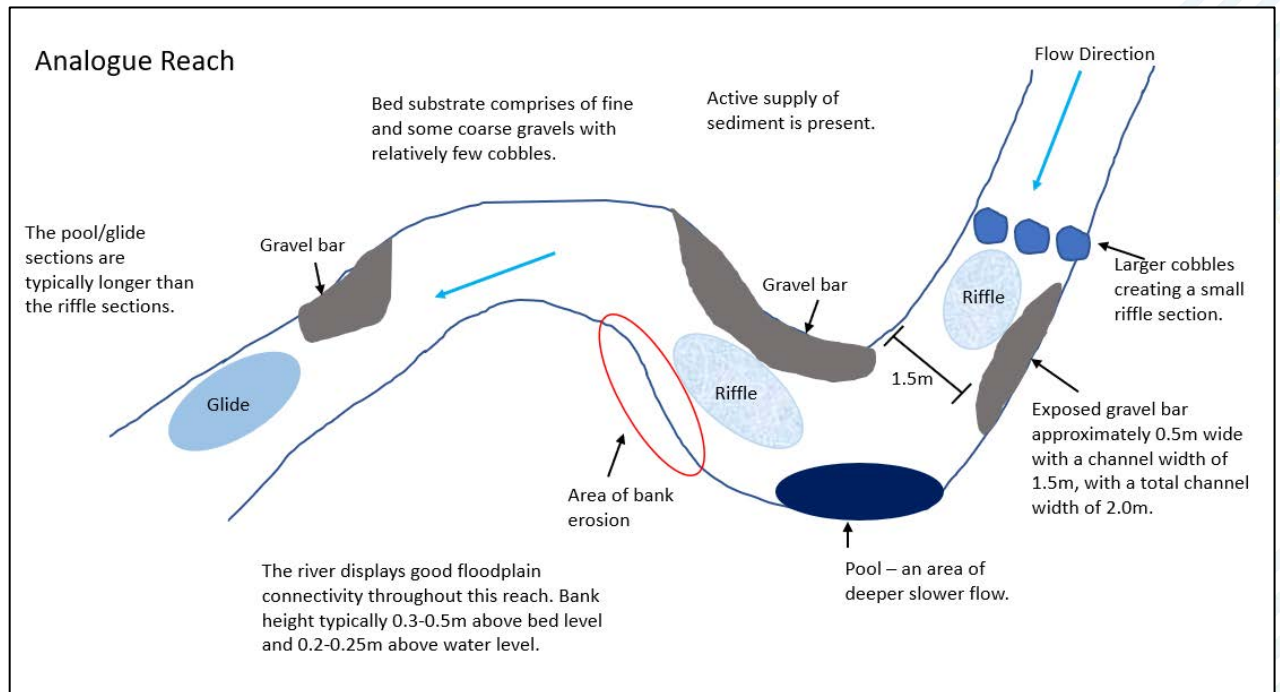
Figure 3-5: Site sketch of the reach to be used as the analogue reach (for lower gradient reaches)

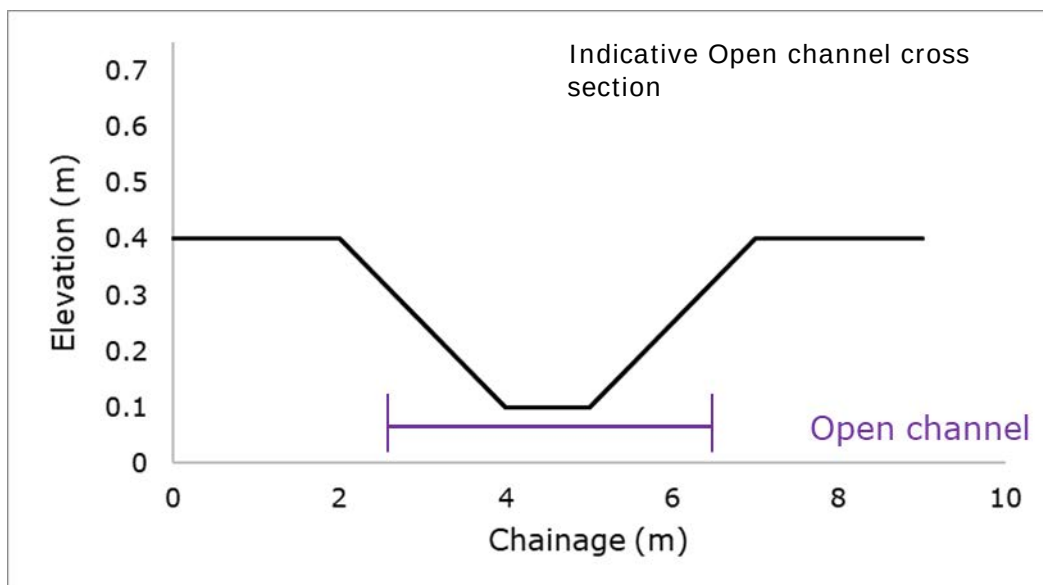
A series of indicative cross sections were developed from using the channel measurements from the site visit. These sections provide a guide to the development of the cross sections.

Figure 3-6: Indicative open channel section

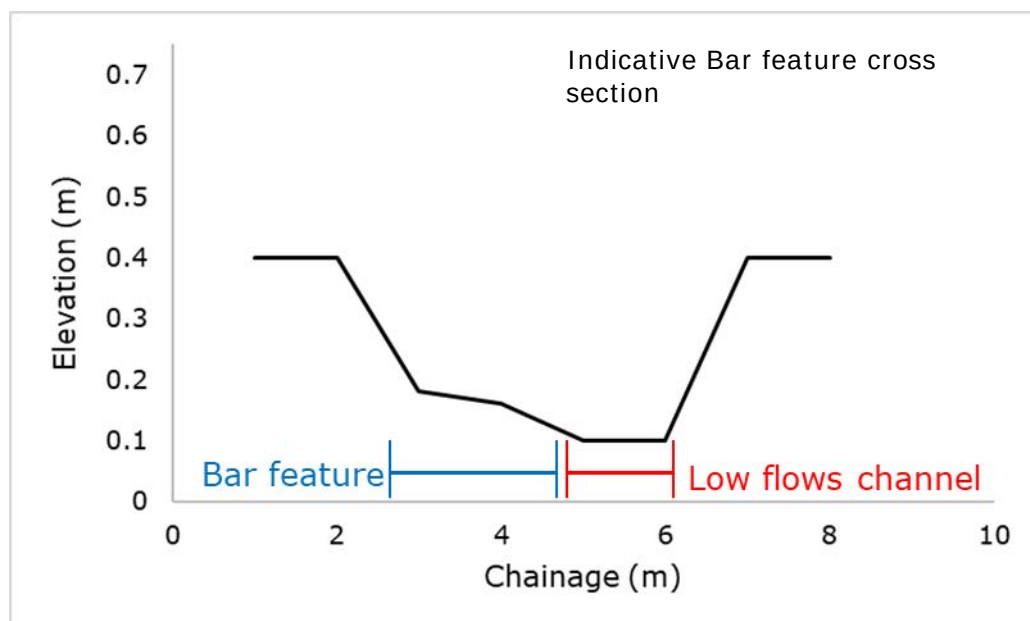
Figure 3-7: Indicative low flows channel section

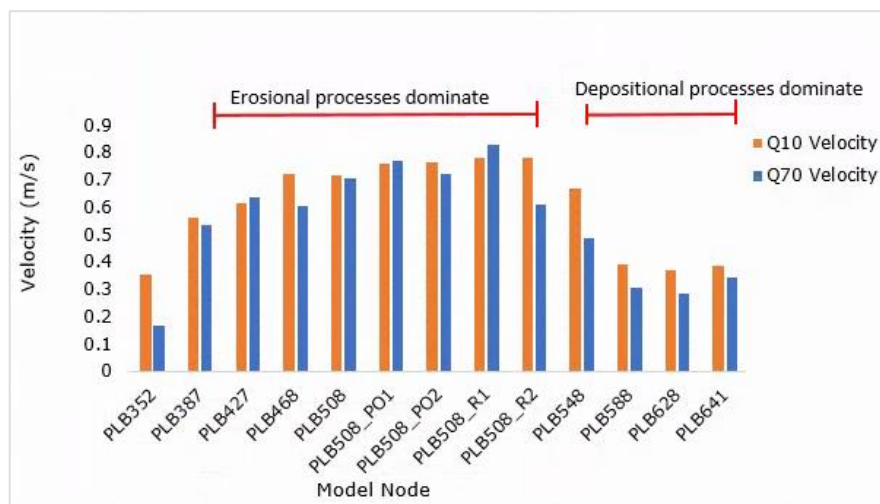
Velocities throughout the site have been extracted from the hydraulic model. Figure 5-1 shows the channel velocities with the open river channel sections without the presence of any in-channel features. The data shows that the gradient steepens, as shown in the long section in Figure 5-2, there is a correlated increase in the in-channel velocities. As the bed gradient become shallower these velocities reduce. It is anticipated to observe erosional process occurring in the steeper sections where the velocities are high, whilst where the gradient becomes shallower it is anticipated to observe a more depositional environment. The Hjulström curve depicts the relationship between the size of the sediment and the velocity that is required to either transport it, erode or deposit it. Within the Q10 flows the velocities range from 0.3-0.7m/s. The calculated entrainment values for the same event would be capable of entraining, transporting and deposition of small gravels between 6-38mm.

Figure 5-1: Velocities across the site (Baseline) sequence\*

\* \*Note not to scale, total model length is 289m and the distance between the model nodes vary.
