**WATER FRAMEWORK DIRECTIVE RISK ASSESSMENT  
FOR  
PROPOSED RESIDENTIAL DEVELOPMENT, FORMER TETROSYL SITE  
WALMERSLEY OLD ROAD, BURY, GREATER MANCHESTER  
ON BEHALF OF  
BARRATT HOMES MANCHESTER**

**FEBRUARY 2021**

**Project:** Proposed Residential Development, Former Tetrosyl Site, Walmersley Old Road, Bury, Greater Manchester

**Document Title:** Water Framework Directive Risk Assessment

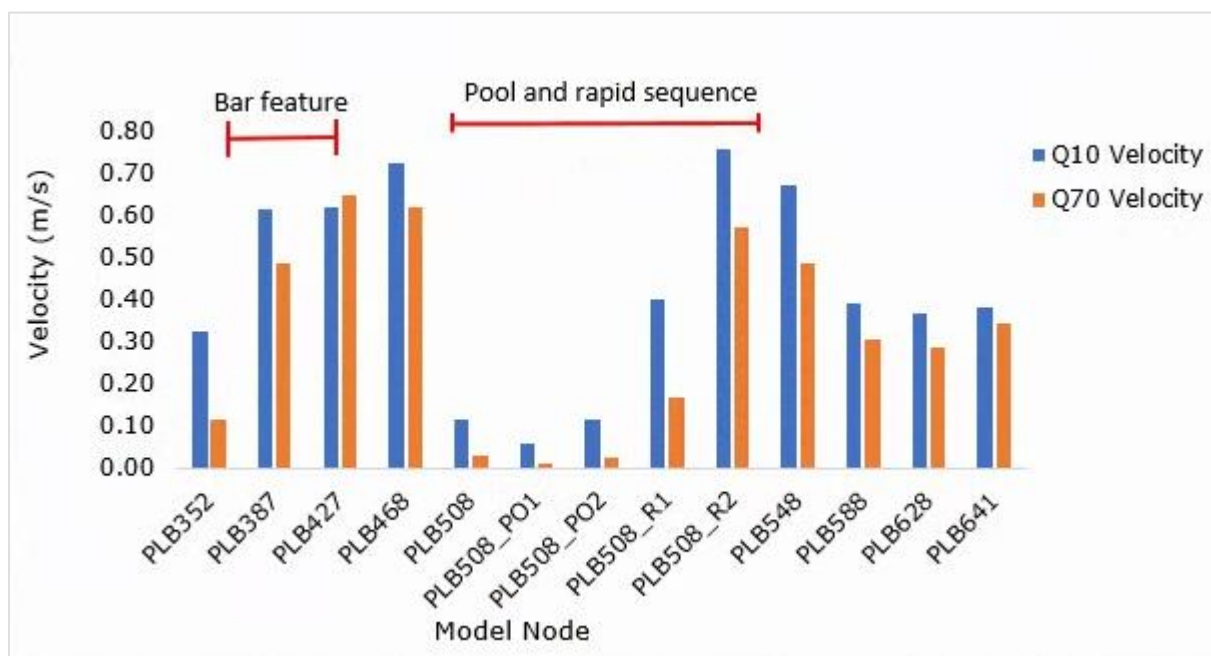
Figure 5-3 shows the results of this scenario in terms of modelled velocities.

Figure 5-3: Velocities across the site (post development) sequence \*

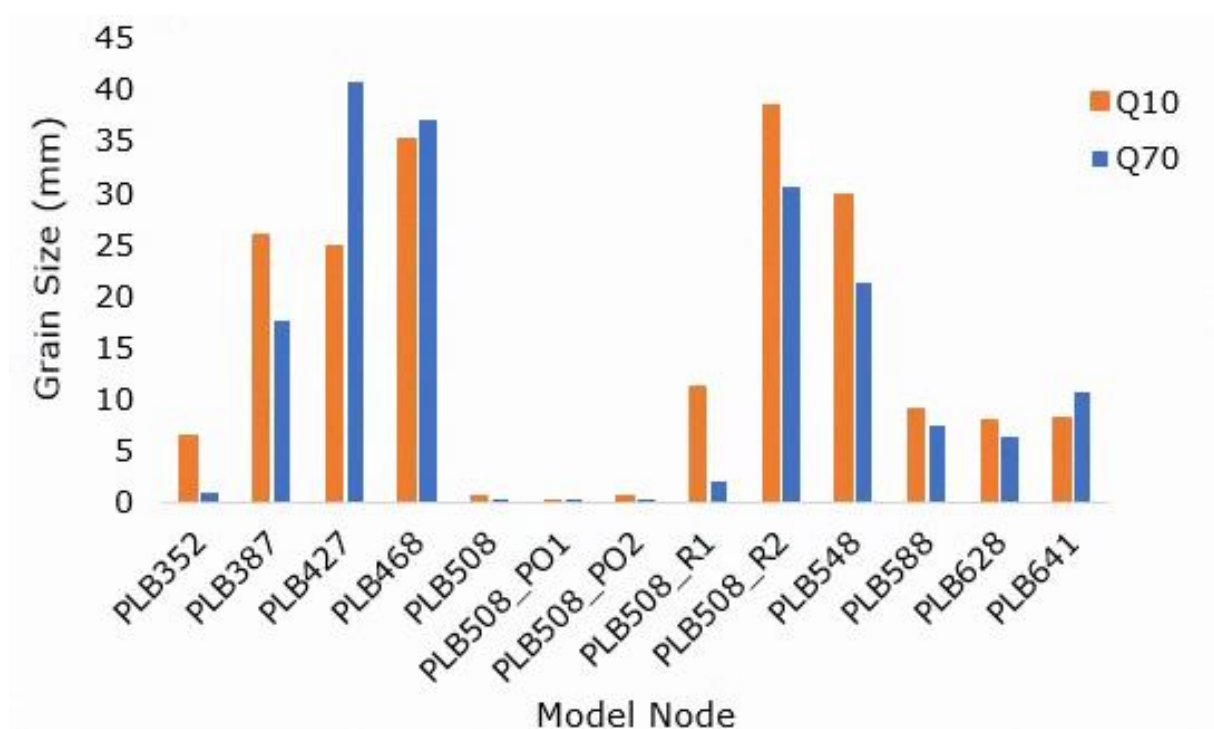
The recorded entrainment values outputted from the hydraulic model, is comparable to observations made on the walkover assessment of the analogue reach. Small gravels were observed typically within the open channel, with larger, coarser gravels identified on the exposed bar features. Whilst, further upstream in areas of steeper gradients step-pool sequences dominated observing very coarse bed material (gravels, cobbles, boulders) indicating an active sediment supply.

Figure 5-4: Entrainment values across the site\*

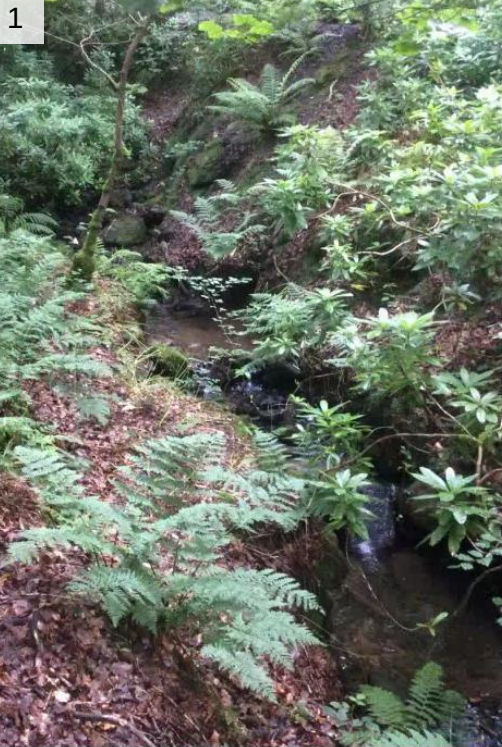
(1) Analogue reach displaying a step-pool morphology with steeper bed gradient. A similar concept could be achieved at the site, but with a wider channel as required.

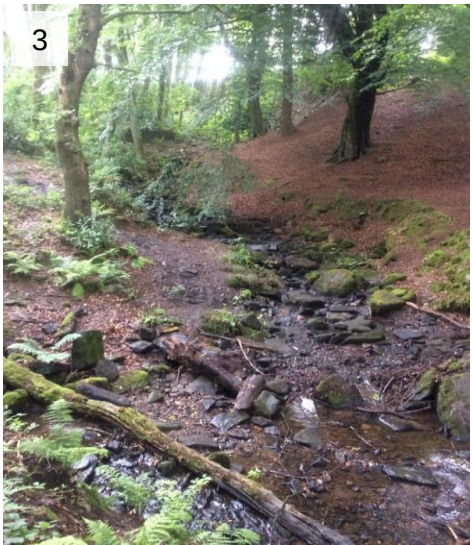
Within areas of steeper bed gradient, features mimicking either step pool or cascade morphology should be created along this reach. Coarser bed material will form the step or rapid (areas of raised bed level) whilst material upstream of the rapid will be scoured out to form a pool, with increased water depths and reduced in-channel velocities. It is expected to see sediment deposition within the pool as a result. Erosional processes will dominate throughout this reach. Appropriate placement and sizing of features will be necessary to mitigate risk of uncontrolled erosion and bed incision.

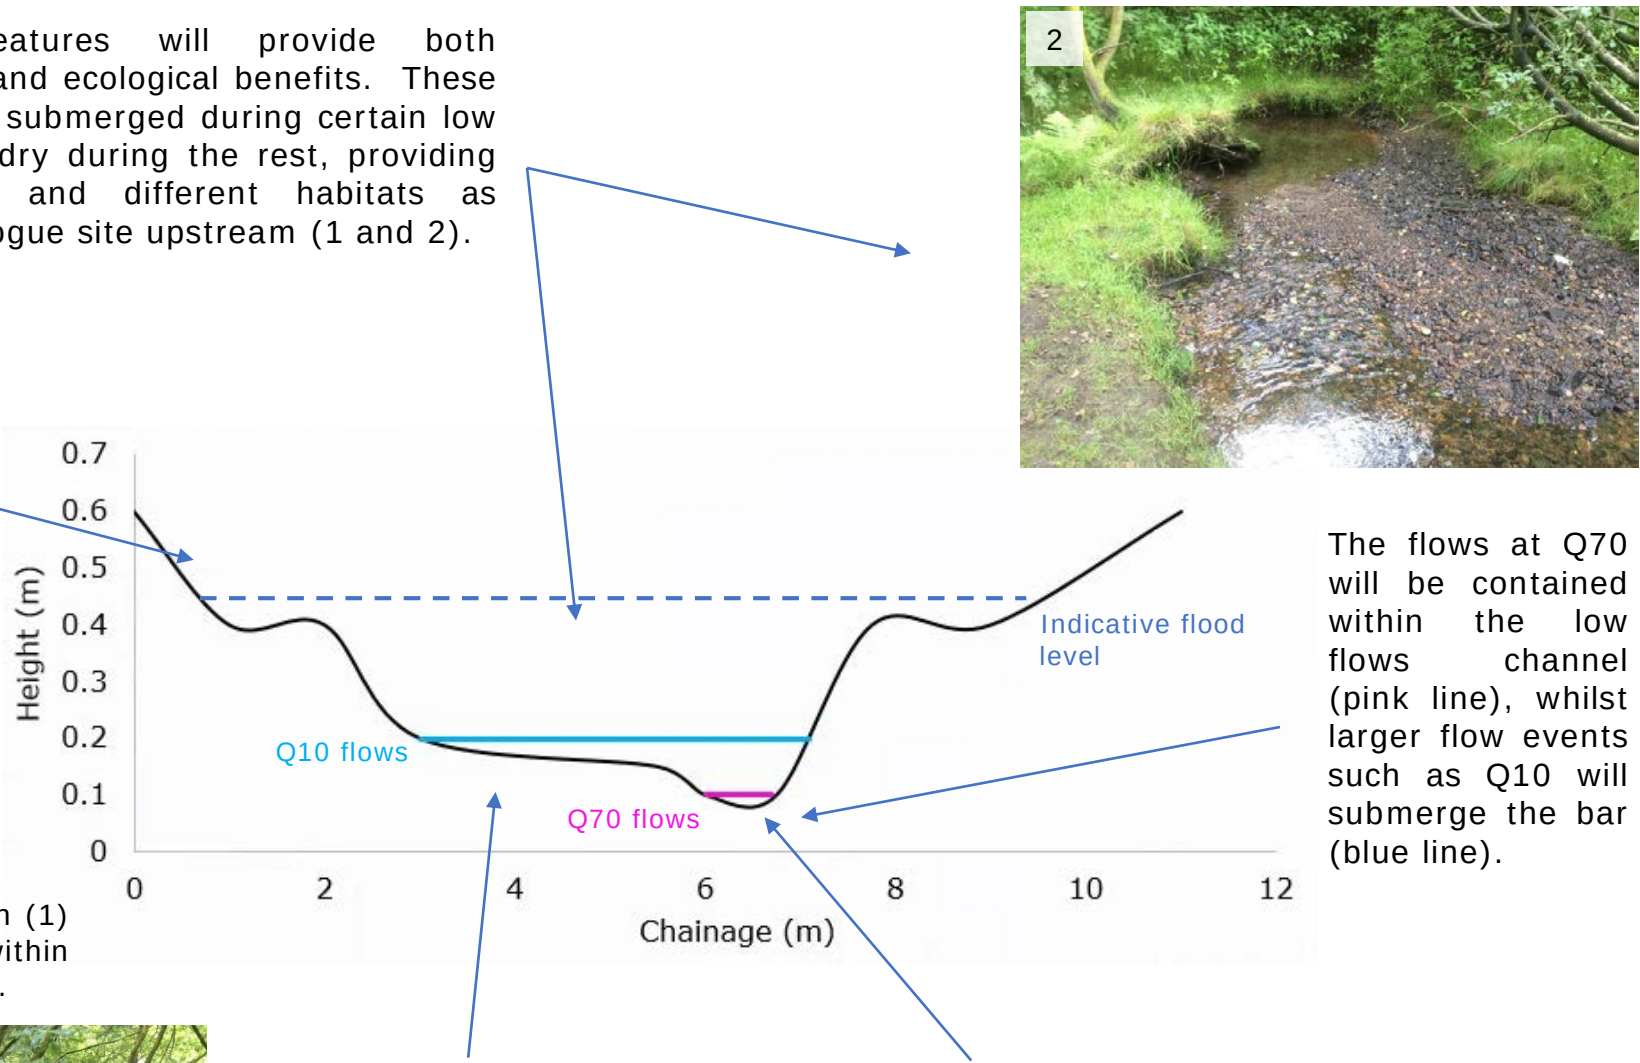
The gradient of this slope will depend on the difference between the desired bed level and proposed site ground levels.

The flows at Q70 will be contained within the low flows channel (pink line), whilst larger flow events such as Q10 will submerge the bar (blue line).

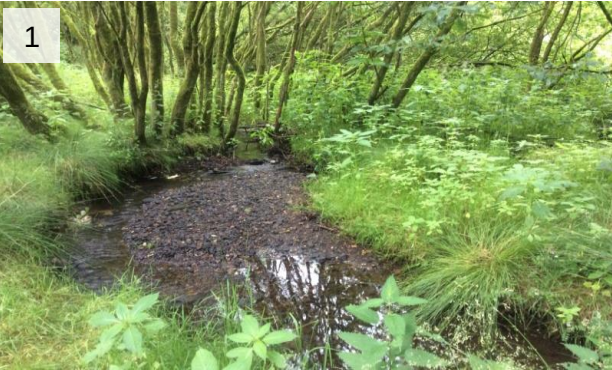
Analogue reach photograph (1) displaying a bar feature within an area of gentler gradient.

Bank heights are relatively shallow which is representative of the analogue reach and is important for maintaining a hydraulic connection to the riparian zone during larger flows.

Narrower low flows channel adjacent to the bar to encourage fine sediment to be transported downstream, as seen in the analogue reach. Generally, the channel is wider with bar features (compared with 'open channel' section) to encourage deposition during higher flows and varied channel morphology.
