# **Former Police Station, Bury**

## **Remedial Strategy Report**

For: Cairnwell Developments

| <b>Report Reference:</b> | | <b>3842-02</b> |

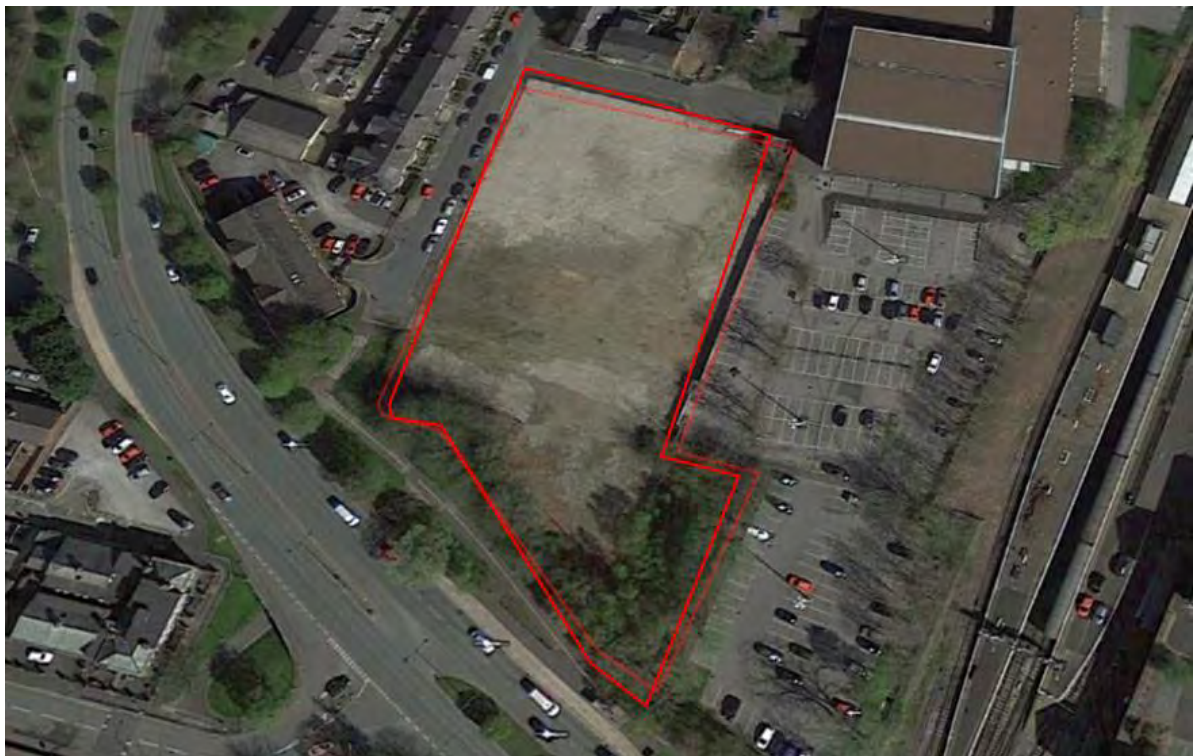
Figure 1: Aerial image of the site dated April 2021.

The site currently comprises a vacant area of land. The site is bound by residential properties and Irwell Street to the west, Jubilee Way (A58) to the south, a car park to the east and Lower Bank Street to the north. Access to the site is off Lower Bank Street to the north.

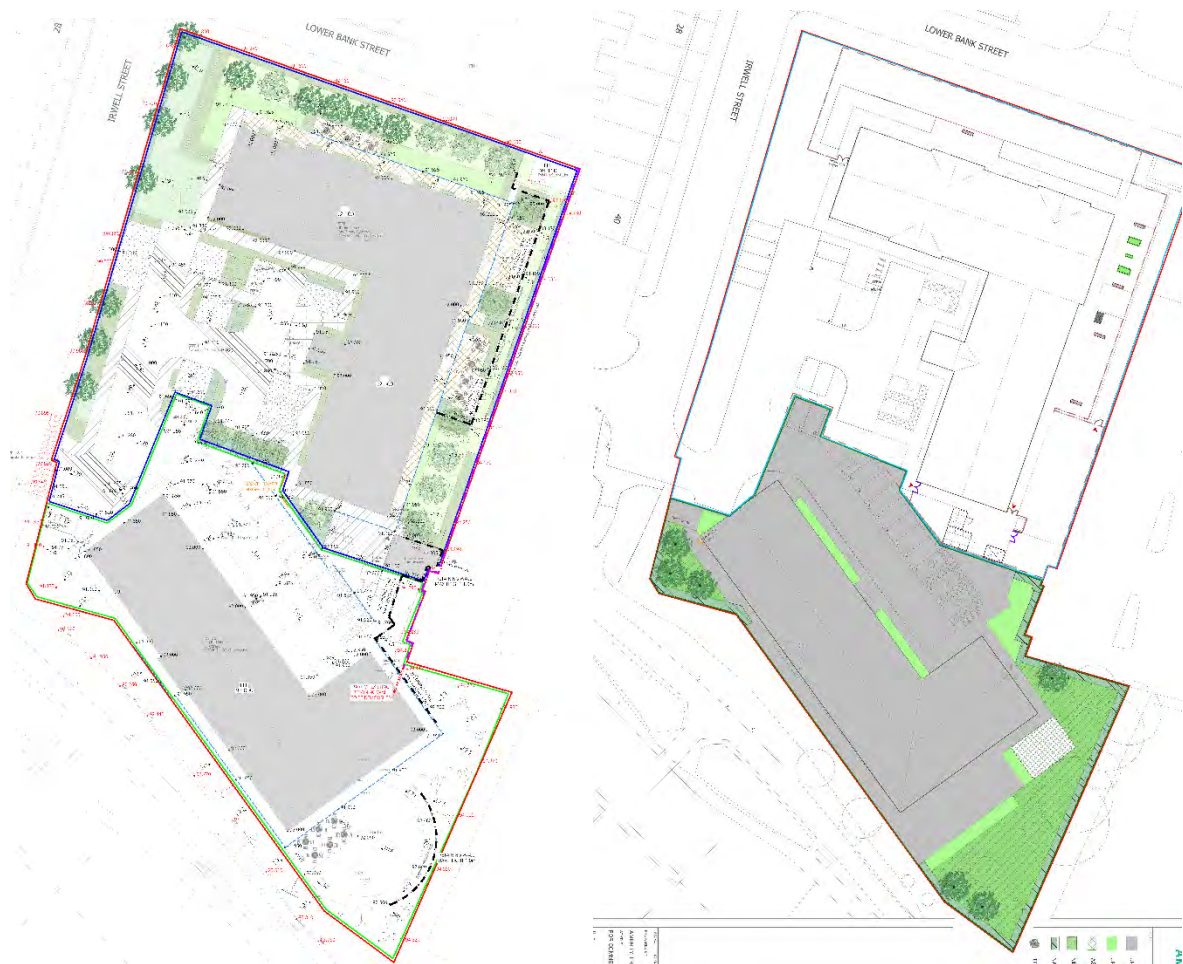
Figure 2: Extract of the proposed development plan (taken from Dudleys Consulting Engineers, Site 1 External Levels and Works, 23389-DCE-XX-XX-D-C-155, Rev. P05, dated August 2024 and Amenity Tree Environmental Planning Consultants, Site 2 External Works / BNG., AT.24.11879.103, Rev. R.01, dated July 2024).

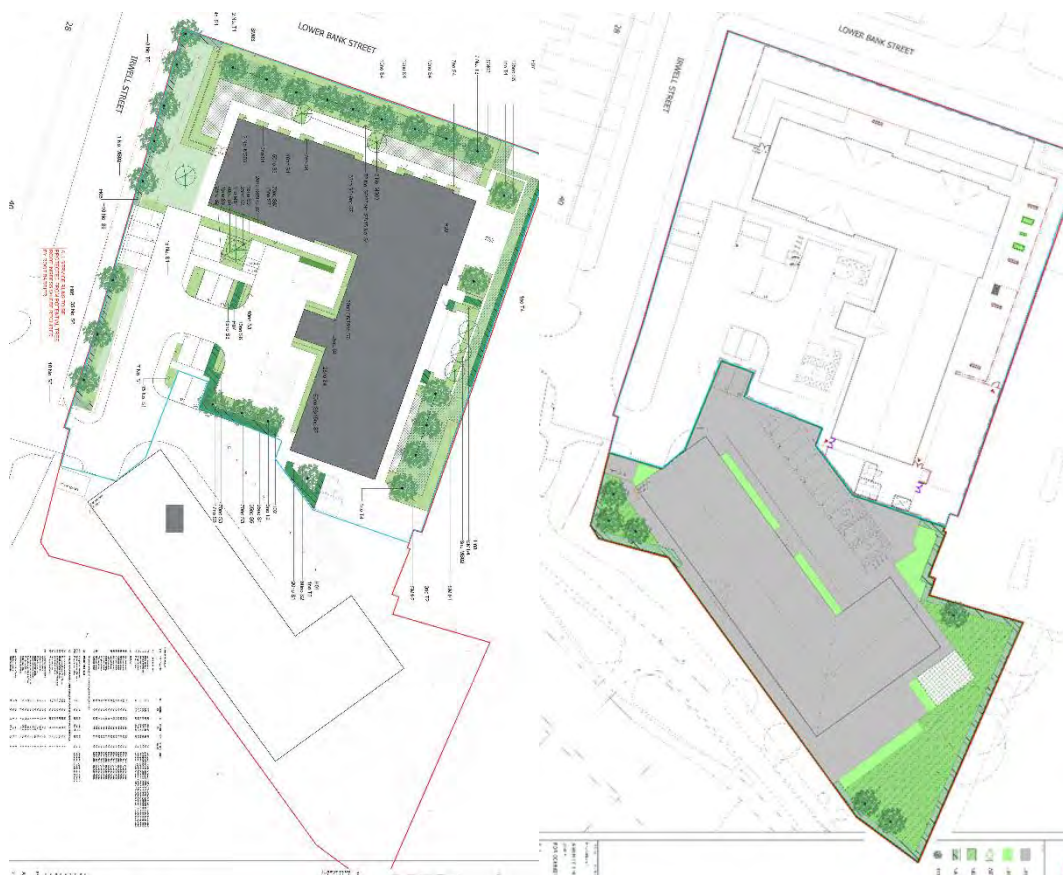
The following Landscaping Plan details the proposed and POS soft landscaping (Public Open Space / POS<sub>resi</sub> – highlighted in green).

Figure 3: Extract of the landscape plans of the 2 No. site phases ((taken from Amenity Tree Environmental Planning Consultants, Softworks and Planting Plan, AT.24.11879.102, Rev. R.08, dated July 2024 and Amenity Tree Environmental Planning Consultants, Site 2 External Works / BNG., AT.24.11879.103, Rev. R.01, dated July 2024)).

**Green = soft landscaping / public open space.**

Made Ground containing exceeding GACs with respect to human health is present below finalised garden levels at depths greater than 300mm in areas of proposed soft landscaping across the site. The following procedure is outlined for use in all areas of soft landscaping:
