Client  
Eccleston Homes

Site  
Mondi - Mill,  
Ramsbottom , BL0 OBS.

Title  
MMP Daily Tracking Record  
21/03/25

| Dwg No. | MONDI-UR-V1-01-MMP-047 | | Rev<br>A |

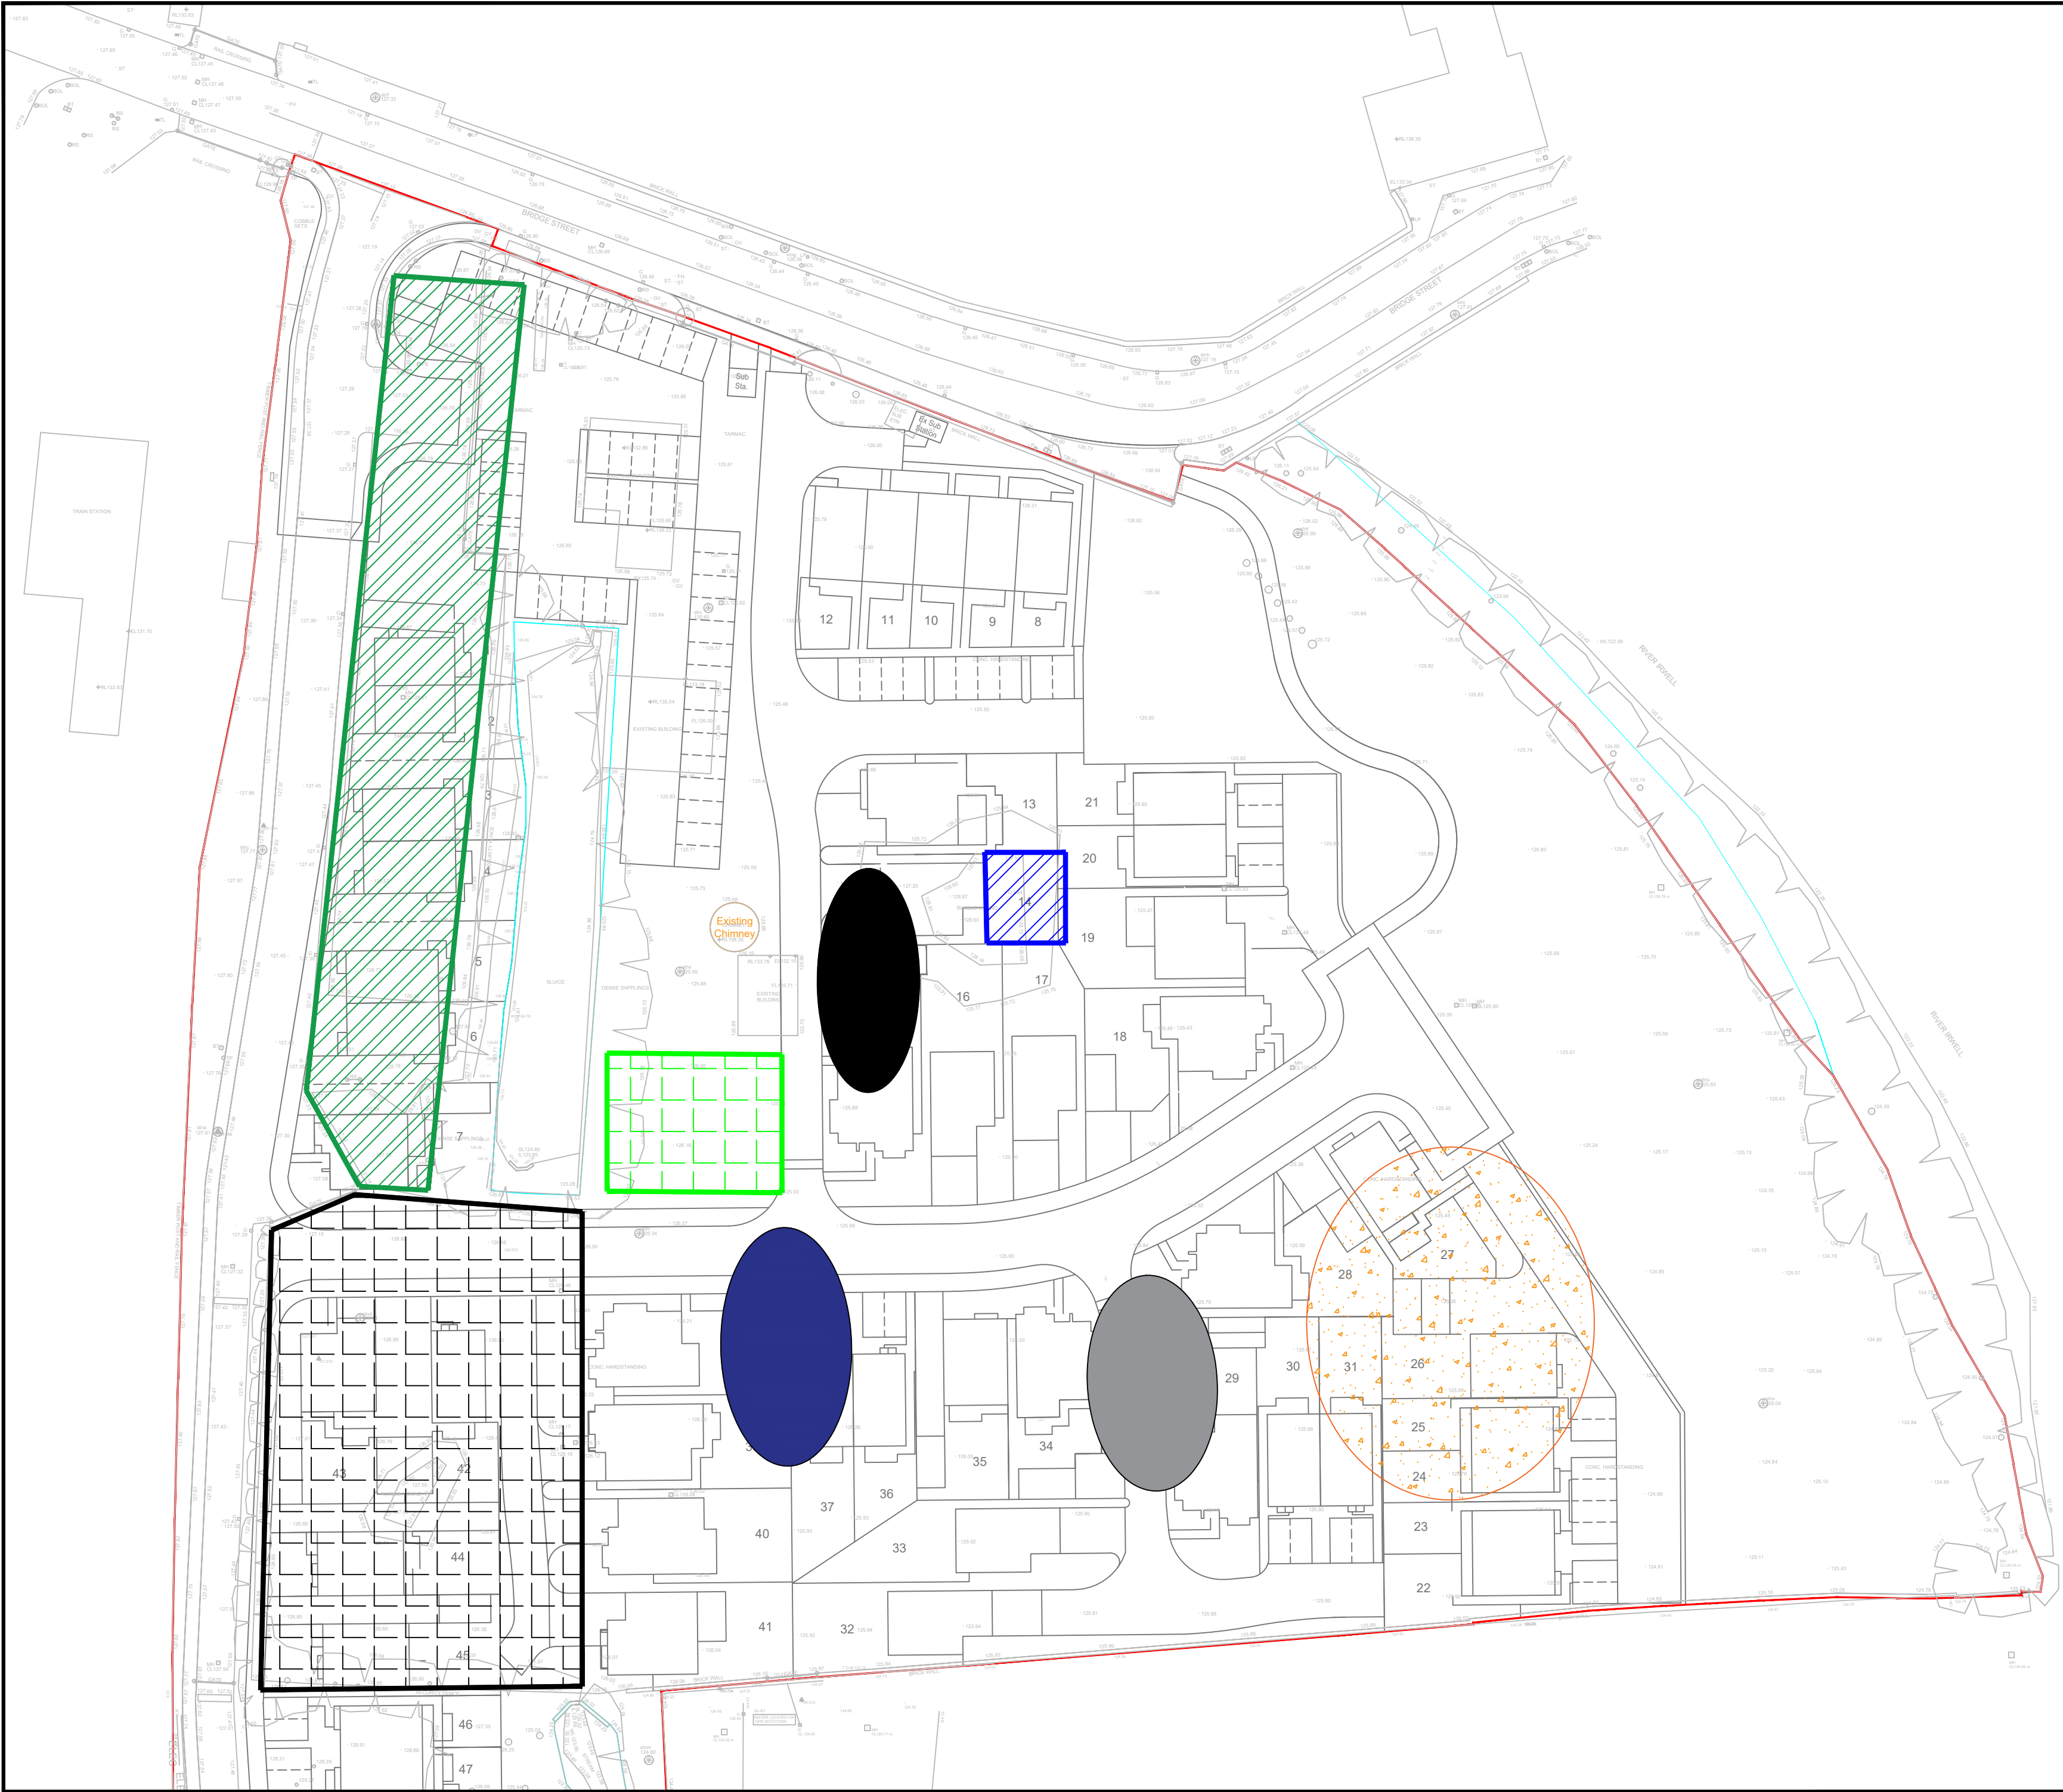
- Works Undertaken:**
- 07:00 - 17:00 : 3St excav. (Kev) completing leveling out fill material below plots 1-7 tidying sleepers and tyres deposited onto Got POS 20/03/25 then undertaking cutfill operation on proposed carpark in preparation of compound being relocated 28/03/25 utilising 3St ADT as required.
  - 07:00 - 17:00 : 3St excav. continuing with breakout of 6x7x3.5m deep mass filled concrete base encountered on the 19/03/25 (Over 36 hrs. with the hydraulic breaker), and loading breakout into 3St ADT. 11:00 leak noticed on breaker by operator, UR fitter's notified on site for 12:00 diagnosed as worn internal hydraulic hose, DT hydraulics notified , on site for 13:00 and repaired and back breaking for 14:30.

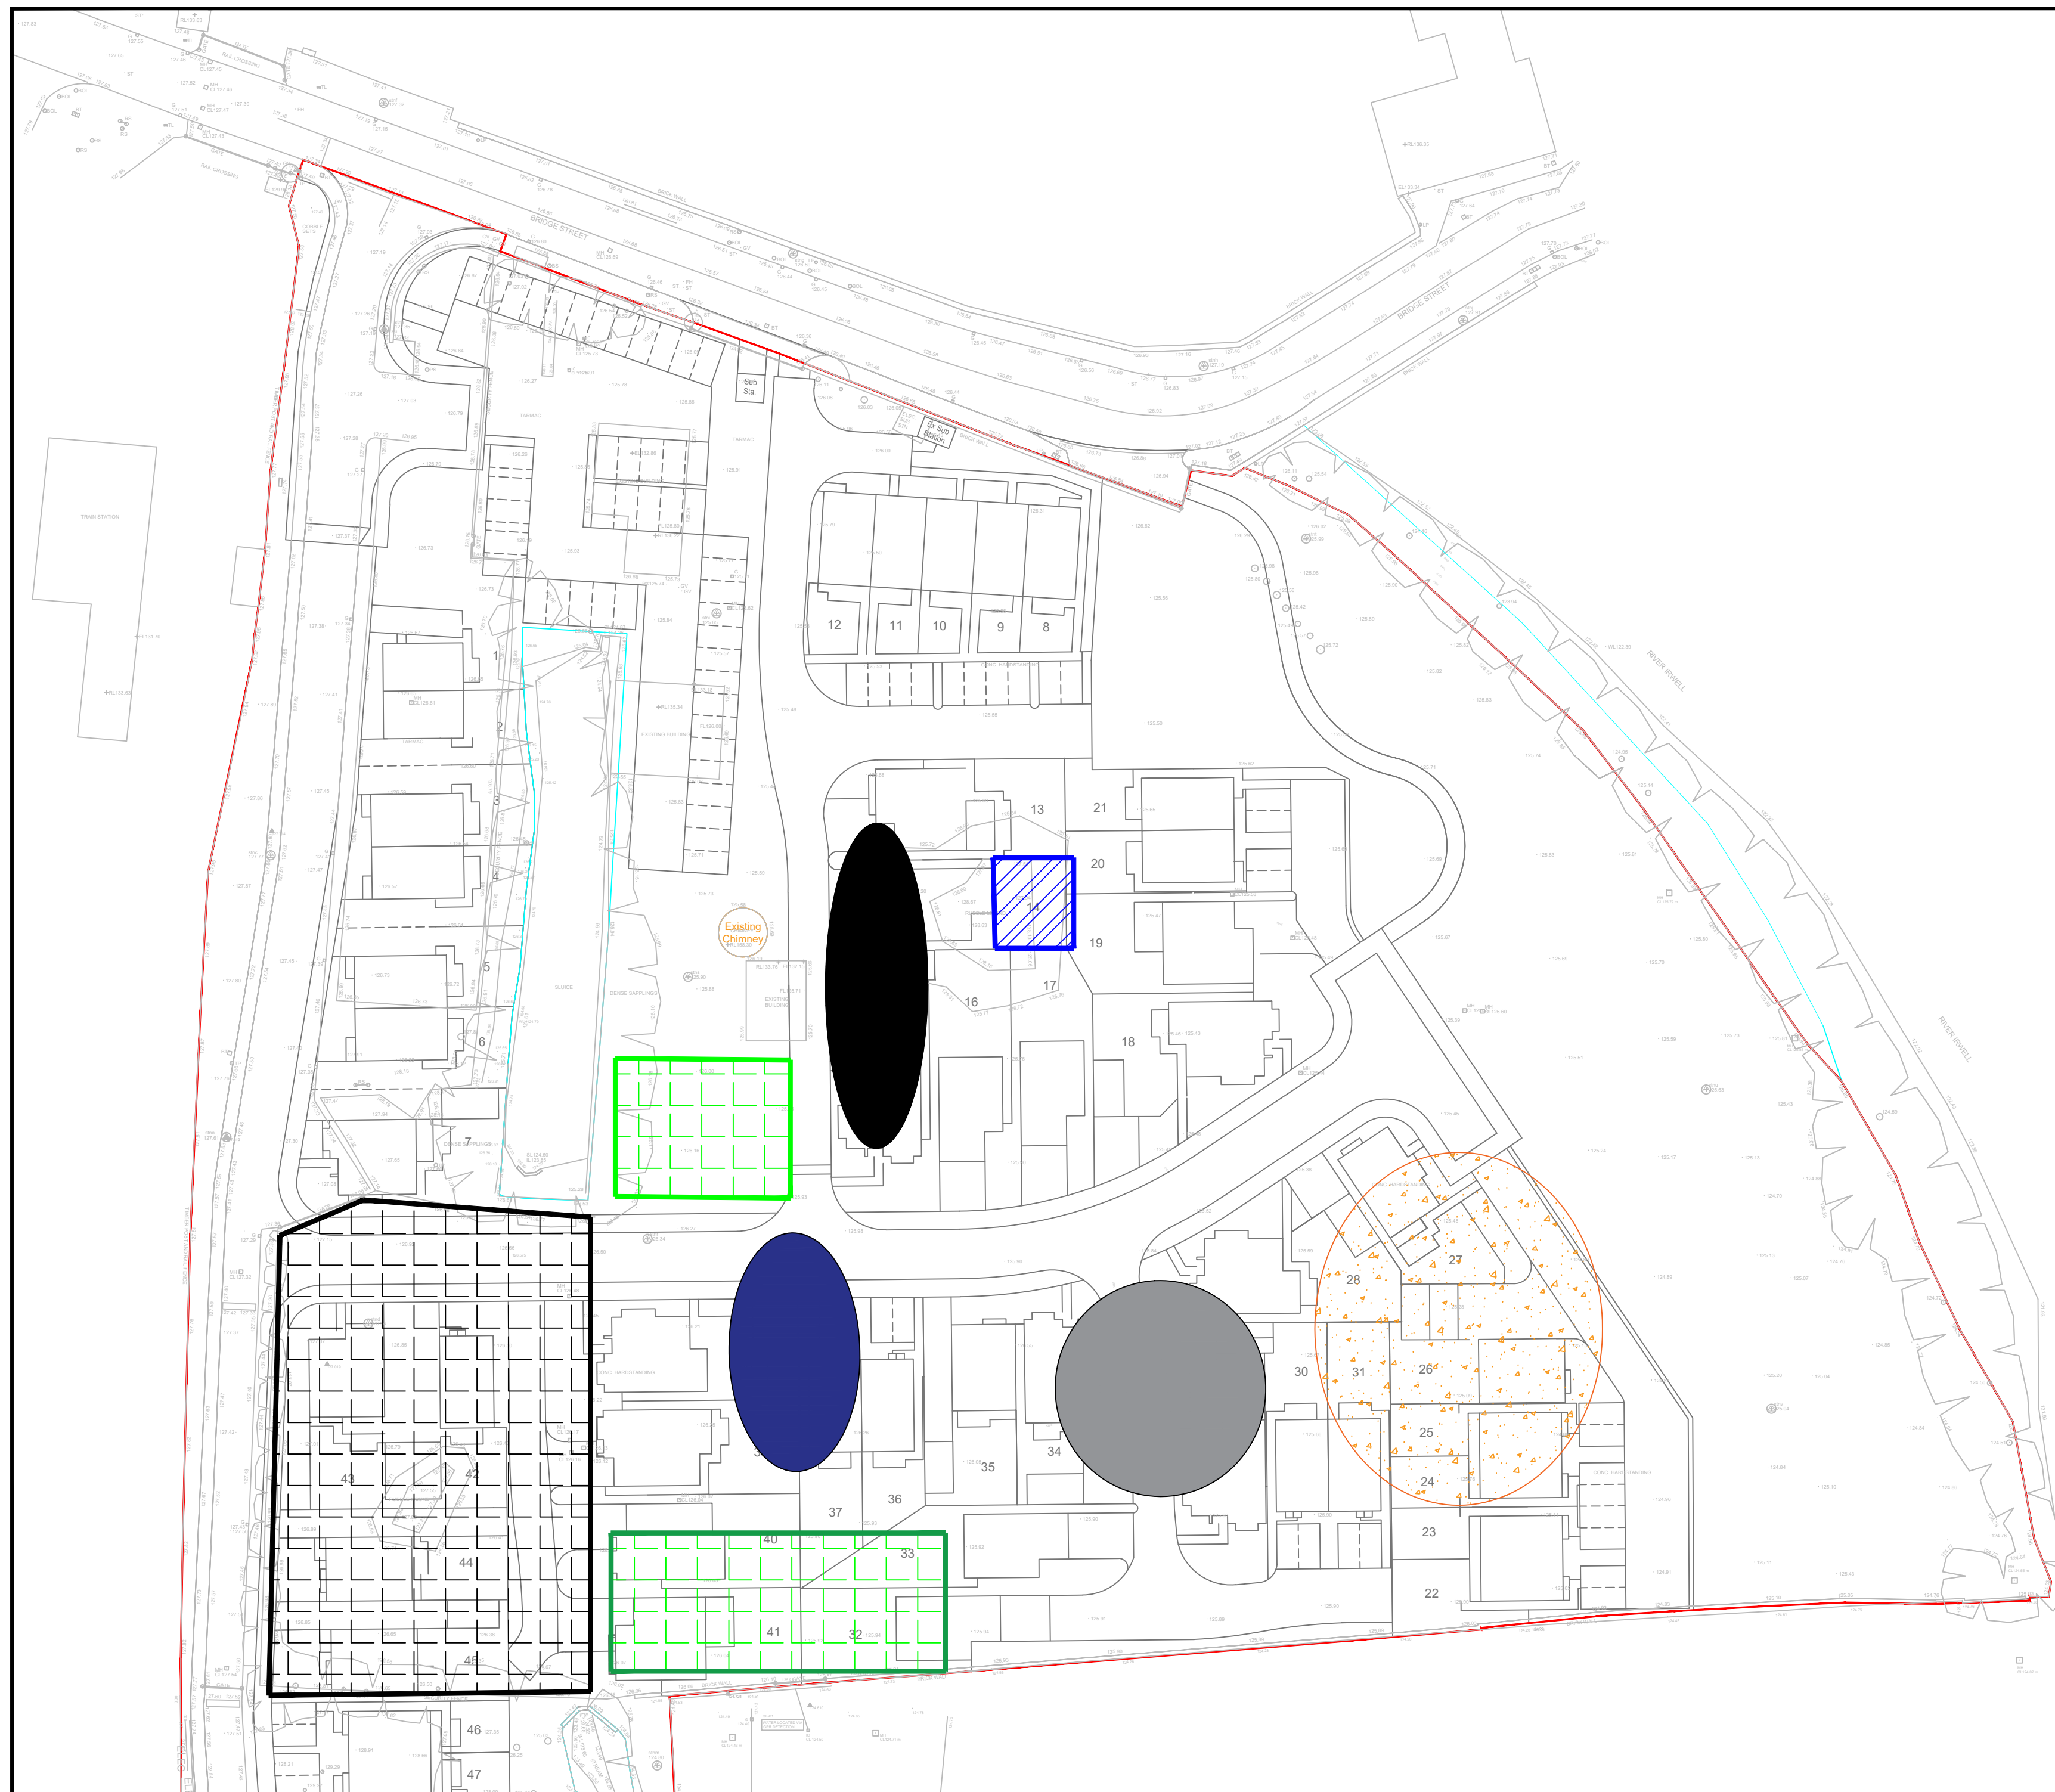
| Dwg No. | MONDI-UR-V1-01-MMP-047 | | Rev<br>A |

- 07:00 - 13:00 : 30t excav. (Rich) continuing with breakout of below ground foundations/structures in area 2 with breakout being stockpiled locally in preparation of being hauled to clean concrete stock when ADT available on 24/03/25
- 07:00 - 13:00 : 35t excav. (Lewis) tidying former off-site processing area on southern boundary, removing existing surface slabs adjacent southern boundary exposing remaining concrete bases associated with southern boundary wall as structural engineer due on site 24-25/03/25, exposed suspected w/d UT/11. Additional investigation to be undertaken 24-25/03/25.

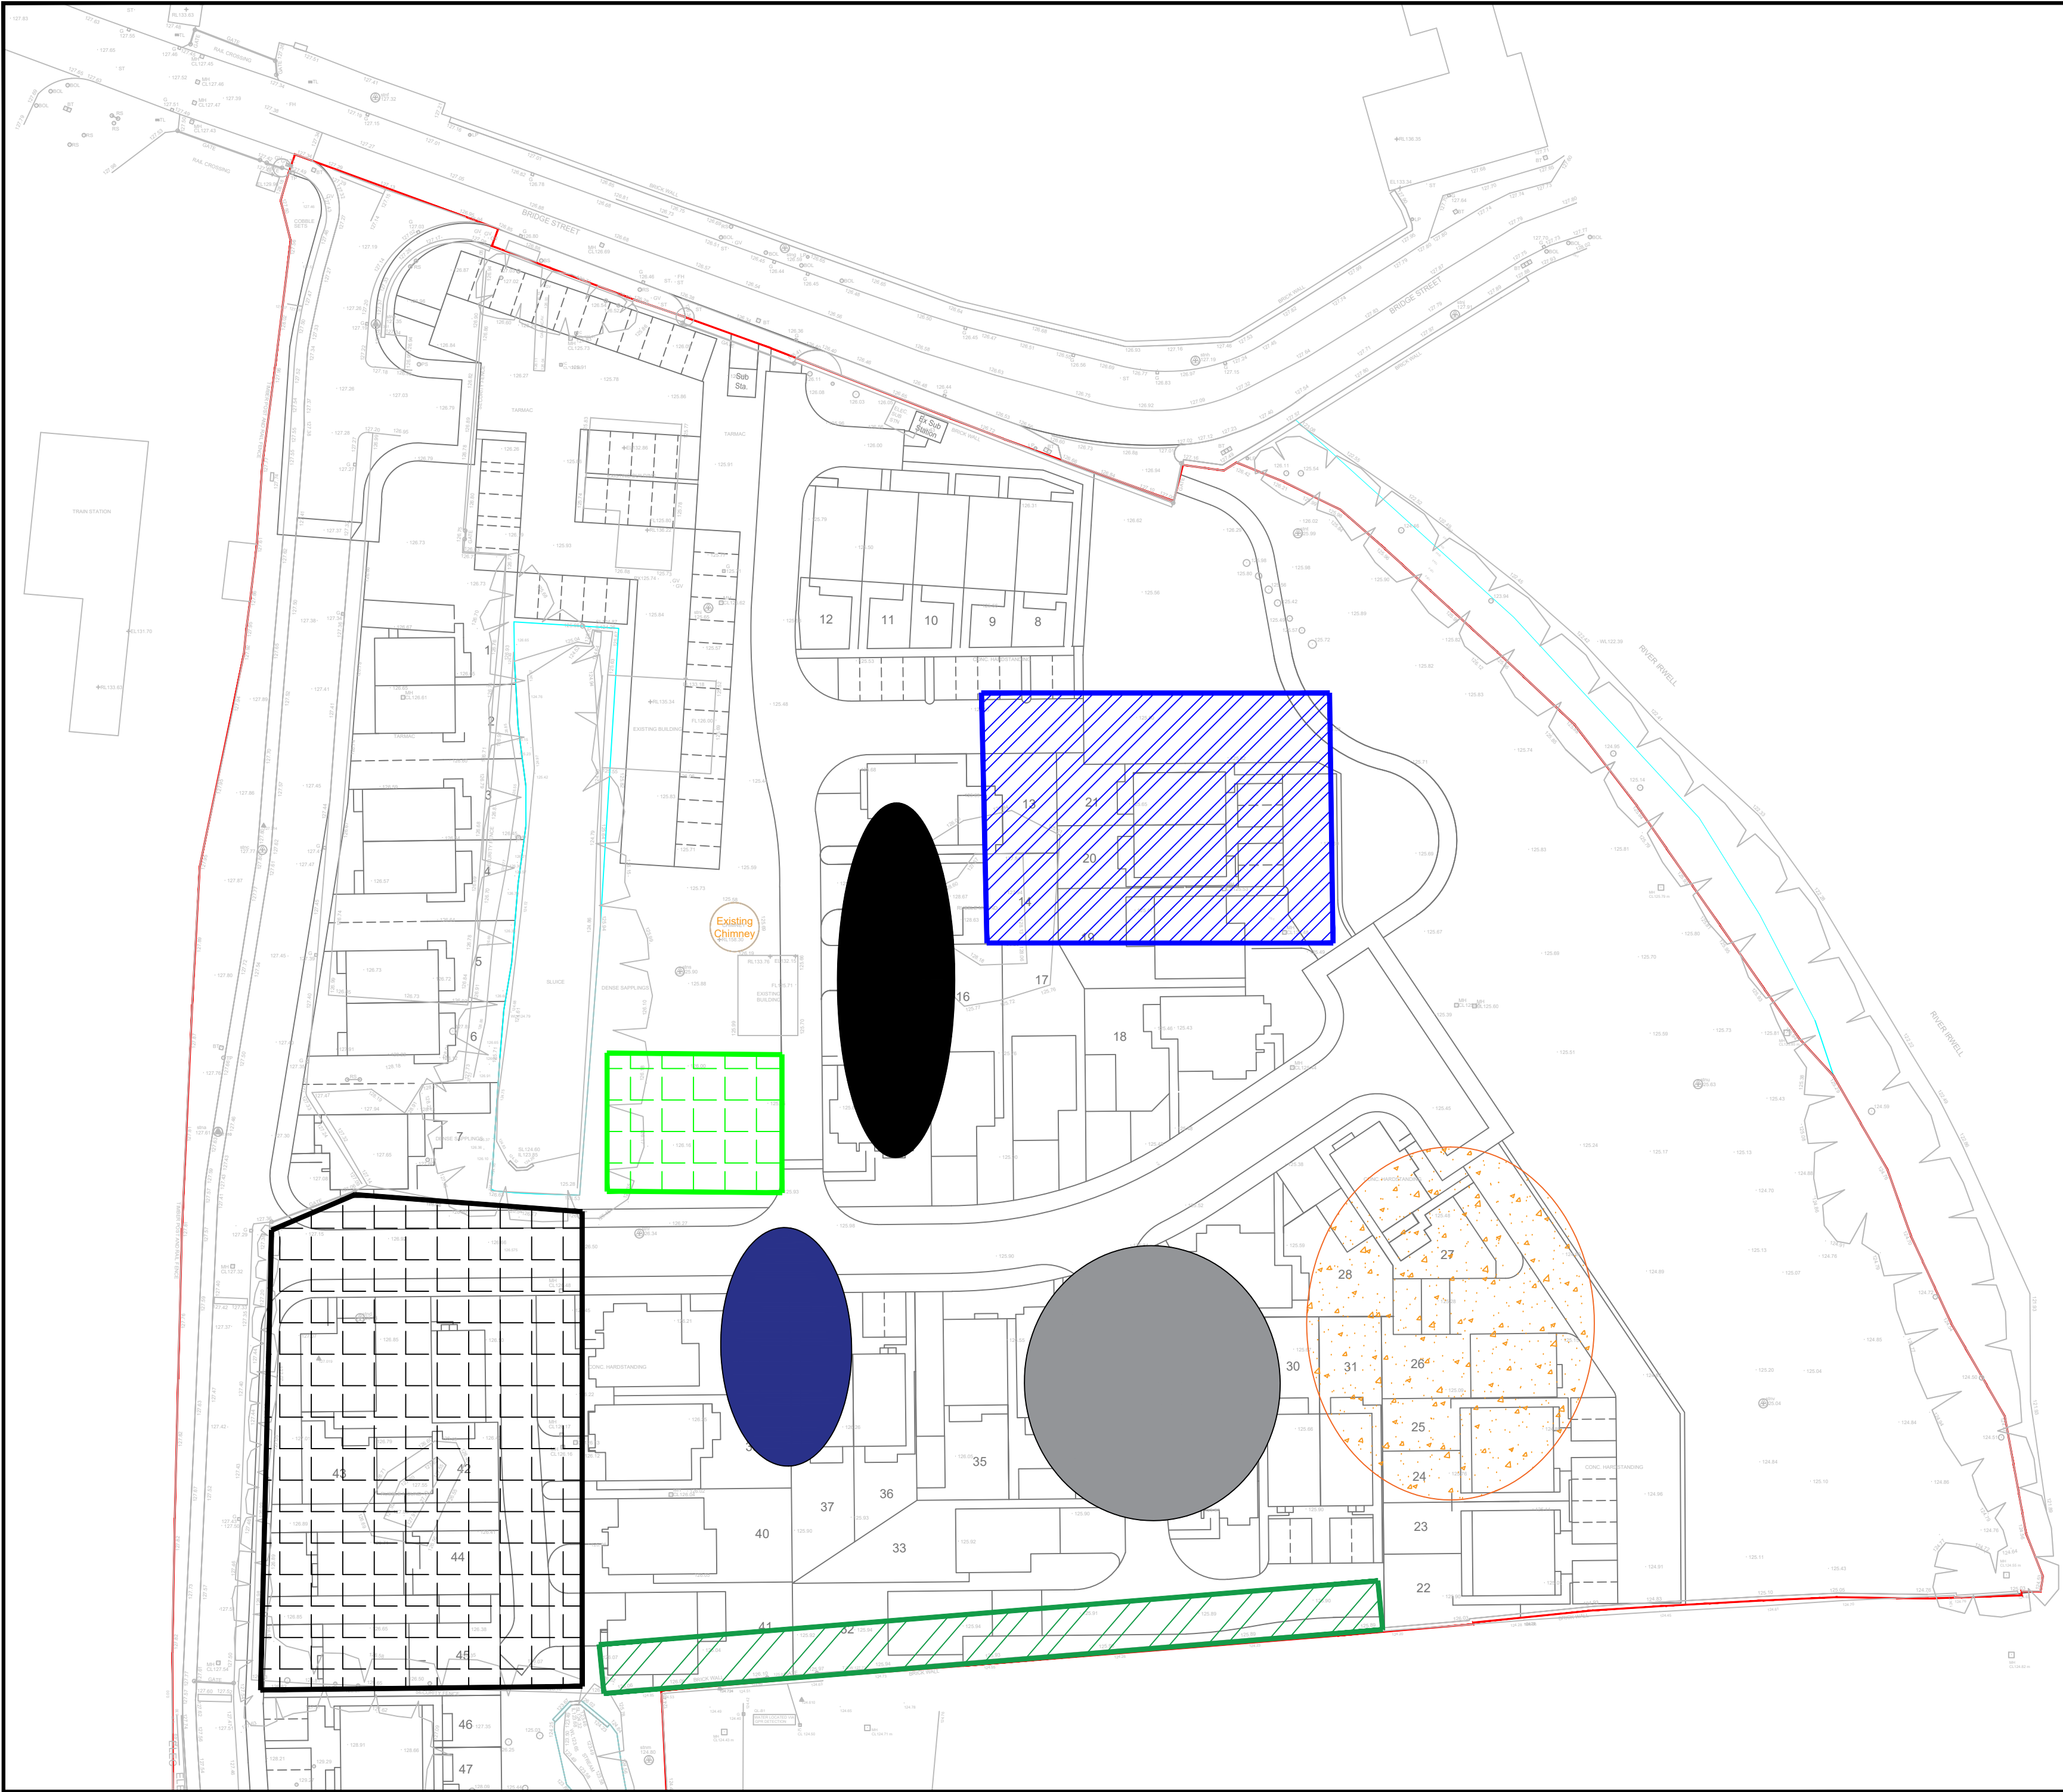
| MONDI-UR-V1-01-MMP-048 | | | | A | |

- Works Undertaken:**
- 07:00 - 18:00 : 35t excav. (Key) utilising hydraulic grab to remove 90m, approx. 2.0m high double skin brickwork from R.C base on Southern boundary wall, also removing steel stanchions previously cut/burnt down of former reit house at 6 m intervals at brickwork removed loaded into 30t ADT and added to clean concrete stock ready for crushing. Heras fence installed on R.C.C side of wall (previously agreed with P. Croft, R.C.C contact) with fence posts used to protect water main at toe of wall. R.C.C land cleaned as works progress. 30t ADT driver used to bank excav, assist in cleaning & erecting fencing with 1 Bentley, 4 no. ADT loads (52 m3) brickwork added to clean concrete stock.

- 07:00 - 18:00 : 30t excav. (Rick) utilising hydraulic breaker continuing with existing slab and below ground foundations/structures encountered in area 2, joined by 22 excav. (Chris) from 14:30 loading localised stockpiles, hard materials encountered taken to segregated stocks on turned works in area 1 by 30t ADT, 19 no. ADT loads ( 247 m3) O/S hard added to clean concrete stock.

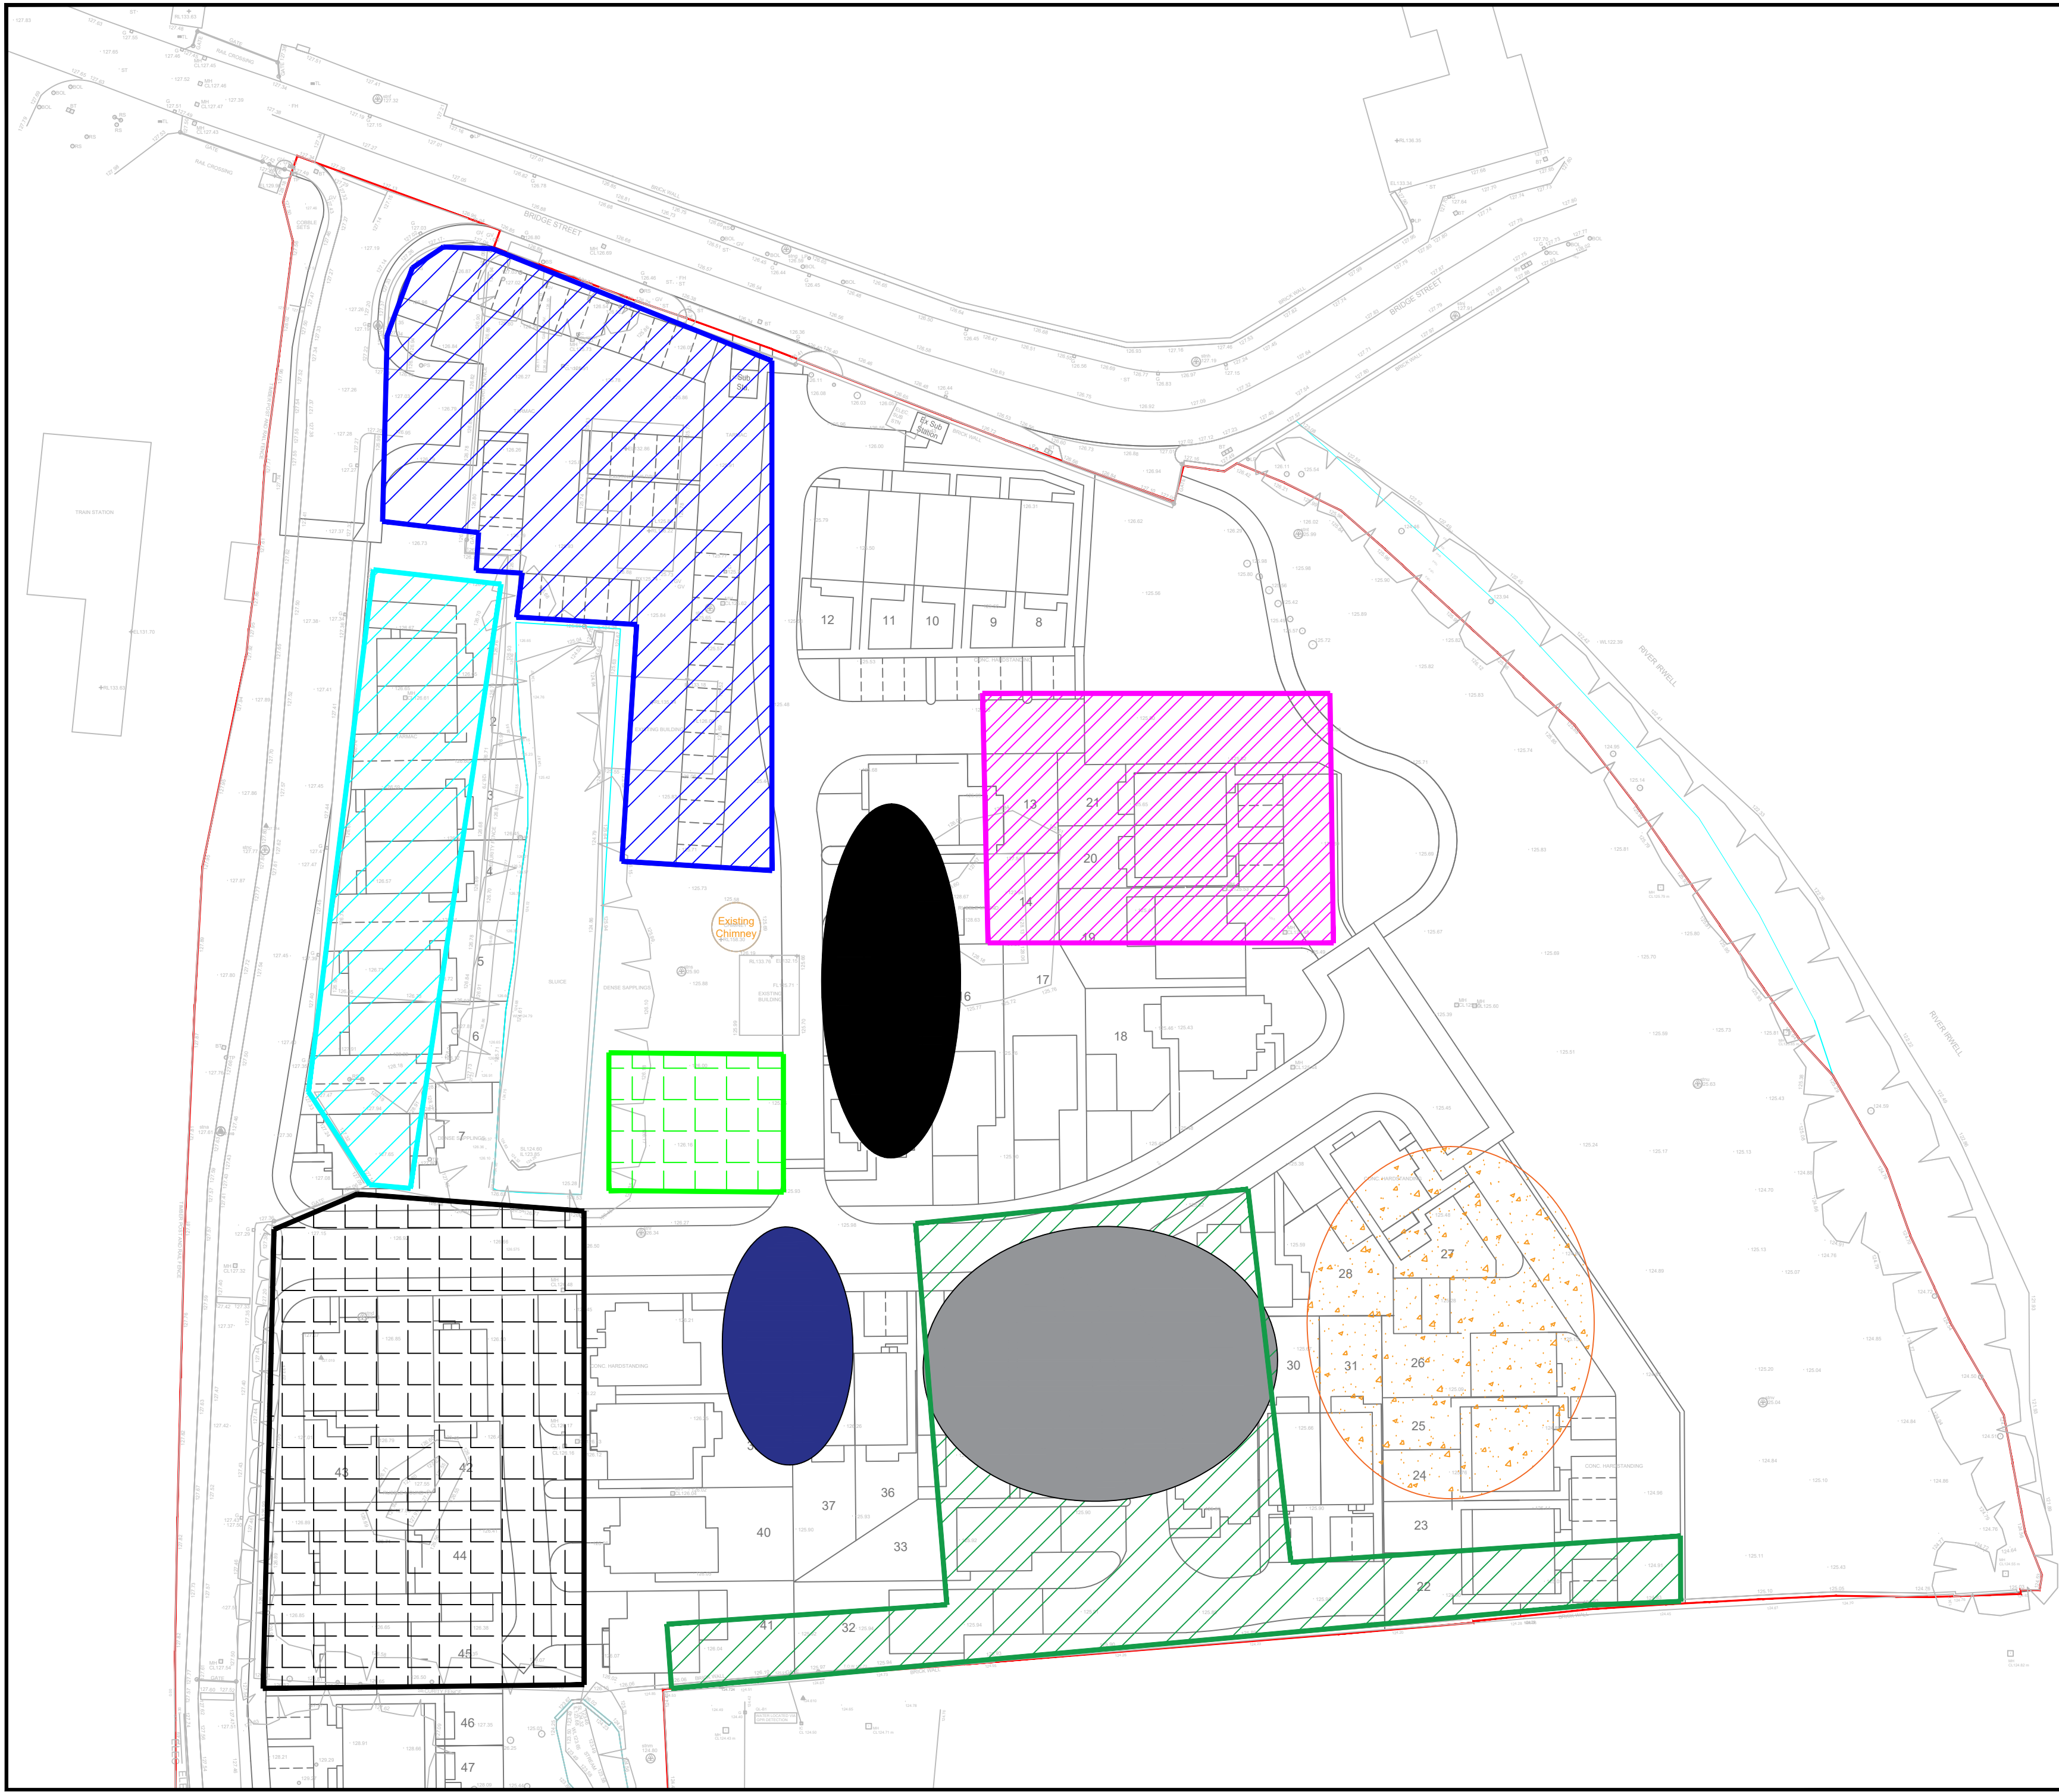
- Works Undertaken:**
- 07:00 - 18:00 : 35t excav. (Kev) tidying processing O/S hard from slab breakout undertaken 22/03 and loading 30t ADT with remaining arisings from southern boundary wall removal, assisted moving fencing materials to southern end of site then commencing with removal of former foul pump on houses on the southern boundary.

- 07:00 - 18:00 : 30t excav. (Rick) utilising hydraulic breaker to remove existing below ground structures & foundations until 10:00 then using GPS to trim carpark/new compound area in N/W corner with surplus fill material being stockpiled on eastern boundary of proposed car park (Area 3) ready to be used as gen fill in area 2. 13:00 - 15:30 Working with Murray Rix operative (Dean) excavating through fill/turned backfilled material to undertake NDG testing. 15:30 - 18:00 back to trimming proposed carpark.

- 07:00 - 18:00 : 22t excav (Chris) loading 30t ADT with slab and below ground structure/foundations broken by 30t excav 24-25/03, then haymaking back approx 500 m3 of 6F2 stockpile to expose existing below ground ring beam of former machine house in preparation of removal of below ground structures on northern work face of area due to commence 26/03/25 24 no. (312 m3) loads of Hard O/S material added to clean concrete stock ready for crushing

- 13:00 - 16:00 : Murray Rix on site to undertake NDG testing in area 3, 17 no. NDG's undertaken achieving 100%+ on compaction, please note a max. dry density has been assumed at 1.84, samples of the material being tested collected by Murray Rix and is to be updated accordingly once true M.D.D is known.

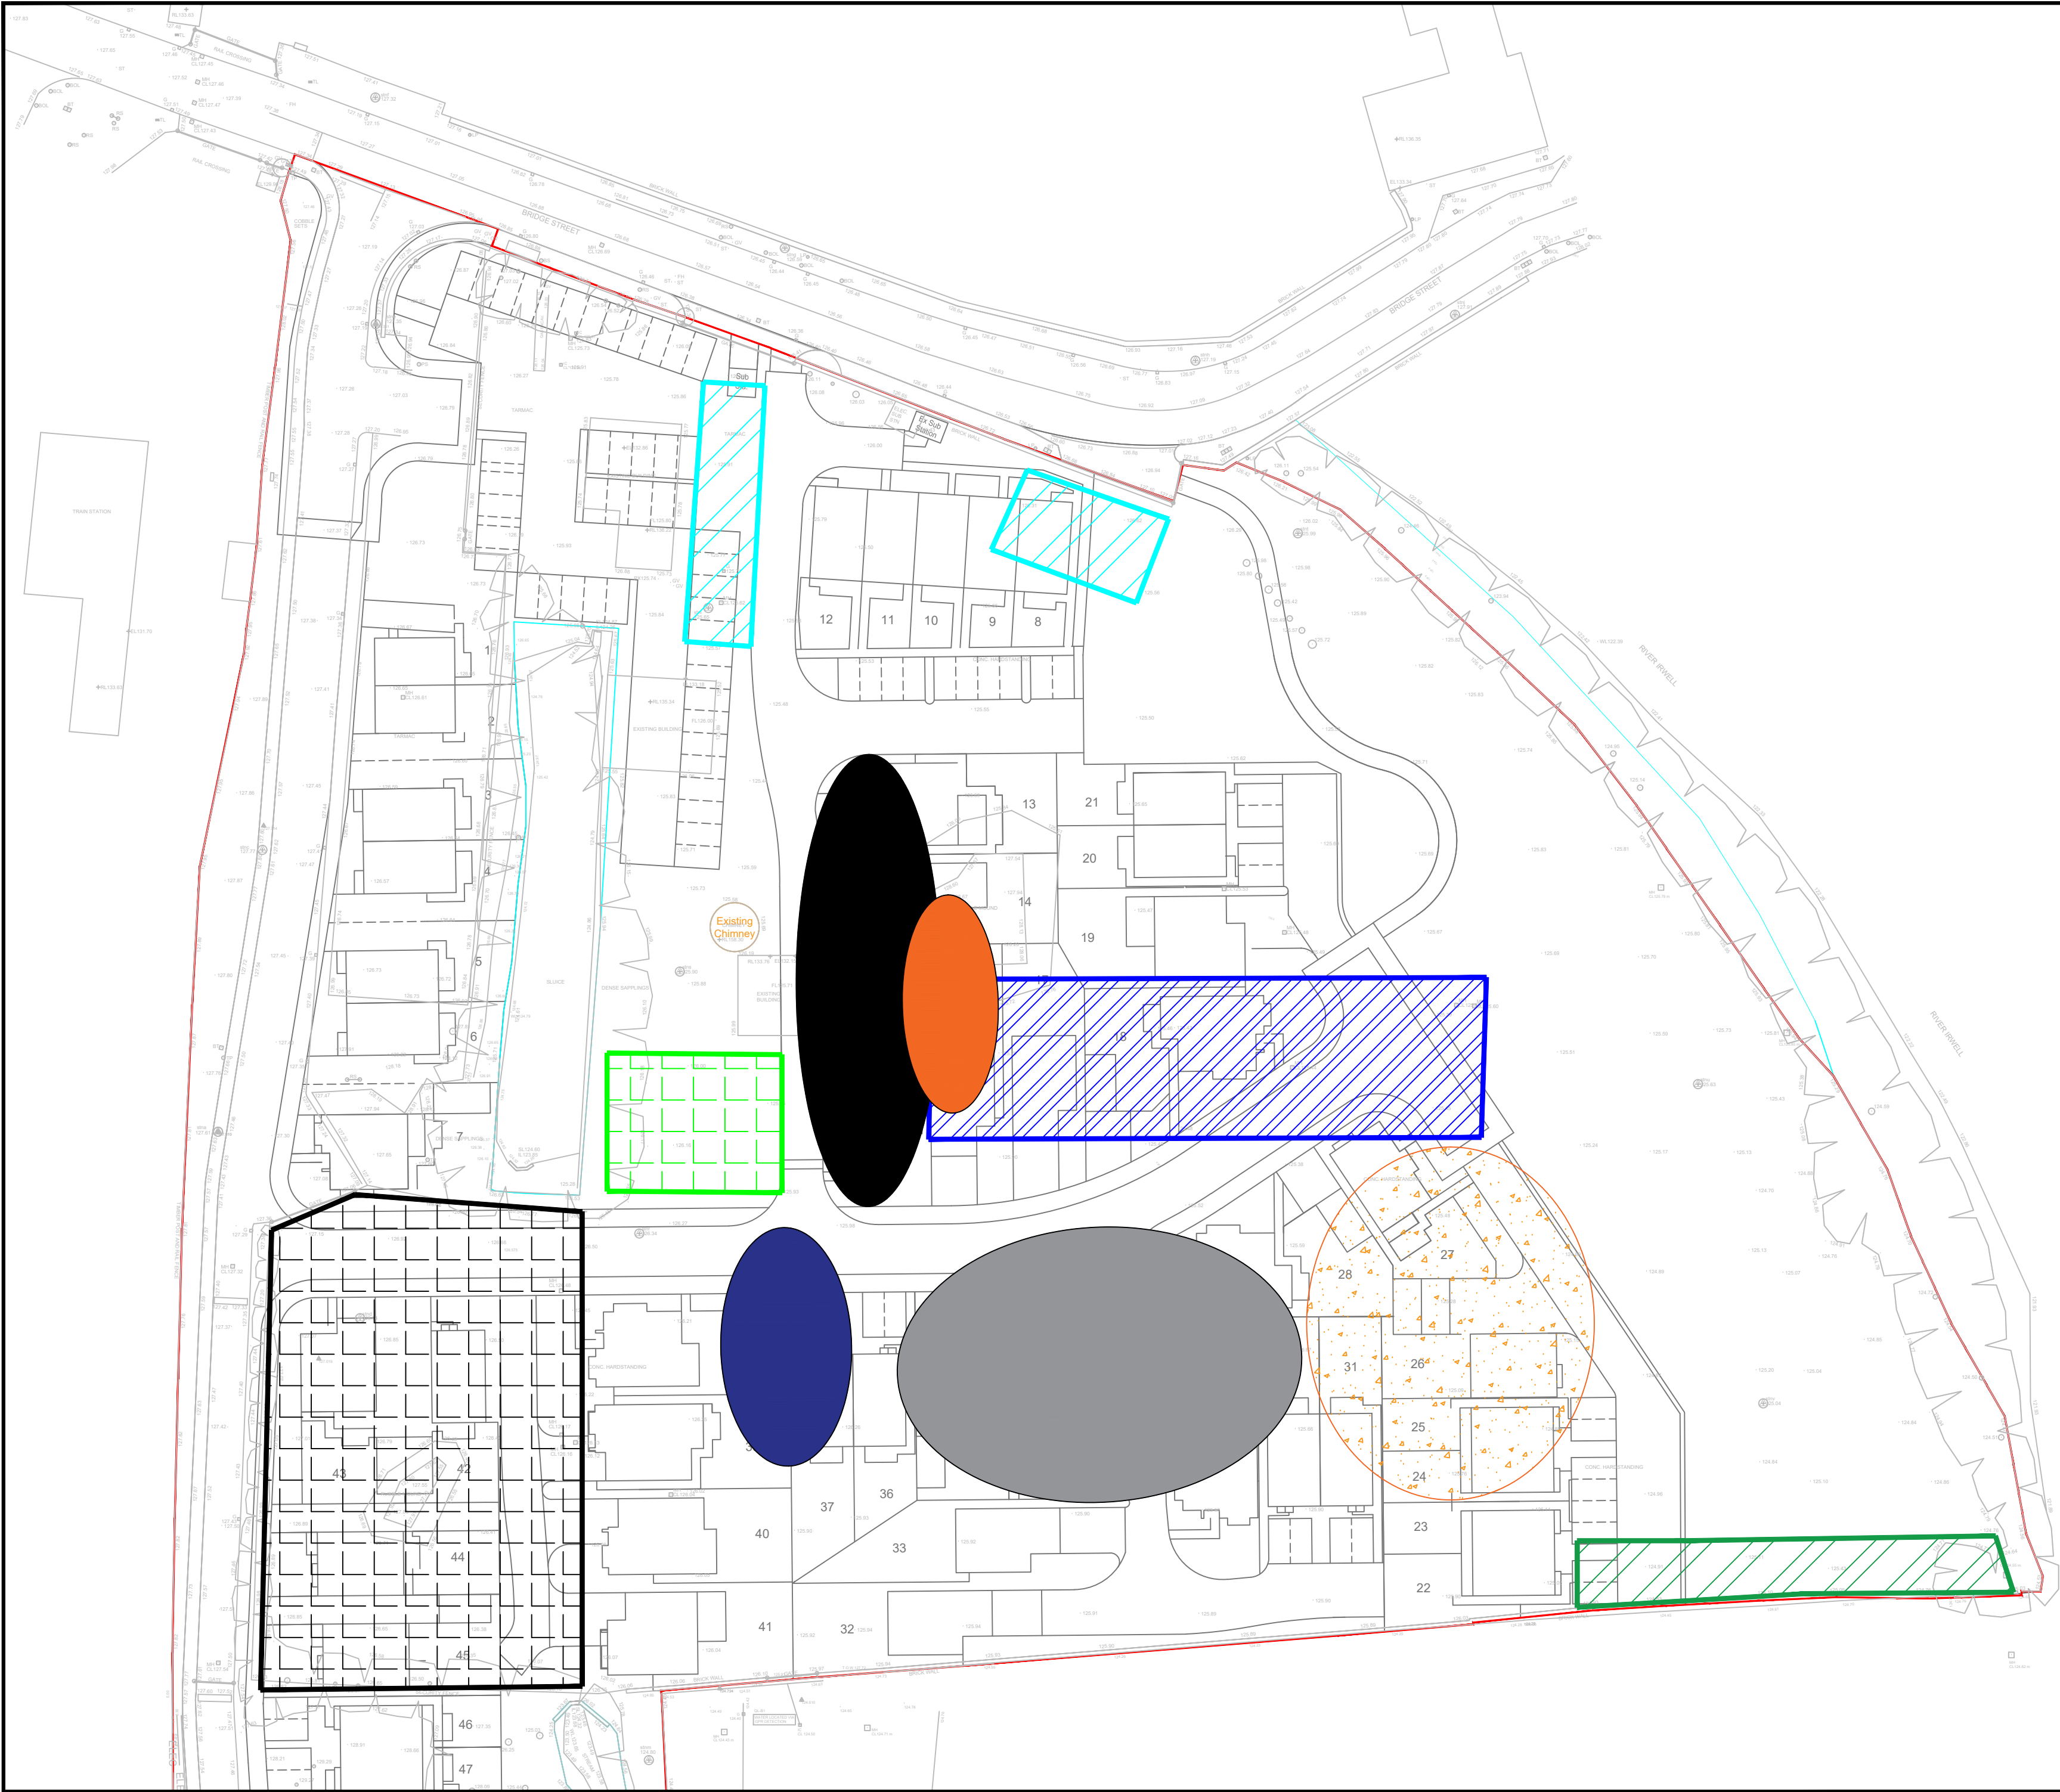
- 07:00 - 18:00 : 30t excav. (Rick) & 22t excav. (Chris) continuing turnover works in area 2, "hymaking" brick rubble made ground from eastern P.O.S to eastern extent of area 1, removing all remaining structures/foundations/hard materials encountered in excess of 150mm, removing piles encountered below former structures, ensuring that any piles that break are taken to a minimum 3.0m below E.W.O. 13:00 - 18:00 22t excav. loading sandvik screen to process brick rubble made ground. 30t excav. stockpiling material from area 1, utilising hydraulic breaker to reduce O/S hard in size as required and breaking up structures removed 26-27/03/25. 13 no. (160 m3) loads of O/S hard sent to base layer crush pile

- 13:30 - 18:00 : 30t excav. (Carl) creating pad for new cabin set up in proposed carpark in N.W corner of site until 15:00 then moved over to undertake turnover works in the vicinity of the proposed sign base adjacent northern boundary, removing all remaining structures/foundations/hard materials encountered in excess of 150mm, removing piles encountered below former structures, ensuring that any piles that break are taken to a minimum 3.0m below E.W.O., re-engineering existing natural made ground materials in 300mm layers compacted with 15t roller in preparation of laying approx. 120 m3 to achieve a 5 x 5m pad within 1.6 m off the top of the northern boundary wall.
