Client  
Eccleston Homes

Site  
Mondi - Mill,  
Ramsbottom , BL0 OBS.

Title  
MMP Daily Tracking Record  
21/03/25

| Dwg No. | MONDI-UR-V1-01-MMP-047 | | Rev<br>A |

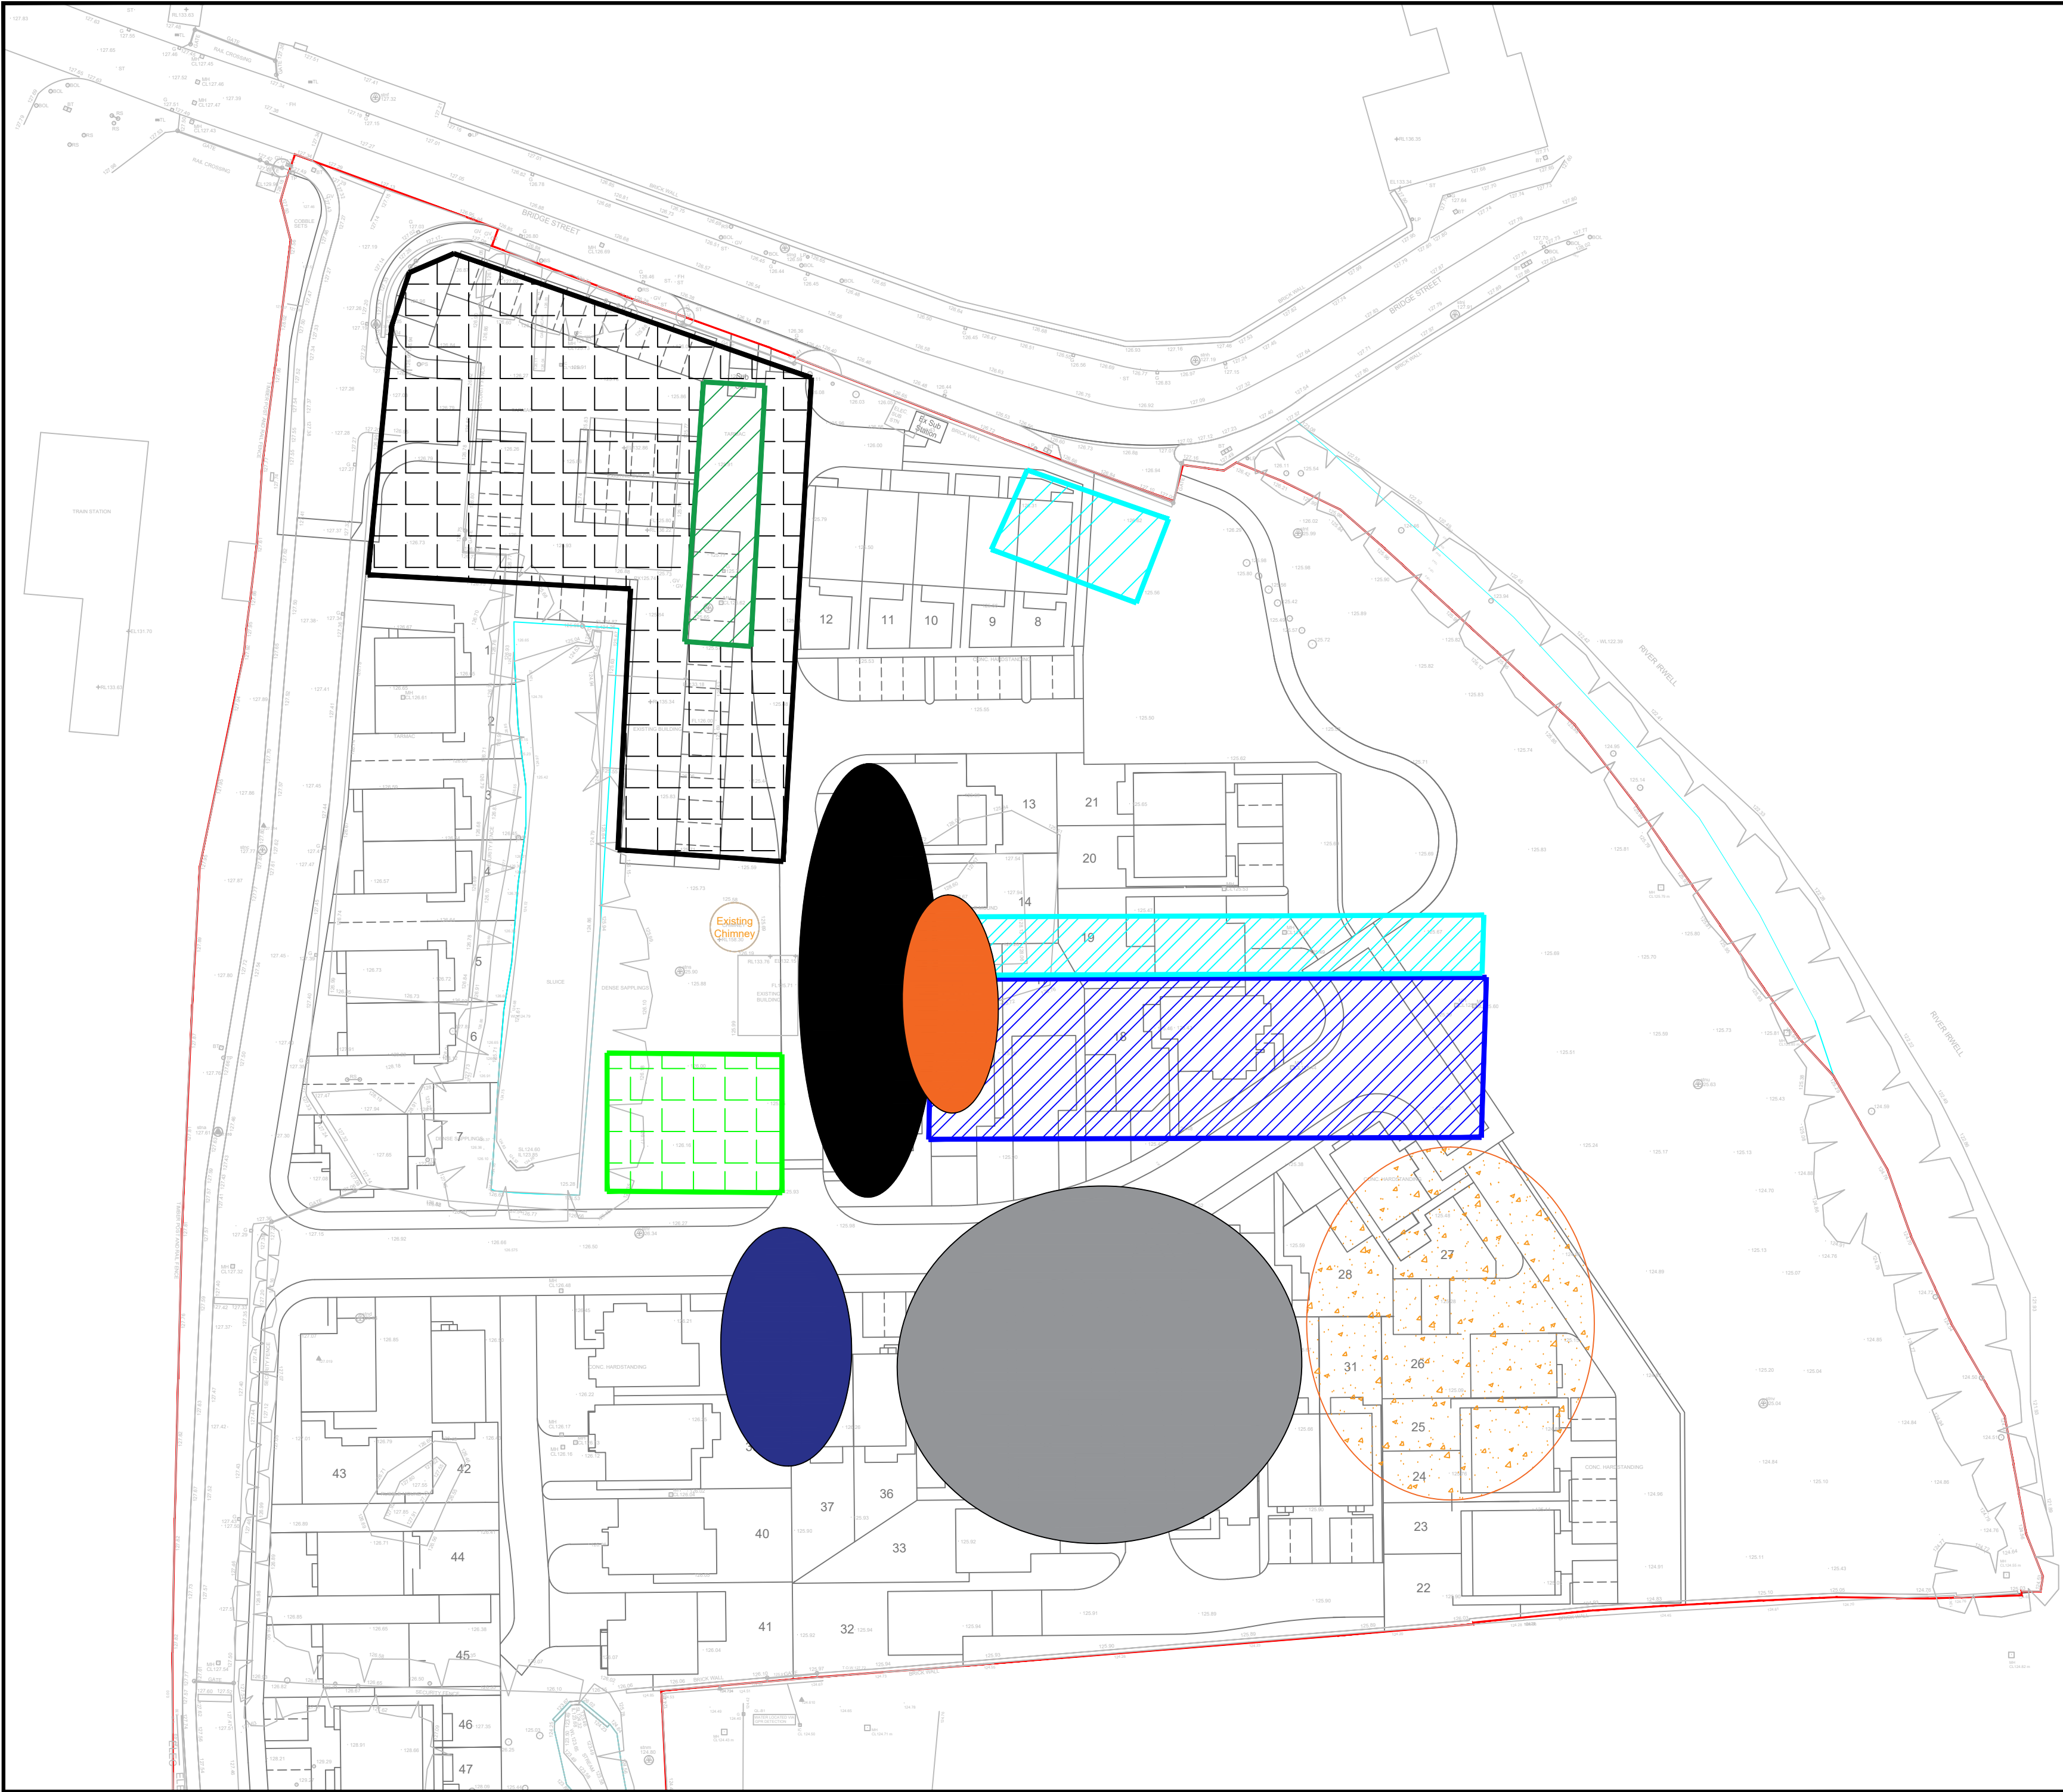
- 07:00 - 17:30 : 30t excav. (Rick) & 22t excav. (Chris) continuing turnover works in area 2, "thymaking" brick rubble made ground from eastern P.O.S to eastern extent of area 1, removing all remaining structures/foundations/hard materials encountered in excess of 150mm, removing piles encountered below former structures, ensuring that any piles that break are taken to a minimum 3.0m below E.W.O. : 13:00 - 18:00 22t excav. loading sandvik screen to process brick rubble made ground. 30t excav. stockpiling material from fines belt in turned works of Area 2, utilising hydraulic breaker to reduce O/S hard in size as required and breaking up structures removed 26-27/03/25.

- 07:00 - 17:30 : 30t excav. (Carl) loading broken oversize generated from turnover works into 30t ADT, laying 10 no. ADT loads onto turned ground of proposed sign base in N.E corner of site, with screened fines from turnover works, compacted in 300mm layers with 13t roller. 8 no. ( 104m3) screened fines sent to sign base & 26 no. ( 340 m3) hard O/S sent to processing stock.

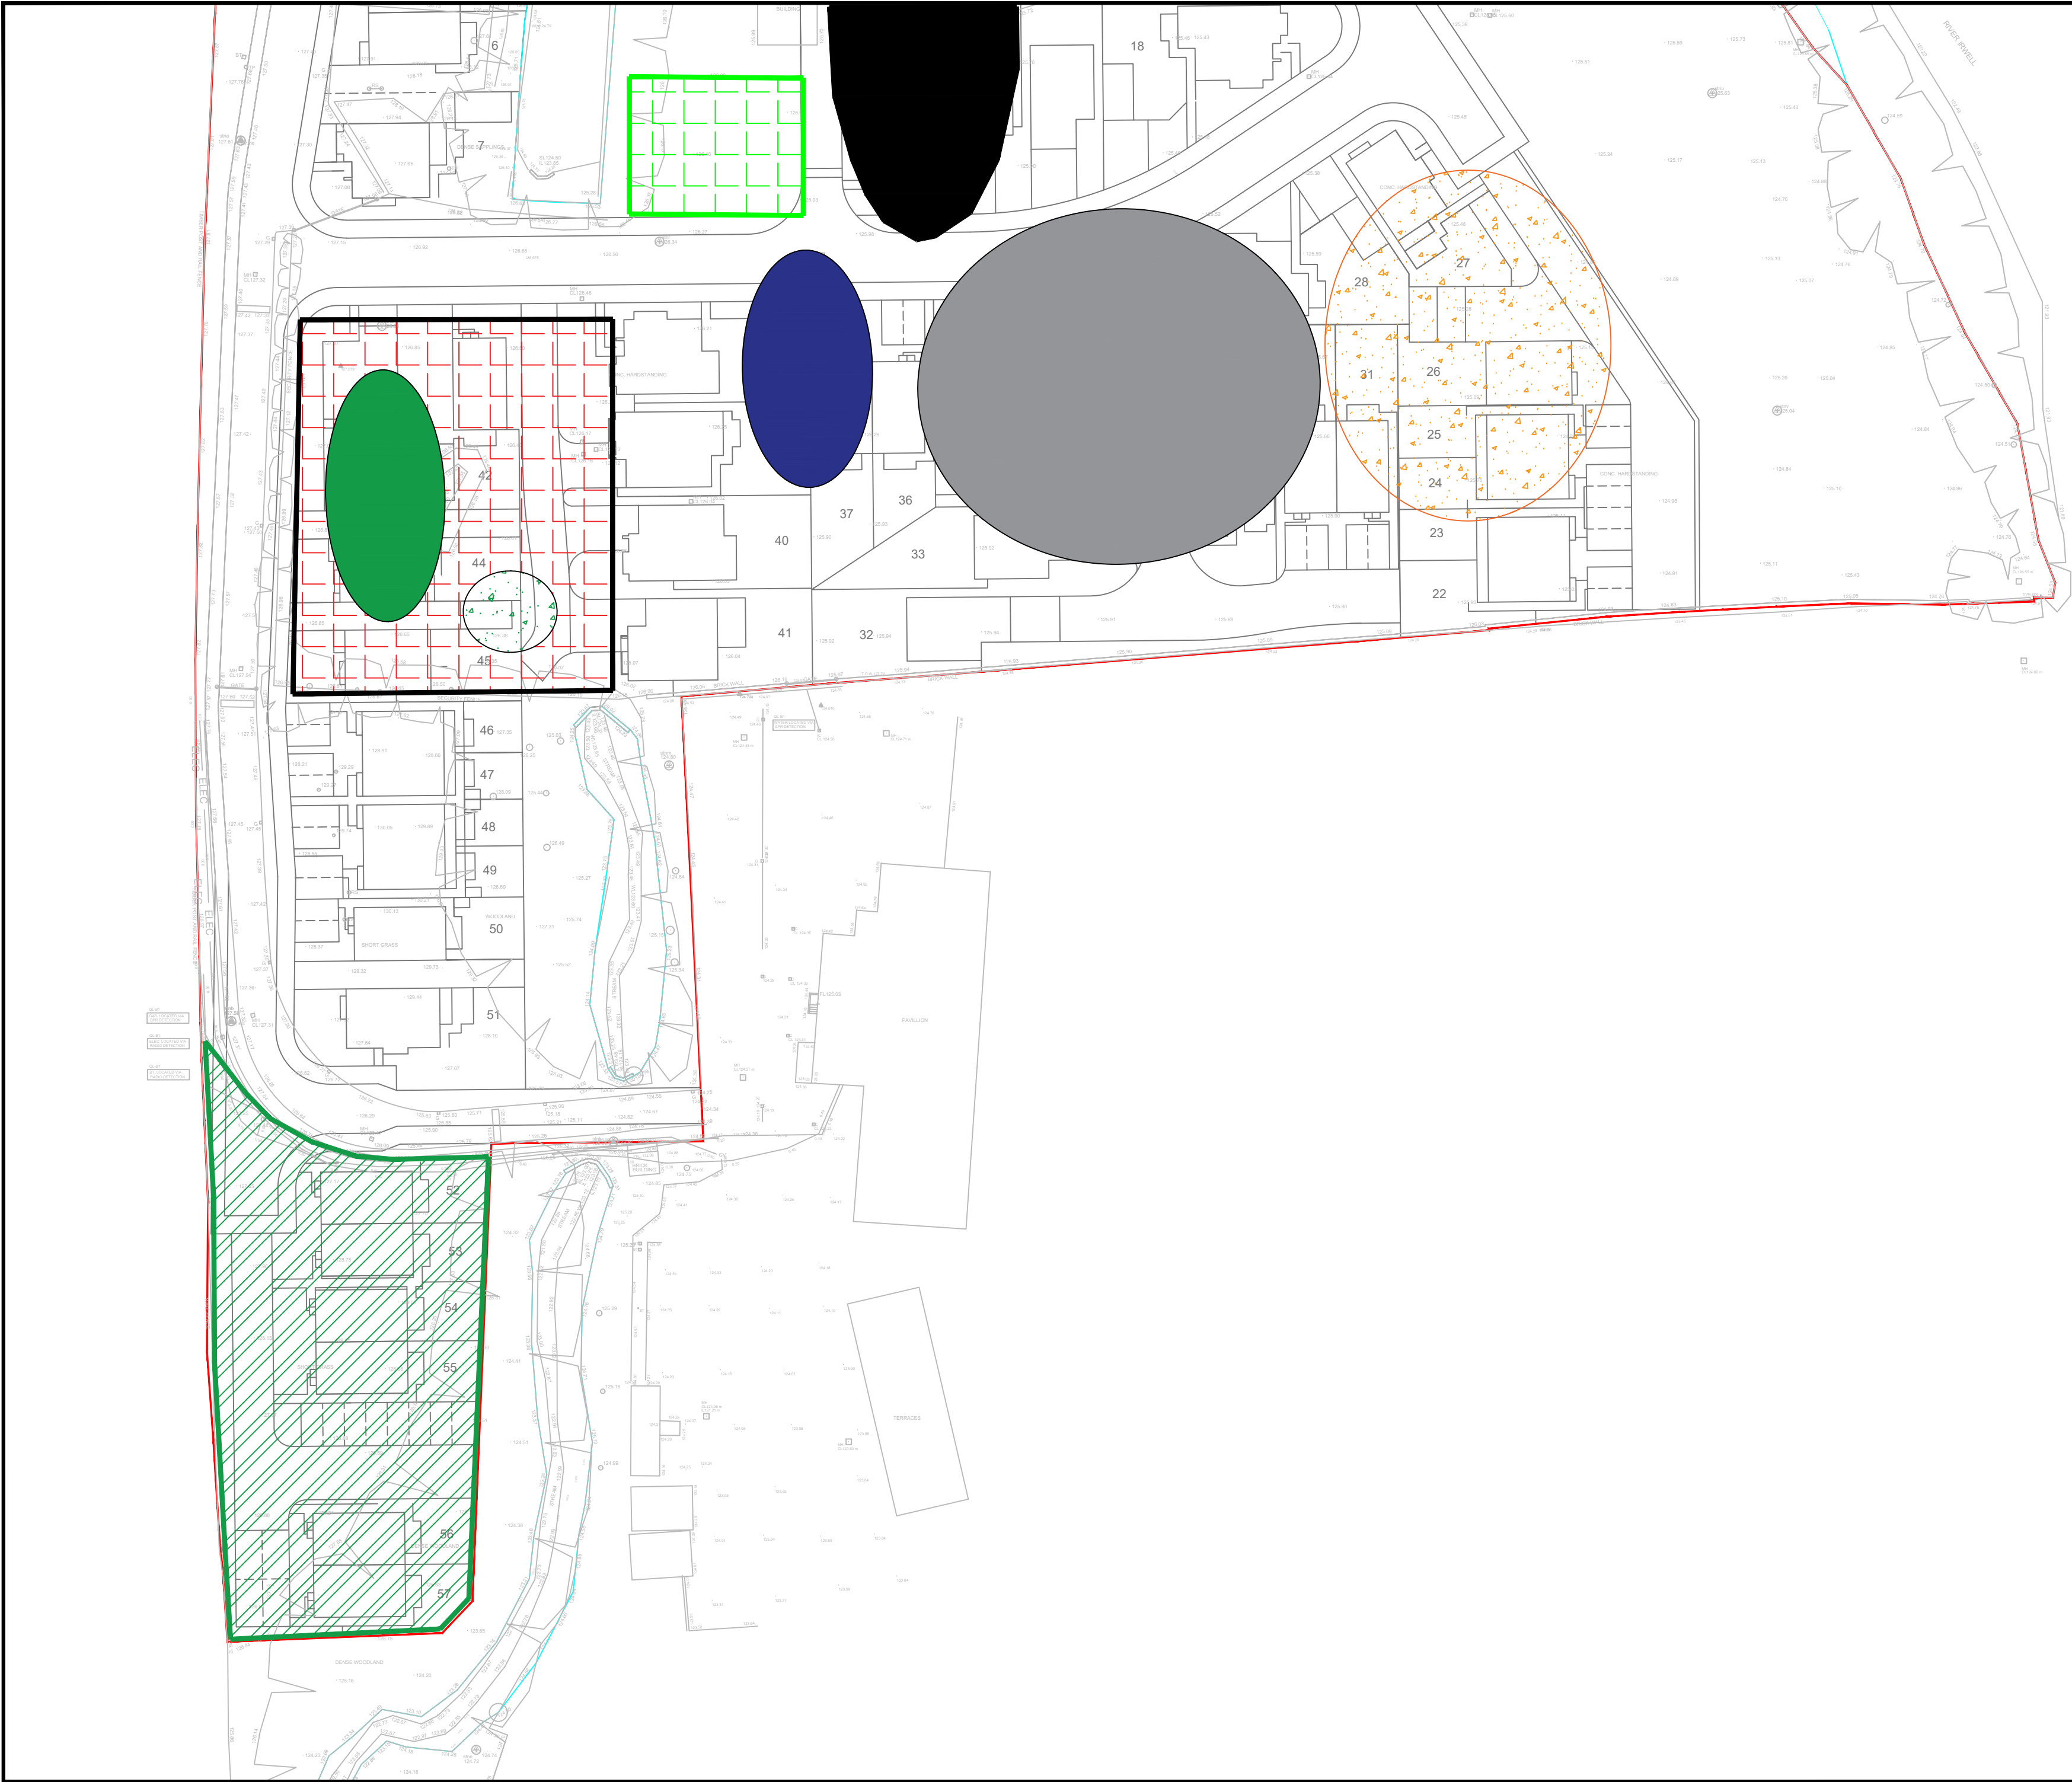
- 07:00 - 17:30 : 30t excav. (Rick) completing turnover below plots 13 & 21 until 09:00, then utilising hydraulic breaker of former transformer house, boiler house & joiners store until 12:30 when pipe blew on oil quick attachment. Using DGN to level screened material into fill area until hose repaired on excav. at 14:30 then back to breaking structures compacted with 15t roller in 300mm layers.

- 07:00 - 17:00 : 22t excav. (Chris) undertaking stockpile maintenance until 09:00 then undertaking reduced level excavation on western boundary ( ELR railway ) of area 6, loading 30t ADT with JK impacted materials under supervision of Knotweed Eradication , G Parry. Material tracked over area 6 to ensure no damage caused to existing kerblines/footpath. 6 no. ADT loads ( 75 m3) of JK impacted materials to processing area from area 6. 14:30 - 17:00 utilising ride bucket to remove handstanding from material and hand picked for rhizomes by G Parry remaining material added to off site stock generated 04-05/04/25 Access rd. to R.C.C closed to traffic as agreed with R.C.C during removal operation, access re-installed at 14:30.

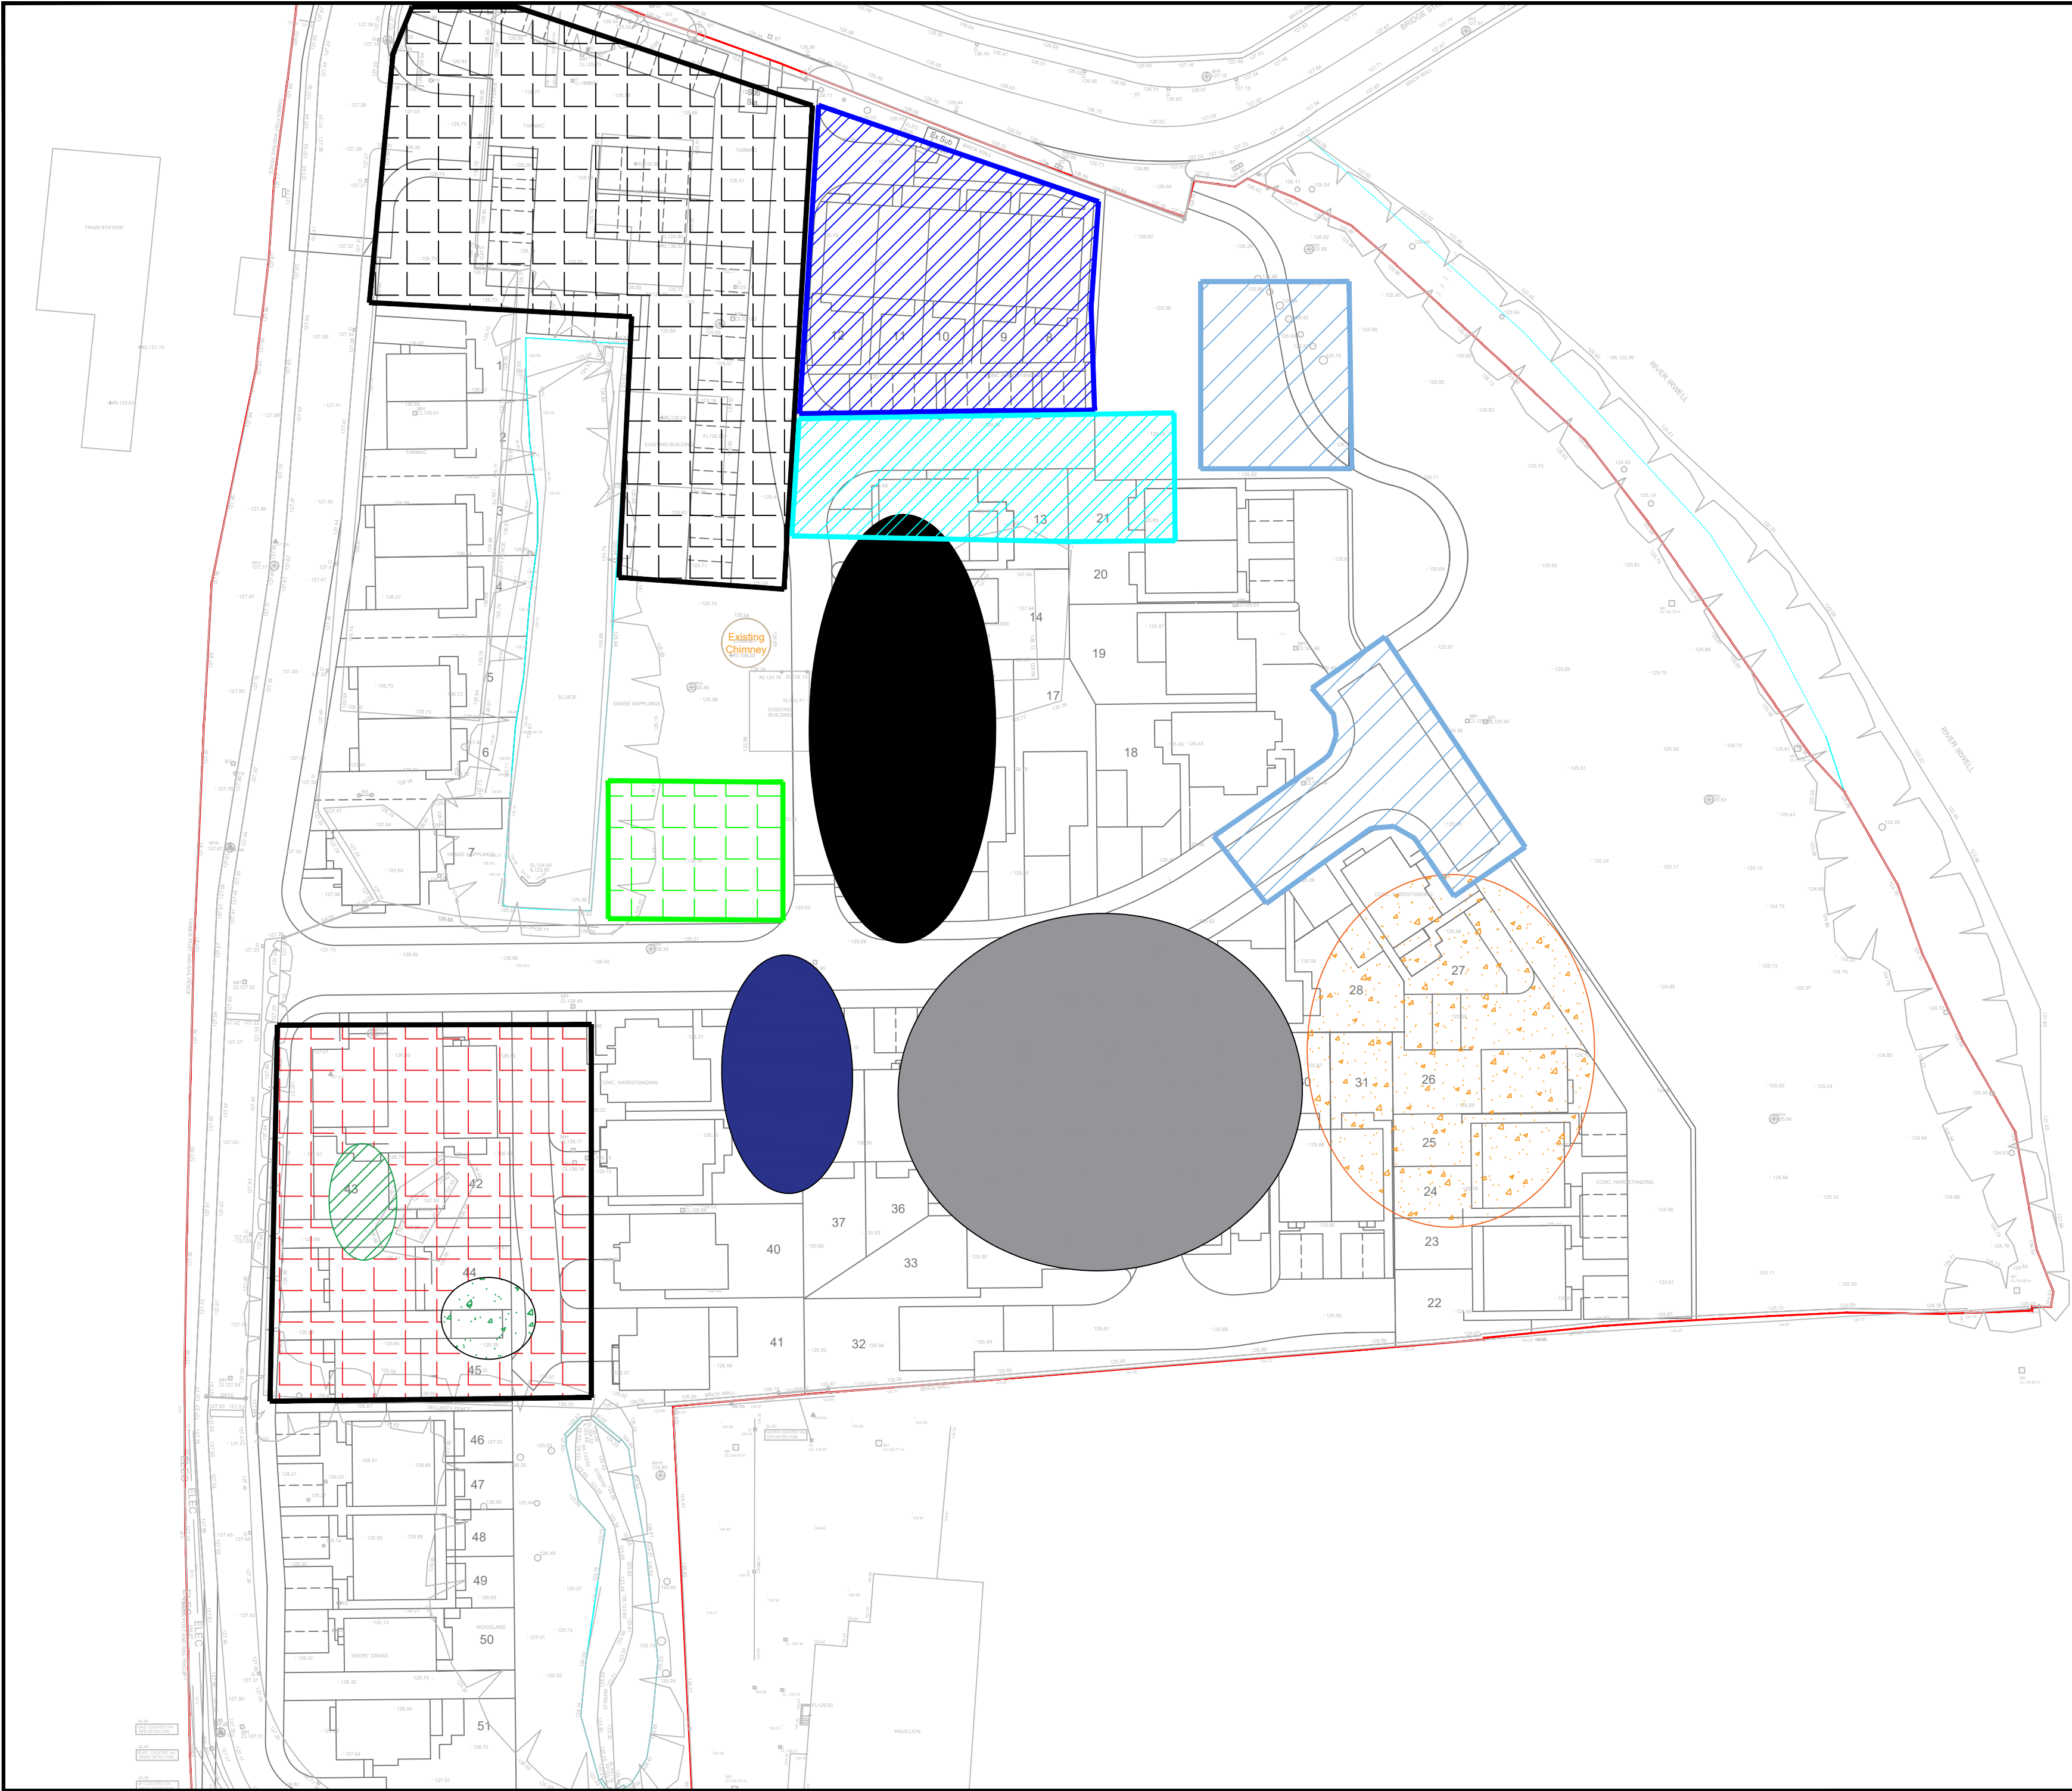
- Works Undertaken:**
- 07:00 - 18:00 : 30t excav. ( Carl) continuing with turnover works below plots 8-12 ( previous reservoir & filter beds) removing all hard materials encountered up to 3m from EGL's in excess of 150mm dia. slow working as previous reservoir & filter beds in area with water encountered in granular materials approx. 2.0m from EGL's tractor & bowser used to de-water area. 12:00 during excavation below plots 11/12 operator encountered assumed reservoir wall at EGL-2.0m, when chasing out found that wall running below area turned 05/04 ( Wall appears to have been previously reduced in height at 1000mm wide below turnover undertaken), wall continued to EGL -4.500m at EGL -3.0m encountered heavy groundwater flow from wall. Tractor & Bowser used to de-water excav. Excav. undertaking slip trenches on works undertaken 03-07/04 through Plots 8-12 to EGL-3.0m to ensure that no other walls have been missed. Slip trenches backfilled and re-compacted. 4" Pump to be set up 08/04/25 to undertake removal.

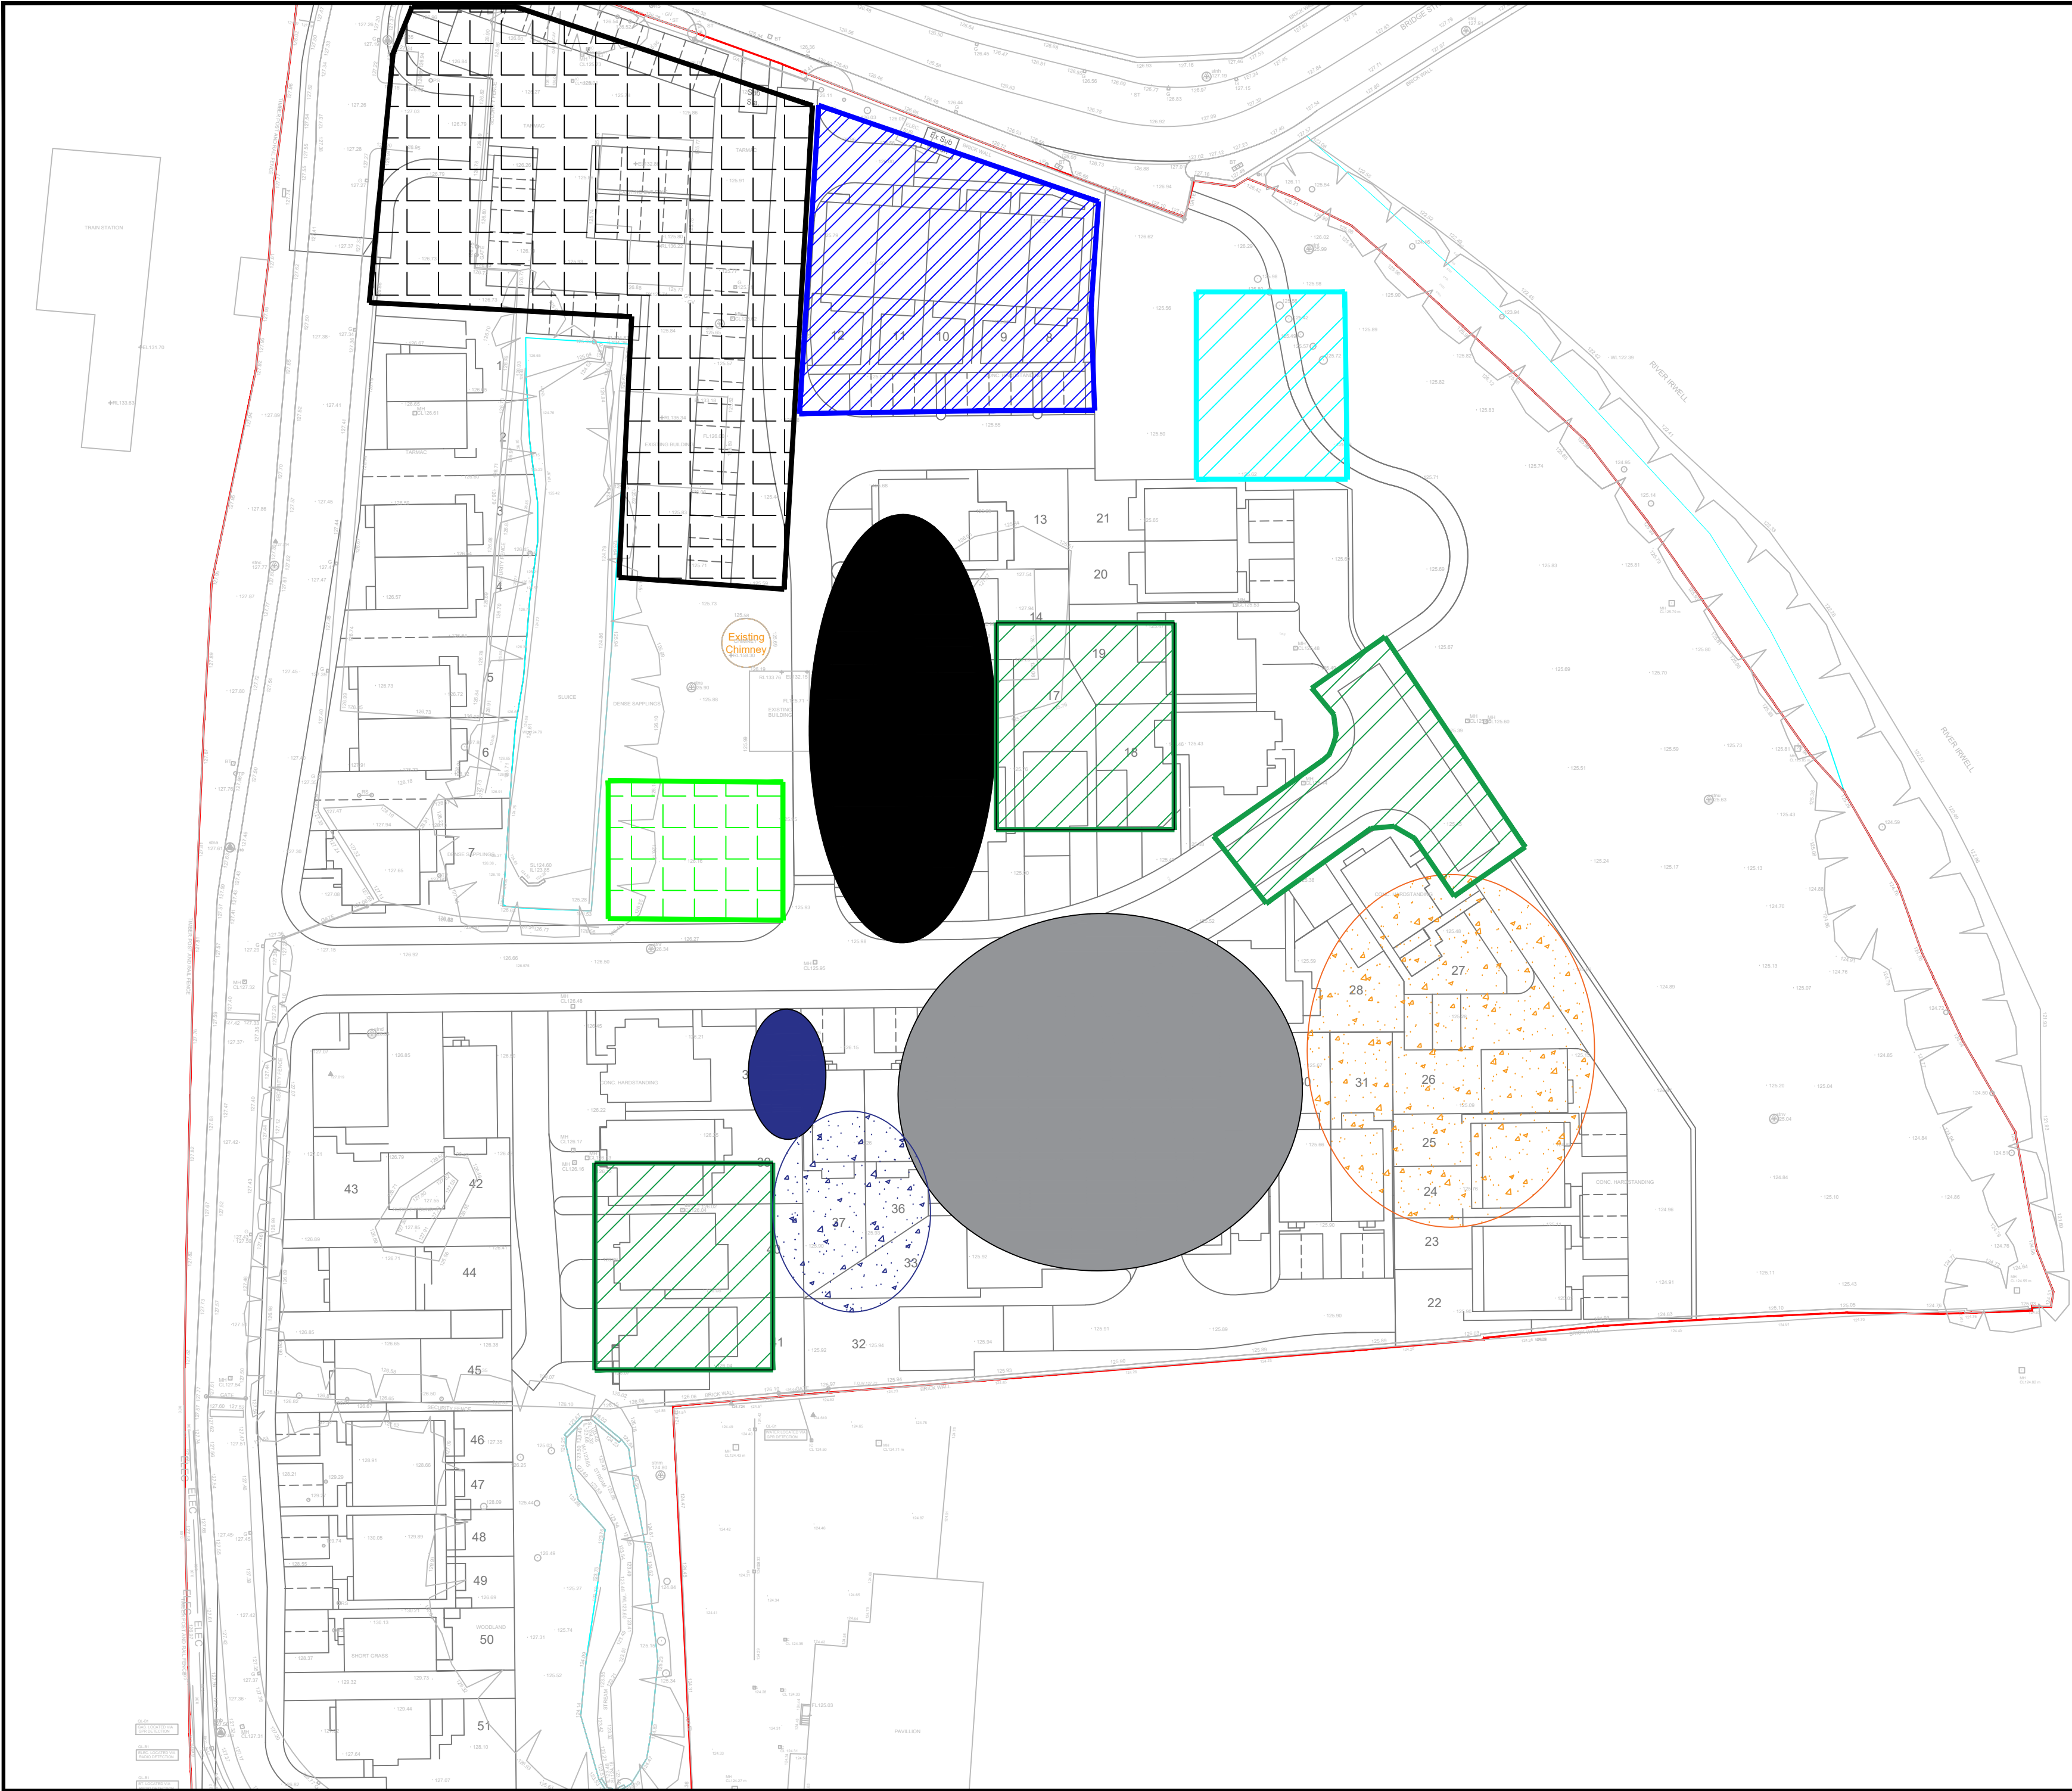
- 07:00 - 18:00 : 30t excav. (Rick) utilising hydraulic breaker to segregate remaining walls then clearing broken O/S hard from excavation of Hex. Tank, then commencing backfilling utilising screened fines from Hex. Tank infill material screened 08/04/25 compacted in 300mm layers with 13t roller. 13:30 - 17:00 loading 30t ADT with 6F2 from crush pile supplying Task 1. Also assisting Task 3 as required, maintaining, moving and clearing crusher.

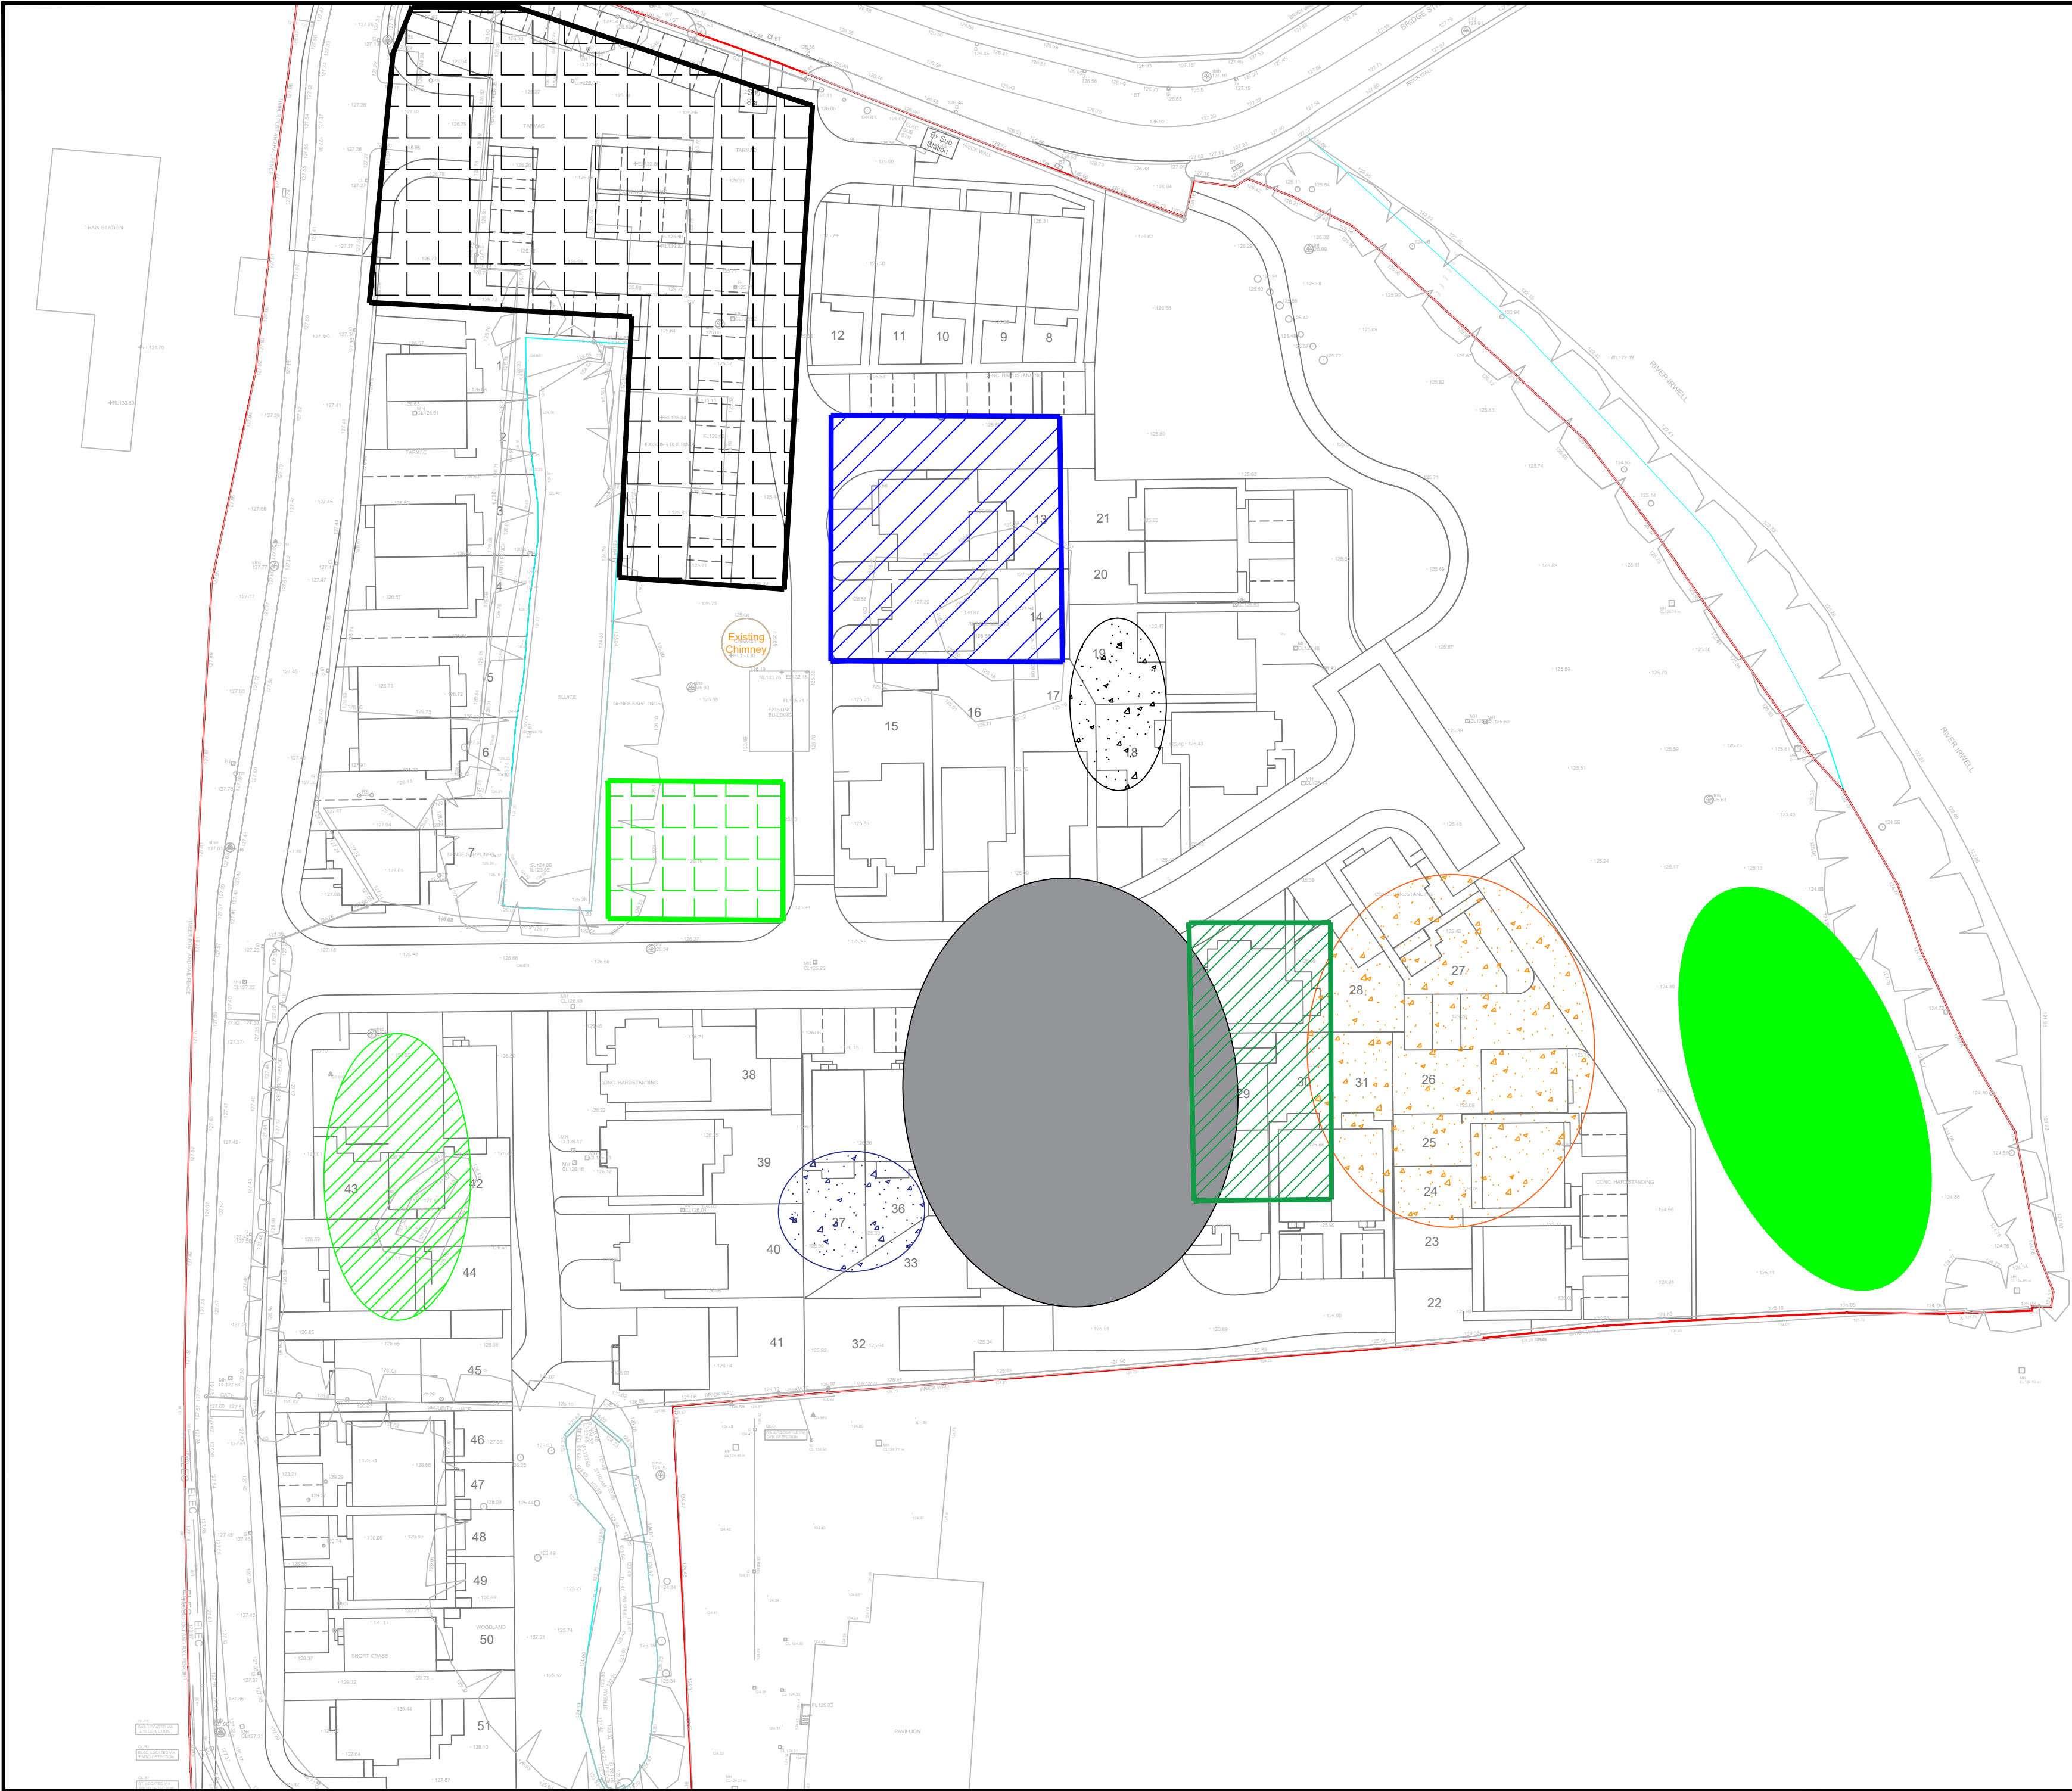
- Works Undertaken:**
- 07:00 - 18:00 : 2 no. 30t excav.'s ( Rick & Carl) utilising hydraulic breaker,pulveriser continuing with breaking remaining slabs below ground structures & foundations below former concrete base layer stock Piles 13-15, O/S hard loaded into 30t ADT & added to Clean concrete stock and undertaking processing at clean concrete stock to assist crushing operation as required.
