Client  
Eccleston Homes

Site  
Mondi - Mill,  
Ramsbottom , BL0 OBS.

Title  
MMP Daily Tracking Record  
21/03/25

| Dwg No. | MONDI-UR-V1-01-MMP-047 | | Rev<br>A |

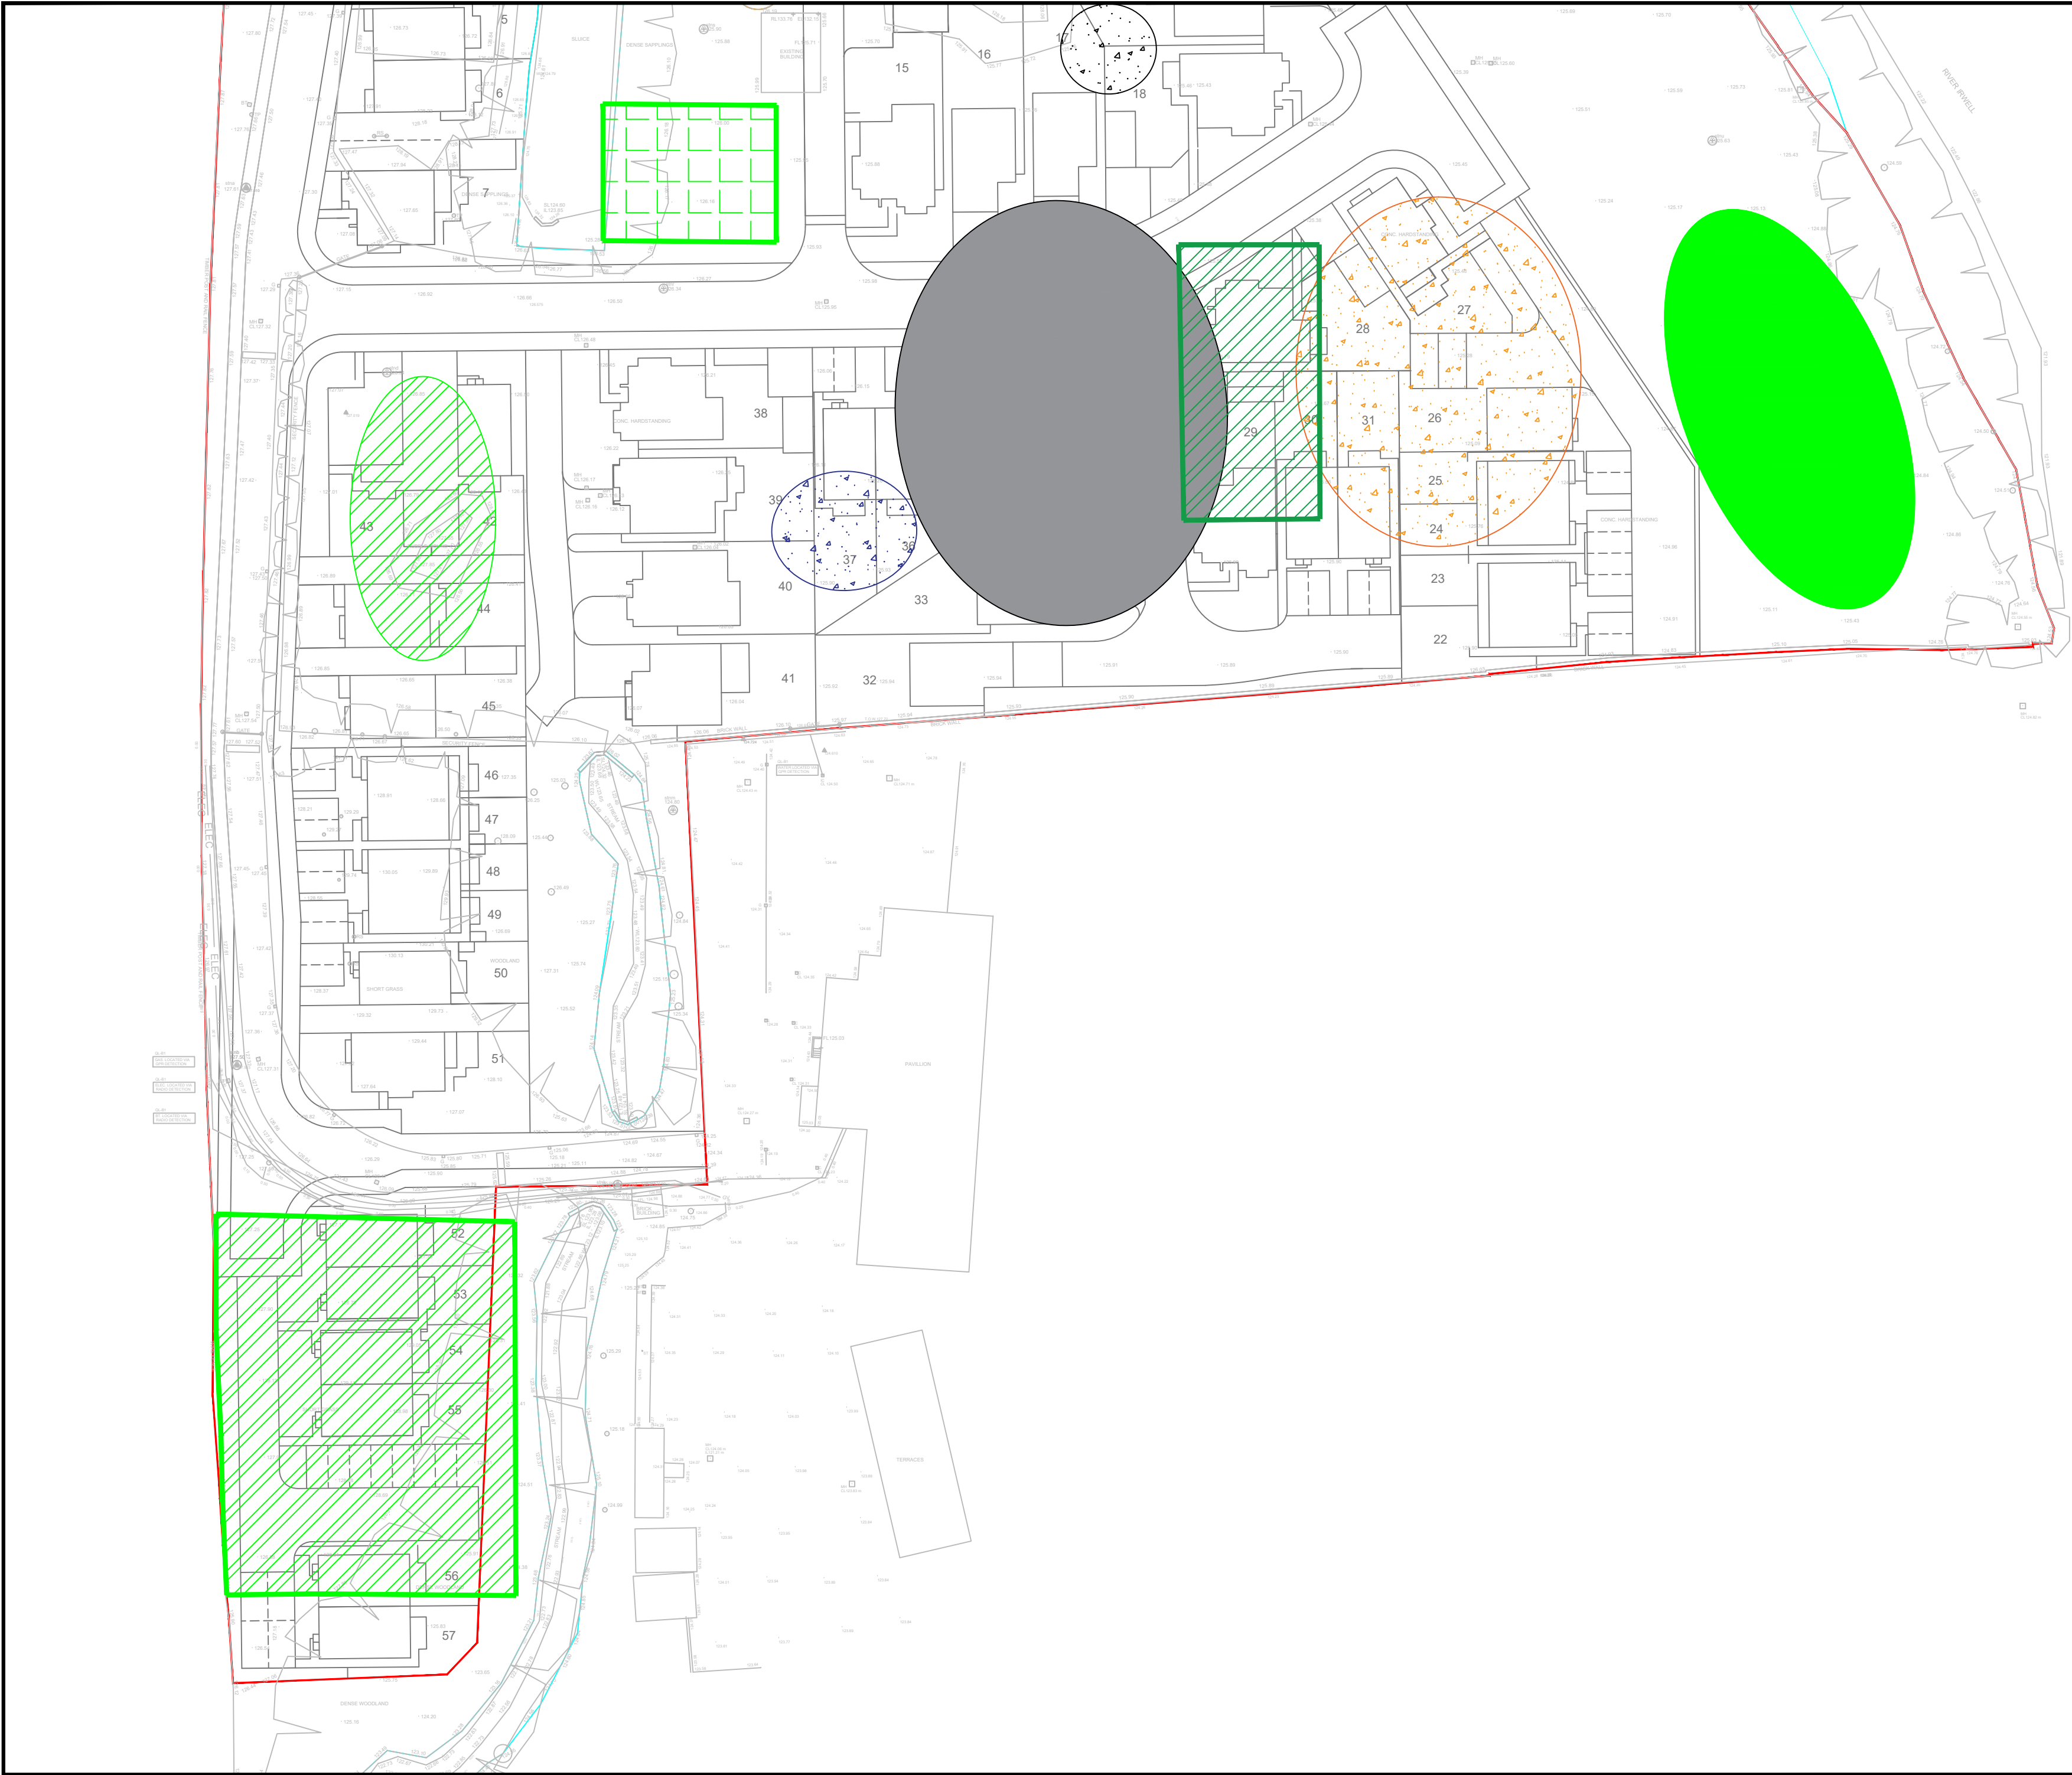
- Works Undertaken:**
- 07:00 - 18:00 : 2 no. 30t excav.'s ( Rick & Carl) utilising hydraulic breaker/pulveriser continuing with breaking remaining slabs/below ground structures & foundations below former concrete base layer stock Piles 13-15, O/S hard loaded into 30t ADT & added to Clean concrete stock and undertaking processing at clean concrete stock to assist crushing operation as required.

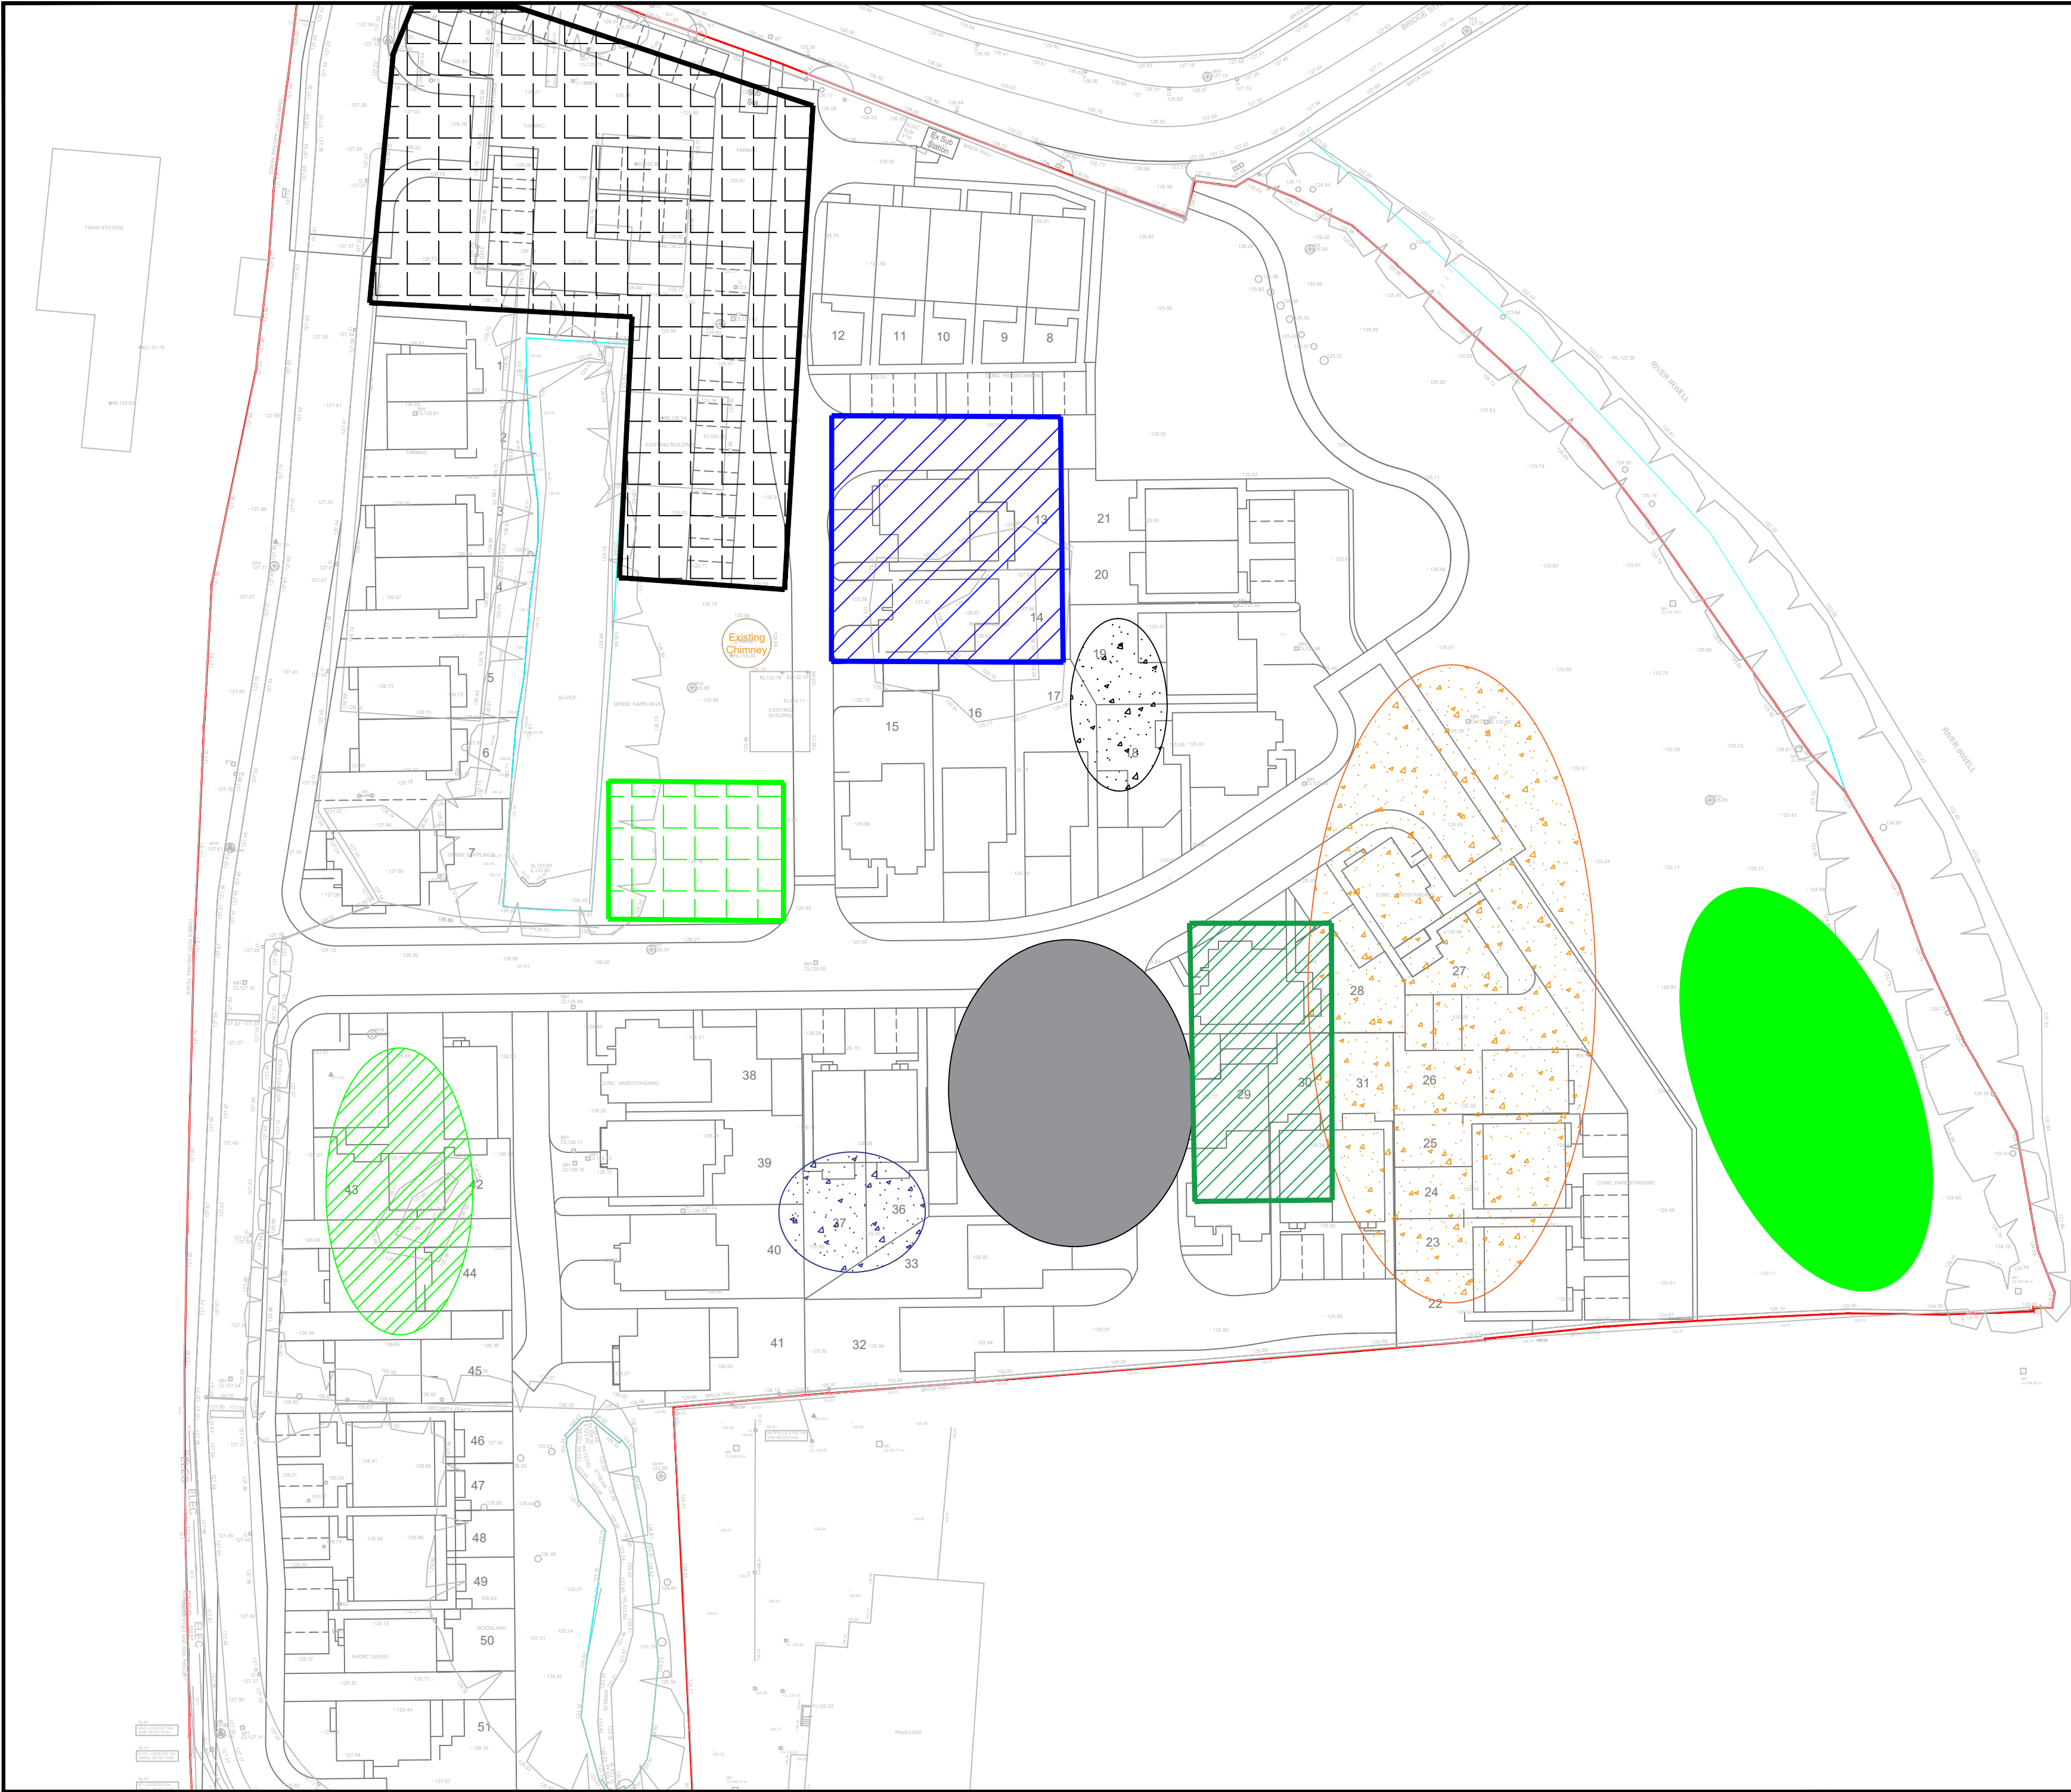
- 07:00 - 18:00 : 2 no. 30t excav.'s ( Rick & Carl) utilising hydraulic breaker/pulveriser continuing with breaking remaining slabs/below ground structures & foundations below former concrete base layer stock Piles 13-15. O/S hard loaded into 30t ADT & added to Clean concrete stock and undertaking processing at clean concrete stock to assist crushing operation as required.

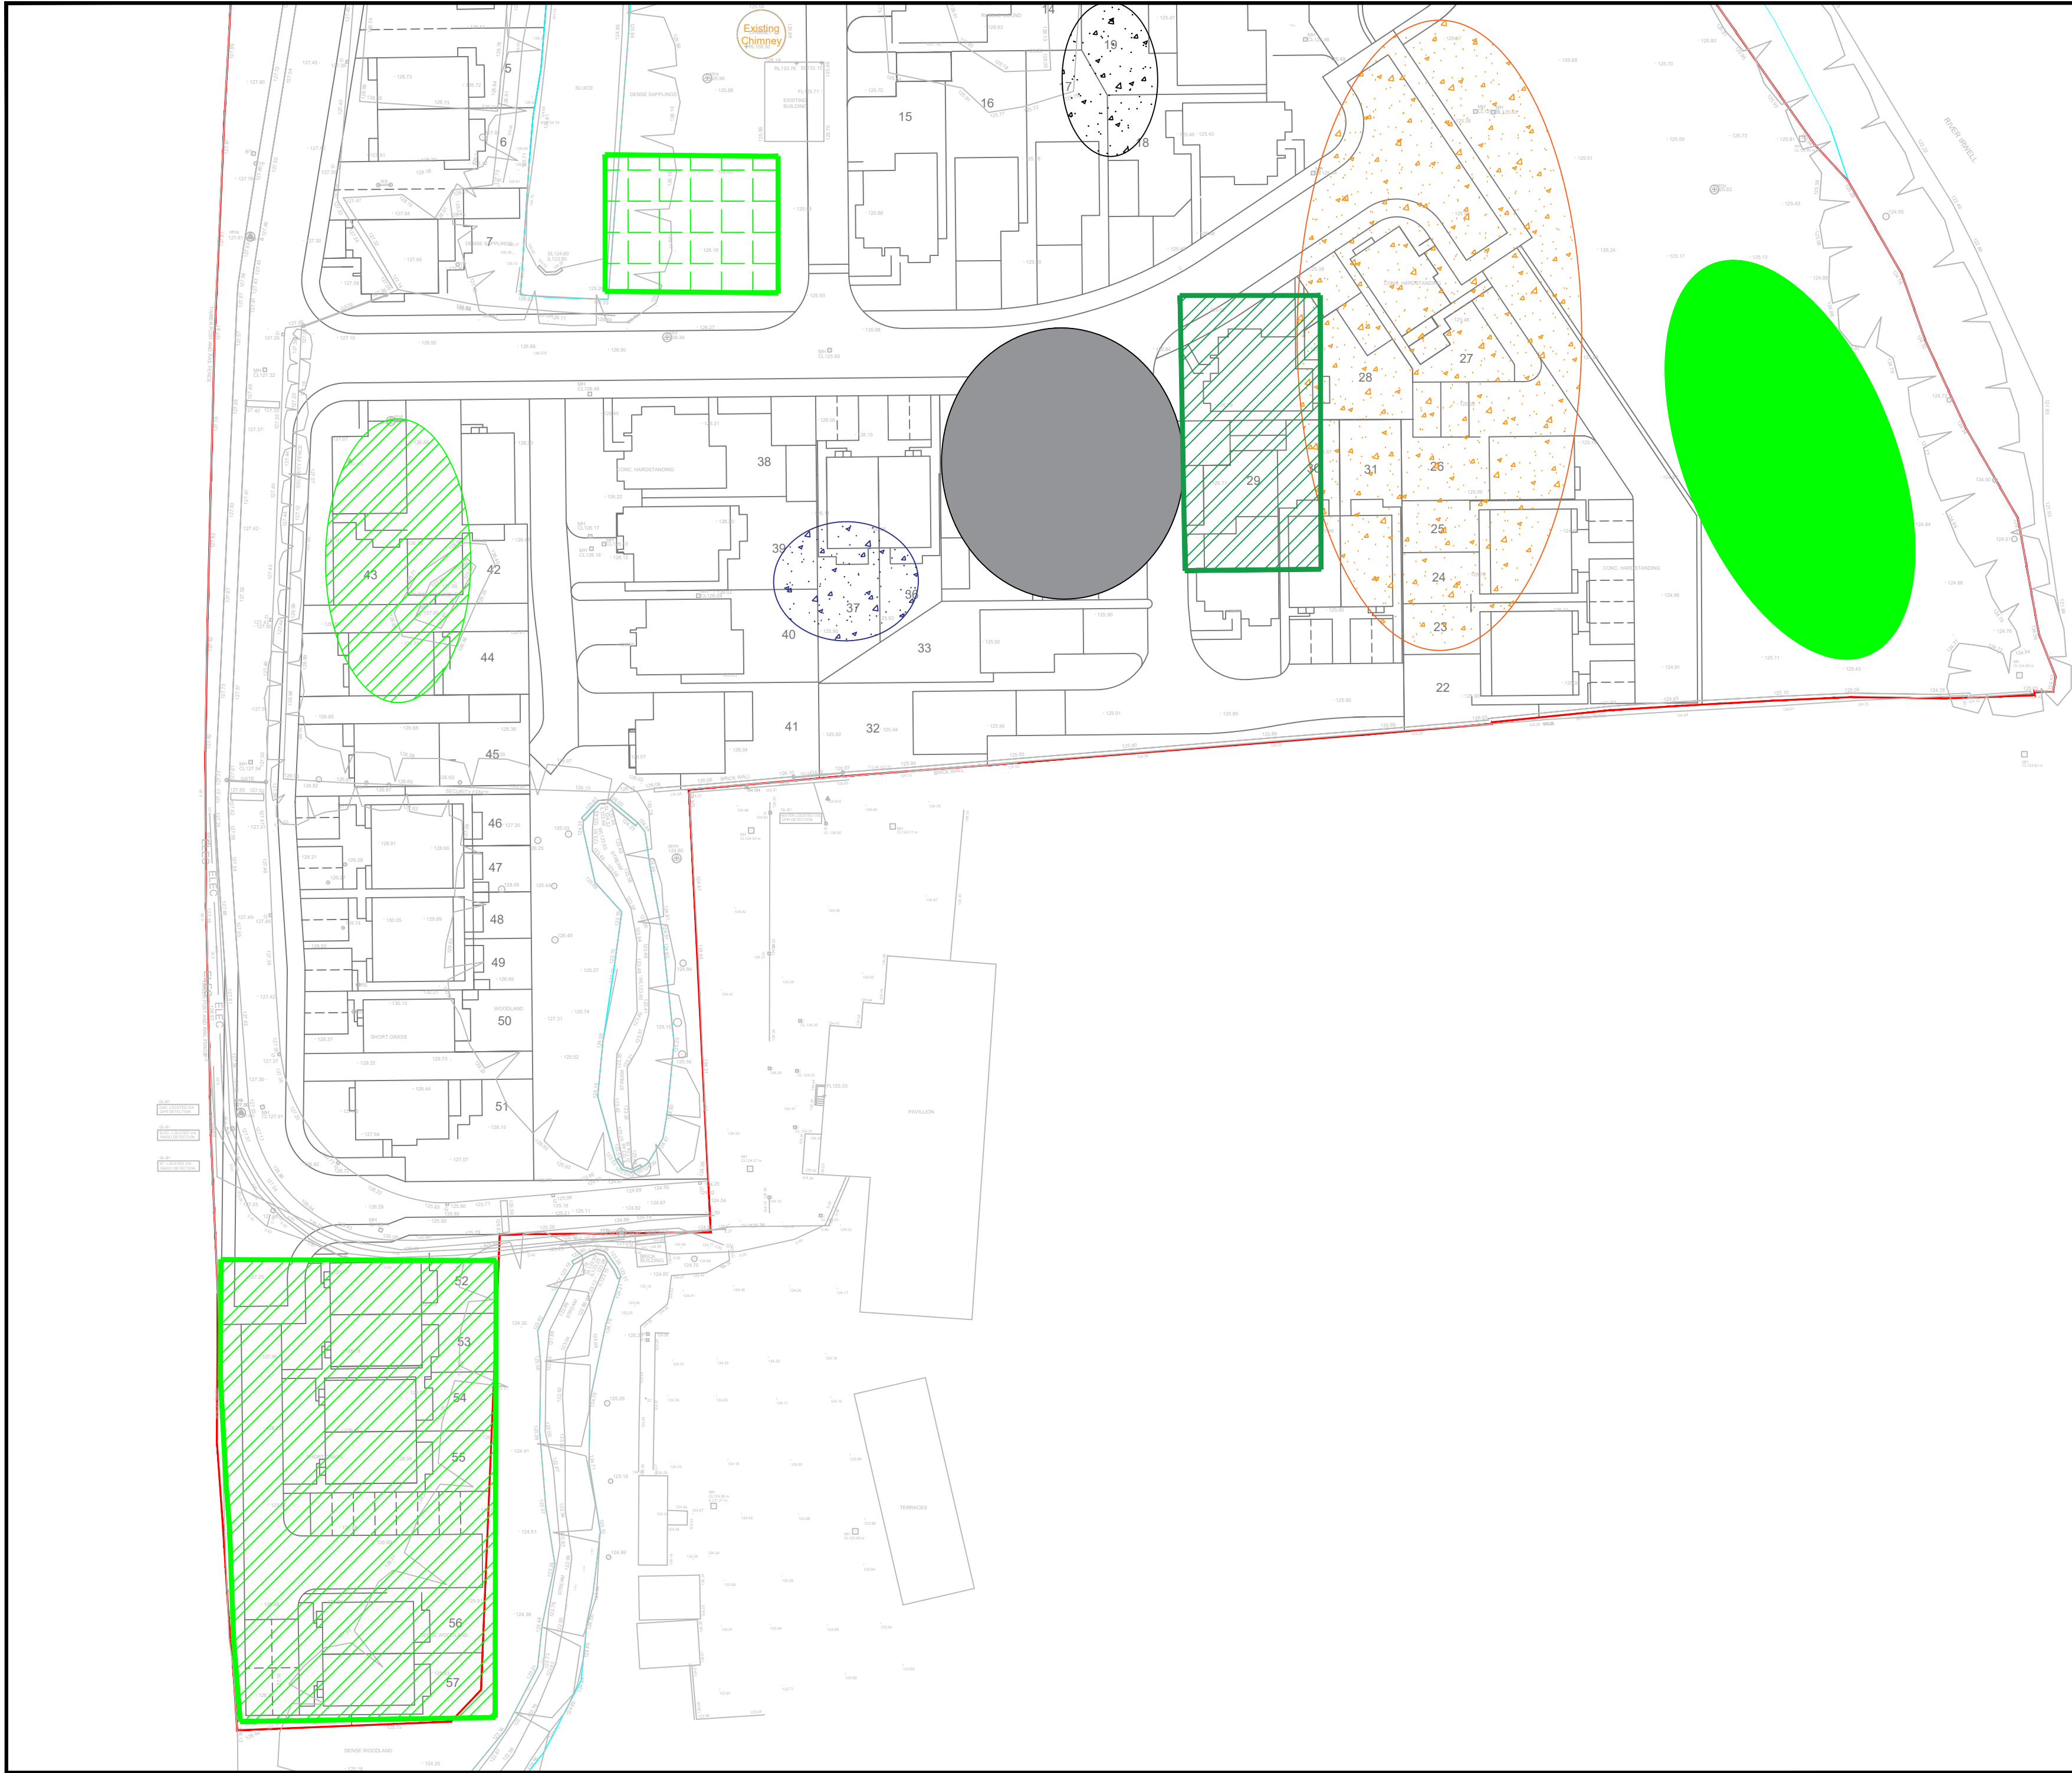
- Works Undertaken:**
- 07:00 - 18:00 : 2 no. 30t excav. 's ( Rick & Carl) utilising hydraulic breaker/pulveriser continuing with breaking remaining slabs below ground structures & foundations below former concrete base layer stock Piles 13-15. O/S hard loaded into 30t ADT & added to Clean concrete 2 stock and undertaking processing at clean concrete stock 2 to assist crushing operation as required.

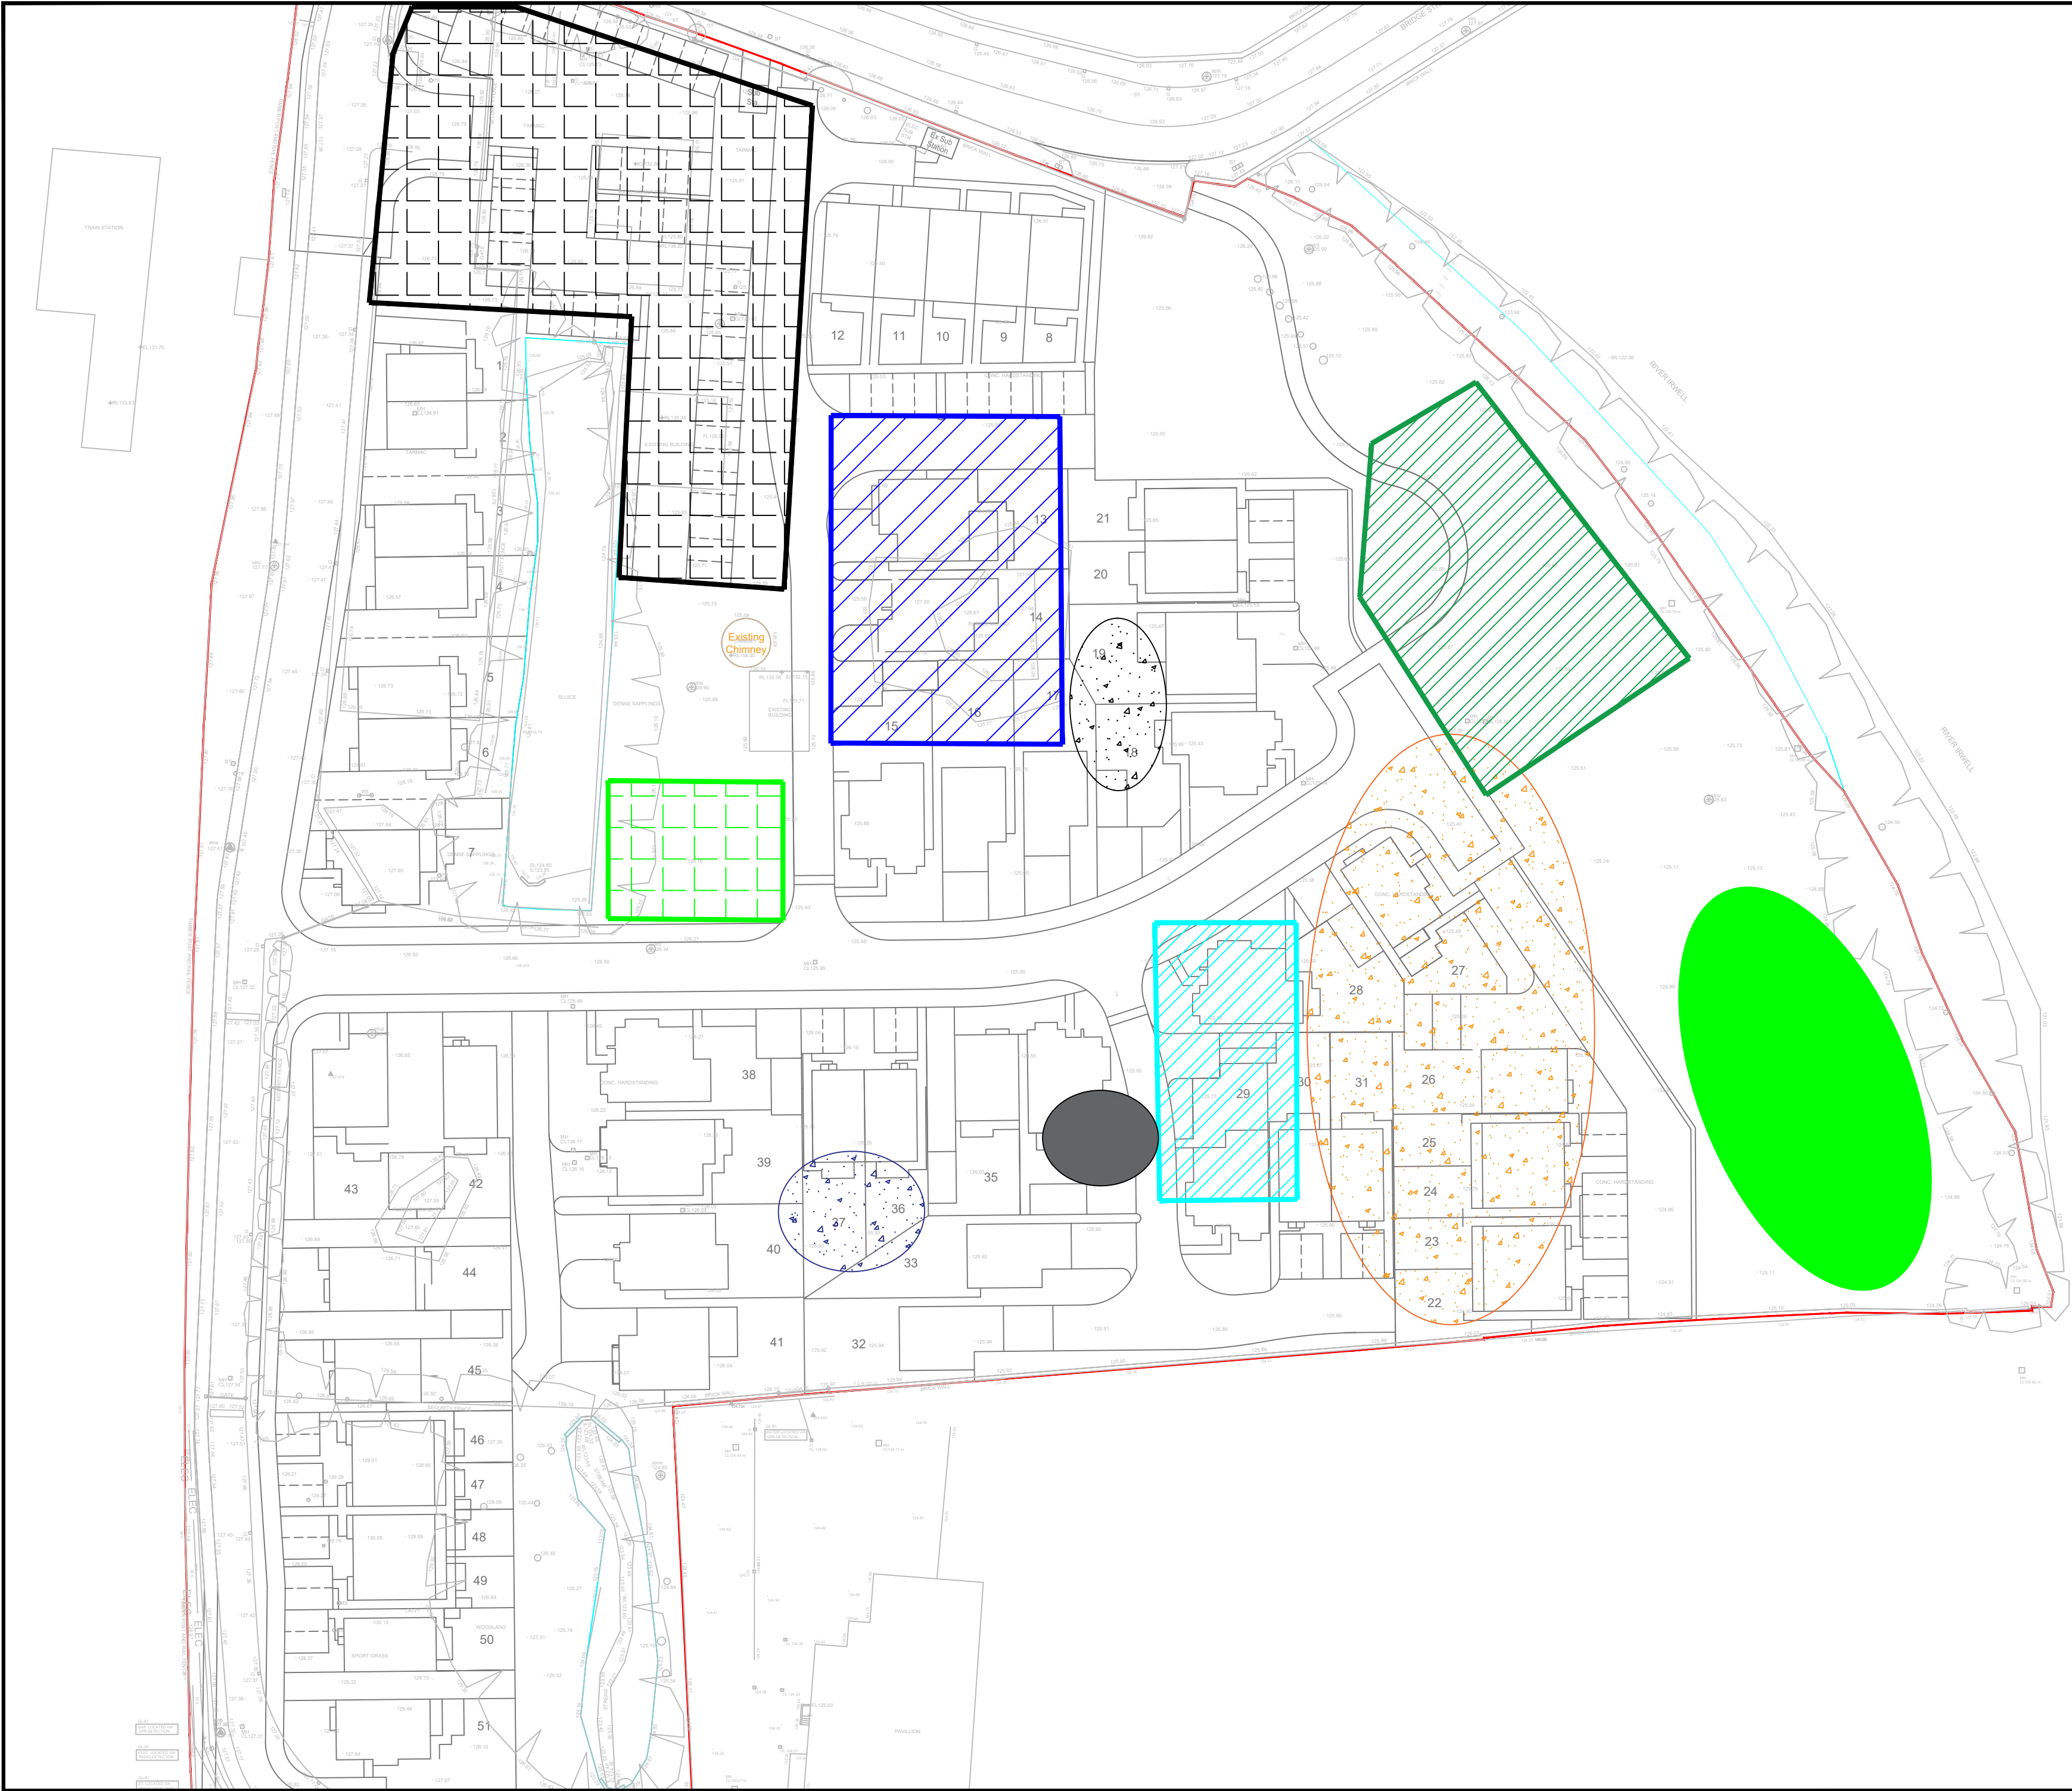
- Works Undertaken:**
- 07:00 - 18:00 : 2 no. 30t excav. 's ( Rick & Carl) utilising hydraulic breaker/pulveriser continuing with breaking remaining slabs/below ground structures & foundations below former concrete base layer stock Piles 13-15, ground turned to 3.0 m from E.W.O removing approx 80 no. R.C piles from below former transformer house. O/S hard loaded into 30t ADT & added to Clean concrete 2 stock.

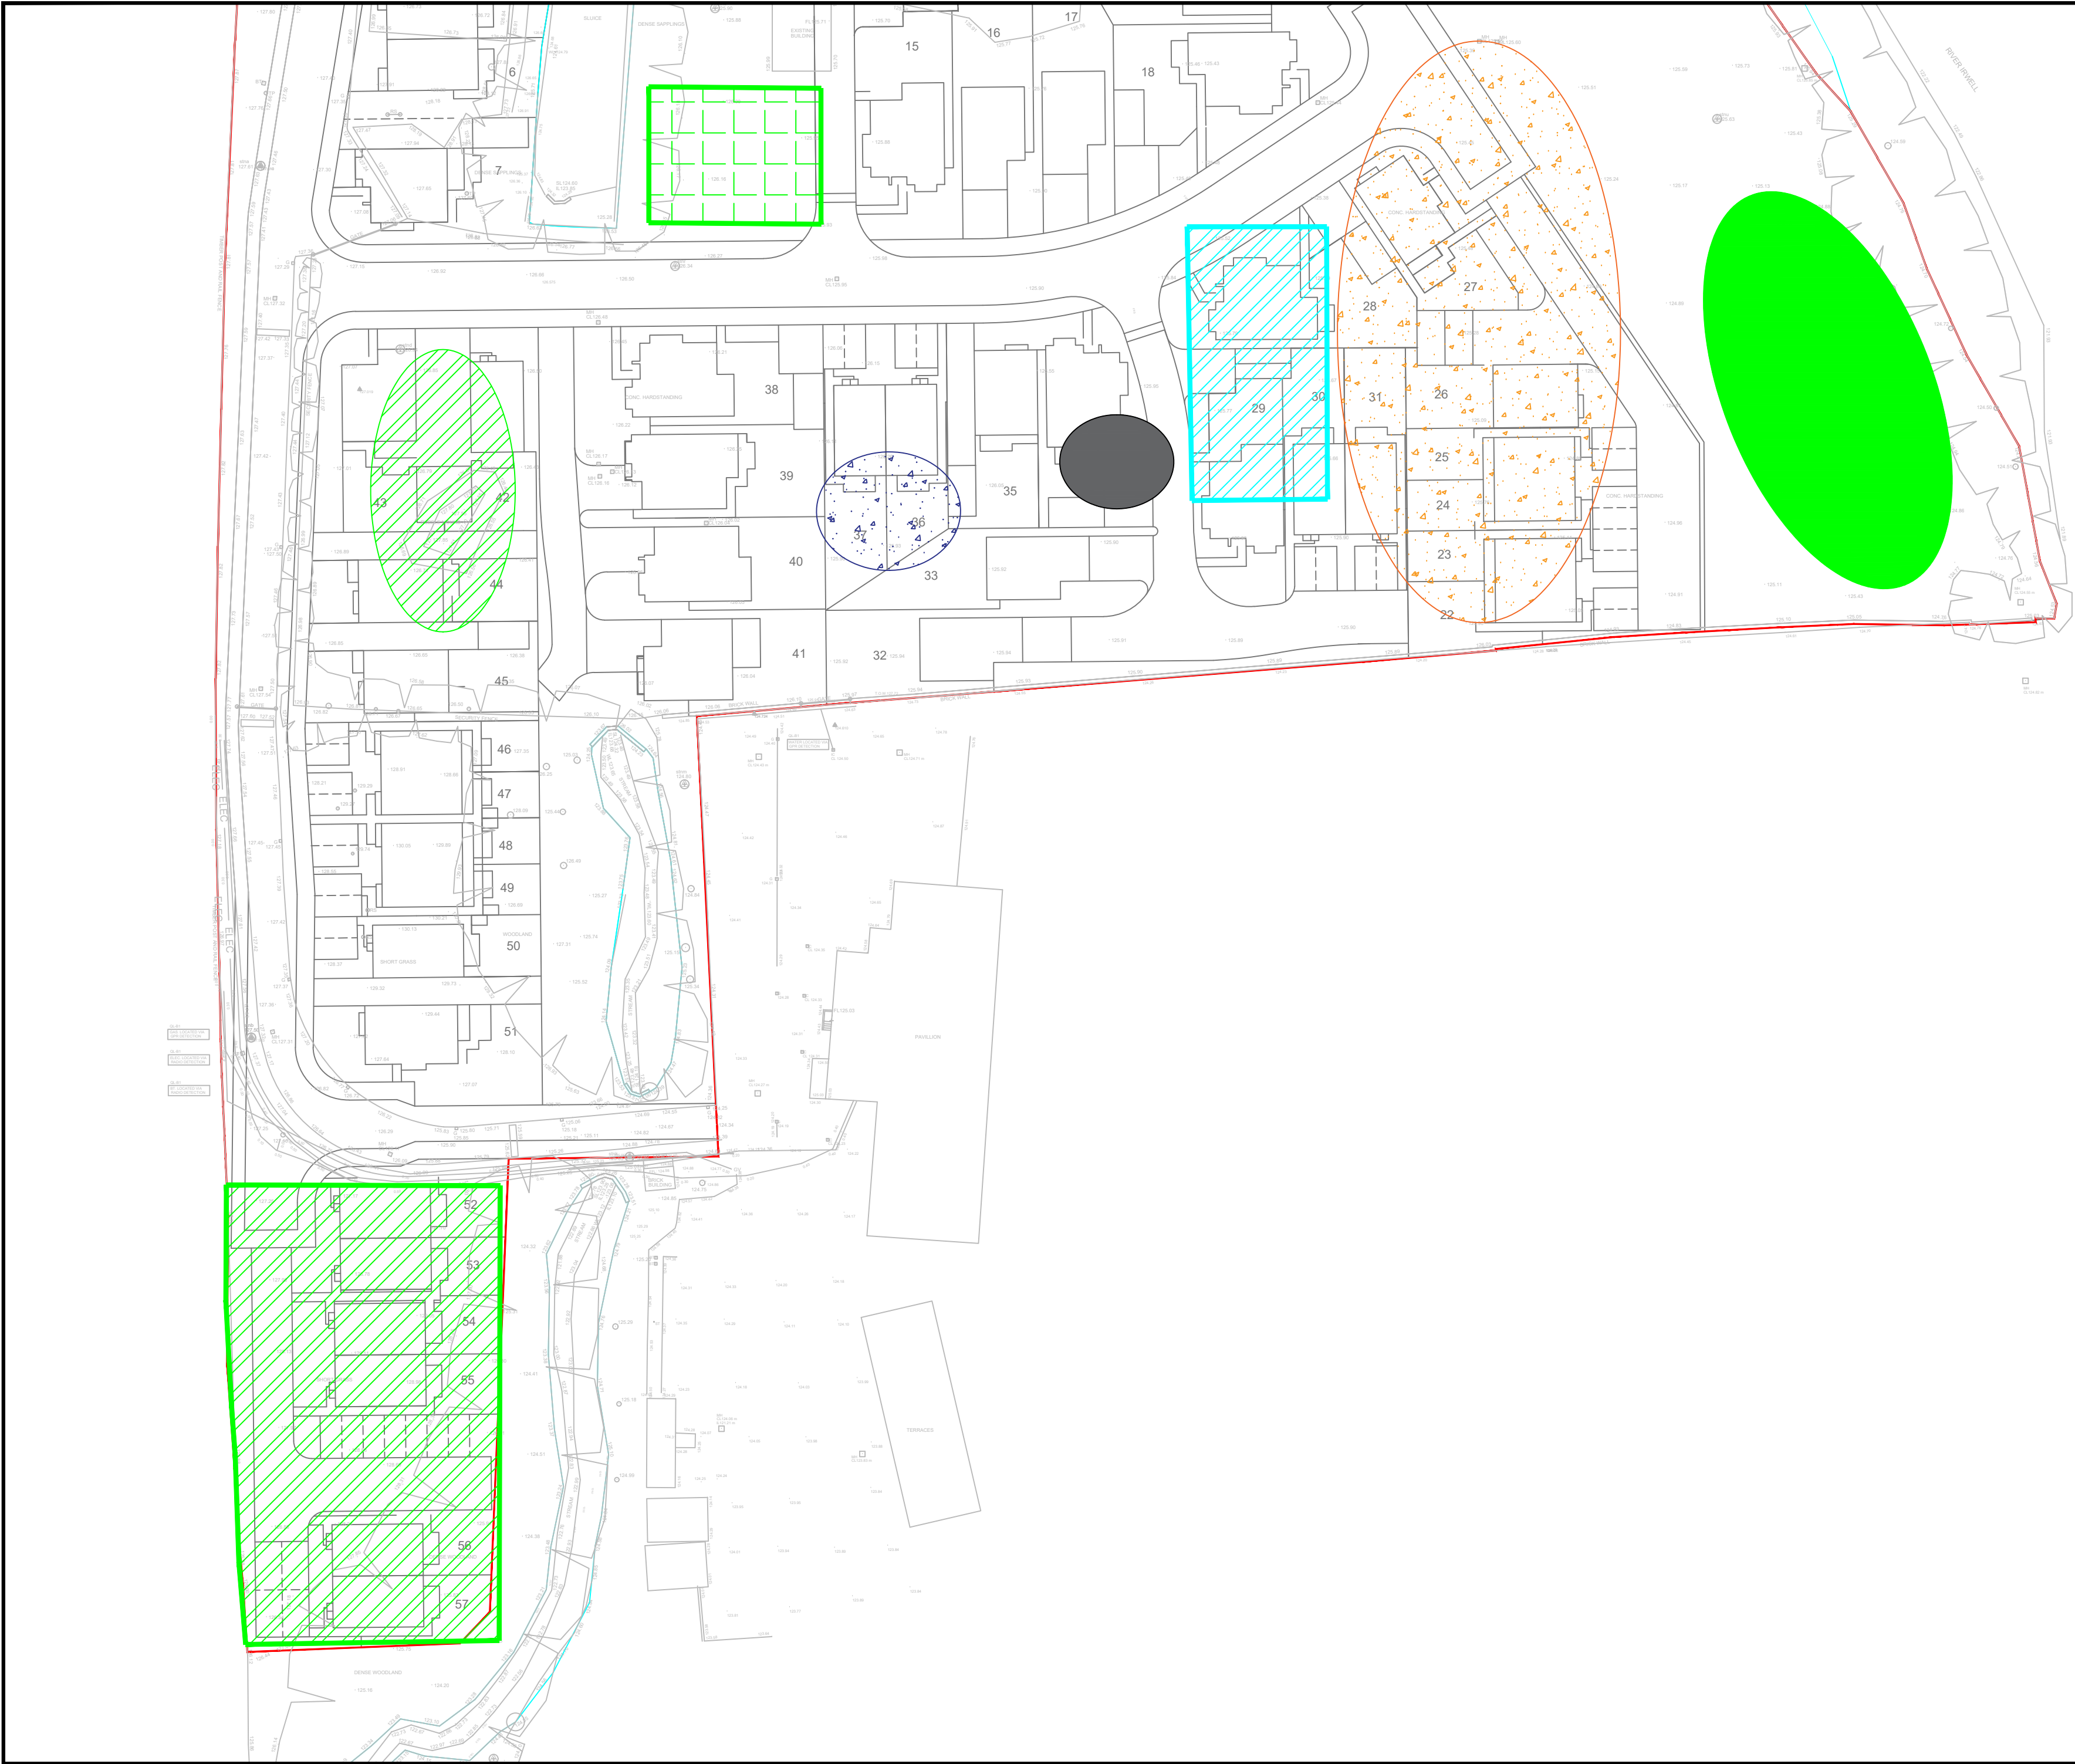
- Works Undertaken:**
- 07:00 - 18:00 : 2 no. 30t excav. 's ( Rick & Carl) utilising hydraulic breaker/pulveriser continuing with breaking remaining slabs below ground structures & foundations below former concrete base layer stock Piles 13-15, ground turned to 3.0 m from E.W.O removing approx 80 no. R.C piles from below former transformer house. O/S hard loaded into 30t ADT & added to Clean concrete 2 stock.

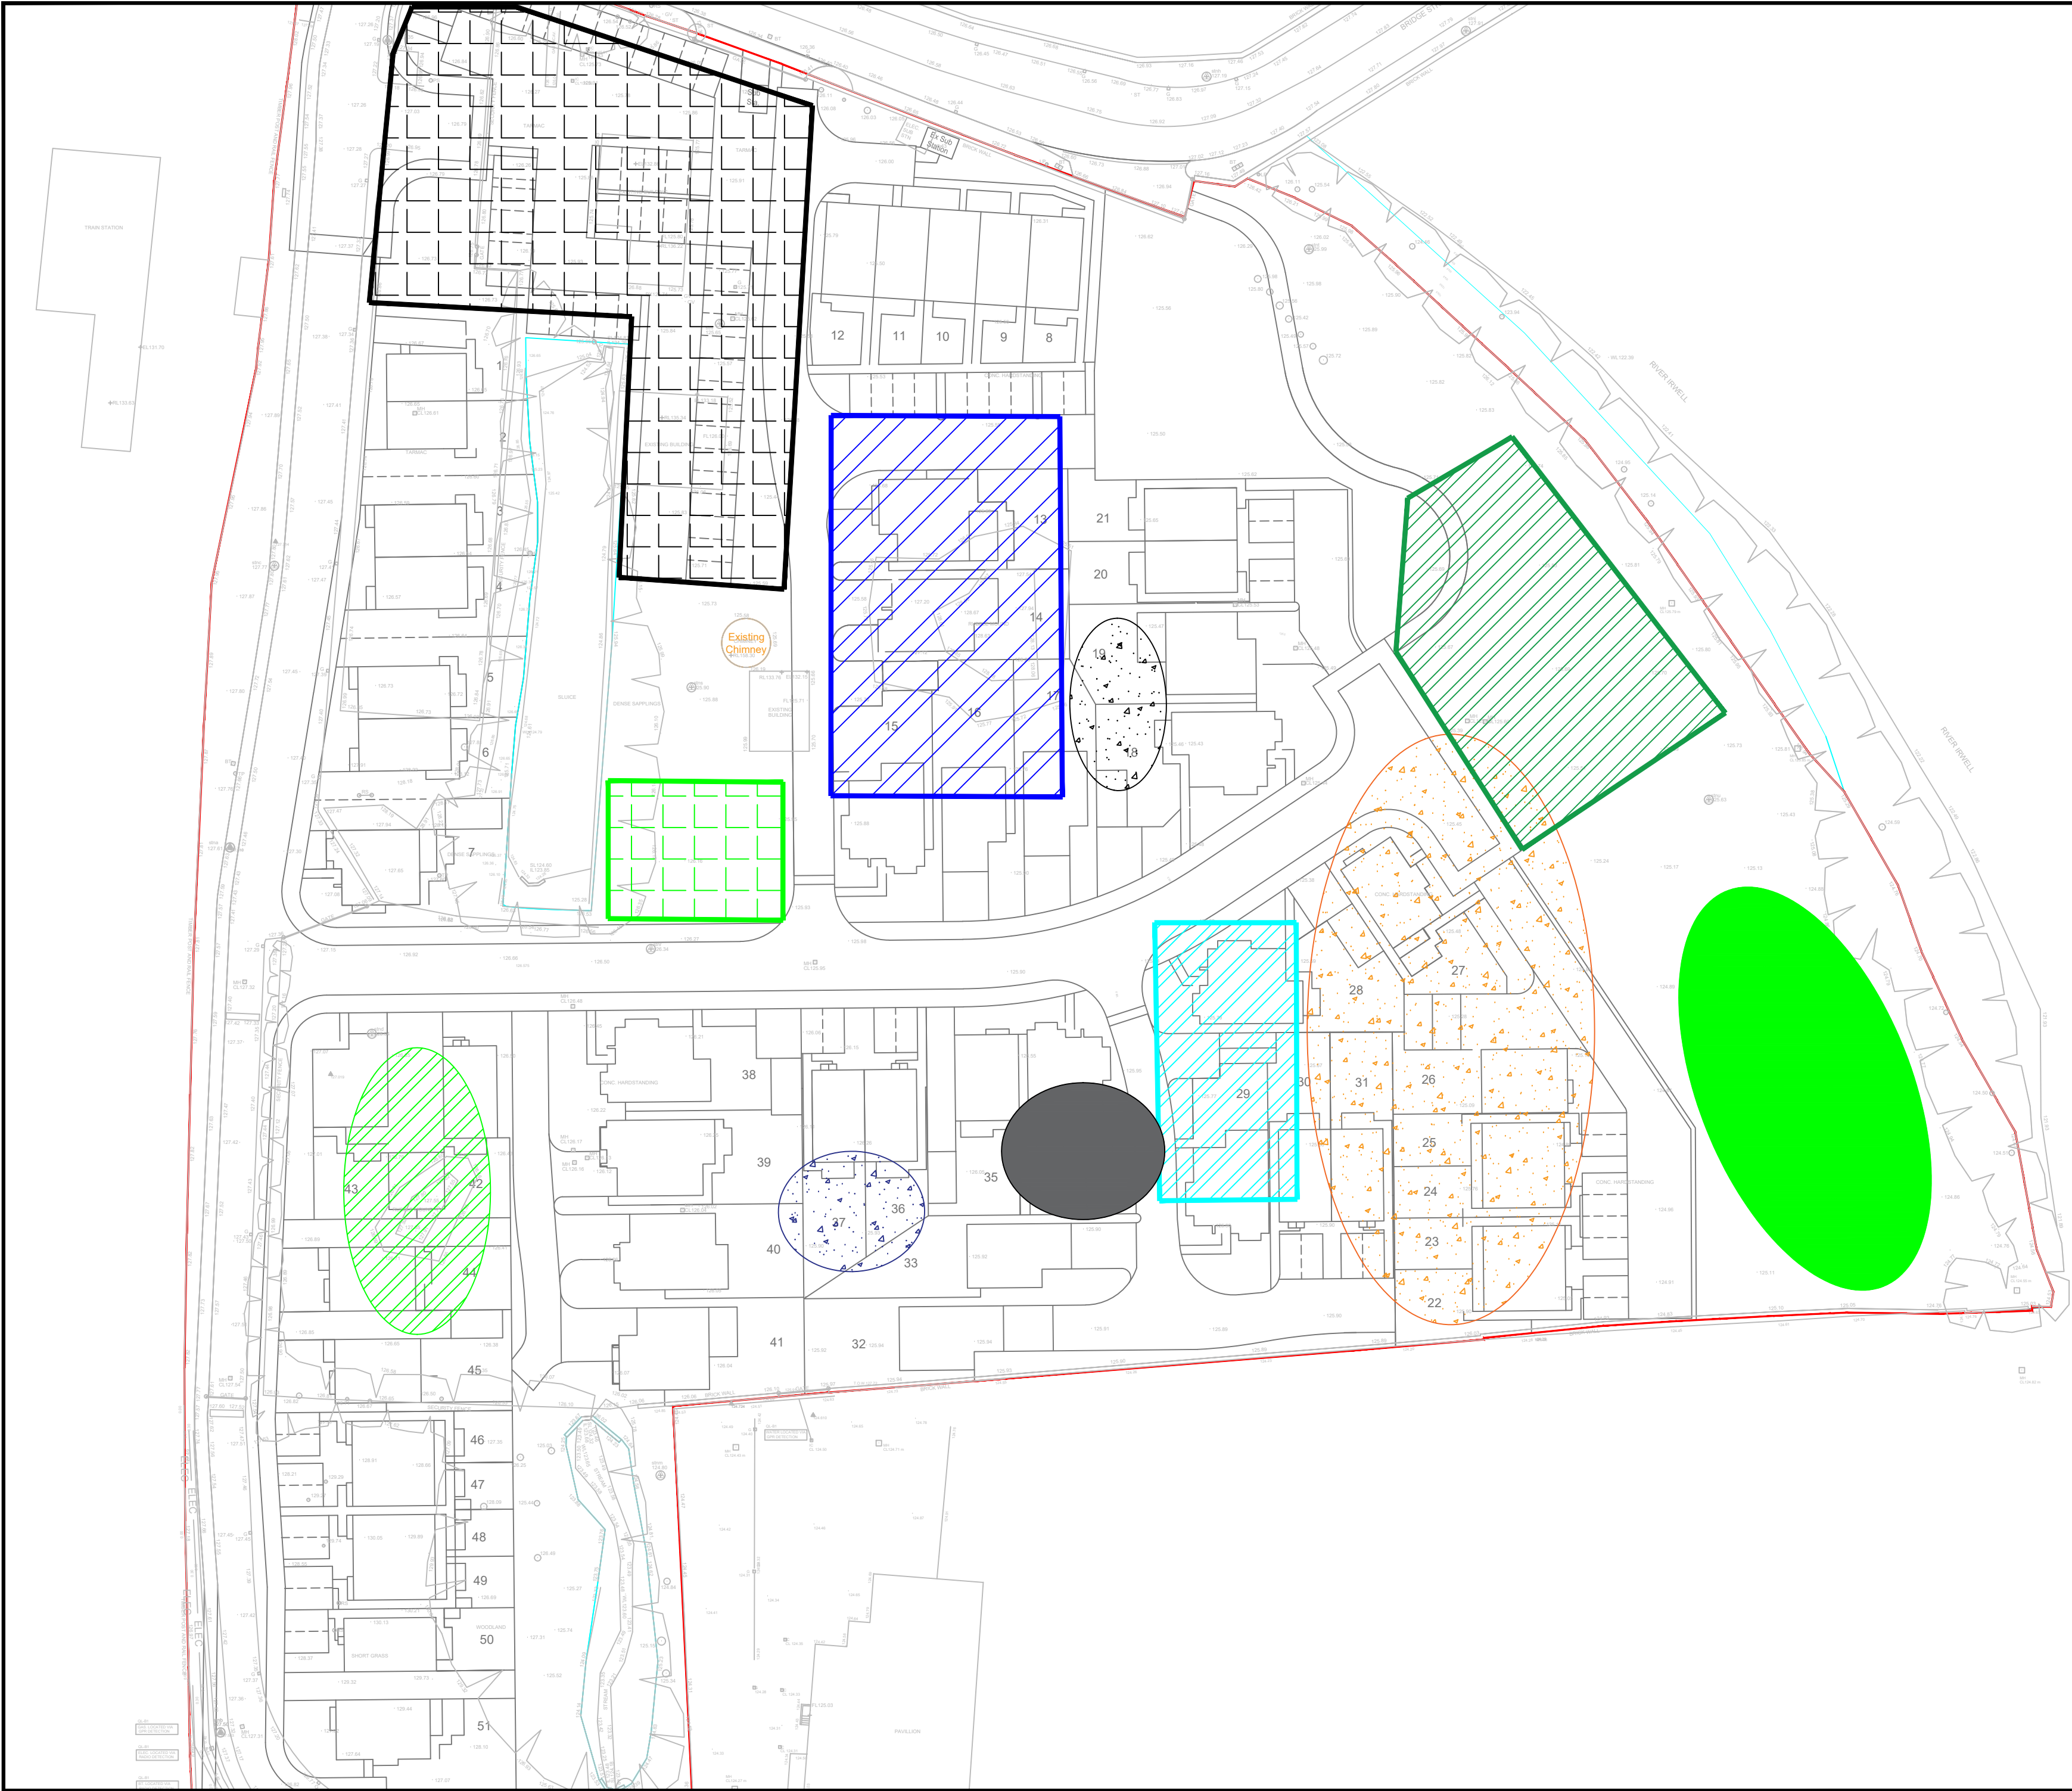
- Works Undertaken:**
- 07:00 - 18:00 : 2 no. 30t excav.'s ( Rick & Carl) utilising hydraulic breaker/pulveriser continuing with breaking remaining slabs below ground structures & foundations below former concrete base layer stock Piles 14 to road 2 working North to south, made ground removed and stockpiled at northern end in preparation of screening due to commence 28/04/25 & allow turnover to be undertaken 25/04/25 to EGL -3.0m. O/S hard breakout hauled to concrete processing in task 3.
