Client  
Eccleston Homes

Site  
Mondi - Mill,  
Ramsbottom , BL0 OBS.

Title  
MMP Daily Tracking Record  
21/03/25

| Dwg No. | MONDI-UR-V1-01-MMP-047 | | Rev<br>A |

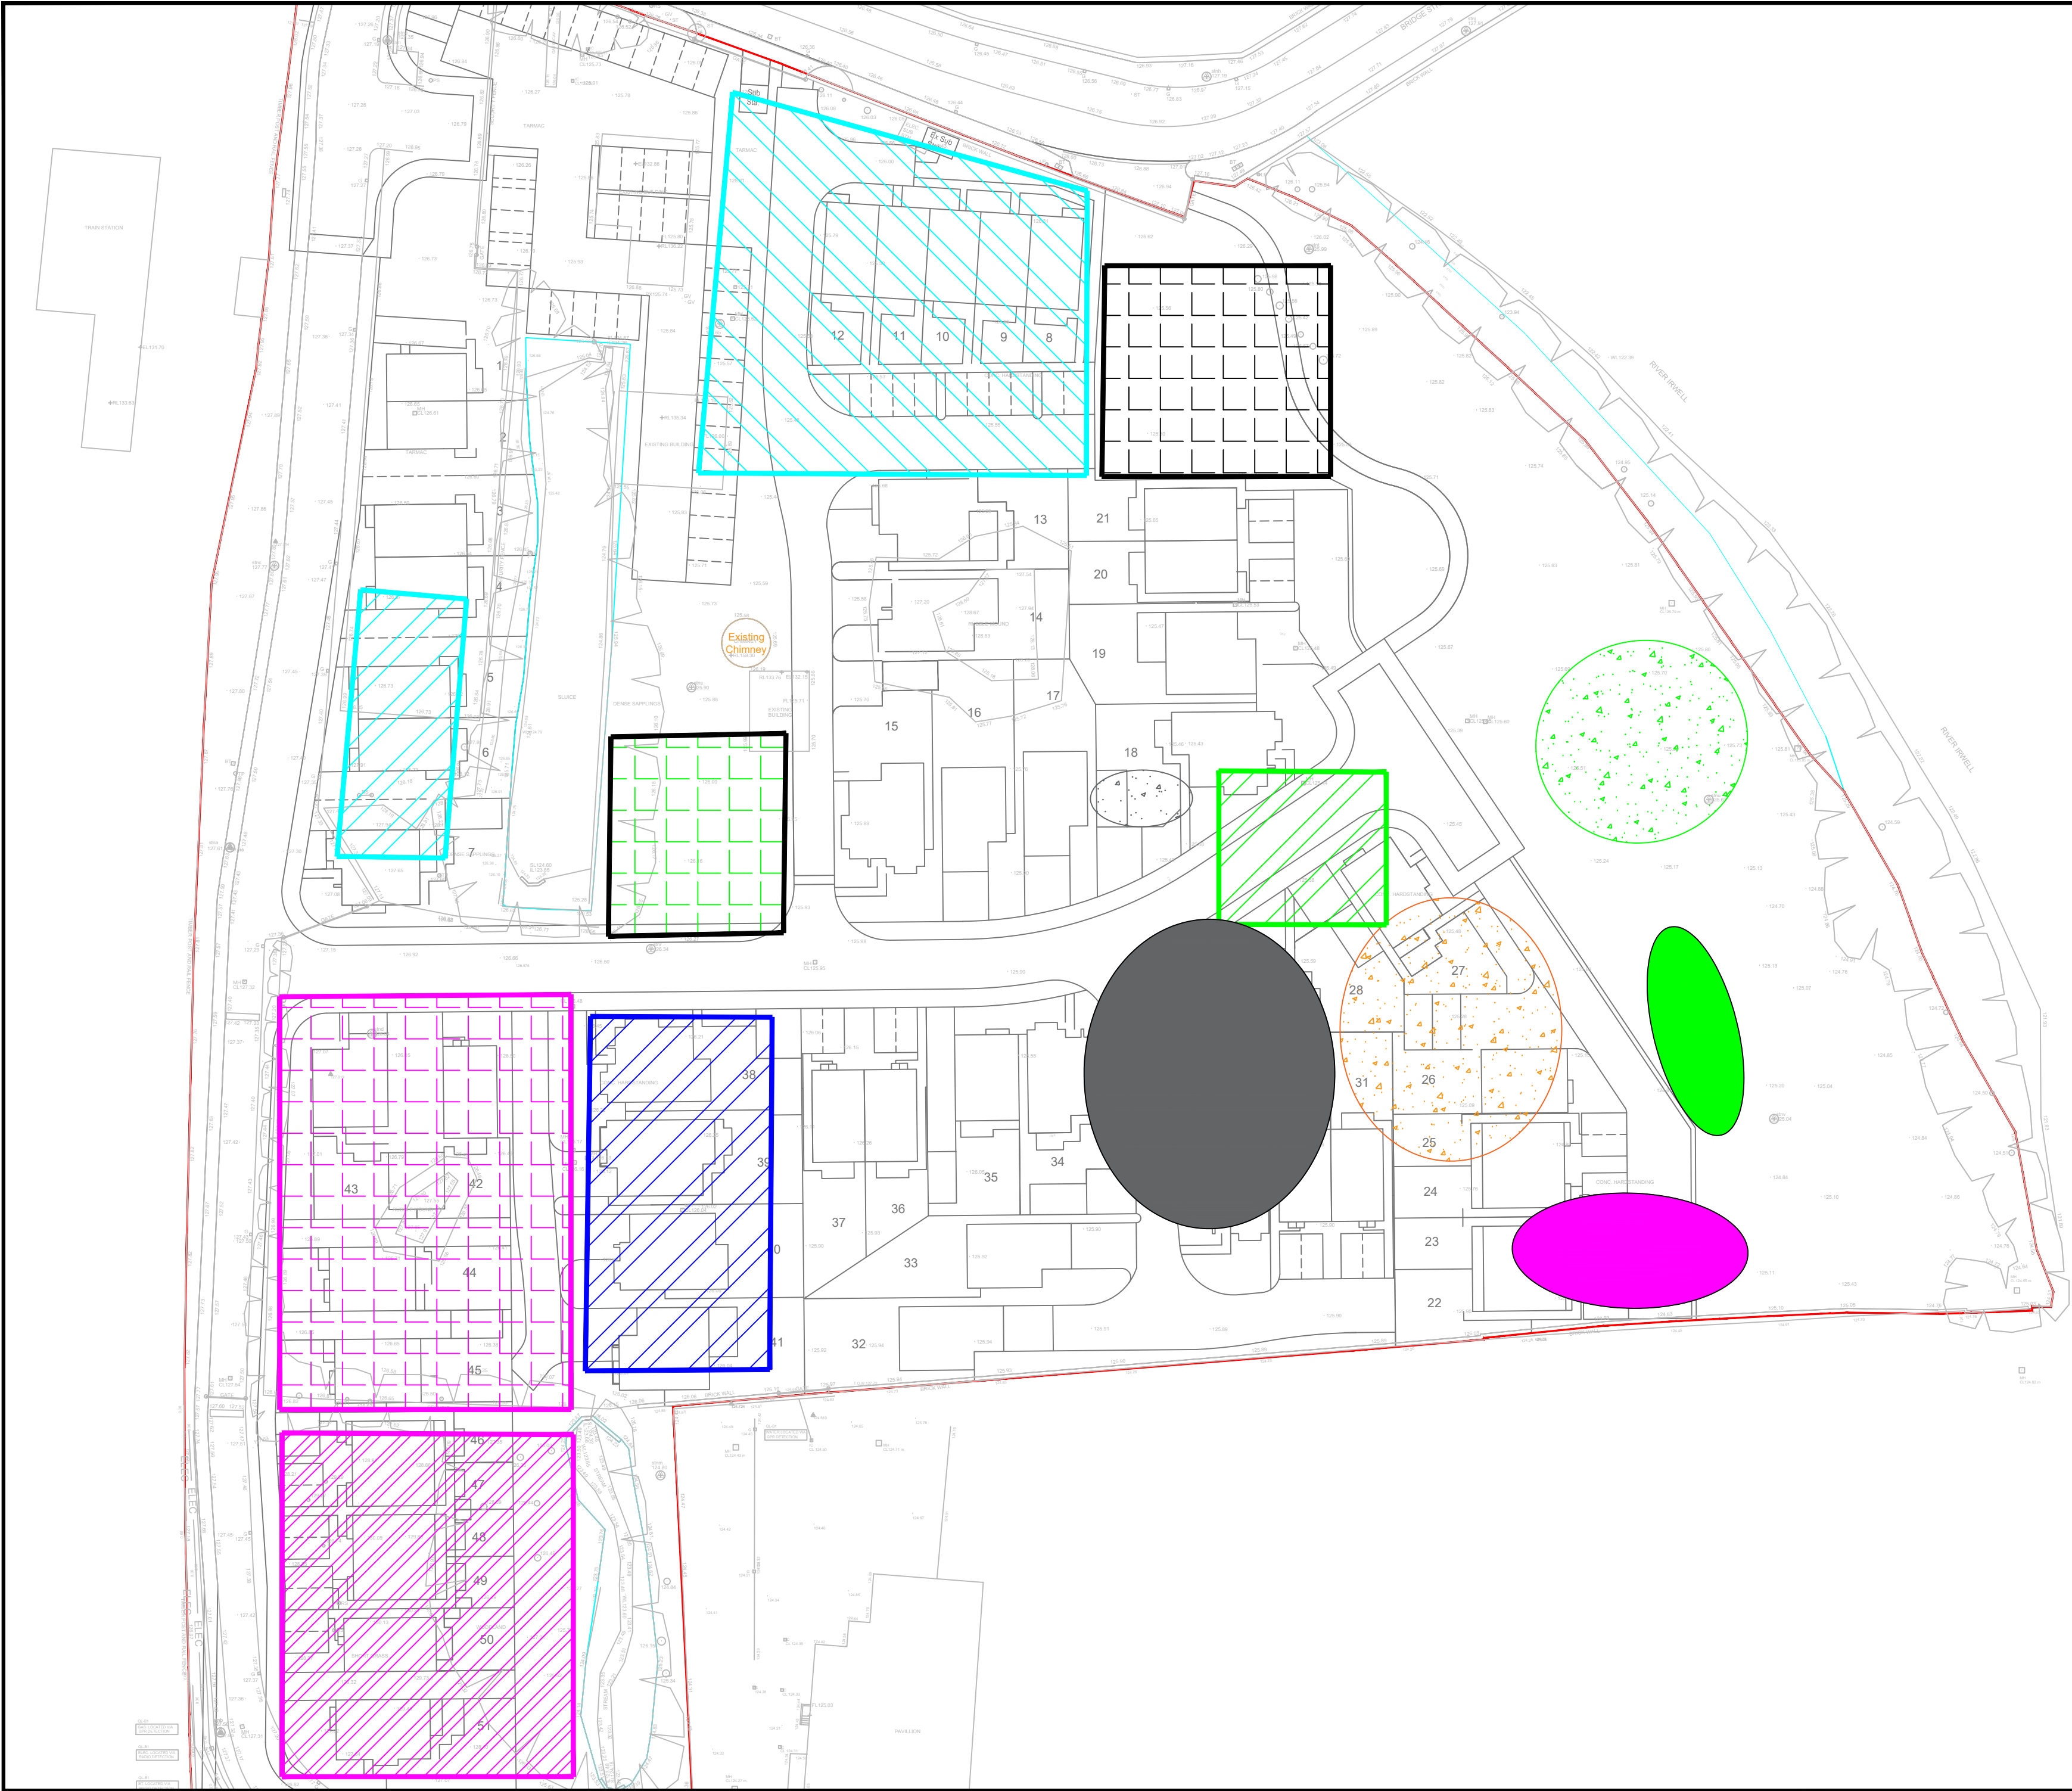
- 07:00 - 18:00 : 20t excav. ( Dan) loading premiertrak 400 crusher ( Casey's) with O/S hard from stock processing 6/2, 2/2 excav. ( Dan-UR Civils) maintaining stock & loading 30t ADT as required. Shims changed in crusher back to 6/2 as causing slow production. Crusher stood 08:00 - 13:00 having bearings replaced on main belt. 20t excav. operated undertaking stock maintenance and exposing larger O/S hard that requires processing (undertaken in task 1).
