**Woodbury South Building, Bury College,  
Market Street, Bury, BL9 0BG**

**Bats: Building Assessment and Activity Survey**

**Ref: SE/GTHQ002/01**

**May 2023**

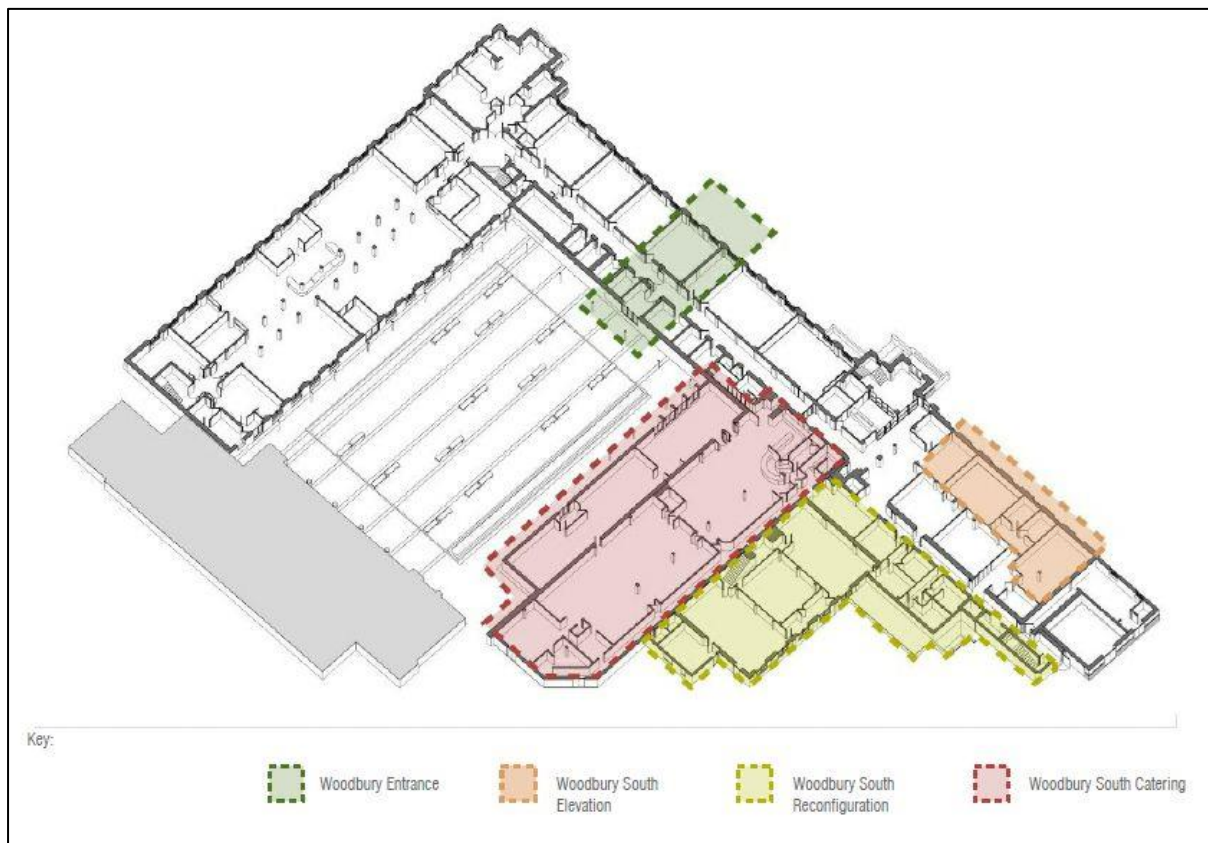
Plan 3: Proposed Works Areas.

- 1.3.2 The surveys described in this report were commissioned to inform a planning application to demolish a small collection of buildings and enclosures in the south west corner of the site and reconfiguration of the existing internal space (see Plan 3).

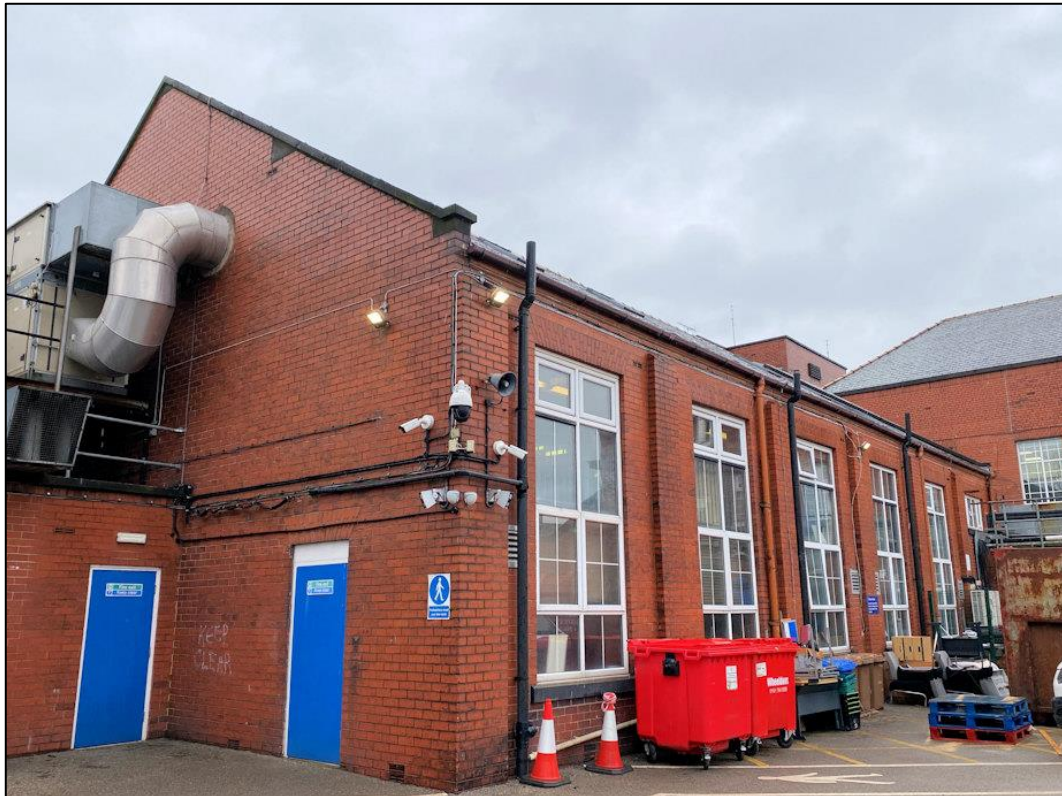
- 3.1.1 The target buildings (see Plate 2) comprised a collection of buildings and ancillary enclosures. The main building was of red brick with a pitched, slate-tiled roof and areas of flat roof with external plant. The building was in use at the time of the Preliminary Roost Assessment and was found to be in generally satisfactory condition and maintained throughout.

*Plate 2: General view of the target building from the South.*

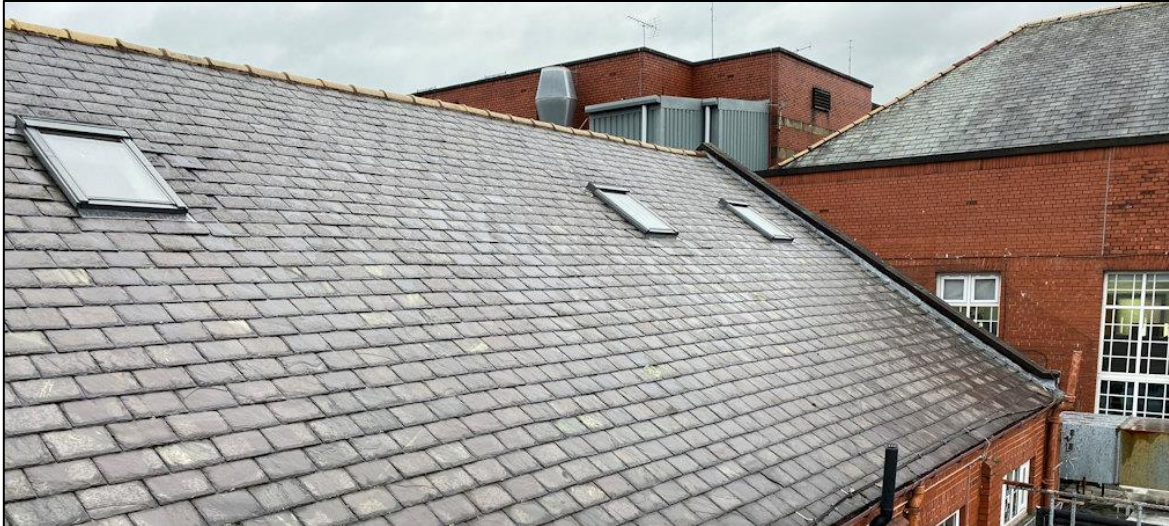
- 3.1.3 The pitched roof was generally in satisfactory condition (see Plate 3) although there were Potential Roost Features (PRFs) noted with gaps in the mortar beneath the ridge tiles (see Plate 4).
- 3.1.4 The flat slates on the roof pitches were intact although there were several partially slipped tiles and there were gaps noted under some of the tiles which offered opportunities for roosting (see Plate 5).

*Plate 3: The pitched roof was generally intact.*

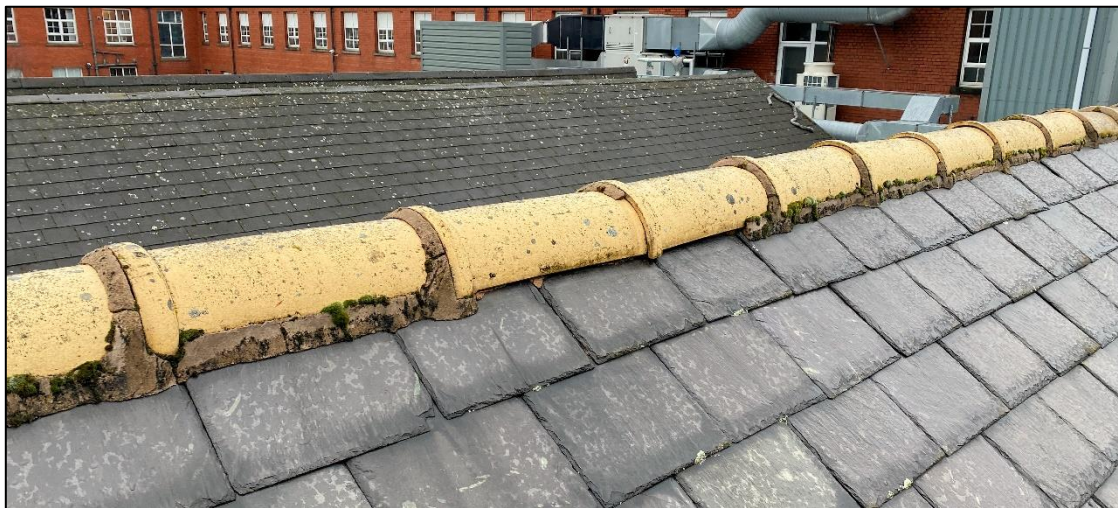
*Plate 4: Whilst the roof was intact, gaps beneath the ridge tiles offered roosting opportunities.*

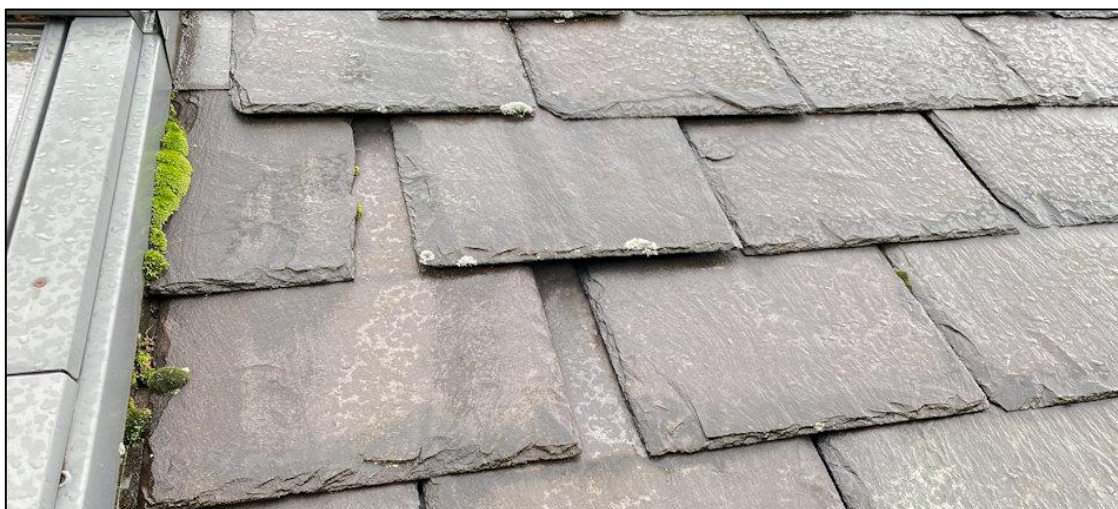
*Plate 5: Gaps were noted beneath the flat tiles that offered further roosting opportunities.*

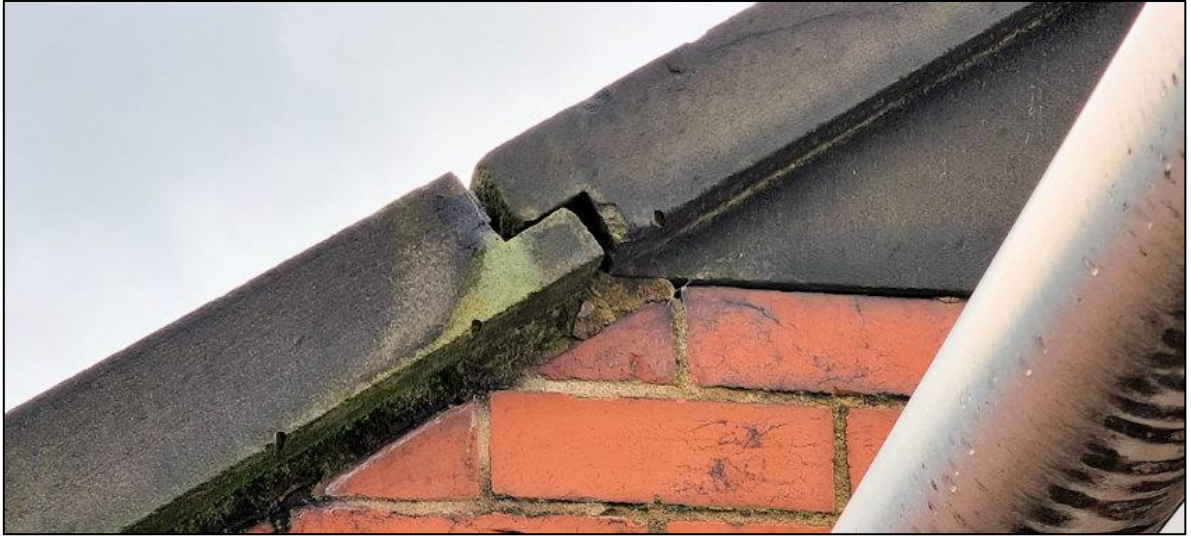
- 3.1.5 The coping stones on the gable ends had gaps between the stones and between the coping and the brickwork (see Plate 6 and Plate 6). Elsewhere, the coping stones were well mortared and these areas offered no roosting potential (see Plate 8).

*Plate 6: The gaps between the coping stones offered roosting potential.*

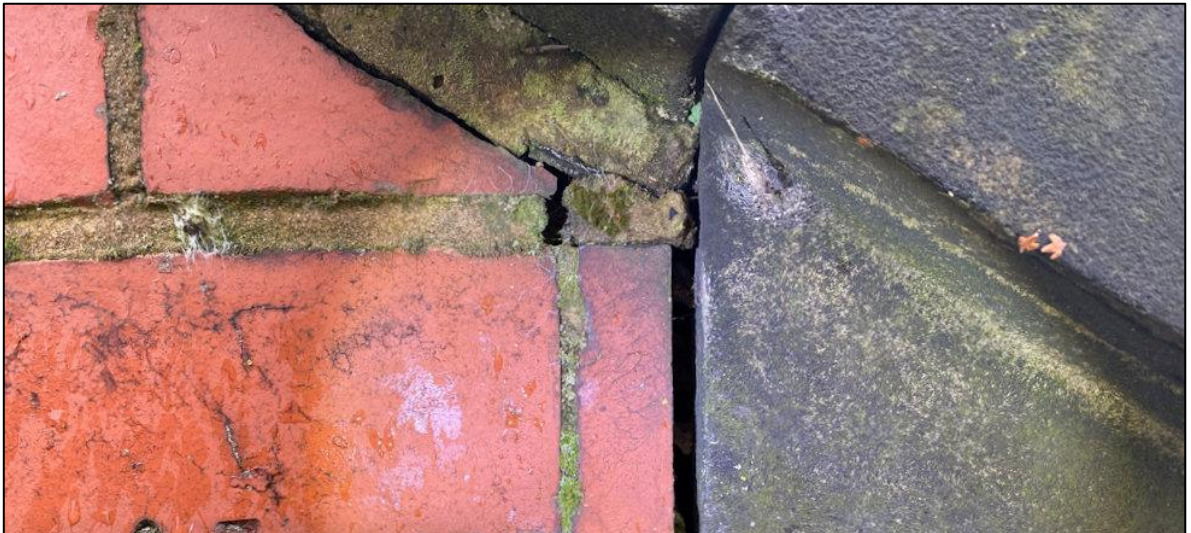
*Plate 7: There were gaps noted at the junction between the walls and the end coping stones offering roosting potential.*

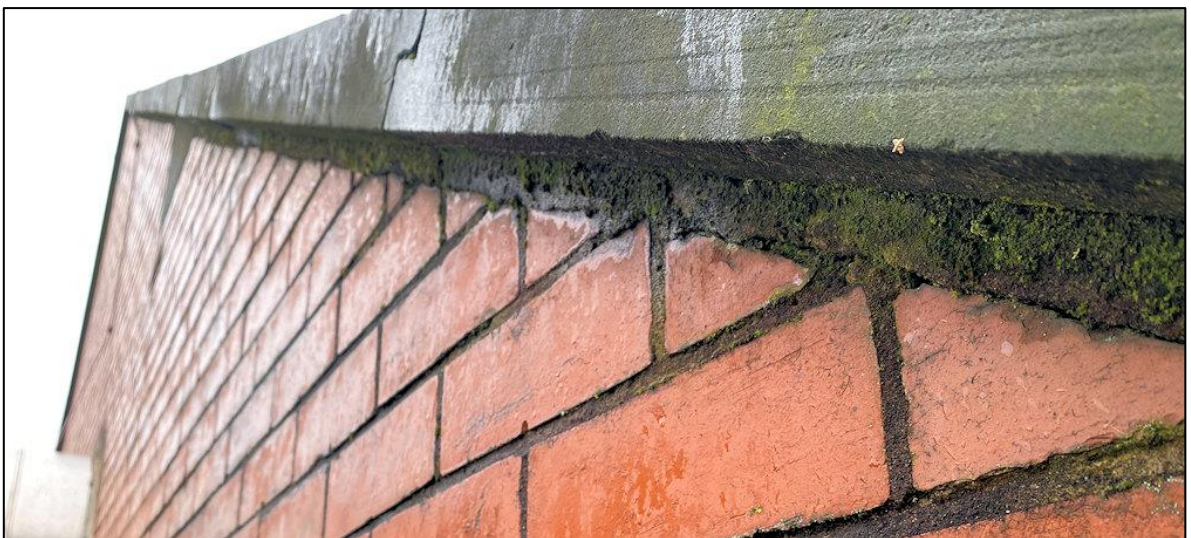
*Plate 8: The mortar beneath the coping stones was generally intact and offered no roosting opportunities.*

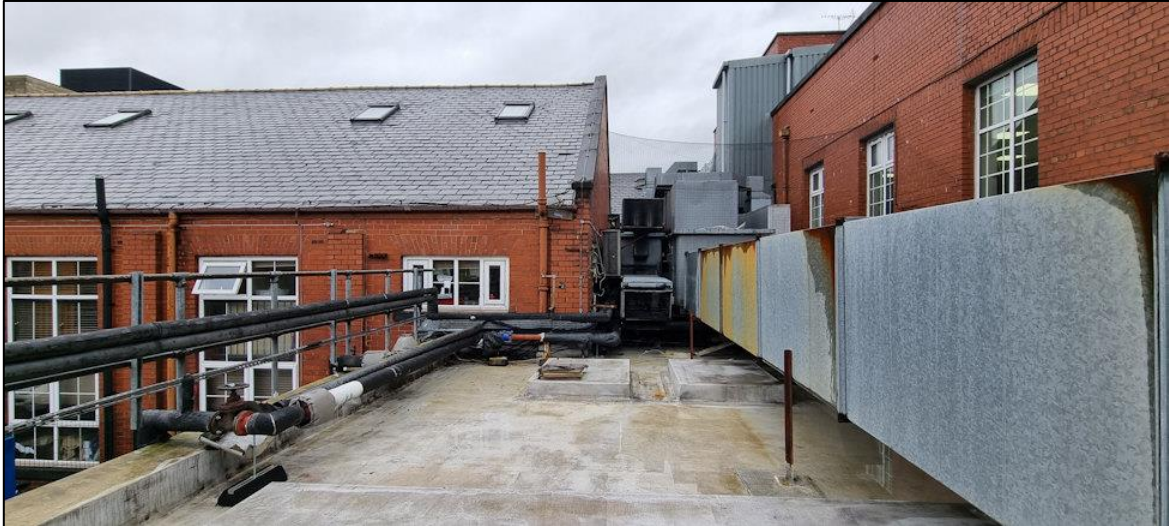
- 3.1.6 The flat roof areas and the external plant were not found to have any roosting potential and, in some areas, had bird netting that prevented access to much of the south facing gable and the plant itself (see Plate 9).

*Plate 9: Elsewhere there were areas of flat roof with external plant; these areas offered no roosting potential.*

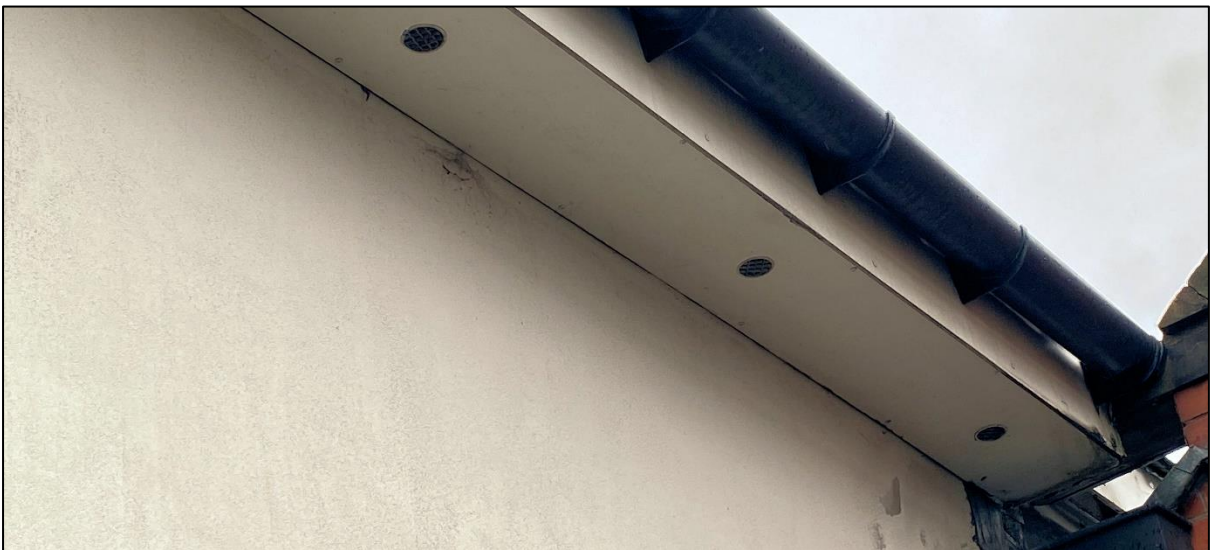
- 3.1.7 The fascia around the target building appeared intact and offered no roosting opportunities (see Plate 10).
- 3.1.8 The soffits of the south facing aspect of the adjacent building were found to be poorly sealed with gaps that offered roosting opportunities (see Plate 11). Similarly, the partial cladding to these aspects was found to have gaps beneath the offered roosting potential (see Plate 12).

*Plate 11: Soffits on the adjoining building were not well sealed and offered roosting potential.*

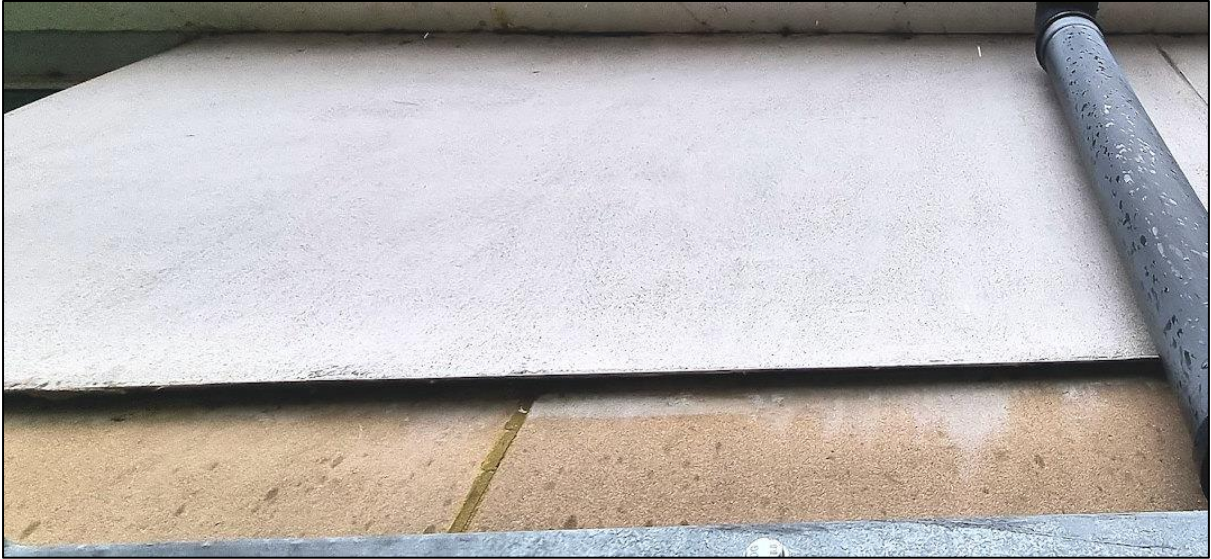
*Plate 12: Cladding on the adjacent building was also found to have gaps beneath offering roosting potential.*

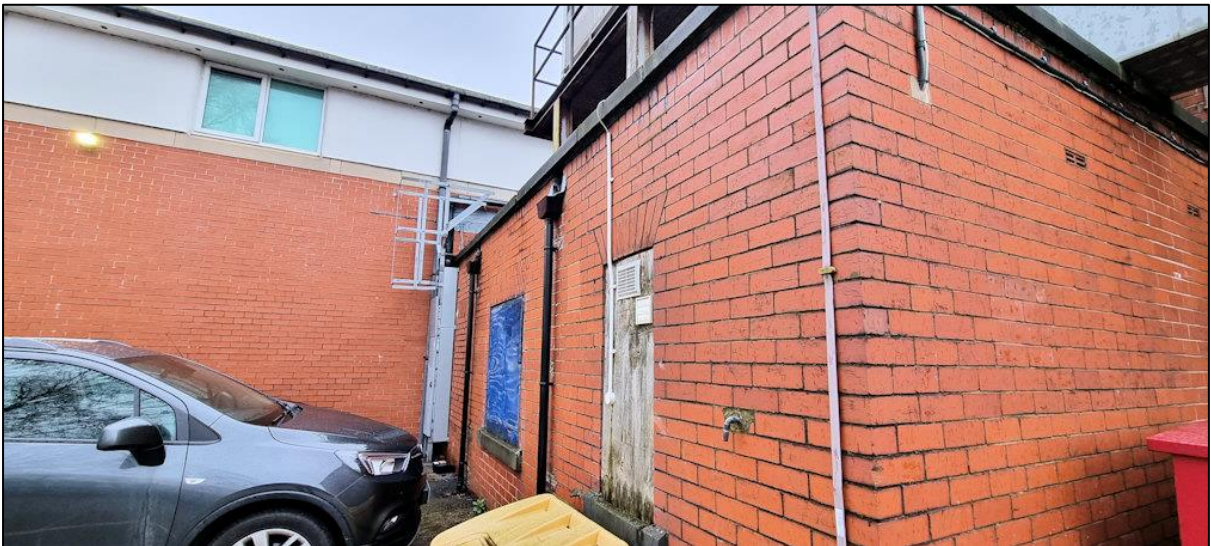
- 3.1.9 The brickwork was intact with no apparent gaps in the mortar (see Plate 13).
- 3.1.10 The window and door frames were intact and these offered no roosting opportunities (see Plate 14 and Plate 15).

*Plate 13: The brickwork was generally intact with no significant gaps in the mortar.*

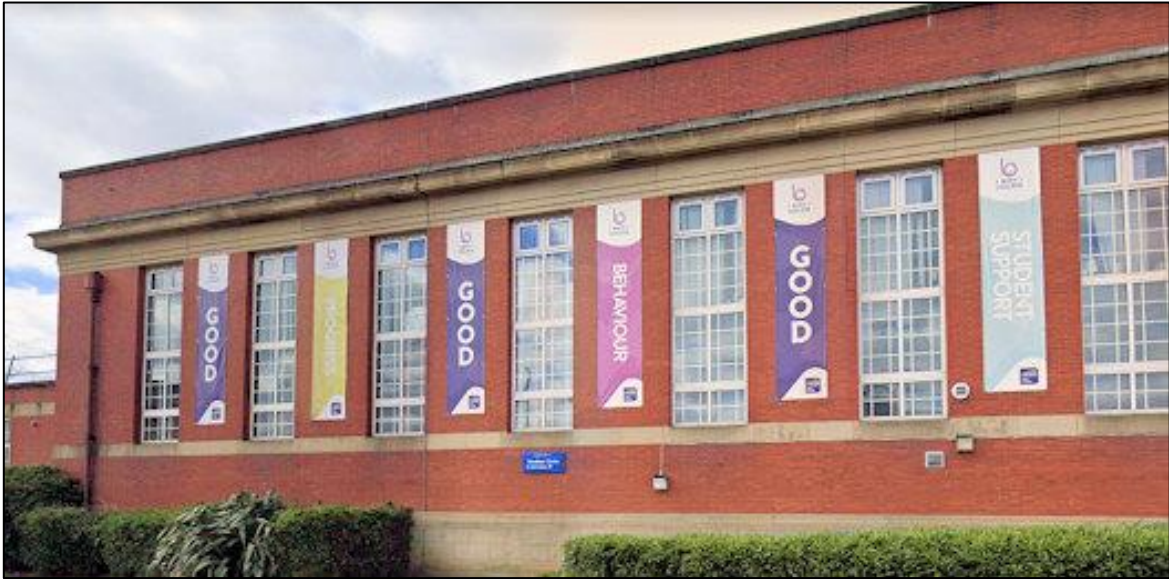
*Plate 15: Windows to the front aspect of the complex were also well sealed and had no bat roosting potential.*

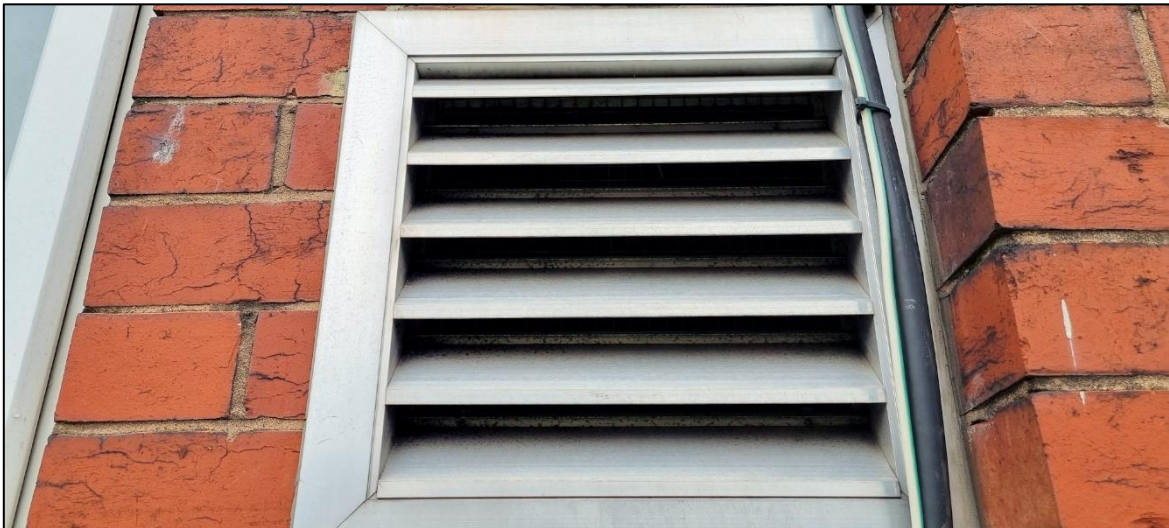
- 3.1.11 A number of vents were also noted but these were found to have internal mesh preventing access to the internal spaces of the building (see Plate 16).

*Plate 16: Vents had internal mesh preventing access for bats to the internal spaces.*

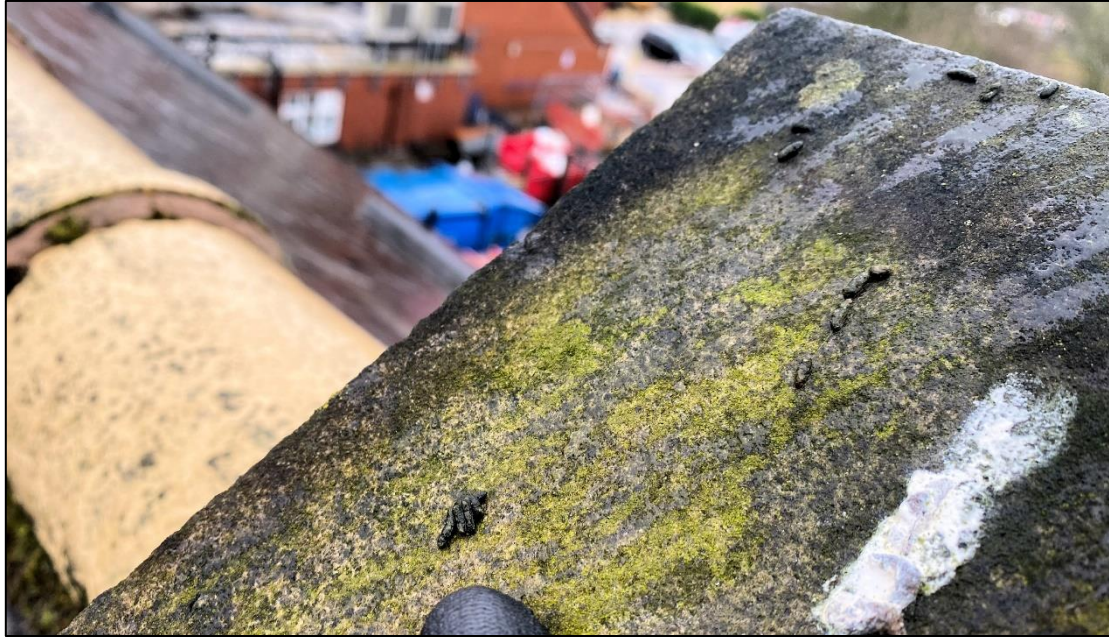
- 3.1.12 The flat surfaces around the building were thoroughly and systematically searched for evidence of bat activity. Droppings were found on the coping stones (see Plate 17) but they could not be confirmed as bat droppings; given their location however, there is considered that there was a reasonable likelihood that they were.

*Plate 17: Droppings were noted on the coping stones but were not confirmed as bat droppings.*

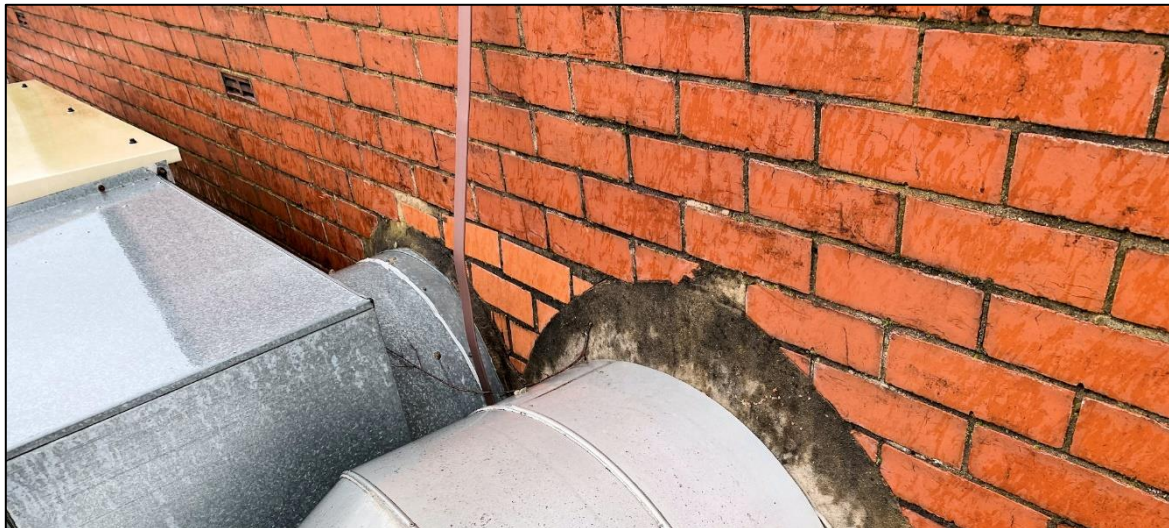
- 3.1.13 Finally, the walls of the building were also searched for evidence of bat activity. The rough surface of the walls provided an ideal substrate for droppings to adhere to and these would have easily been observed, however no further evidence of bats was discovered.

*Plate 18: There was no evidence of bat activity on the walls or flat surfaces around the building.*

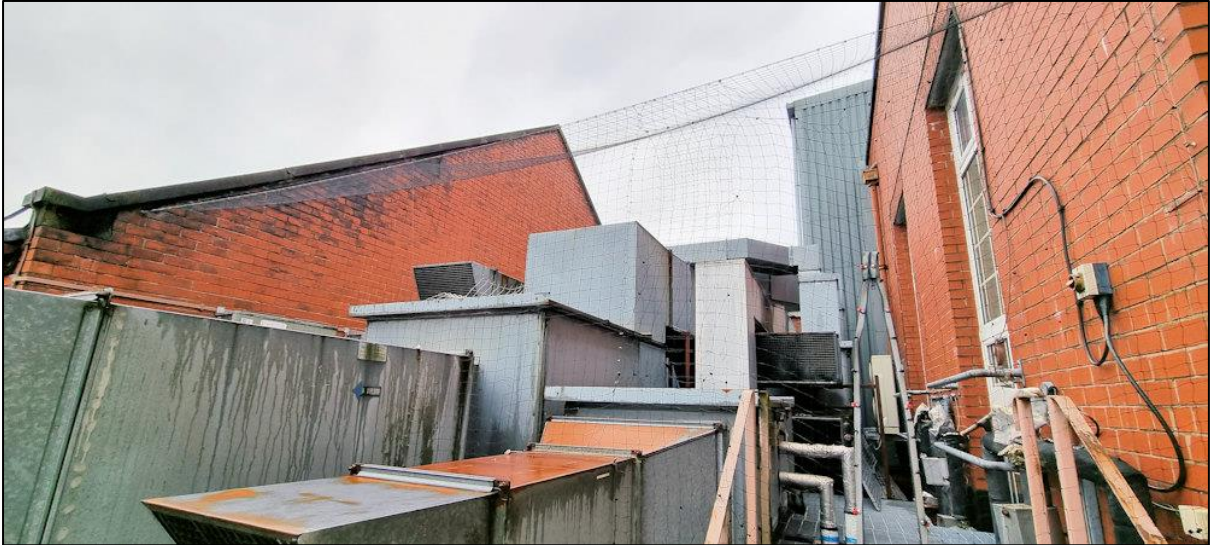
*Plate 19: Bird netting around the external plant effectively excluded bats from some areas.*

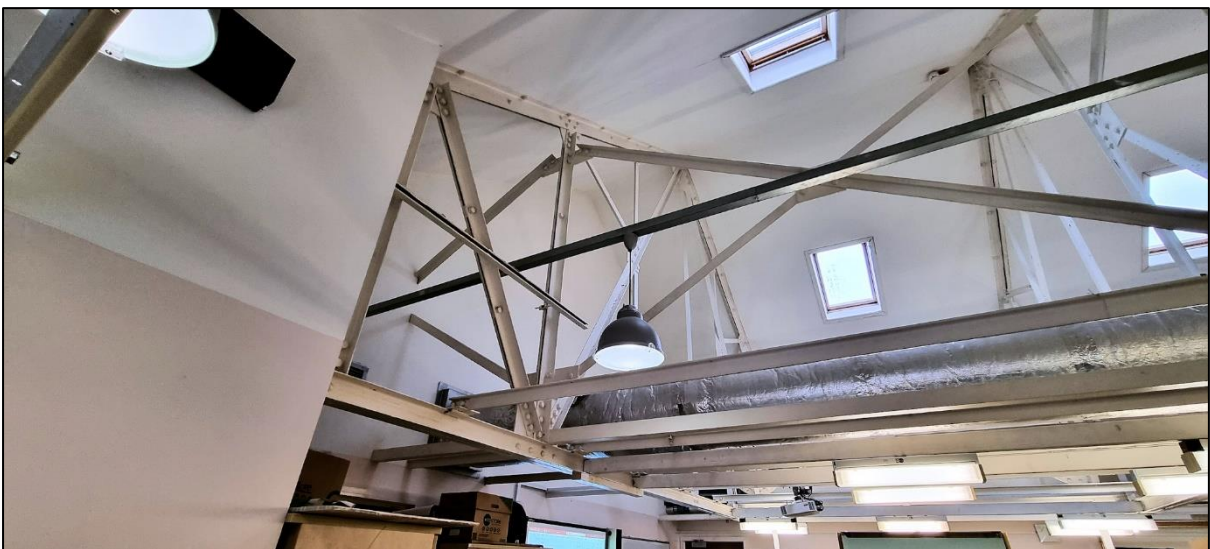
- 3.1.14 There were no roof voids within the building with the upper floors having vaulted ceilings (see Plate 20) and the lower floors had suspended ceilings (see Plate 21).
- 3.1.15 There were no internal teaching spaces or thoroughfares with any suitability for roosting bats or other protected species areas (see Plate 22).
- 3.1.16 **In summary**, the target building was assessed for signs of bat activity and potential roost features. Whilst PRFs were identified across the building, including beneath ridge and flat tiles, there was no evidence of bat activity internally or externally.

*Plate 20: The upper floors had vaulted ceilings with no access to the underside of the roof.*

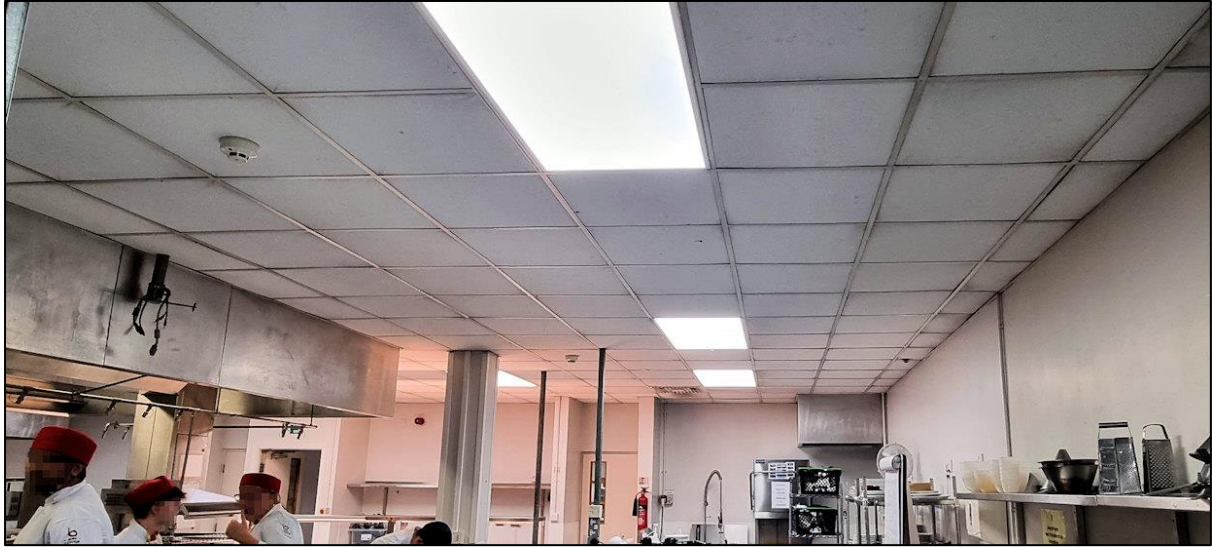
*Plate 21: The ground floor had suspended ceilings and no potential for roosting bats.*

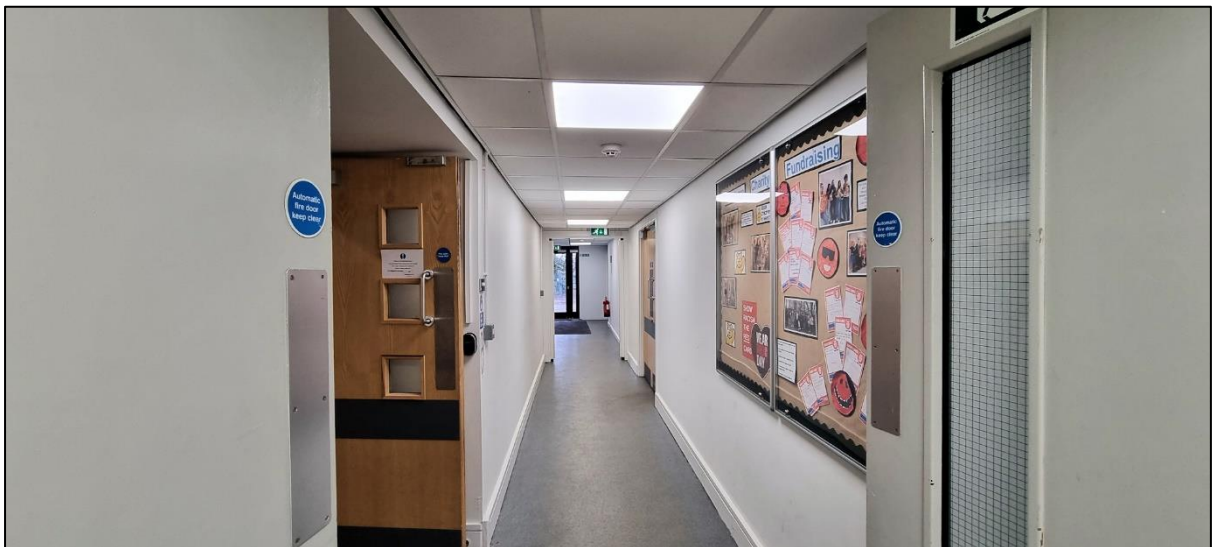
*Plate 22: Internally, there were no suitable areas for roosting bats within the areas for reconfiguration.*

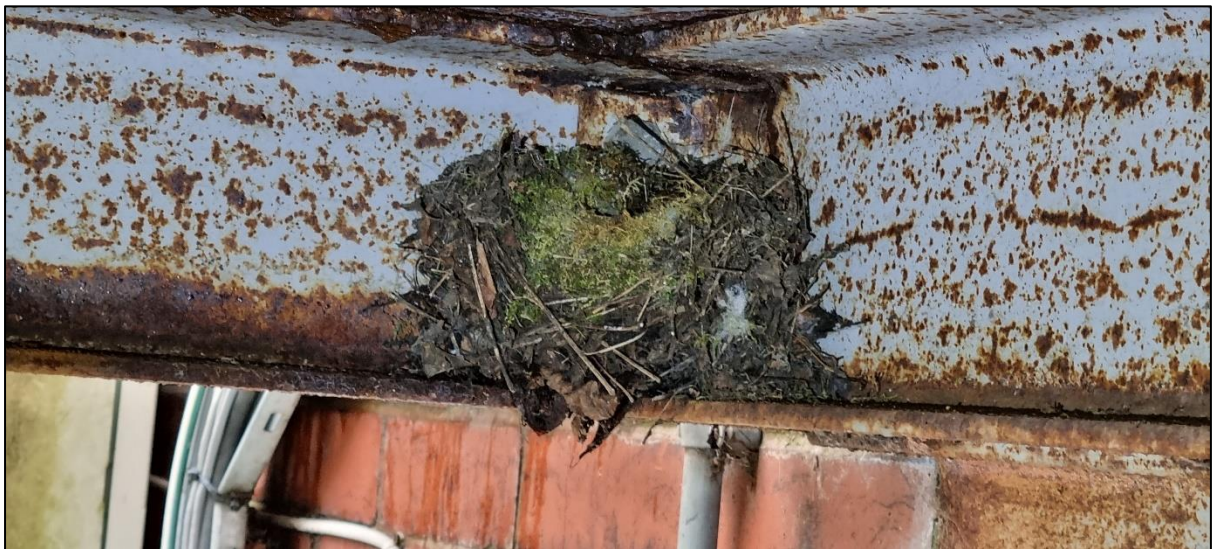
- 3.4.1 A single nest was identified within the roof top plant (see Plate 23). No other nests were identified elsewhere on the building or on the flat roofs.

*Plate 23: A single nest with fresh dry moss was identified within the rooftop plant.*

4.3.1 Given the presence of a nest on the external plant and the possibility of nesting on the flat roofs on the building, the existing site clearly presents opportunities for breeding birds.

- *It is recommended* that all demolition work should be carried out outside of the bird breeding season (March to August inclusive). Where this is not possible, a suitably qualified ecologist should carry out a check to confirm the absence of nesting birds immediately prior to works commencing. If a bird nest in current use is discovered, then an appropriate buffer zone around the nest should be created where works can only continue after the nest is vacated. This should be implemented by way of a Planning Condition. **Reason:** This will ensure that no offences are committed under The Wildlife and Countryside Act 1981 (as amended). The bird-nesting season is generally regarded to extend between March and August inclusive.
