## **REMEDiation STRATEGY REPORT**

**FOR  
LAND AT  
BILLBERRY CLOSE  
AND ALBERT ROAD,  
WHITEFIELD,  
GREATER MANCHESTER**

**PREPARED FOR  
THOMPSON CONTRACTS  
(BLACKPOOL) LIMITED**

**REPORT NO. 8130E  
REVISION 1  
JULY 2025**

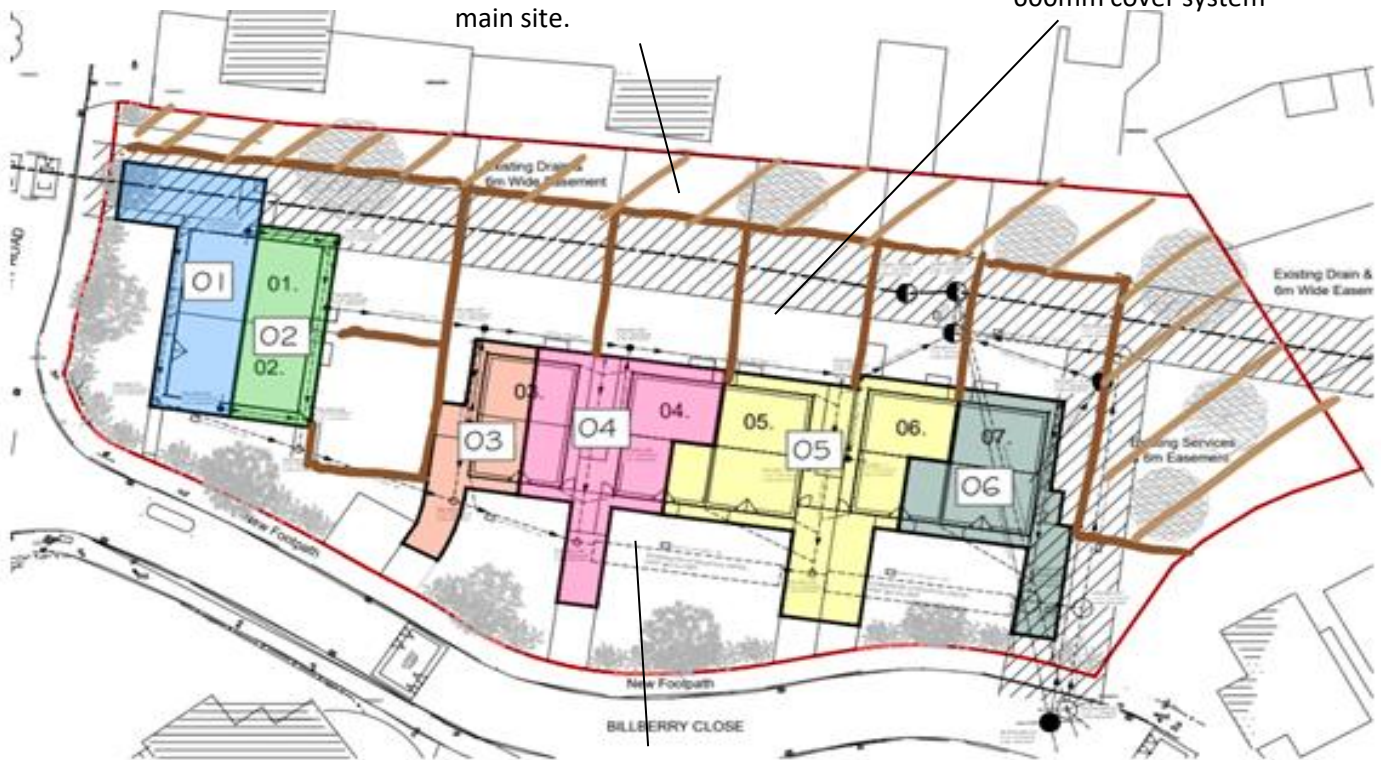
Hatched area to remain fallow and segregated from main site.

Rear gardens to incorporate 600mm cover system

Front & side gardens to incorporate 450mm cover system.

We understand that it is proposed to erect seven residential bungalows (three pairs of semi-detached and one detached), with driveways, gardens and landscaped areas, as shown in Figure 3.

It should be noted that the proposed layout has been revised since our previous report with the changes including reduced rear garden sizes and a fallow area along the northern boundary of the site.
