## **GROUND INVESTIGATION REPORT**

**FOR  
LAND AT  
BILLBERRY CLOSE  
AND ALBERT ROAD,  
WHITEFIELD,  
GREATER MANCHESTER**

**PREPARED FOR  
THOMPSON CONTRACTS  
(BLACKPOOL) LIMITED**

**REPORT NO. 8130D  
JULY 2025**

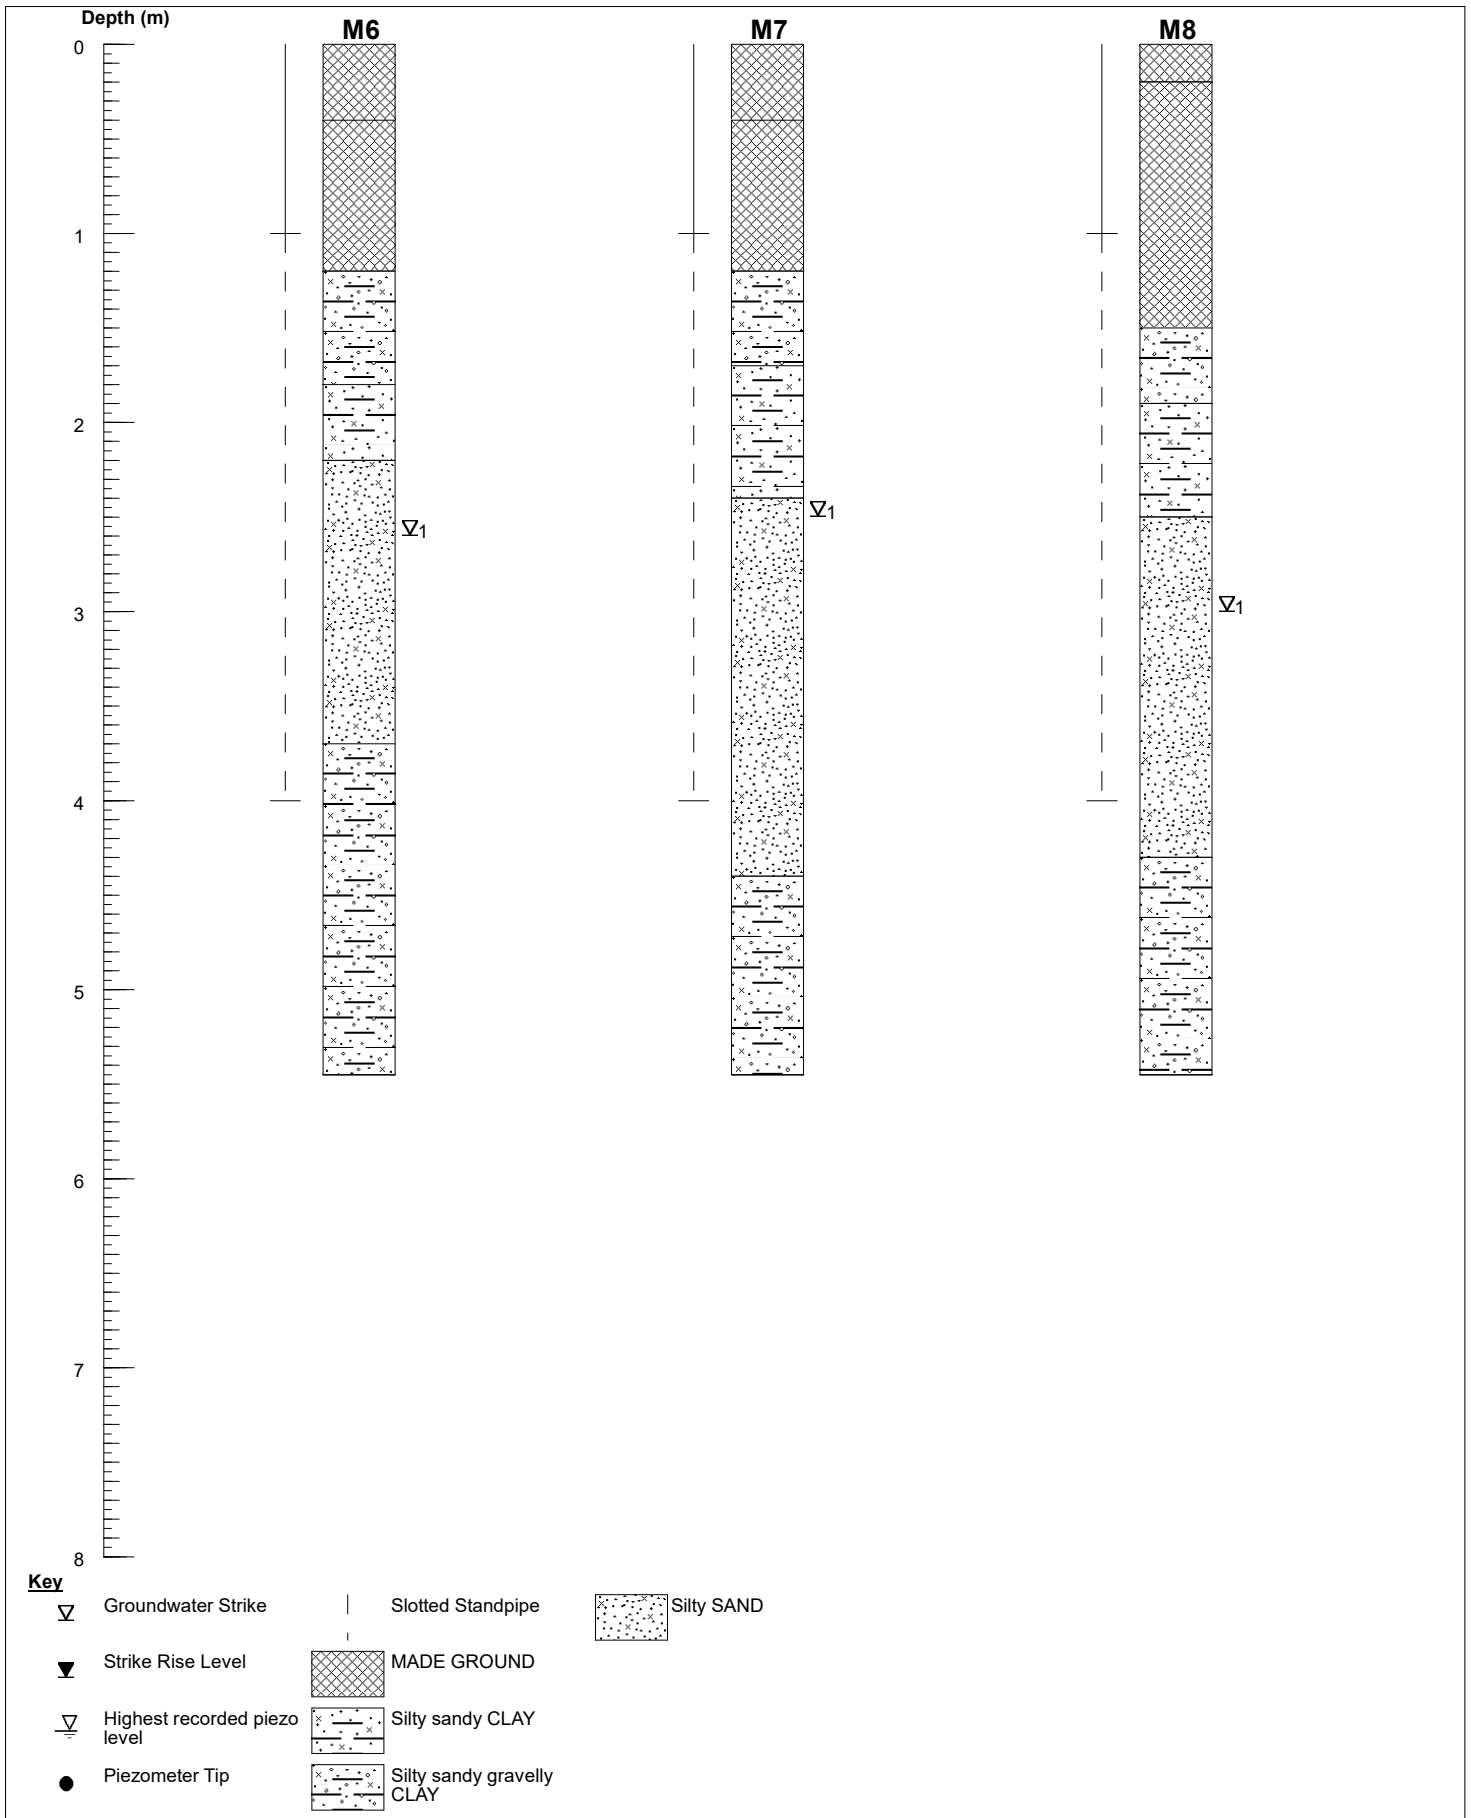
| Exploratory Hole Number | Depth of Made Ground (m) | Depth of Cohesive Drift Deposits (m) | Depth of Granular Drift Deposits (m) | Depth of Hole (m) |
|---|---|---|---|---|
| M8 | 1.50 | 1.50 – 2.50<br>4.30 – >5.45 | 2.50 – 4.30 | 5.45 |

The above was underlain by granular drift deposits, which were found to be dark brown silty to very silty fine to coarse sands, with a band of clay at 3.25m to 3.45m in M6, to depths of 3.70m, 4.40m, and 4.30m respectively.

Groundwater inflows were encountered at depths of 2.60m in M6, 2.50m in M7, and 3.00m in M8.

Monitoring of standpipes installed in M6, M7 and M8 between 28<sup>th</sup> May 2025 and 4<sup>th</sup> July 2025 found groundwater to be at 3.03m to 3.14m, 3.01m to 3.15m, and 2.91m to 2.98m respectively.

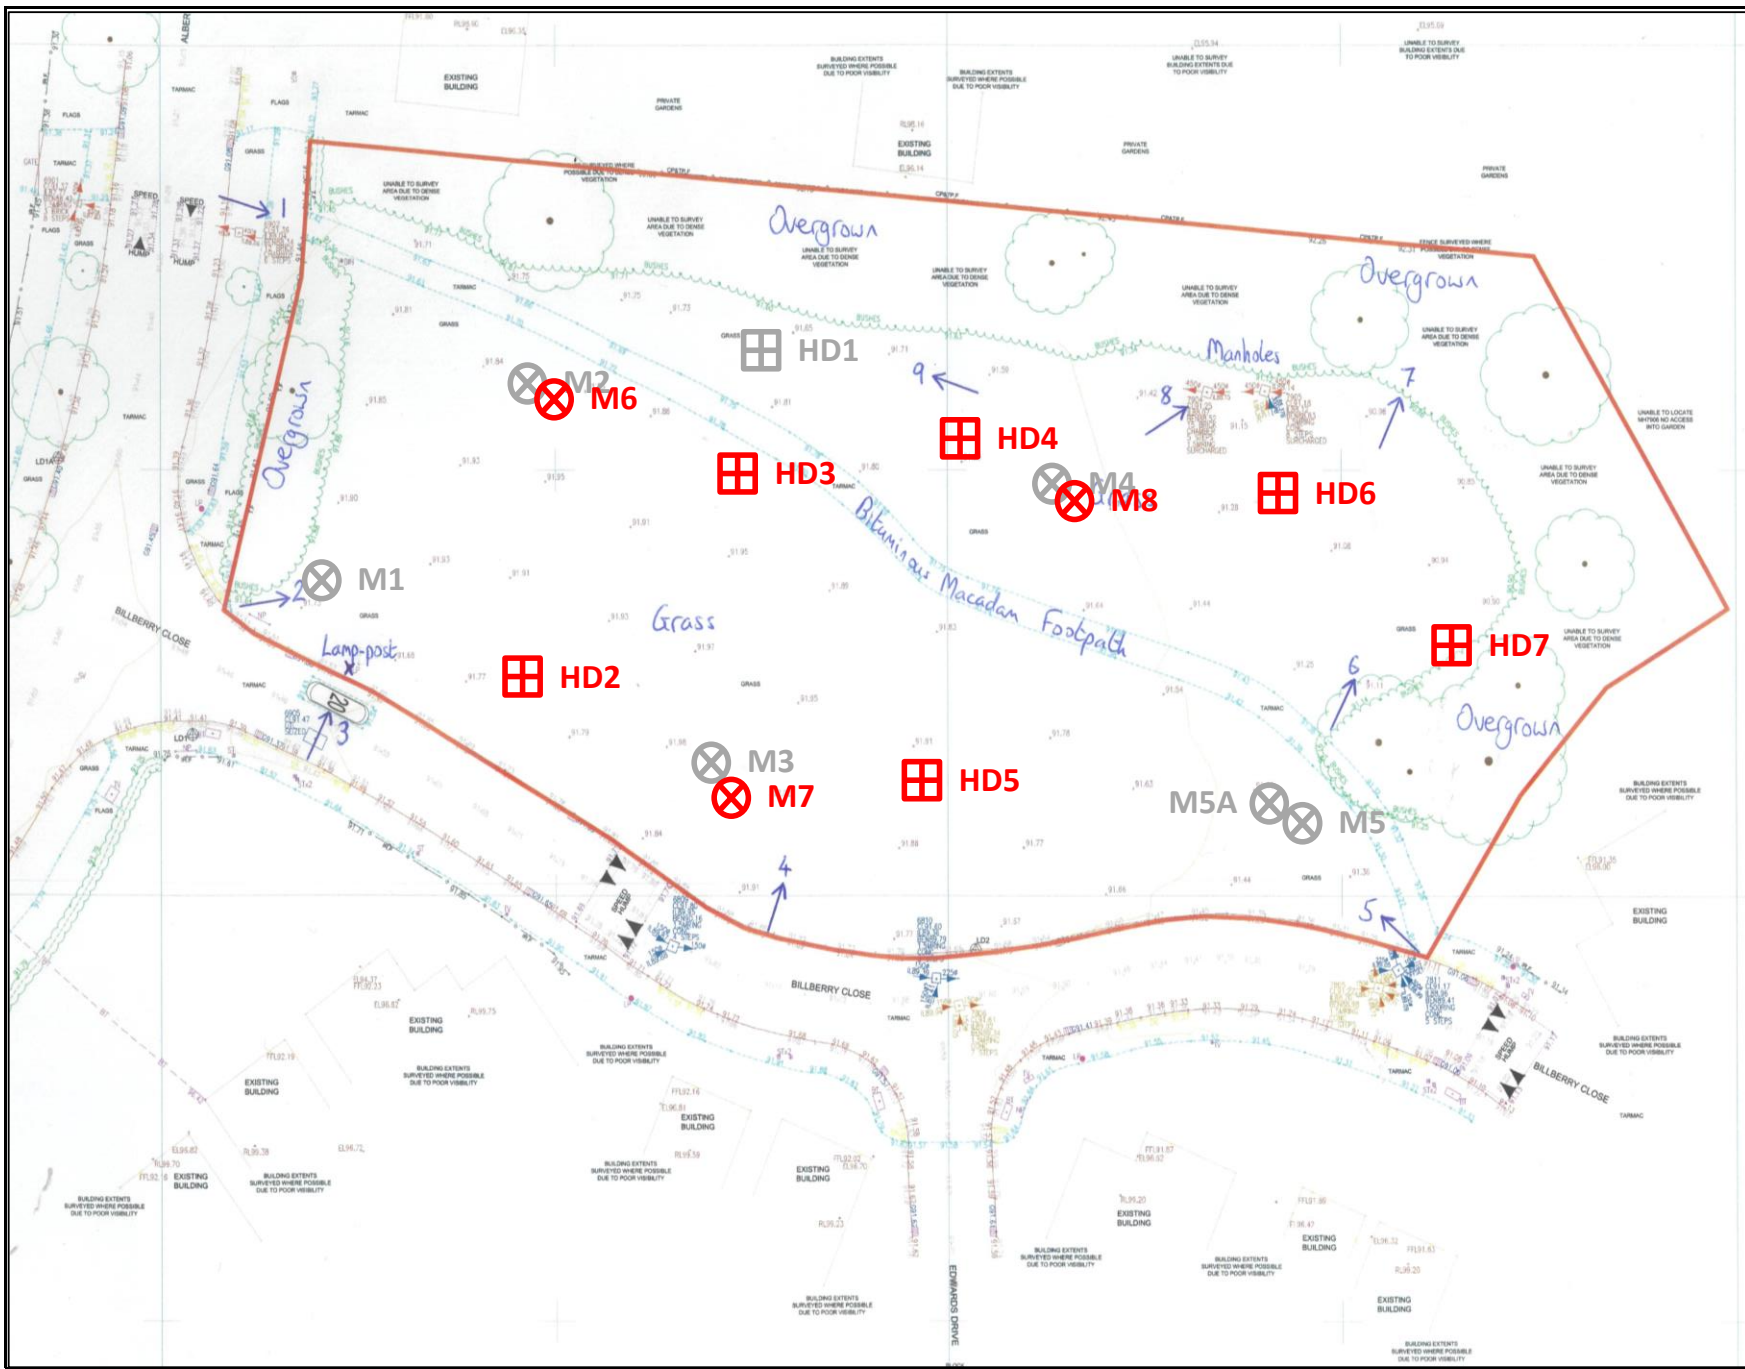
**Site Plan / Walkover Photo Locations**

As shown in Figure 2, the site comprises an irregular shaped plot of land of 0.3ha. At the time of the walkover carried out for the Phase I Report (27<sup>th</sup> November 2024), the site comprised a predominantly grassed area with overgrown areas in the north, east and west and a bituminous macadam surfaced footpath running from northwest to southeast. The site is bound by 8-16 and 38 Regal Close to the north, 31-35 Brook Drive to the northeast, 17-19 Billberry Close to the southeast, Billberry Close to the south, and Albert Road to the west.

Six hand dug trial pits were taken out at the positions determined and set out by Sub Surface North West Ltd, as shown on Figure 2. The hand dug trial pits were excavated to a depth of 1.20m. Samples were taken for logging, in accordance with BS.5930:2015+A1:2020, and testing. The resulting Hand Dug Trial Pit Records are appended. On completion the hand dug trial pits were backfilled with arisings.
