## Preliminary Roost Assessment

Fairfield General Hospital, Rochdale Old Road, Bury BL9 7TD

This report is prepared to inform a planning application with the Bury Metropolitan Borough Council. The proposal is described as: The reroofing of the existing boiler house.

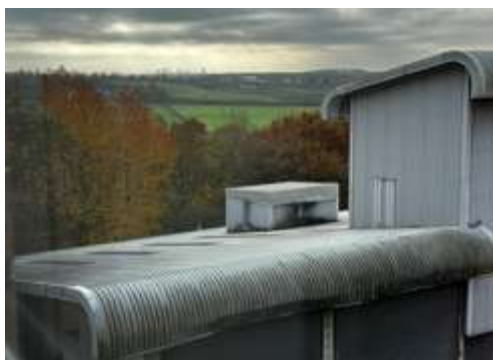
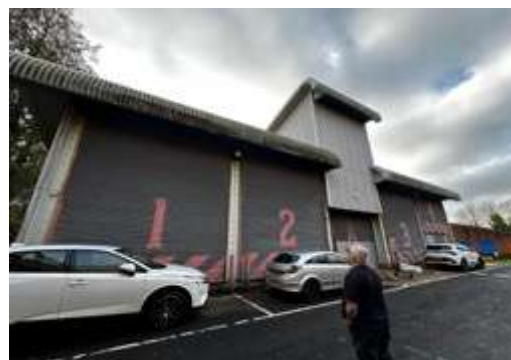
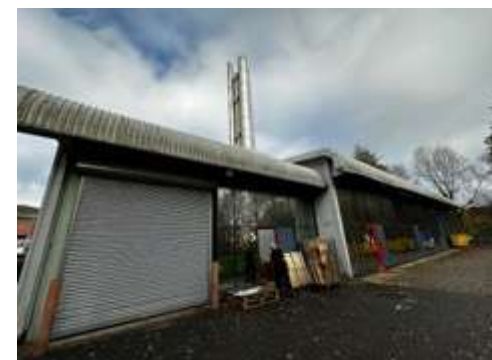
**Building One (B1) – Overview**

B1 is a boiler rooms located along the southern boundary of the hospital campus and comprises several interconnected industrial units constructed with steel framing and clad throughout in vertically oriented corrugated metal sheets, with a combination of curved corrugated metal roofing and shallow pitched sheeted roofs that incorporate flush roof-light boxes. External elevations include large roller-shutter service doors set within metal surrounds, enclosed eaves, continuous metal flashings, and sealed junctions along roof edges and corners.

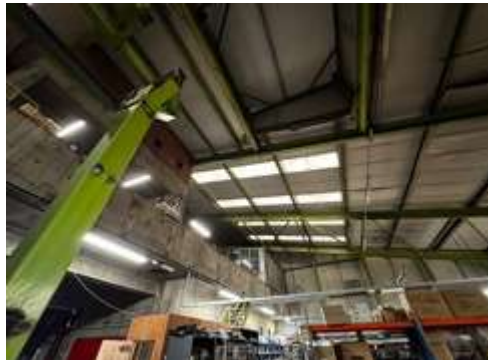
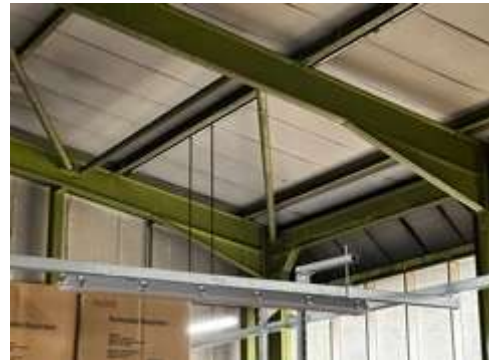
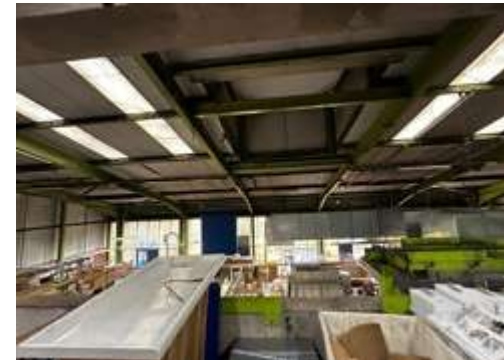
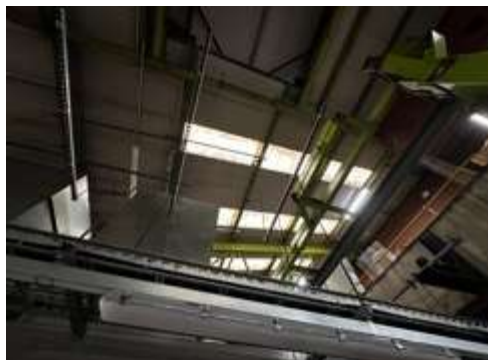
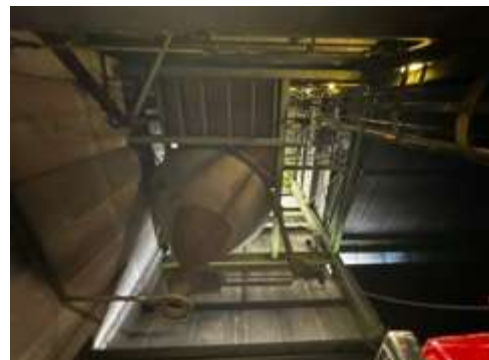
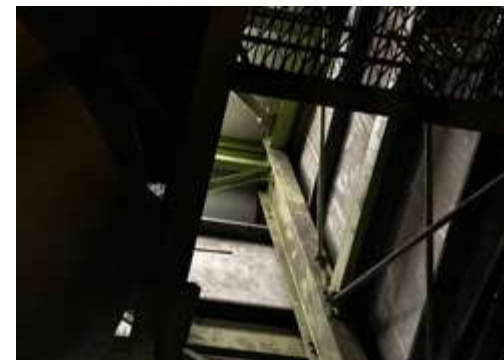
**Internal Inspection**

The internal space of B1 comprises a large open industrial workshop/storage area formed by exposed steel framing, supporting insulated profiled metal roof panels and translucent roof-light strips set between the beams. The walls are lined with metal cladding above a lower section of blockwork, and the interior contains extensive fixed plant, mezzanine walkways, suspended ducting, and storage racking. Lighting is provided by suspended fluorescent fittings hung from the steel frame large single glazed windows and translucent panels along the ceiling, with various access platforms and gantries are installed around the machinery. The roof structure shows continuous panel joints with no open voids, while the internal elevations present smooth, sealed surfaces typical of an insulated metal-clad unit.

The interior is brightly lit, heavily disturbed, and fully open with no enclosed voids, crevices, or gaps within the steel framing or roof junctions that could provide roosting opportunities. The insulated panels meet tightly along the beams, and the combination of constant human activity, machinery, and illumination further reduces any potential for bat use. In addition, in metal panel will experience fluctuation in temperature, varying the conditions within the building on a daily basis. This is like to deter bats from roosting internally.

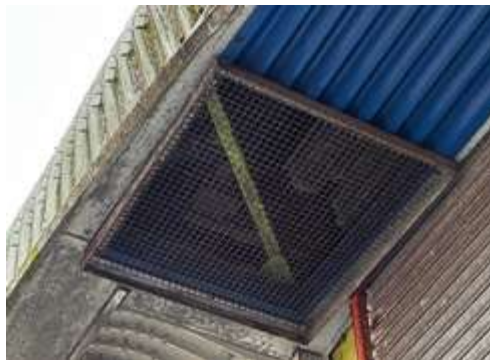
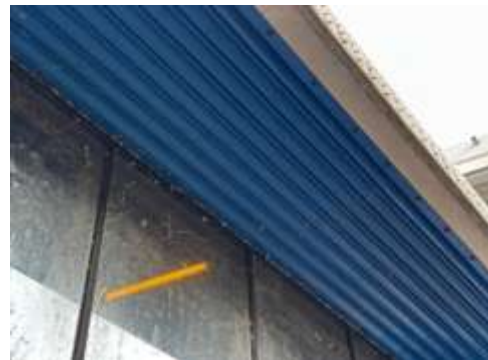
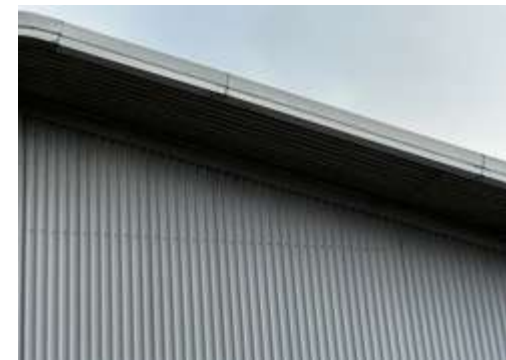
### **External Inspection**

The external elevations consist of vertically aligned corrugated metal cladding across all façades, with a mix of shallow-pitched and curved corrugated metal roofs incorporating sealed junctions, flashing strips and enclosed eaves. Several protruding roof structures and ventilation boxes are present on the main roofscape, all formed from the same insulated metal panelling system. Roller-shutter doors sit within metal surrounds on the main frontage, while other elevations include fixed mesh-covered vents, glazed panels and isolated service fittings. Some sections show localised dents, staining and wear, but the cladding, roof edges and soffit interfaces remain generally tight fitting. The building offers no continuous gaps along the eaves, no lifted sheets and no crevice-forming defects within the cladding or roof junctions. Vents and openings are either sealed or mesh-covered. The metal construction provides smooth, uniform surfaces with no sheltered recesses, and the exposed location and lighting reduce any potential for use by bats.

| | <b>Suitability Assessment</b><br><br>B1 is assessed to provide negligible suitability for roosting bats. Its construction is dominated by smooth corrugated metal cladding, tight-fitting insulated roof panels, enclosed eaves, and sealed junctions with no crevices or voids that could offer shelter. External features such as vents are either flush or mesh-covered, and internal areas are brightly lit, open, and subject to regular disturbance from machinery and human activity. No evidence of bats or potential access points was noted. |

| <i>Recommendations</i> | No further surveys are required. In the unlikely event that a bat or roost is discovered during the development, all works must stop immediately and an appropriately licensed ecologist consulted. |
